**DRAFT
2003 ANNUAL REPORT FOR THE
BIG TUJUNGA WASH
MITIGATION BANK**

**LOS ANGELES COUNTY
DEPARTMENT OF PUBLIC WORKS
900 South Fremont Avenue
Alhambra, California 91803-1331
(626) 455-6138**

**CHAMBERS GROUP, INC.
17671 Cowan Avenue, Suite 100
Irvine, California 92614
(949) 261-5414**

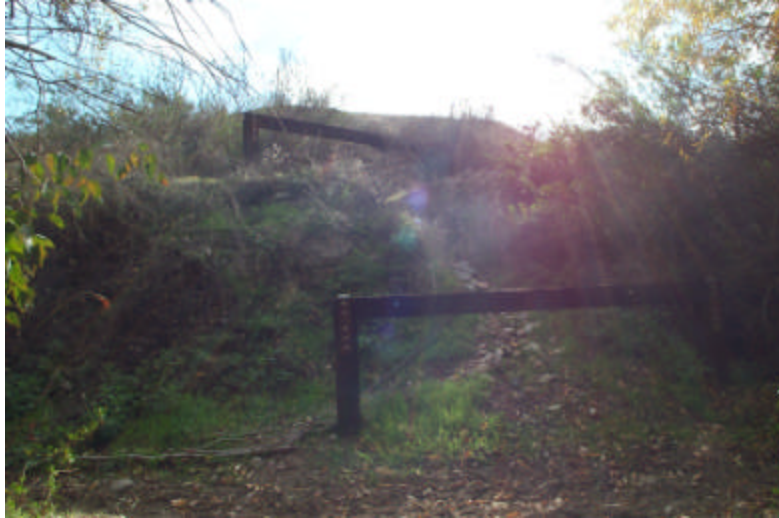
Figure 8-3a: Railroad ties used to repair the erosion gully below the Cottonwood bluff.

The erosion gully located below the Cottonwood bluff was repaired during the fall of 2003. The Flood Maintenance department used railroad ties to block off the gully from trail use. The erosion gullies in the upland area have not been repaired yet. Figure 8-3 shows the condition of the repaired Cottonwood gully and the upland erosion issues. Figure 8-4 shows the checklist for the trails monitoring tasks that have been completed thus far.

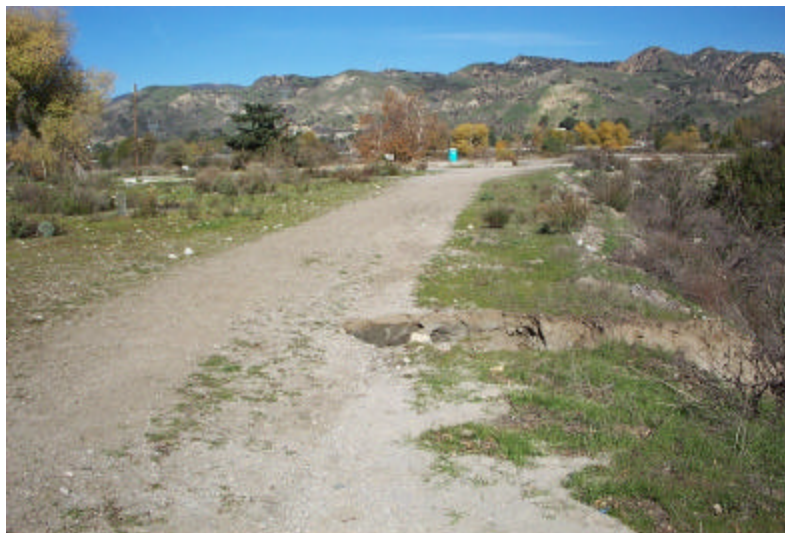
Figure 8-3b: Erosion gully near the upland area.
