Effects of Reduced Outflow from Prado Dam Water Conservation 2015/2016

Report to

Natural Resources Department
Orange County Water District

January 2016

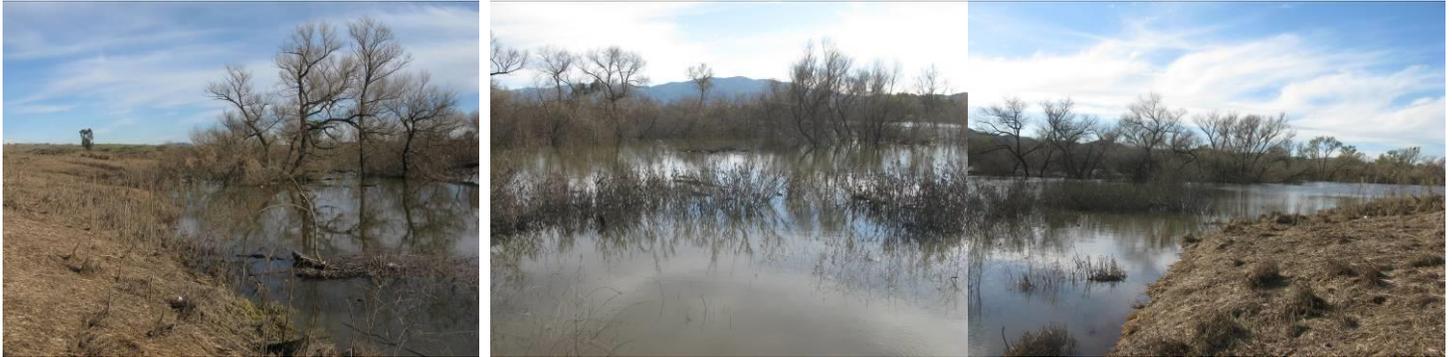
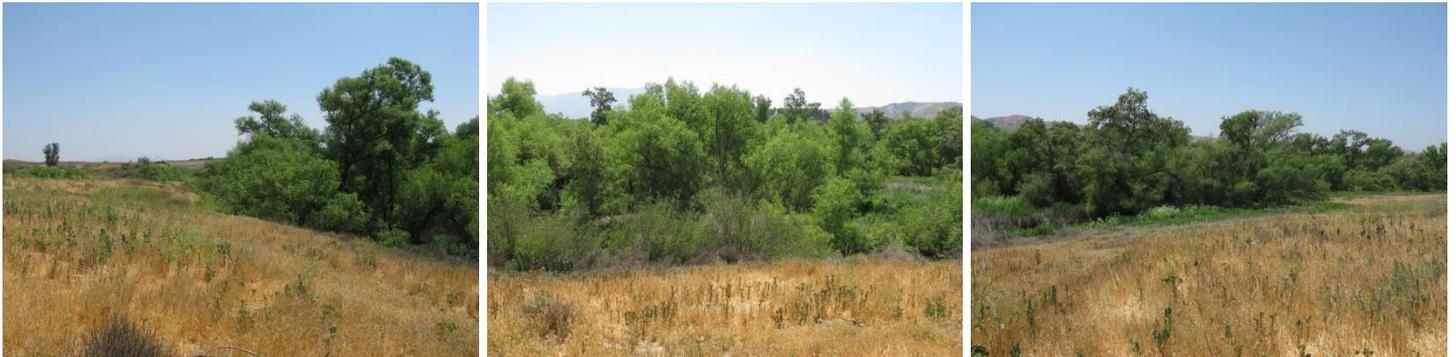
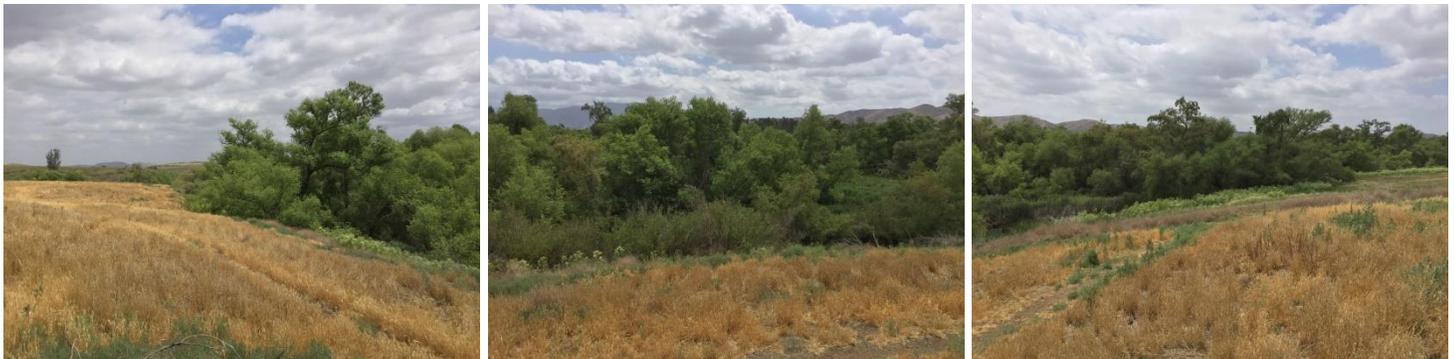
Figure 6: Photo Station #8

Mulefat clump in the center photo showing continued significant regrowth into 2016 after inundation.

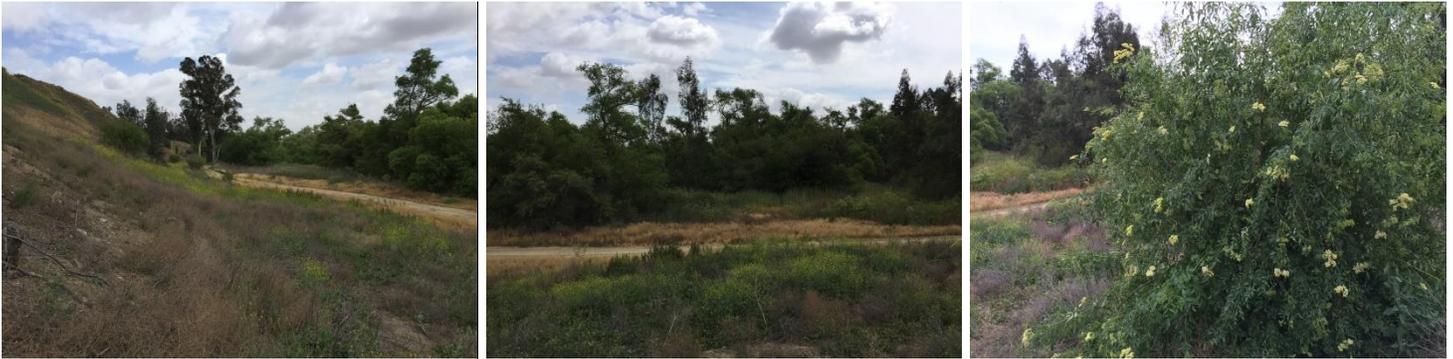
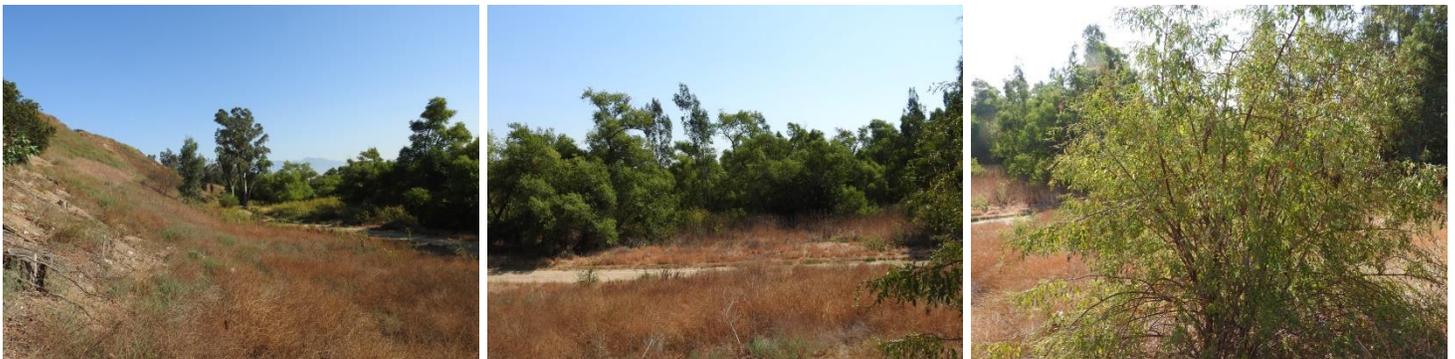
Figure 7: Photo Station #6

This point is located just north of Prado dam and sees regular inundation during the rain year. The habitat in the photos ranges in elevation from 495-498 ft. The Black Willows are in prime condition whereas the mulefat was slow to recover from sustained inundation during 2010-11. Crown sprout and seedling recruit was visible by mid-late summer 2012. Note the drought stress of the Mexican elderberry in the third picture.

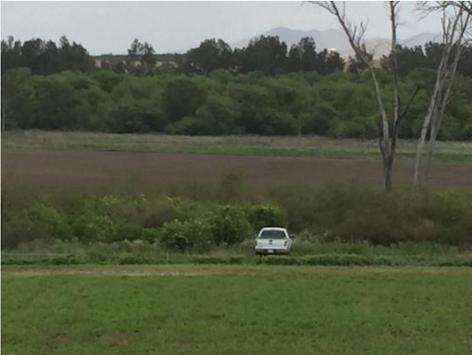
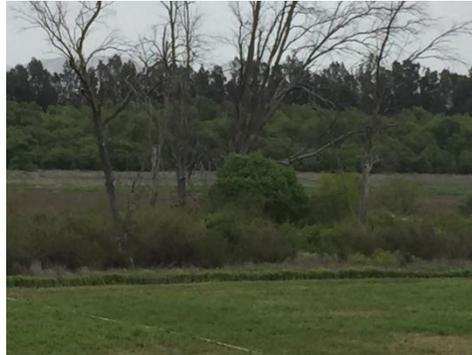
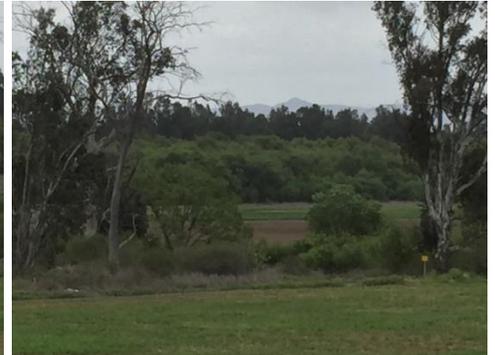
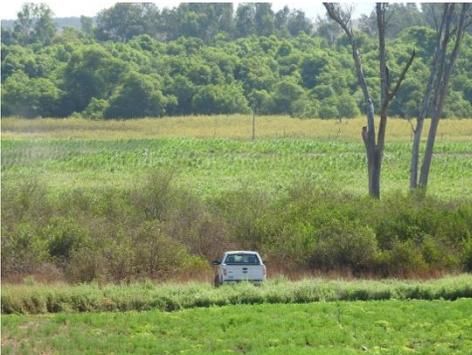
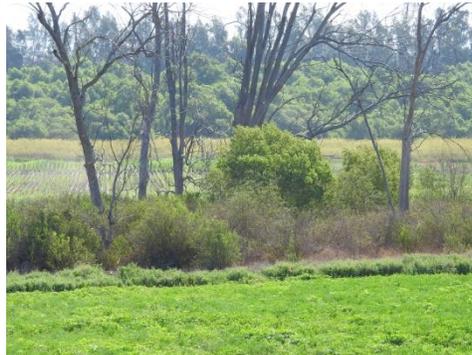
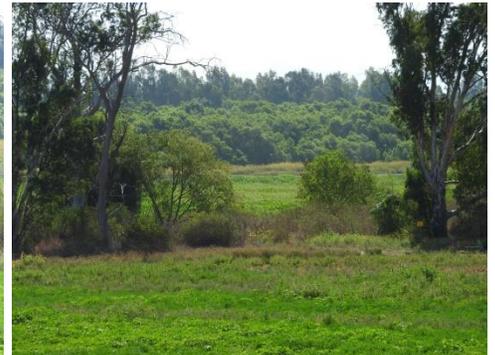
Figure 8: Photo Station #1

Overlooking a mitigation site along the 71 Hwy in Chino this site features the Chino Creek riparian belt in the background as well as a mulefat dominated band situated between two agricultural fields. This site often becomes inundated during high water years. The vegetation at this site was thought to be all wiped out by the floods of 2010-11, but has since shown significant regrowth through 2016.

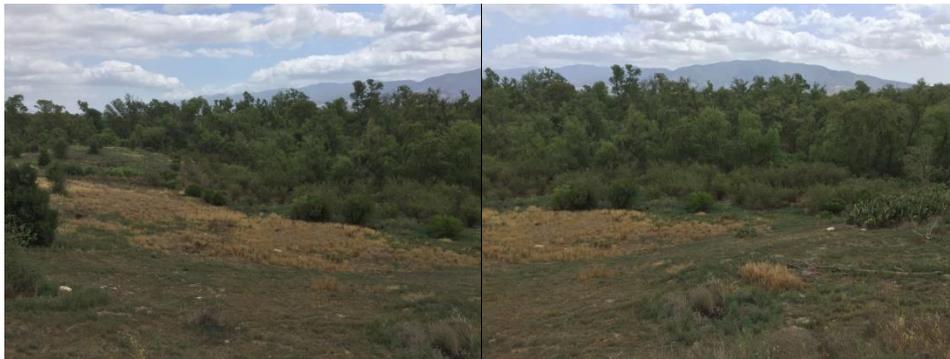
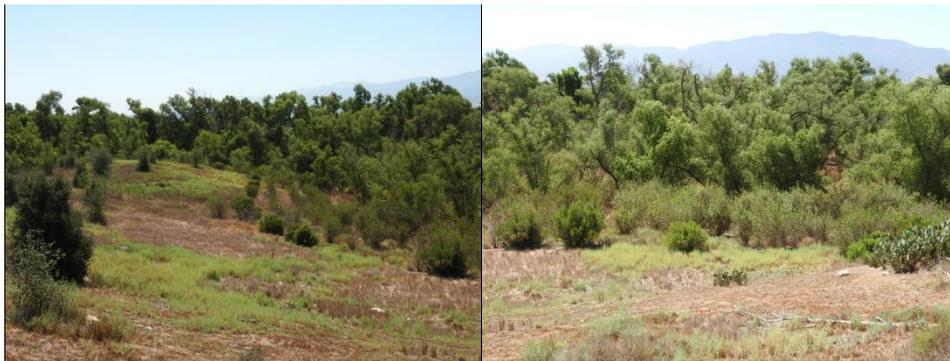
Figure 9: Photo Station #11

This station is located just upslope of Mill Creek. The light green foliage in the immediate foreground of the tree line is mulefat. This part of the creek is affected by the Prado Dam pool. Standing water inundates the habitat in most normal to high water years. Even with the typical inundation the mulefat/black willow habitat has been very healthy through 2016.
