February 29, 2024

**Subject:** Status Report for the Oak Woodland Habitat Revegetation/Mitigation Program for the Santa Anita Dam Riser Modification and Reservoir Sediment Removal Project, Los Angeles County, California

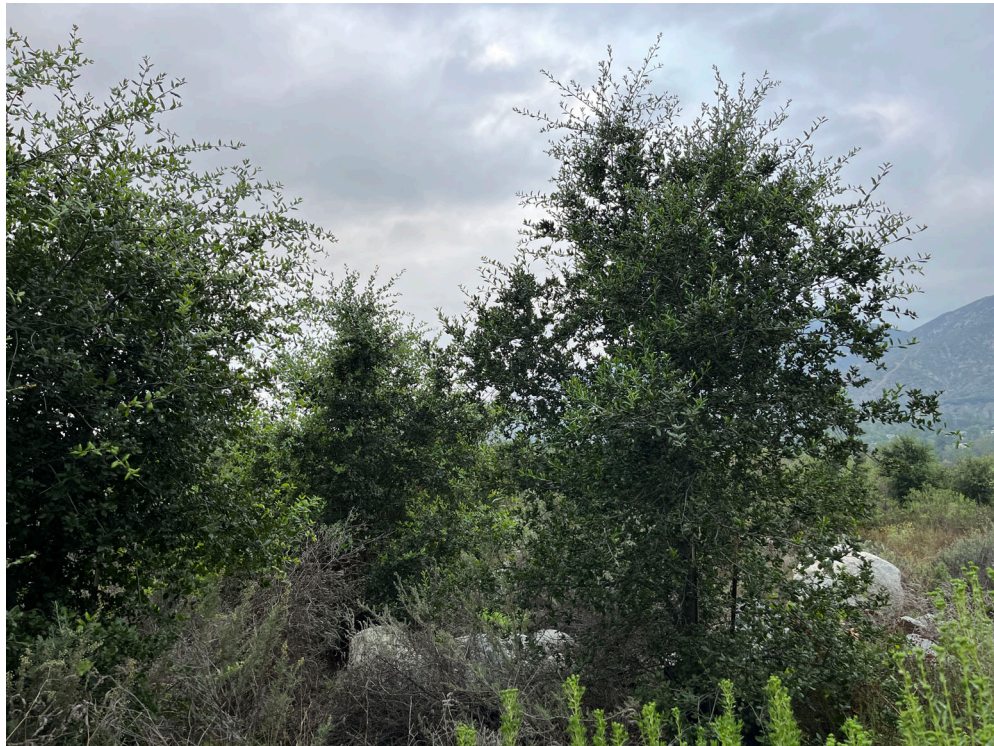
**September 2023.** The planted oaks exhibit good survival, growth, and drought resiliency.

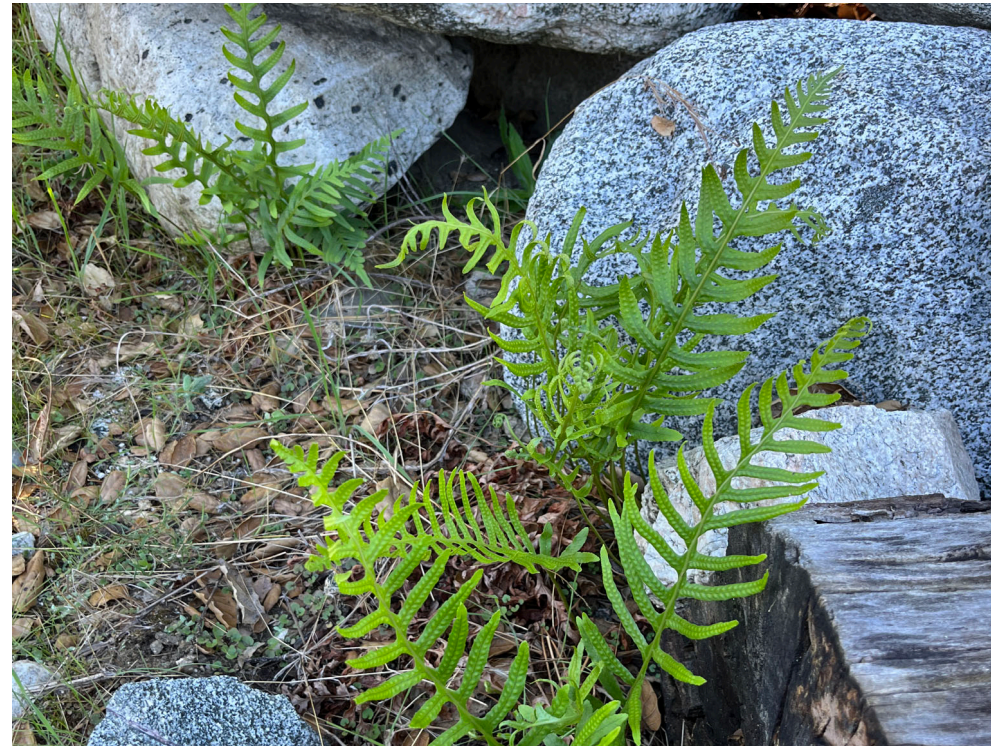
**October 2023.** More than 600 native ferns of 7 species such as California polypody (shown here) were planted on the mitigation site and ongoing fern regeneration is being observed.

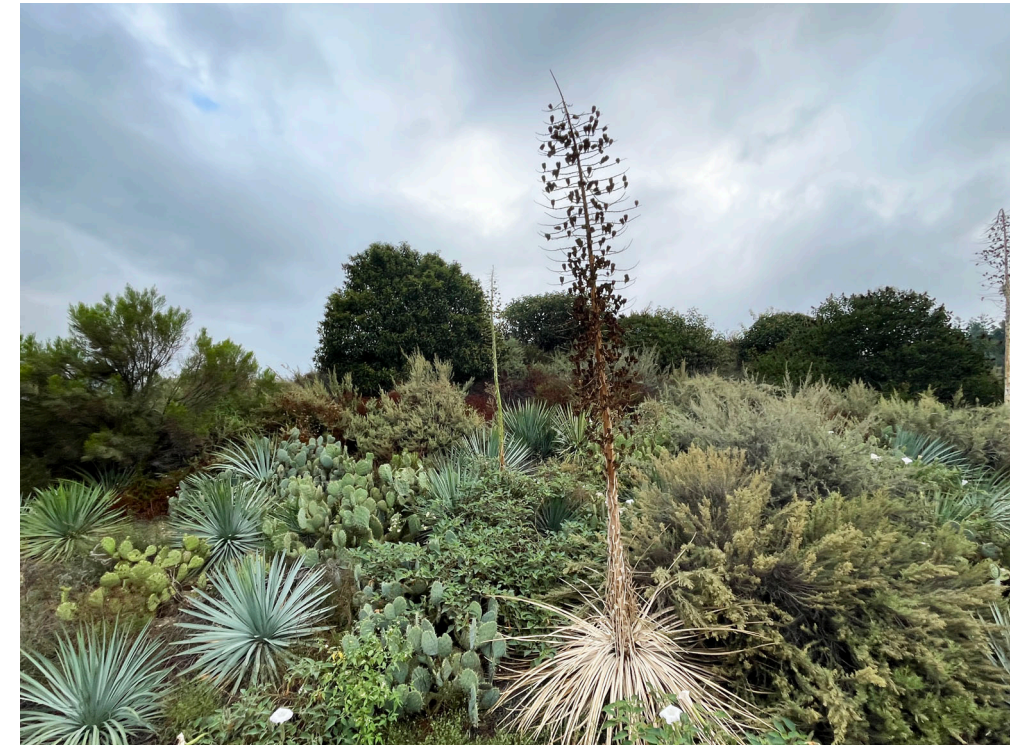
**September 2023.** The coastal sage scrub mitigation site includes several polygons that were planted with spiniferous shrubs such as cactus and yucca.

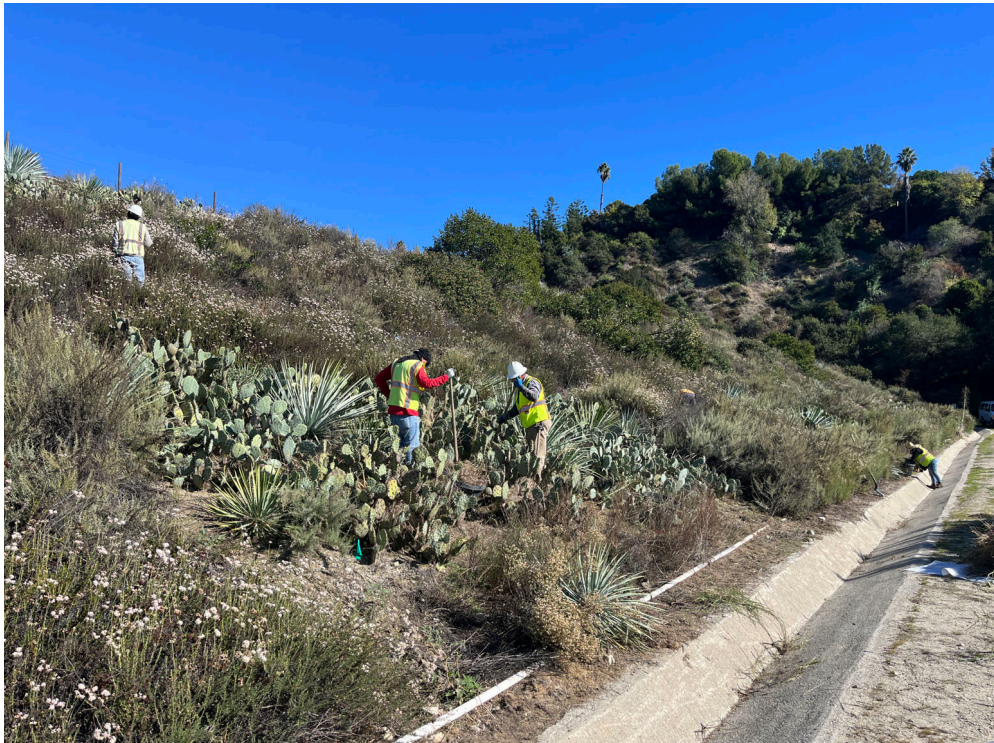
**November 2023.** Psomas' subcontractor is performing intensive weeding of the mitigation site via hand-pulling and the use of hand tools.

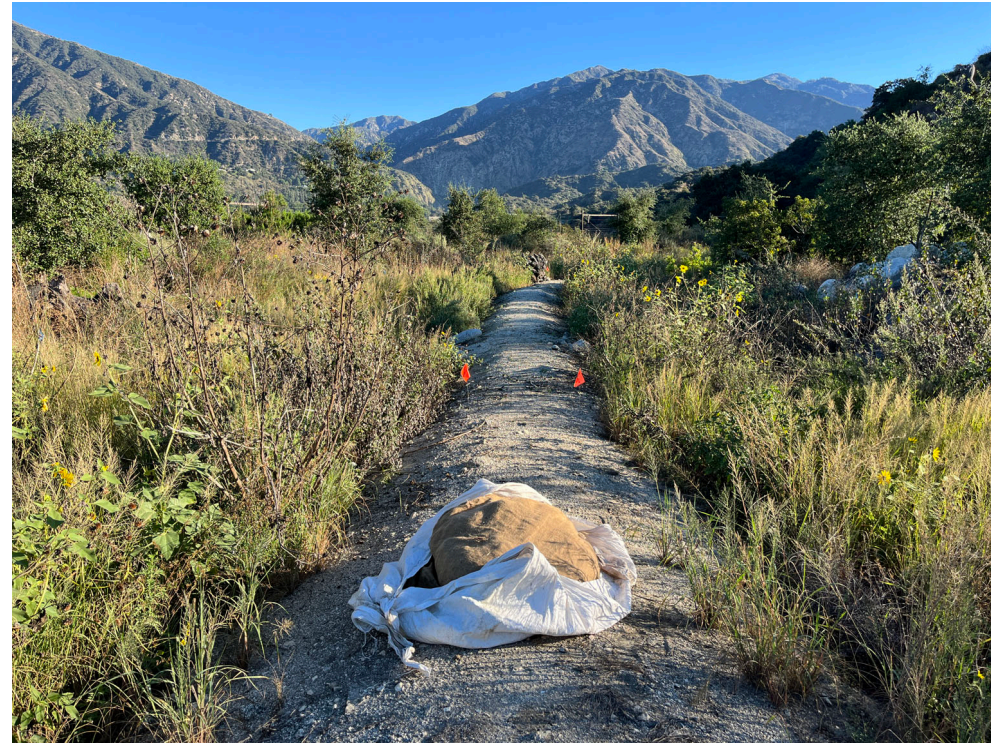
**October 2023.** A sack of weeds removed by Psomas' subcontractor Nakae & Associates was transported to an off-site landfill. There is good cover/diversity of native herbs in the drainages.

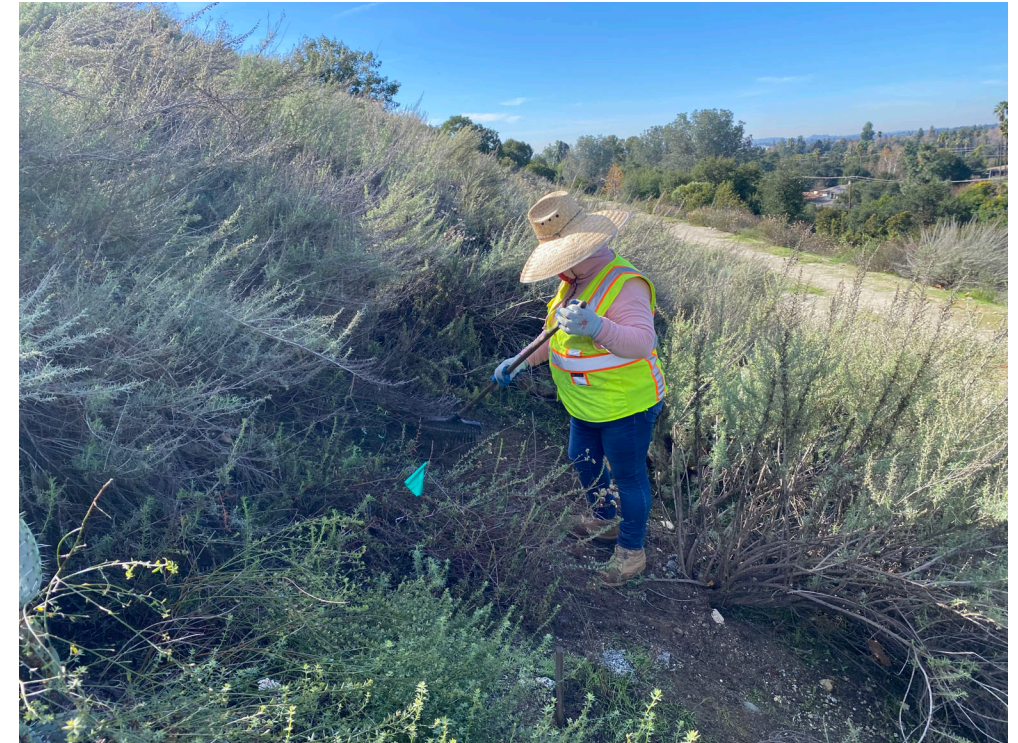
**January 2024.** A Nakae crew member is scratching in a supplemental seed mix in a gap in the scrub cover under the supervision of Psomas' restoration ecologist.

Psomas' Biological Monitor hand broadcasted a diversity of collected native seeds in various combinations/mixes in January 2024 (as was done in December 2021 and December 2022), shortly before a significant rain event. Psomas' Biologists, along with Nakae personnel, scratched the seed approximately 1/4-inch into the soil surface using heavy metal bow rakes. The seed was applied to several hundred patches within the CSS slope areas especially to improve native herbaceous cover in gaps between established shrubs. A list of all seed species that were installed on the site in January 2024 is provided in Attachment B.

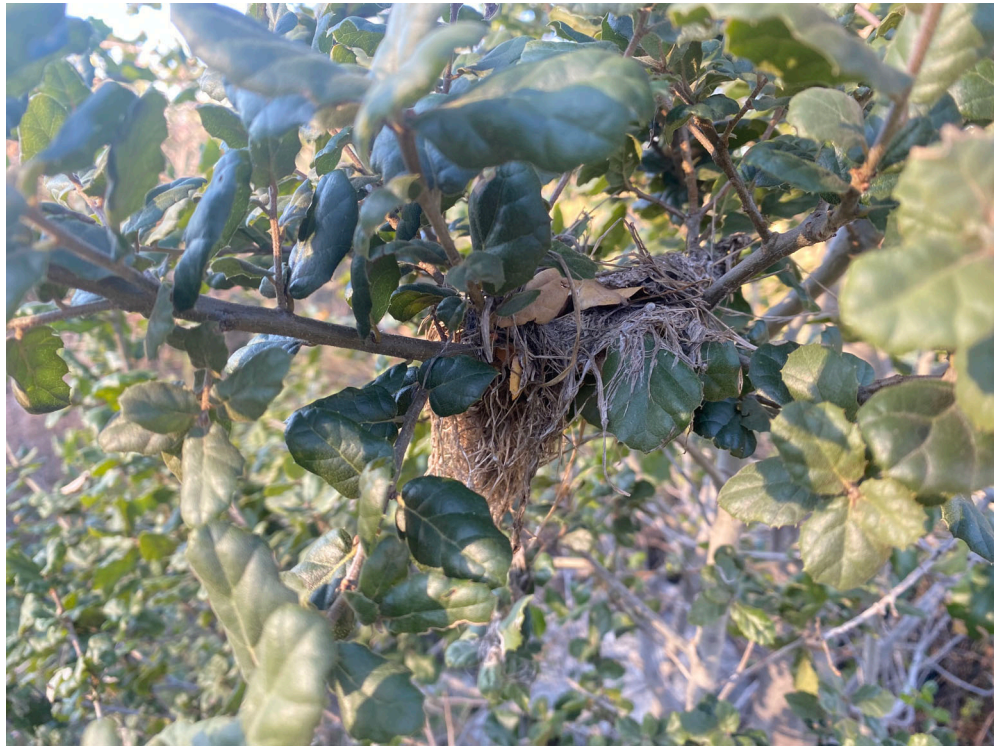
**October 2023.** An old, inactive bird nest in a planted coast live oak sapling on the mitigation site.

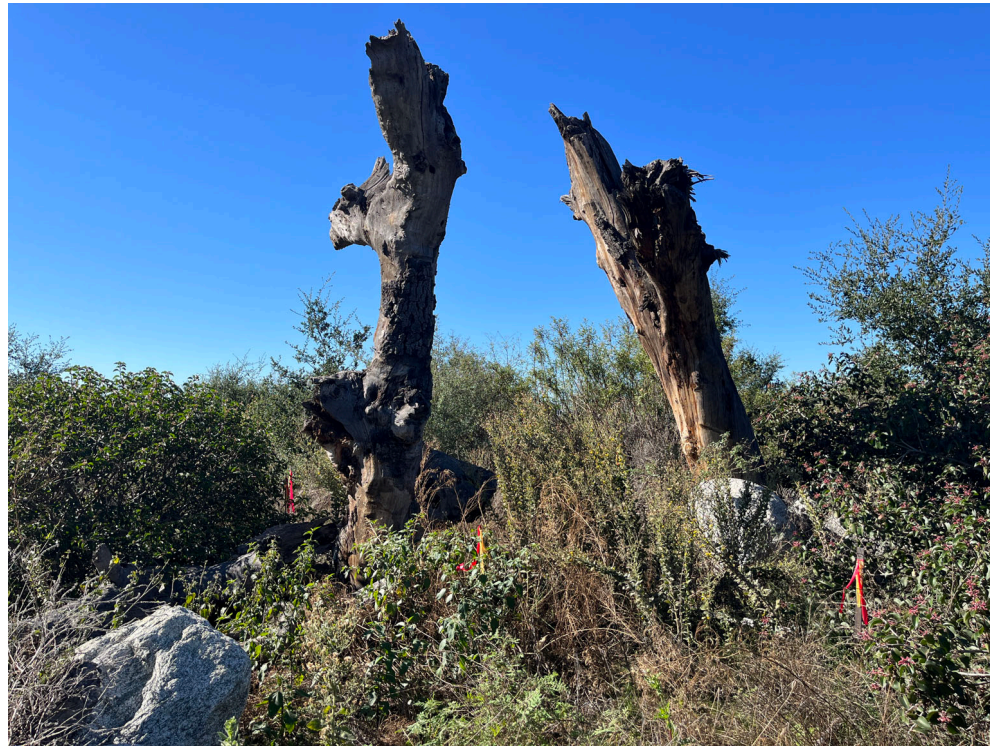
**November 2023.** These two placed natural snags in the center of the oak woodland mitigation site are surrounded by planted oak saplings and native understory vegetation.

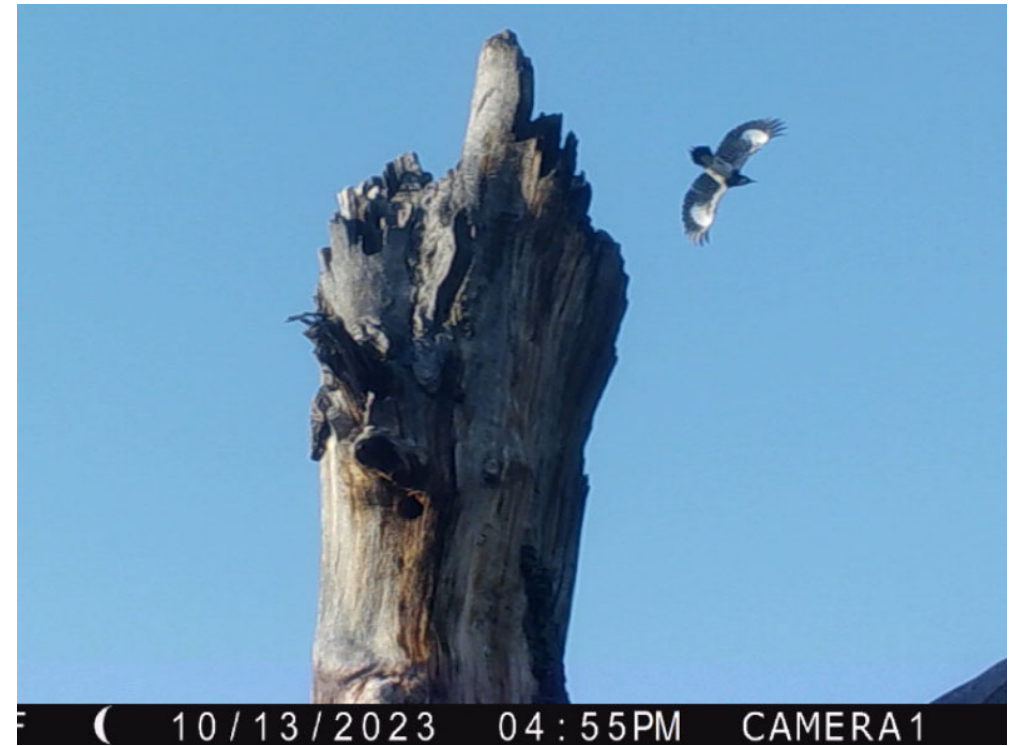
**October 2023.** An acorn woodpecker takes flight from a placed snag (shown in top center and top right photos) where birds of this species have created a nesting cavity. 10/13/2023 04:55PM CAMERA 1

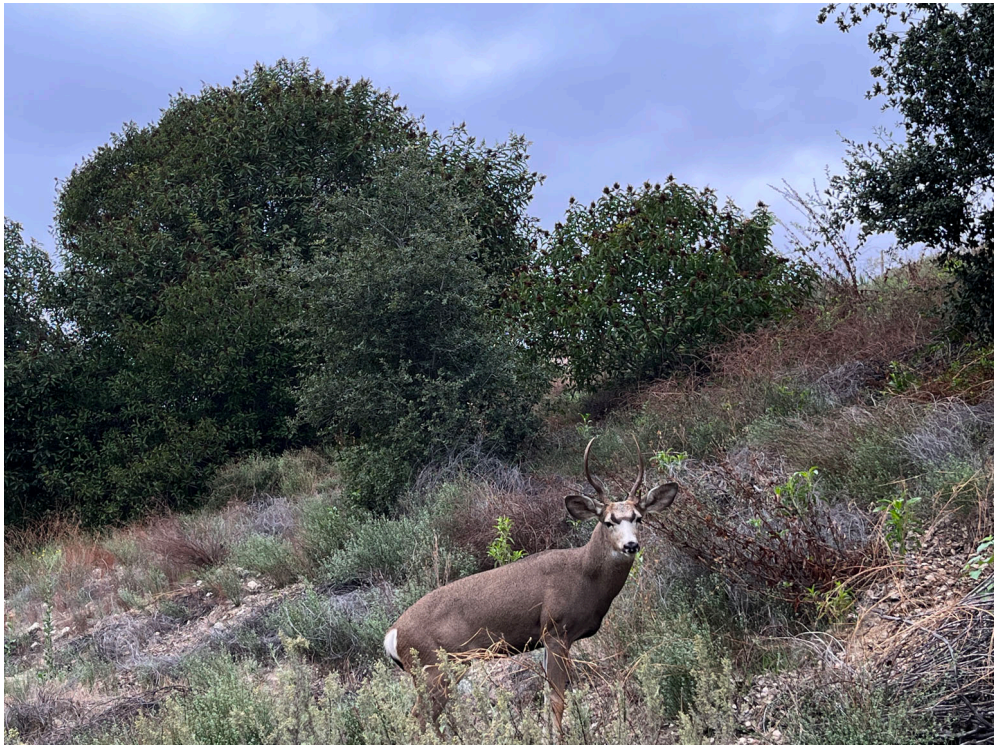
**September 2023.** A mule deer buck observed in one of the voluntarily restored/maintained weed abatement buffer areas that surround the mitigation site.

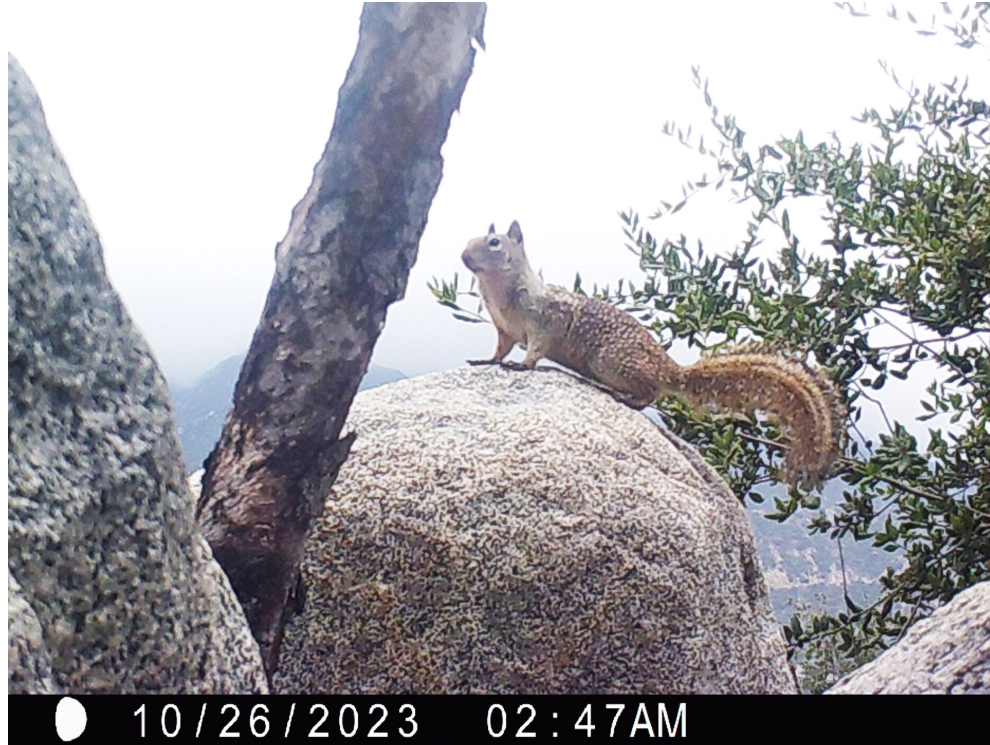
**October 2023.** A California ground squirrel, captured by a wildlife camera, is perching on a placed assemblage of salvaged boulders and coarse woody debris (CWD). 10/26/2023 02:47AM

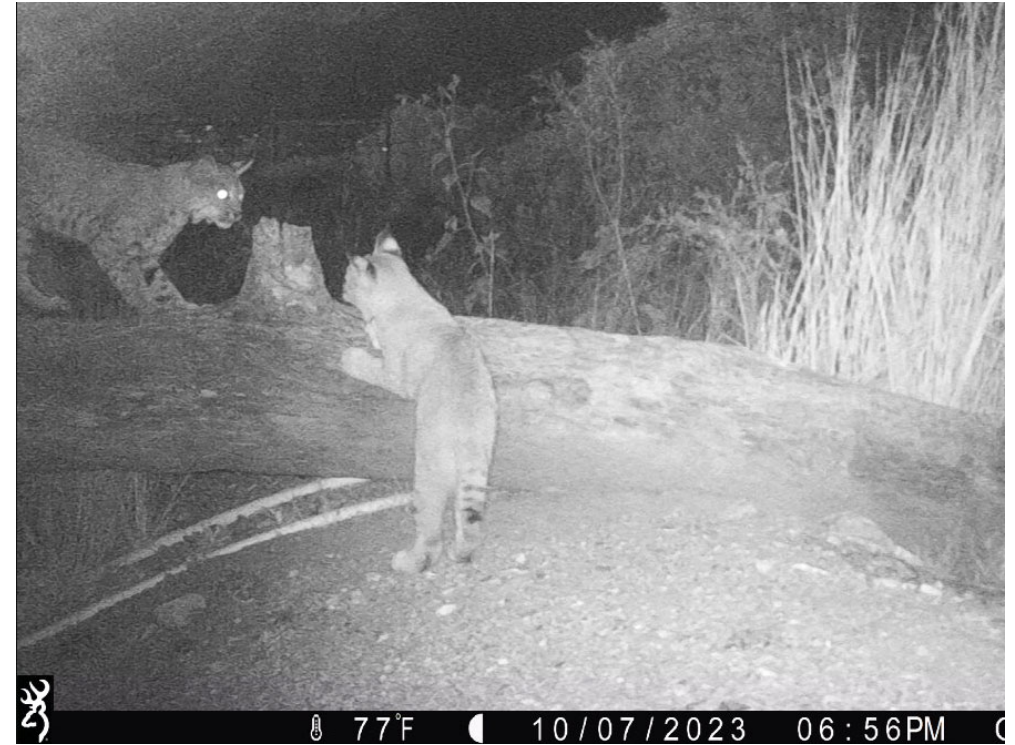
**October 2023.** Two bobcats captured by a wildlife camera at one of the many salvaged tree trunks (CWD) that were placed on the site. 77°F 10/07/2023 06:56PM
