Permit No. 36342

Address 207-1/2 N. Kern Ave

Block No.2 Tract Maravilla Park

ADDITIONAL INSPECTION NO. 7725

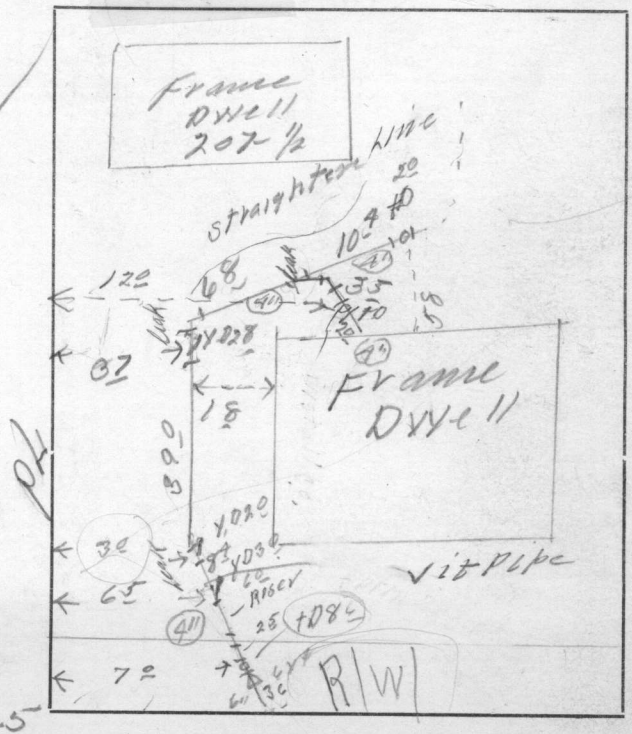
9/23/37 Peare
add inspection
Reverse Grade to Rear House
Con- water stands 2" Deep
FIX Leaks install 1/8 Bend on Riser
Bad Pinched Joint

ADDITIONAL INSPECTION NO. 7747
9/28/37 Peare
Add inspection FIX Leaks
in Front of Rear House Back Fill
Rest of Line
