Sunshine Canyon Landfill
Independent Monitor
Quarterly Site Monitoring Status Report
October 1, 2014 – December 31, 2014

City of Los Angeles Department of City Planning

County of Los Angeles Department of Regional Planning

February 16, 2015

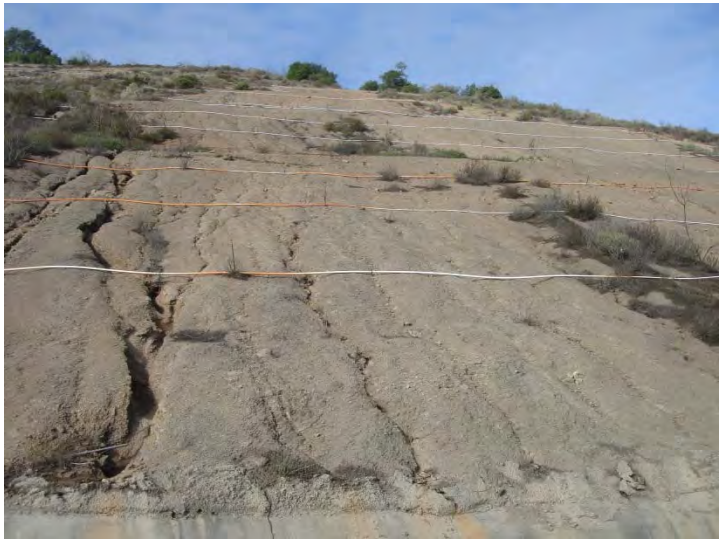
Photo 22: County Sage Mitigation Area: December 18, 2014

Current Status/Comments – On December 18, 2014 it was observed that City Deck C sage mitigation plants have greened up and grown from the recent rains and cool weather. The California sage and other non-Atriplex (salt tolerant) plants were observed doing well. The County sage area was much greener and appeared more filled in with vegetative growth due to the recent rains.
