Notification	405987052		Notification Type	E1
Subject Matter	EZ-ELEV 0010	Distribution Primary		
Description	REPLC DAMAGE PRI INSLTR POLE			
Reporter	MITCHED	1:15:46 PM	Notification Date	03-31-2014
Start Date	03-31-2014		End Date	03-30-2015
Start time	9:46:22 AM		End time	11:59:59 PM
Priority	EA 2	Priority 2		
Funct Location	OH-2054958E	POLE-DISTRIBUTION 2054958E LOCATION		
Location Description		KANAN RD E/S 1330' E/O TRIUNFO CYN RD		
City	AGORA HILLS/L.A.CO			
Thom. Guide		CALOSA-587-H2		
Equipment	201874572	POLE-DISTRIBUTION 2054958E		
Circuit Name	ED-12350	MULHOLLAND

Notification	405987030		Notification Type	E1
Subject Matter	EZ-ELEV 0010	Distribution Primary		
Description	REPLC DAMAGE PRI CUT/FUS POLE			
Reporter	MITCHED	1:14:30 PM	Notification Date	03-31-2014
Start Date	03-31-2014		End Date	03-30-2015
Start time	8:36:00 AM		End time	11:59:59 PM
Priority	EA 2	Priority 2		
Funct Location	OH-2054962E	POLE-DISTRIBUTION 2054962E LOCATION		
Location Description		KANAN RD W/S 2150' E/O TRIUNFO CYN RD		
City	AGOURA HILLS			
Thom. Guide		CALOSA-587-H2		
Equipment	201874575	POLE-DISTRIBUTION 2054962E		
Circuit Name	ED-12350	MULHOLLAND

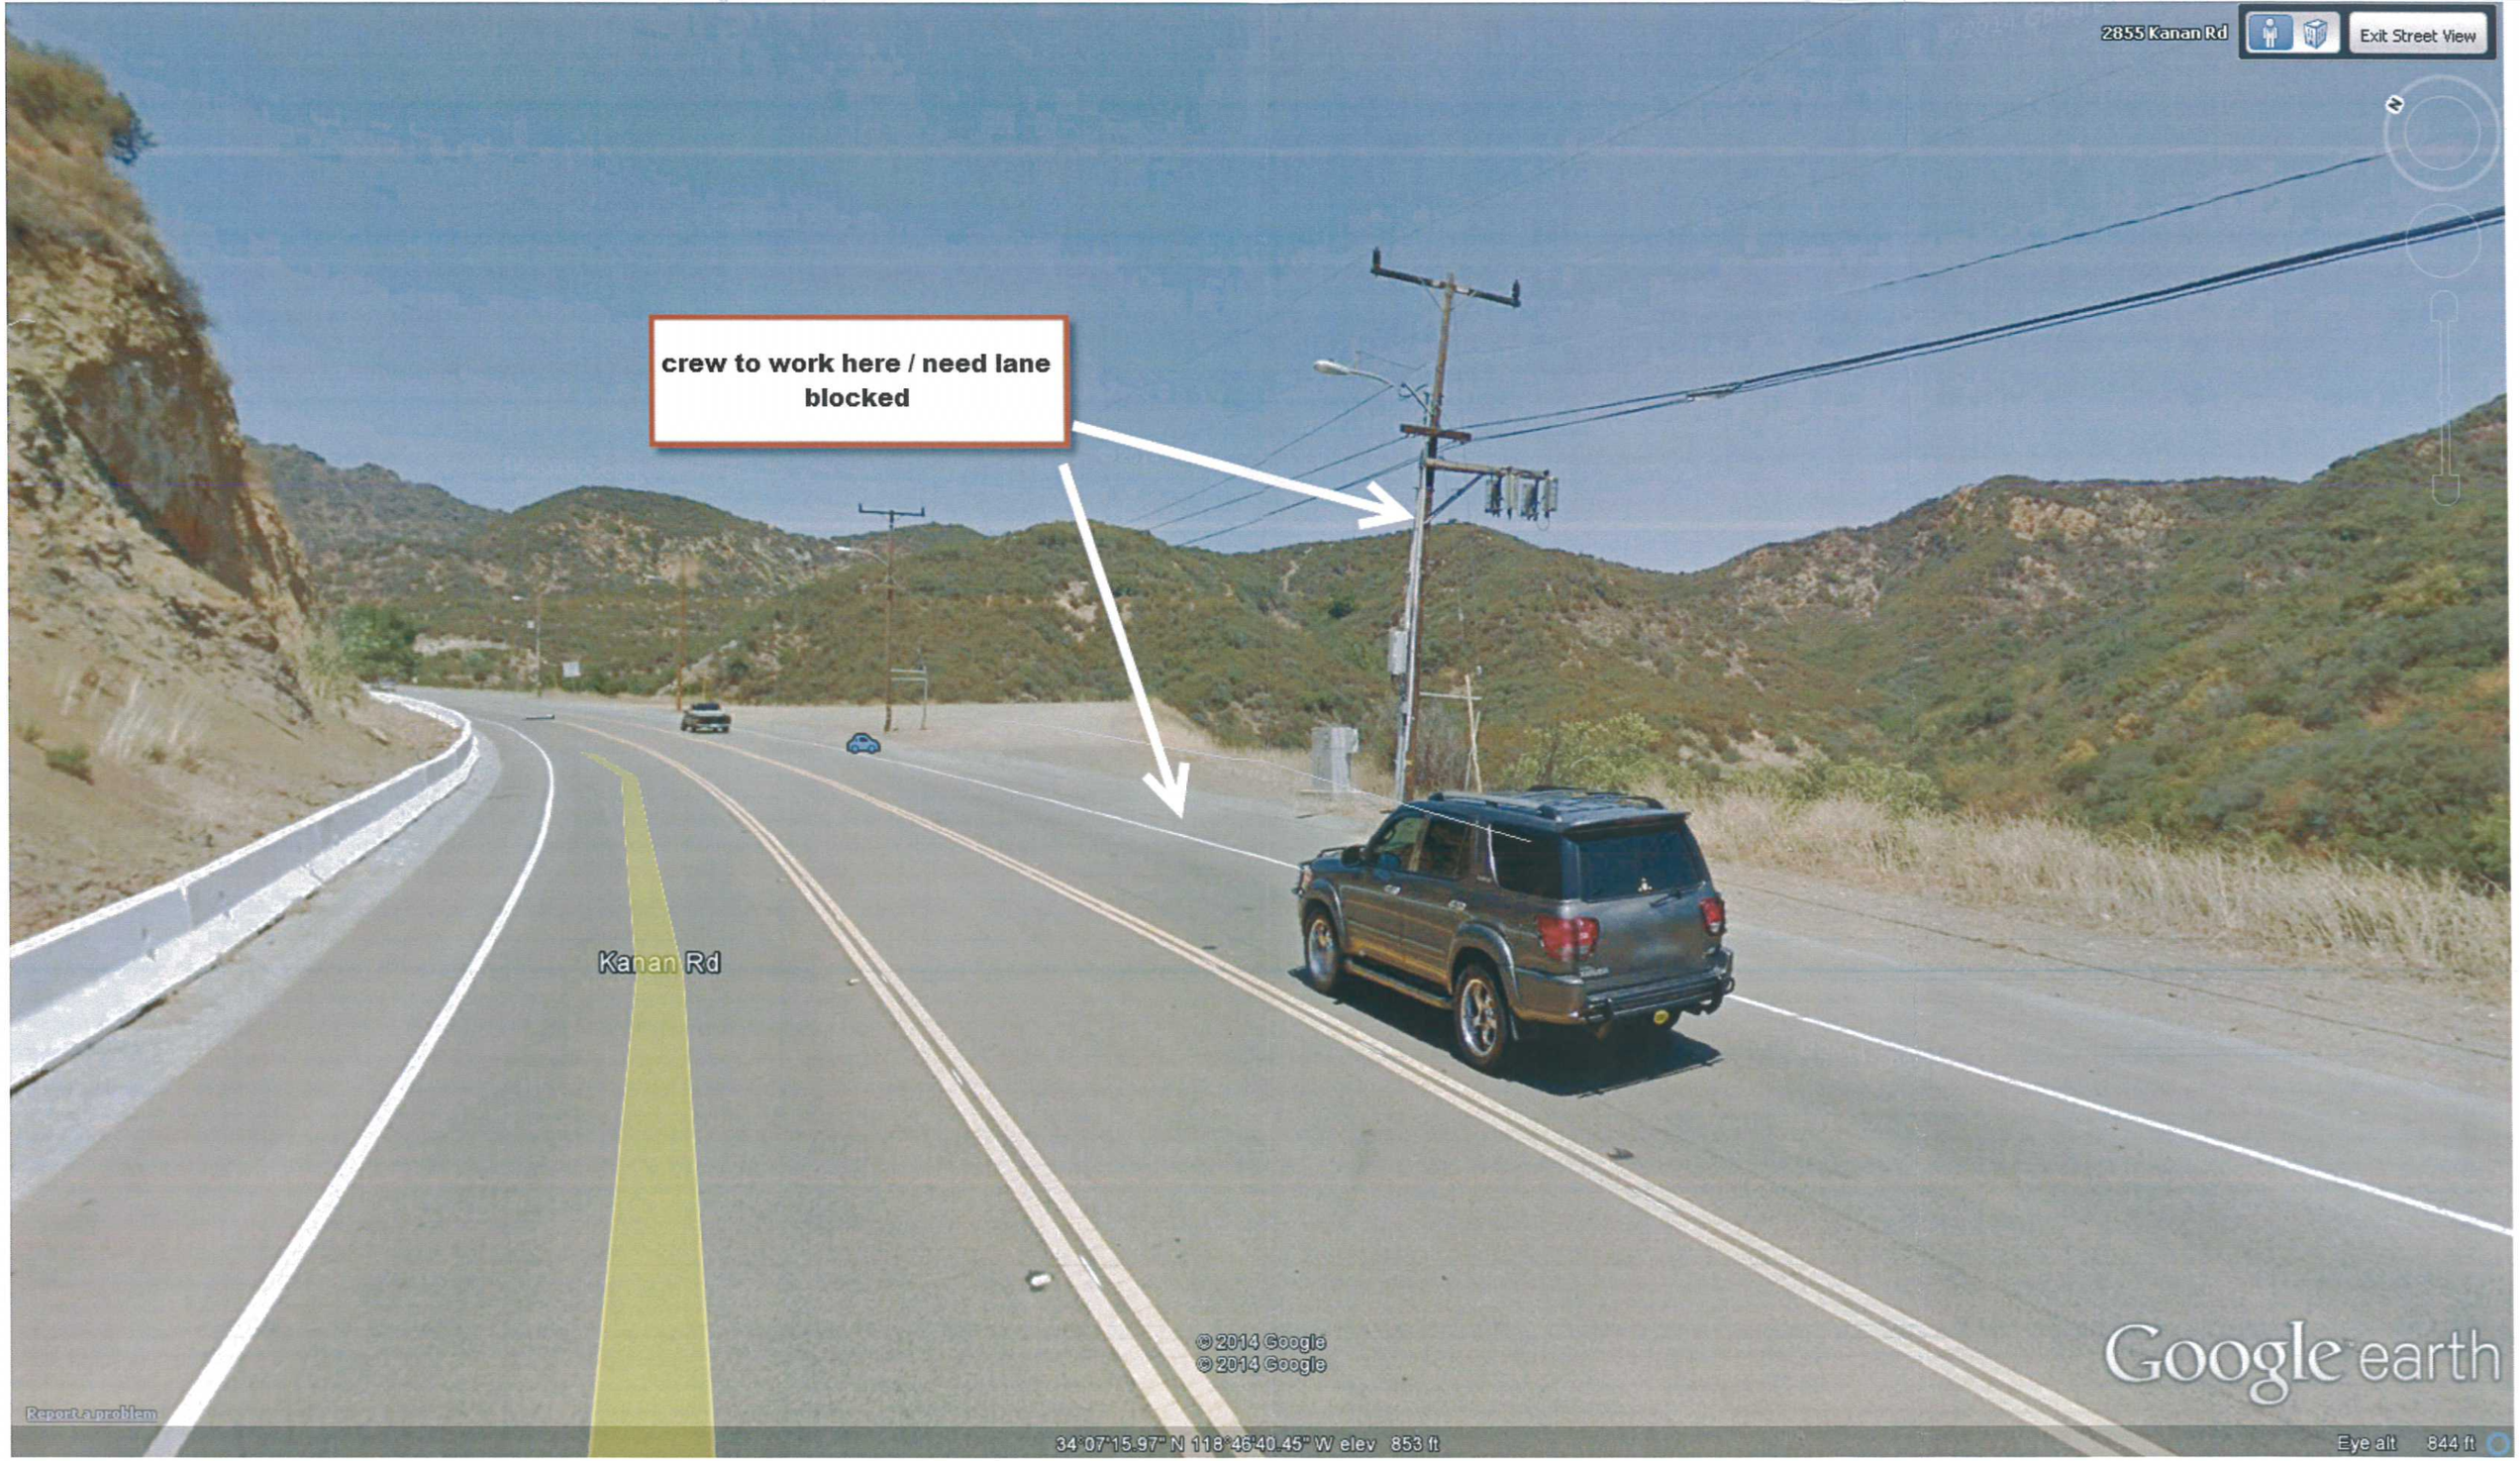
2855 Kanan Rd
Exit Street View
crew to work here / need lane blocked
Kanan Rd
© 2014 Google
© 2014 Google
Report a problem
34°07'15.97" N 118°46'40.45" W elev 853 ft
Eye alt 844 ft
Google earth

3001 Kanan Rd
Exit Street View
crew to work here / need lane blocked
Kanan Rd
© 2014 Google
© 2014 Google
Report a problem
34°07'18.73" N 118°46'40.02" W elev 879 ft
Eye alt 902 ft
Google earth
