CONSOLIDATED SEWER MAINTENANCE DISTRICT CONDITION ASSESSMENT PROGRAM REPORT PROJECT NO. Y0TV1011B

**CONDITION ASSESSMENT REPORT
COUNTY OF LOS ANGELES DEPARTMENT OF PUBLIC WORKS
CONSOLIDATED SEWER MAINTENANCE DISTRICT**

PROJECT NAME:	Y0TV1011B	PROJECT MGR:	Hanna Kebede
PROJECT DATE:	08/08/2011	CONTACT NO:	(626) 300-4686
SUP. DISTRICT(s):	5	MAP PAGE(S):	2017 □ 2018
Report By:	Hanna Kebede	Report Date:	09/26/2011

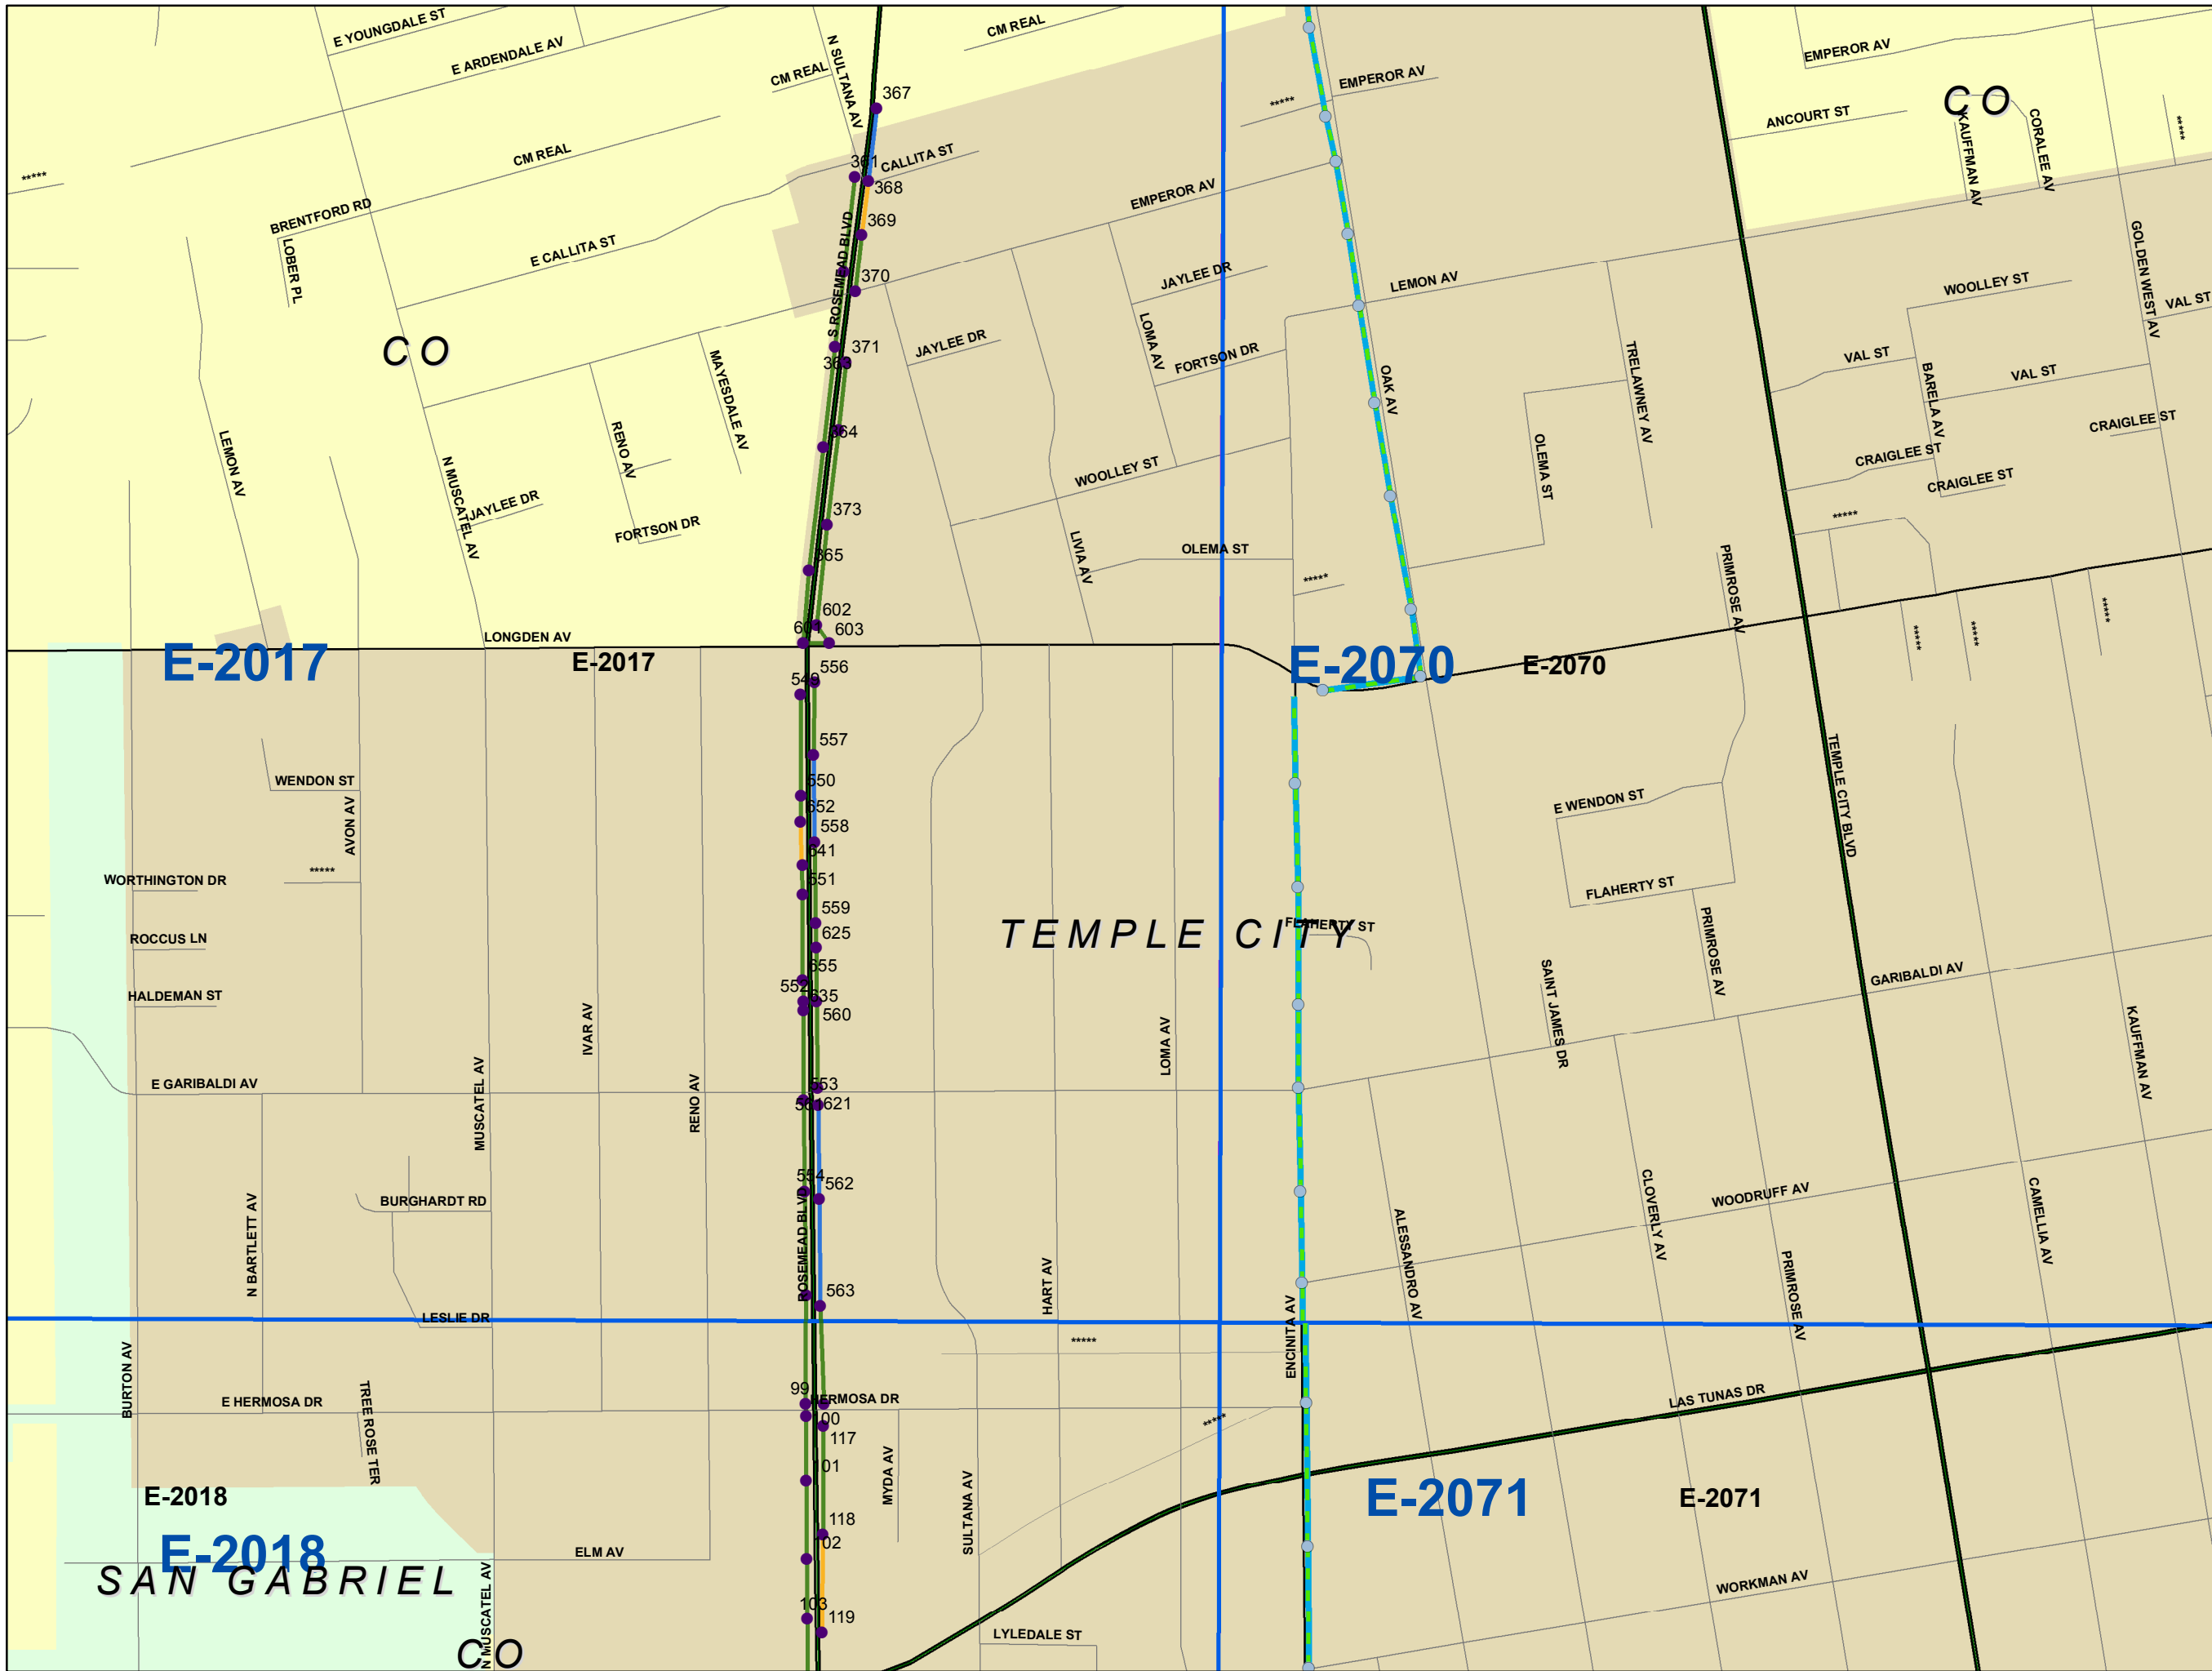
ENCLOSURE 3:

NO.	QSR	START MH	END MH	STREET	OBSERVATION: LOCATION	PROPOSED CORRECTIVE ACTION
1	4100	2017-0553	2017-0554	ROSEMEAD BV	Hole at base of MH 2017-0554	CSMD will repair base of MH 554.
