## **COMPREHENSIVE ASBESTOS, HAZMAT & XRF-LEAD ASSESSMENT**

### **High Desert Hospital**

44900 60th Street West, Various Buildings, Interior and Exterior

Project Number: Atch-211061

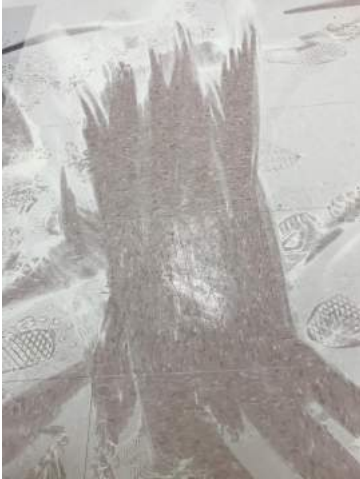
View of 12" x 12" Pink Streaked Resilient Flooring/Resilient Floor Mastic

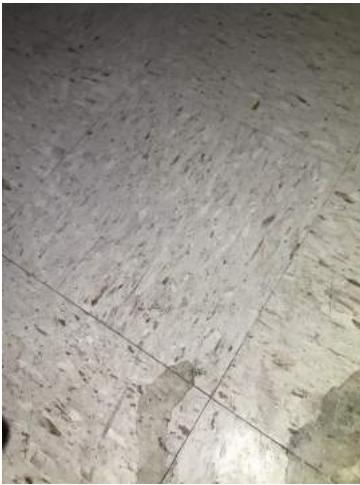
View of 12" x 12" Light Brown with Red Streaked Resilient Flooring/Resilient Floor Mastic

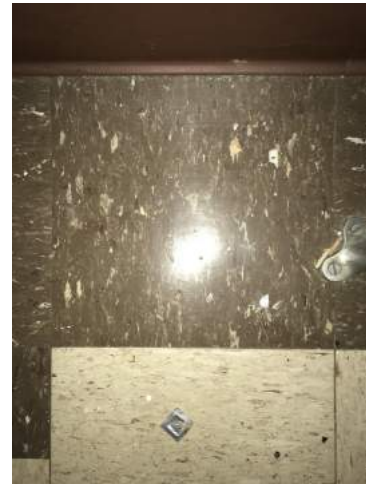
View of 12" x 12" Dark Brown with Tan Streaked Resilient Flooring/Resilient Floor Mastic

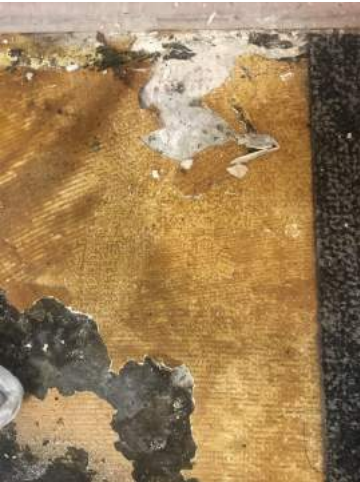
View of Carpet Glue with Leveling Compound

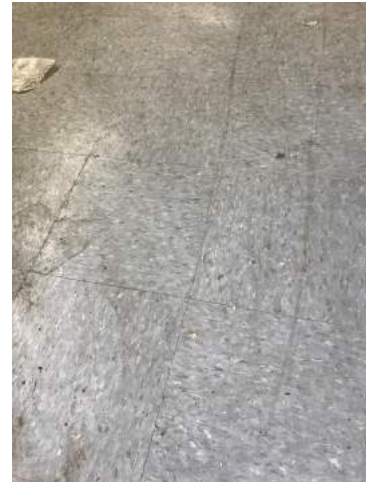
View of 12" x 12" Light Blue Streaked Resilient Flooring/Resilient Floor Mastic

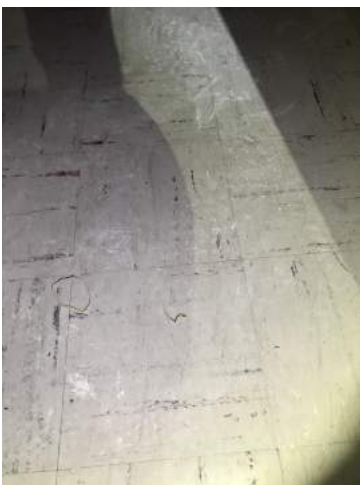
View of 9" x 9" Pink with Black and Red Streaked Resilient Flooring/Resilient Floor Mastic

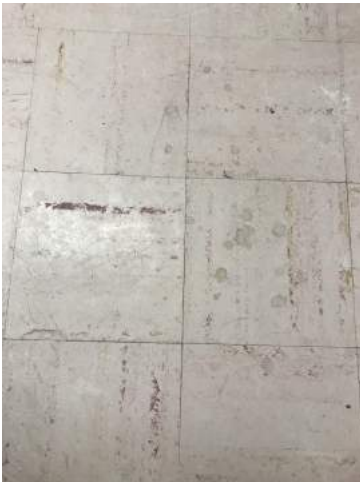
View of 9" x 9" Light Brown with Tan and Dark Brown Streaked Resilient Flooring/Resilient Floor Mastic

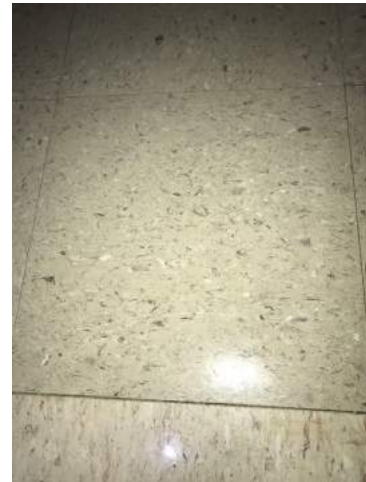
View of 9" x 9" Pink with Red and Brown Streaked Resilient  
Flooring/Resilient Floor Mastic

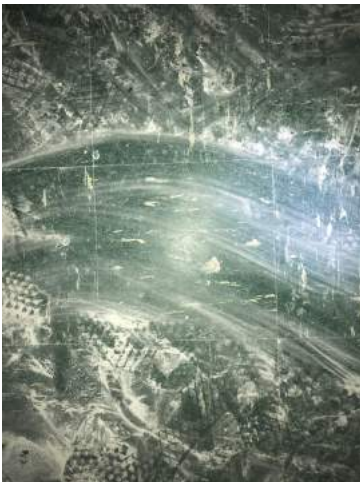
View of 12" x 12" Tan With Brown and White Streaked Resilient  
Flooring/Resilient Floor Mastic

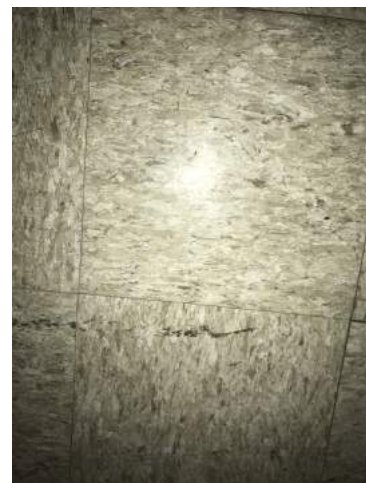
View of 12" x 12" White with Blue and Red Streaked Resilient  
Flooring/Resilient Floor Mastic

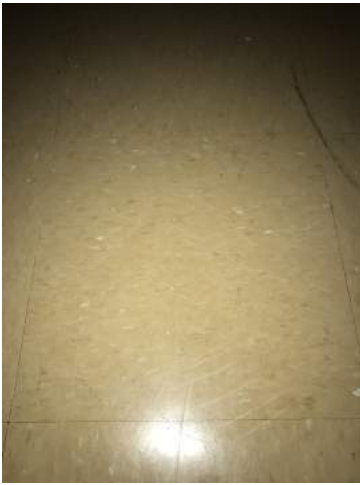
View of 12" x 12" Brown and White Streaked Resilient  
Flooring/Resilient Floor Mastic

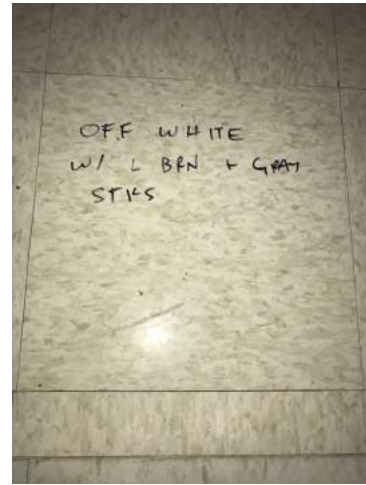
View of 12" x 12" Orange with White Streaked Resilient Flooring/Resilient Floor Mastic

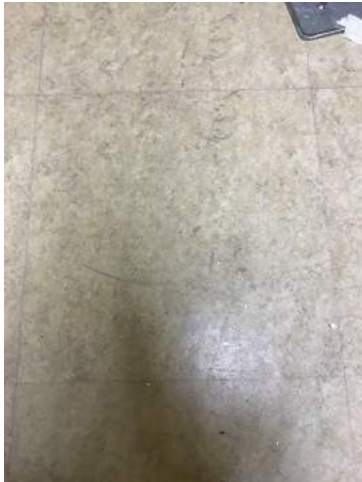
View of 12" x 12" Off-White with Light Brown and Gray Streaked Resilient Flooring/Resilient Floor Mastic

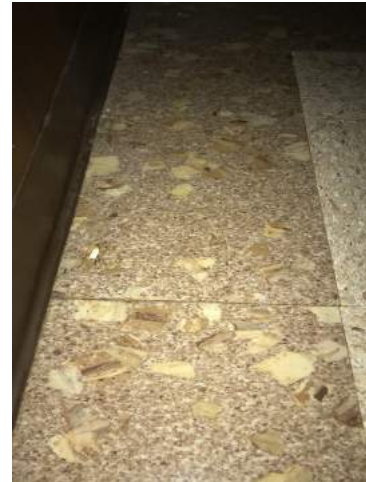
View of 24" x 24" Gold Resilient Flooring/Resilient Floor Mastic

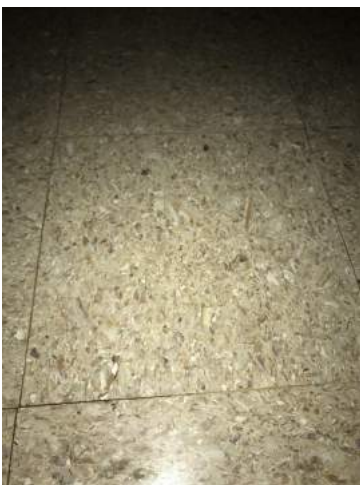
View of 12" x 12" Brown with Gold Flakes Resilient Flooring/Resilient Floor Mastic

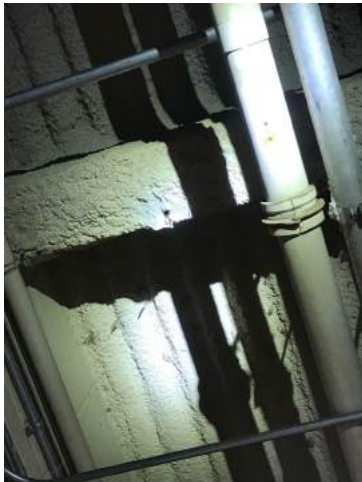
View of Concrete

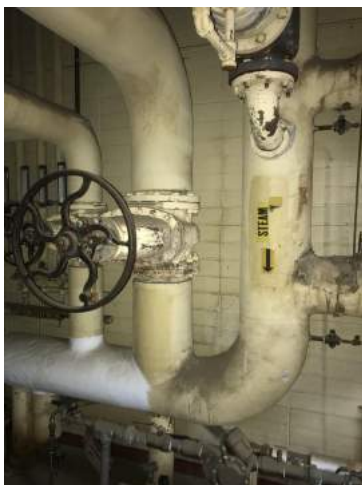
View of Light Brown Boiler TSI

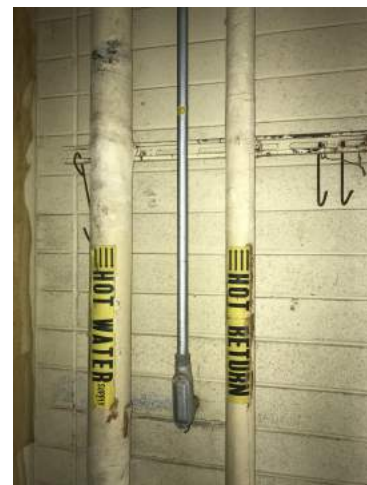
View of 4" Thermal System Insulation Pipe Elbows/Runs

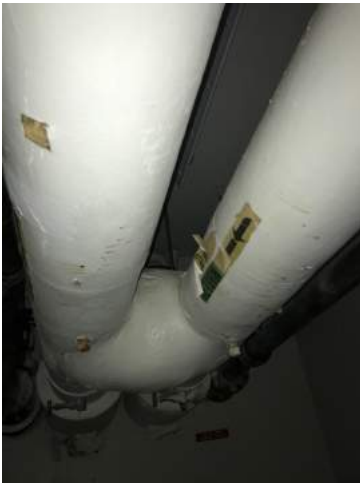
View of 2" Thermal System Insulation Pipe Elbows/Runs

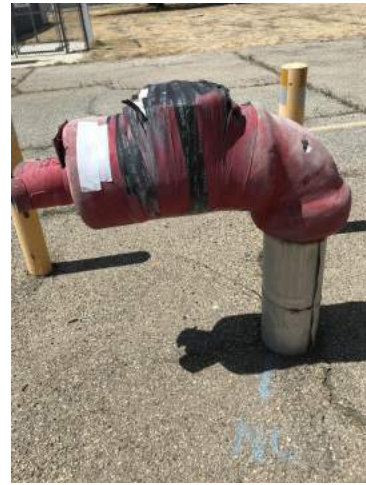
View of 4" Thermal System Insulation Pipe Run Wrapped in Foil

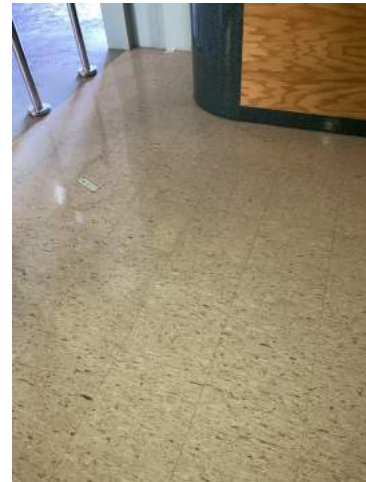
View of 12" x 12" Blue with Gray Stripes Resilient Flooring/Resilient Floor Mastic

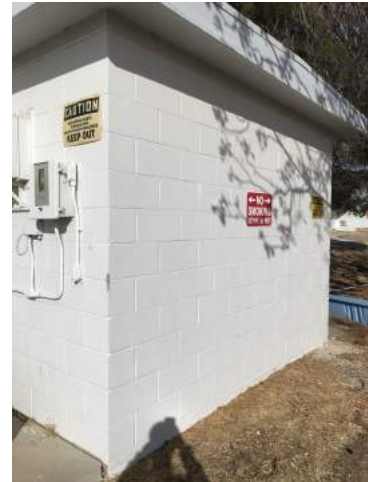
View of Silver Mastic

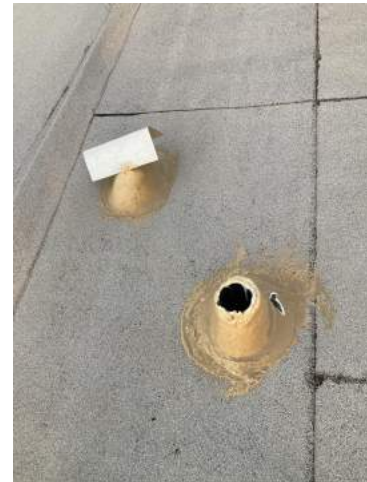
View of Silver Penetration Mastic

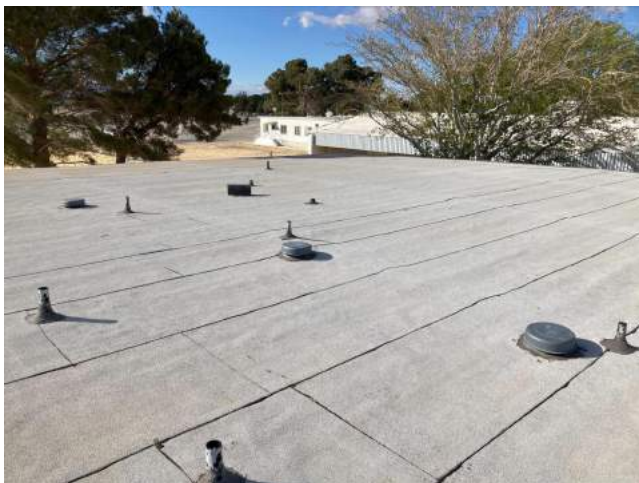
View of Brown Penetration Mastic

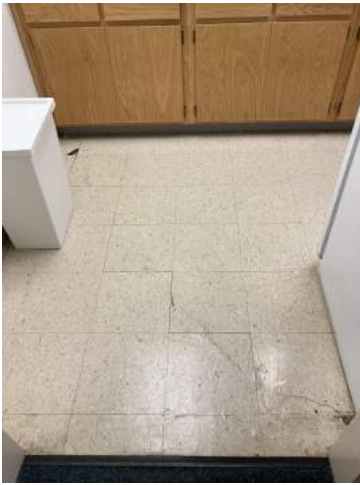
View of 12" x 12" Tan with Brown and White Streaked  
Resilient Floor Tile/Resilient Floor Mastic

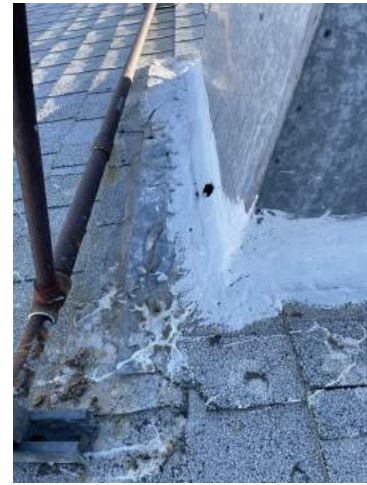
View of Penetration Mastic

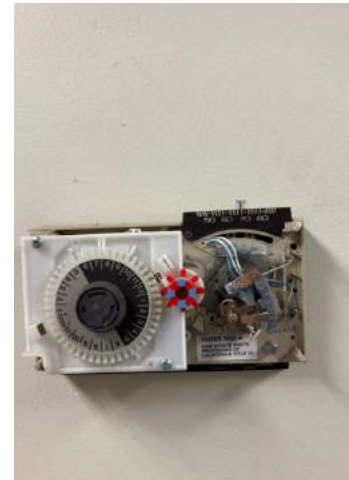
View of Mercury Switch

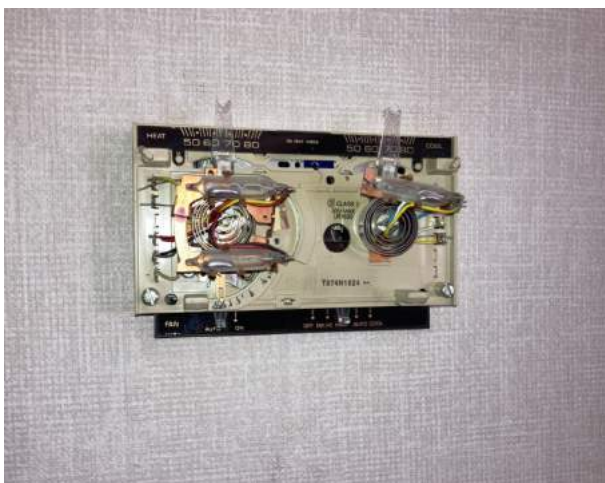
View of Mercury Switch

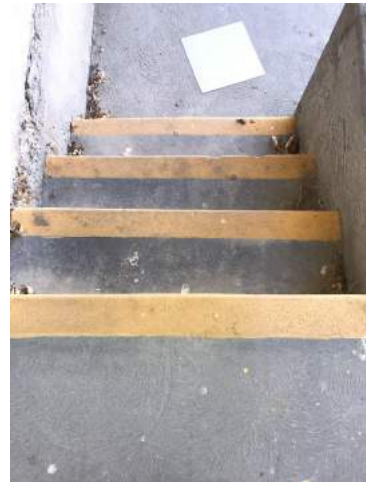
View of 6" x 6" Light Green Ceramic Wall Tile
