**Sunshine Canyon Landfill  
Independent Monitor  
Quarterly Site Monitoring Status Report  
January 1, 2016 – March 31, 2016**

**City of Los Angeles Department of City Planning**

**County of Los Angeles Department of Regional Planning**

May 16, 2016

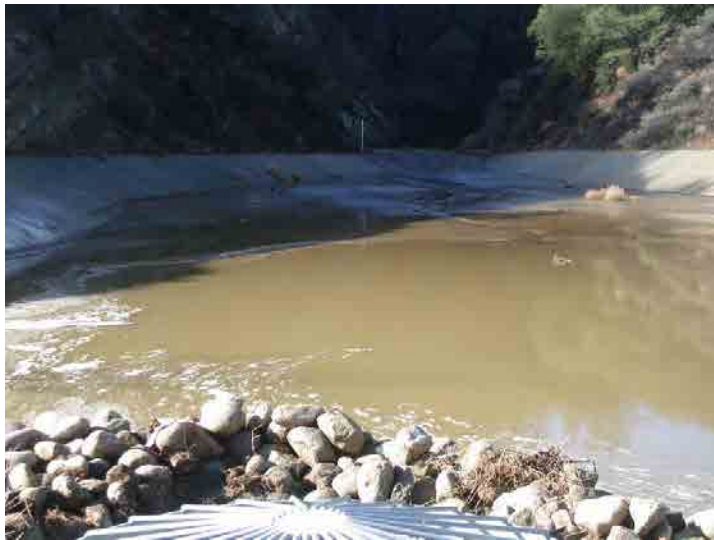
**Photo 1: Basin A: January 7, 2016**

| <ul style="list-style-type: none"> <li>• tour the neighborhood to detect potential odors – None</li> <li>• it was the tail end of rainstorm, water still flowing down the main western ditch into the terminal basin, water is clear (Photo 1). A large amount of fines have accumulated in the basin (Photo 2). Source of the fines is runoff from cell CC3B under construction. The temporary lined diversion trench towards the remnants of the 96 inch-culvert draining into the basin failed (Photo 3) and muddy water flew into the basin. The K-rails (Photo 2) in the basin slowed down the muddy water leading to a limited build-out against the risers (Photo 4)</li> </ul> | |

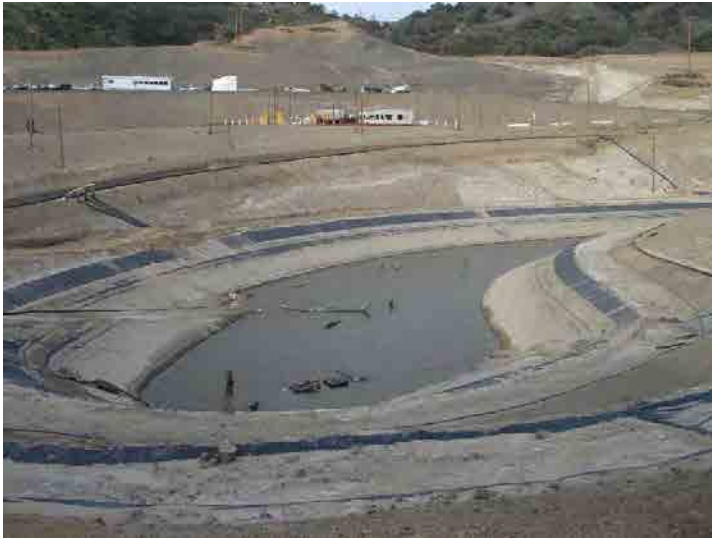
**Photo 80: Water Removal at City Lined Drainage Lift Area:  
January 7, 2016**

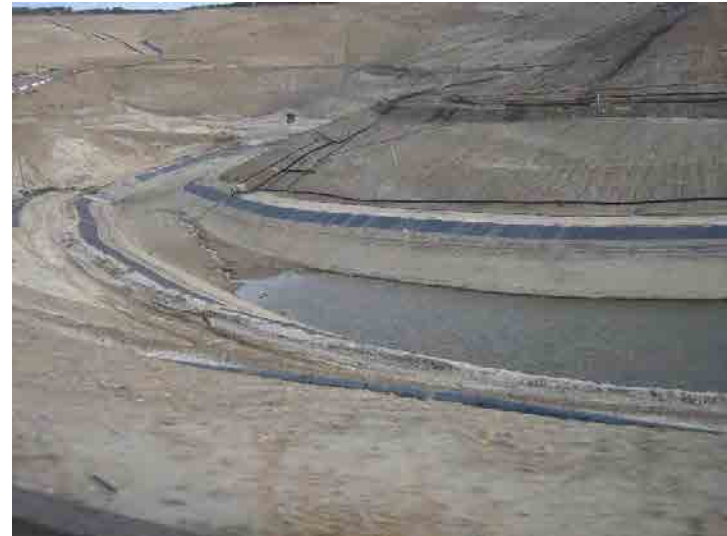
**Photo 81: City Lined Drainage Lift Area: January 27, 2016**

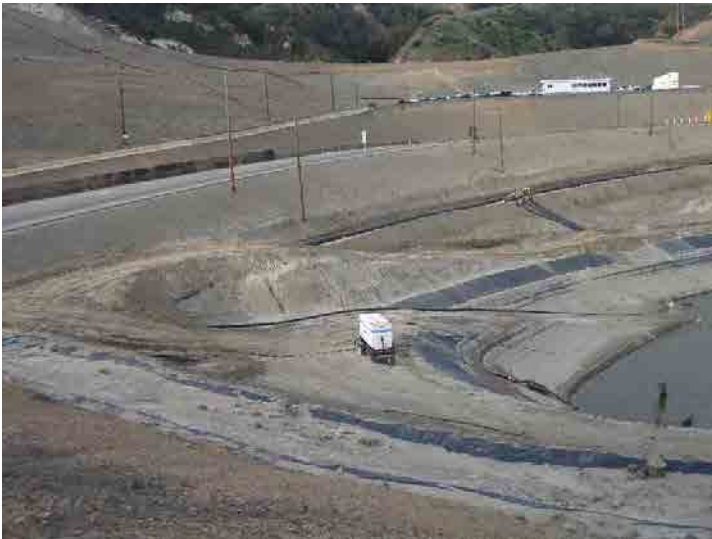
**Photo 82: City Lined Drainage Lift Area: January 27, 2016**

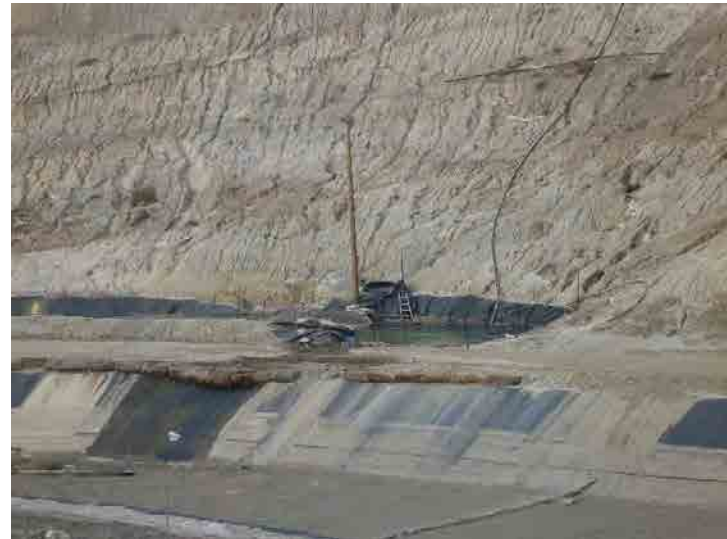
**Photo 83: City Lined Drainage Lift Area: January 27, 2016**

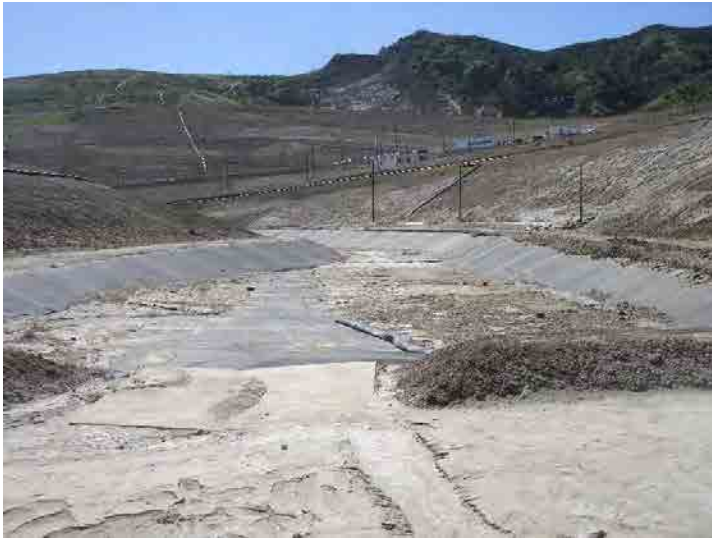
**Photo 84: City Lined Drainage Lift Area: January 27, 2016**

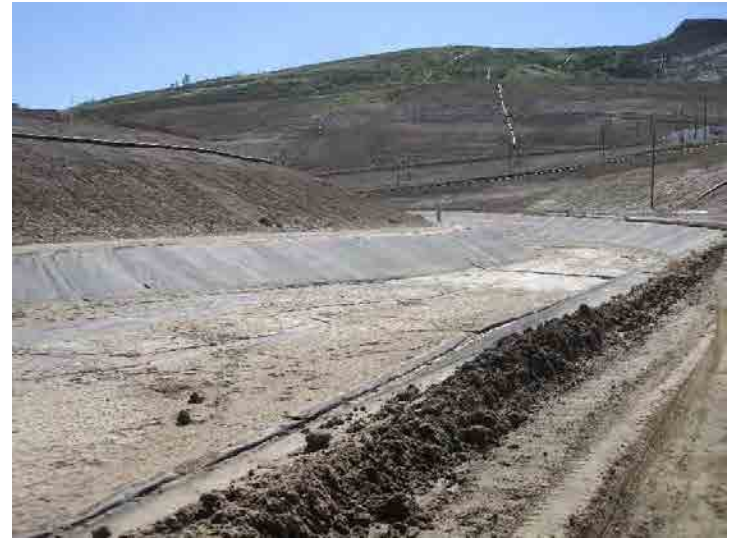
**Photo 85: City Lined Drainage Lift Area: February 24, 2016**

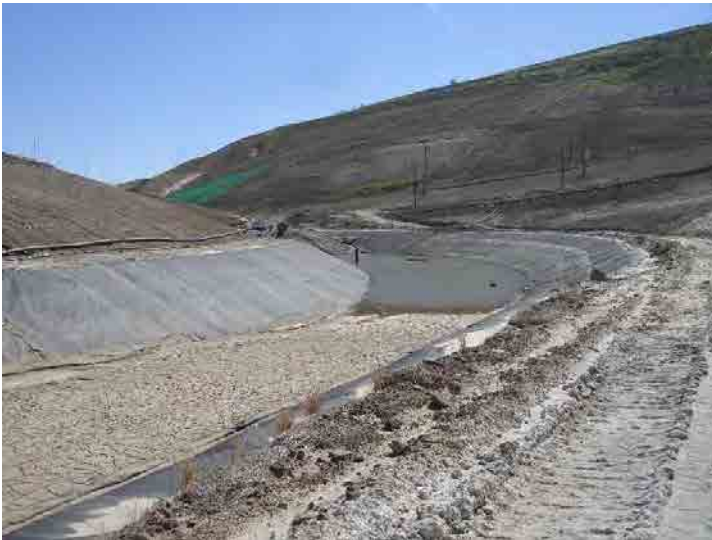
**Photo 86: City Lined Drainage Lift Area: February 24, 2016**

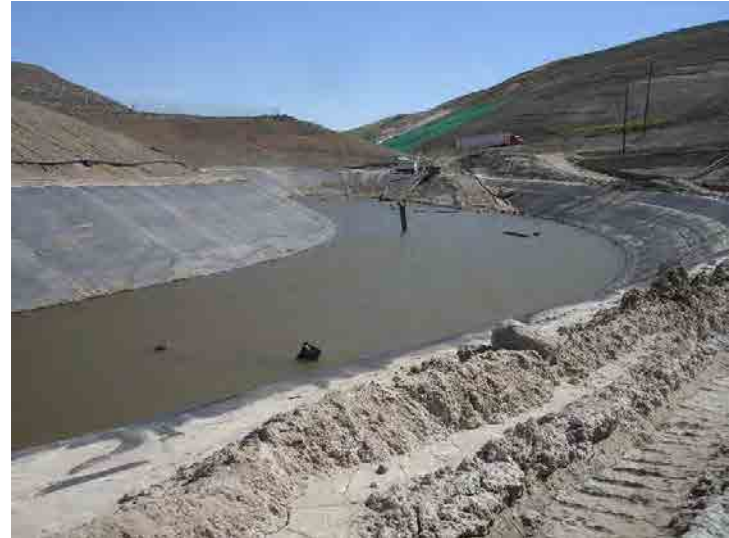
**Photo 87: City Lined Drainage Lift Area: February 24, 2016**

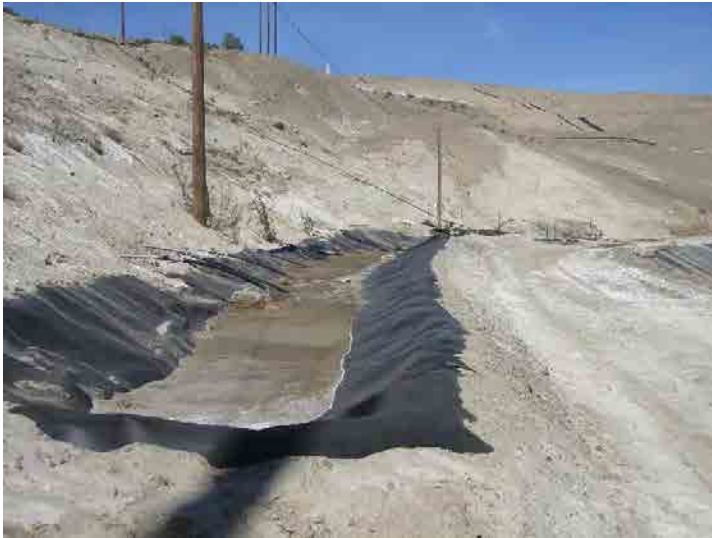
**Photo 88: City Lined Drainage Lift Area: February 24, 2016**

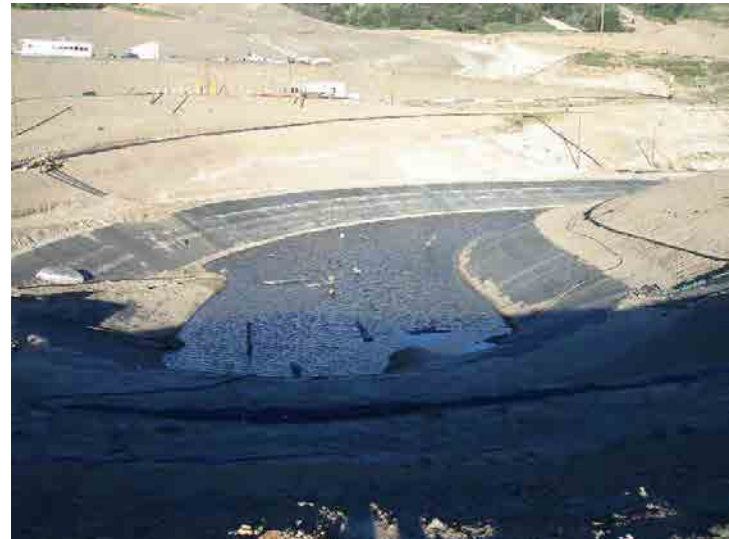
**Photo 91: City Lined Drainage Lift Area: March 23, 2016**

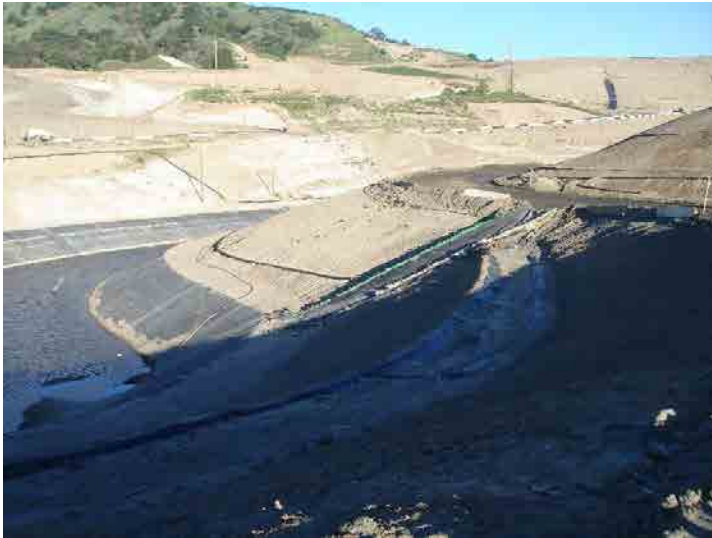
**Photo 92: City Lined Drainage Lift Area: March 23, 2016**

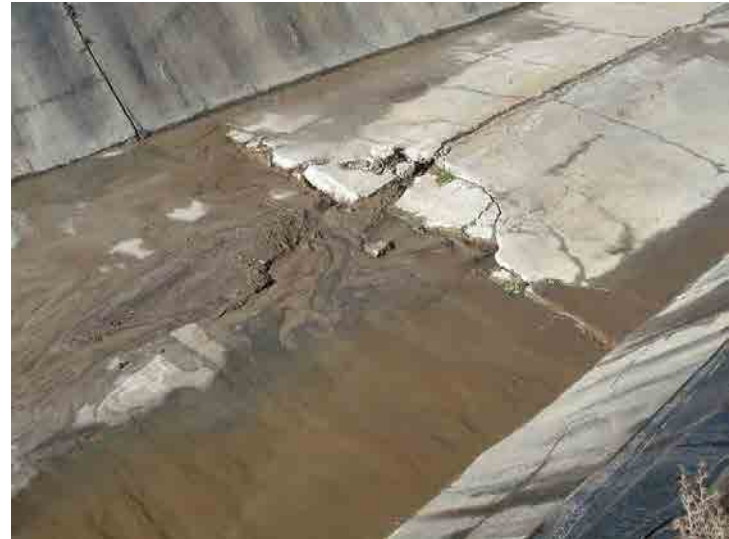
**Photo 93: City Lined Drainage Lift Area: March 23, 2016**

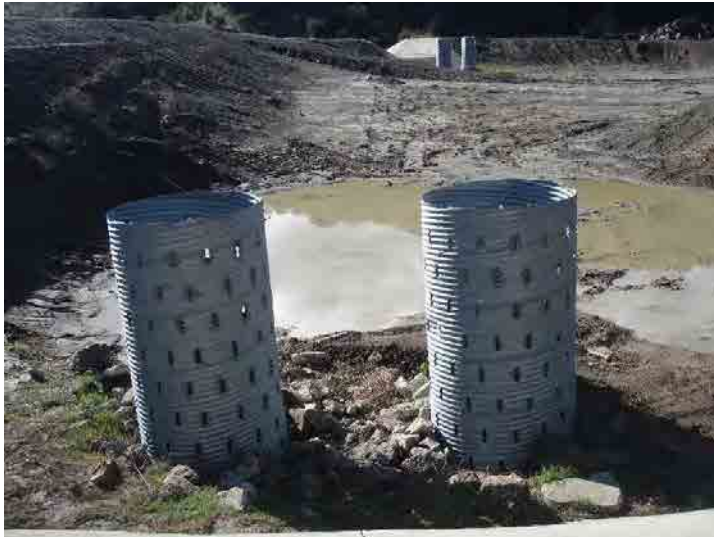
**Photo 119: Basin D: January 7, 2016**

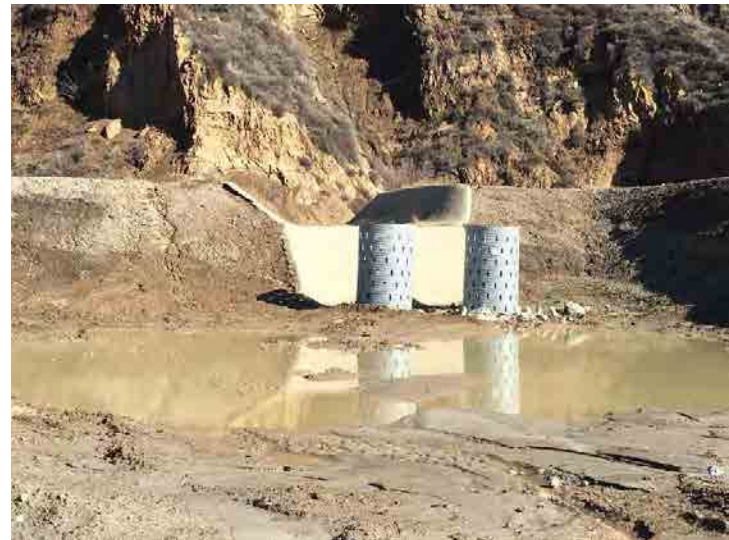
**Photo 120: Basin D: January 7, 2016**

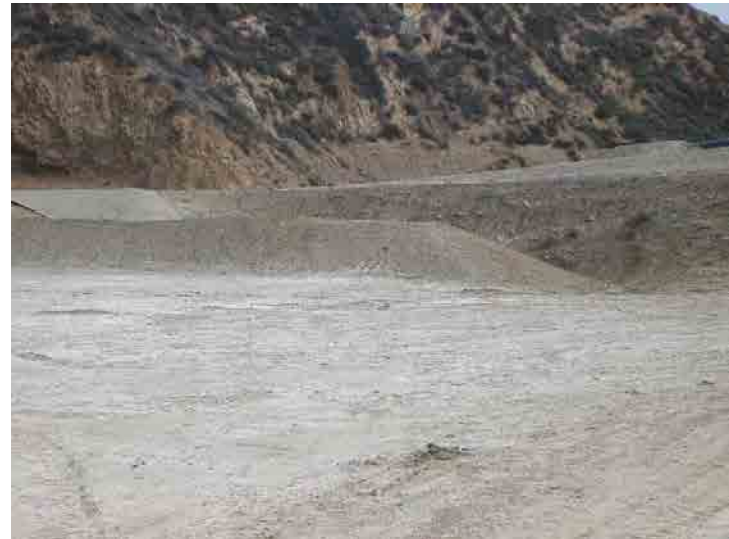
**Photo 124: Basin D: January 27, 2016**

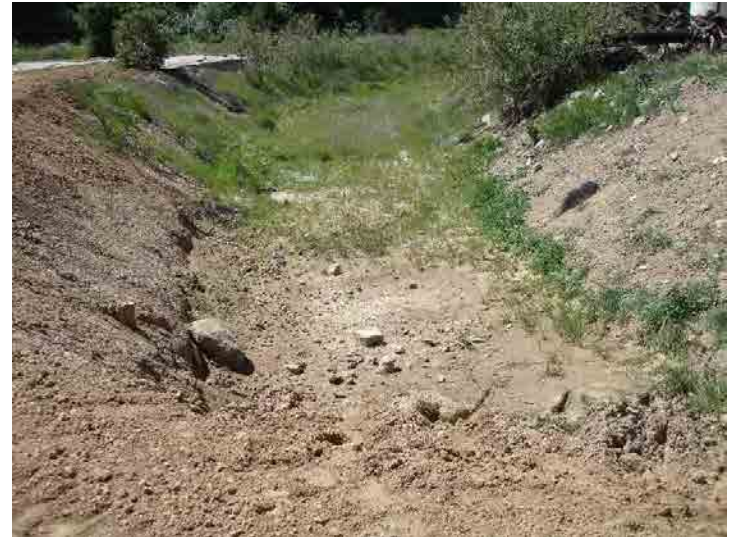
**Photo 128: Hillside Drainage into Basin D: March 23, 2016**

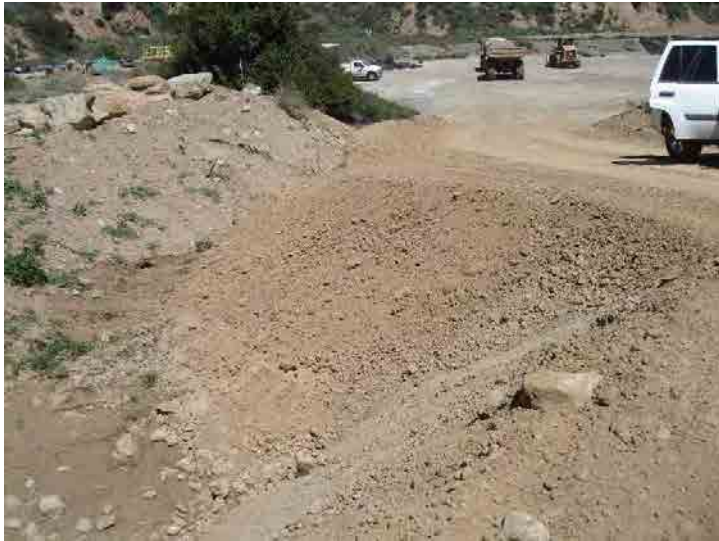
**Photo 129: Hillside Drainage into Basin D: March 23, 2016**

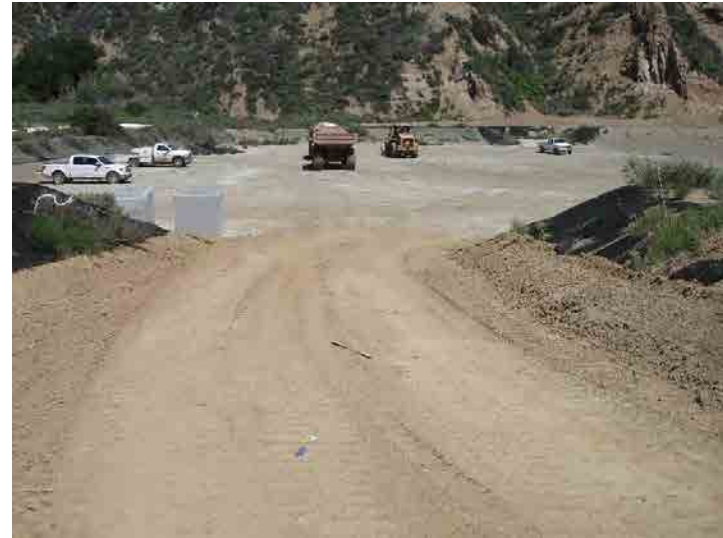
**Photo 130: Hillside Drainage into Basin D: March 23, 2016**

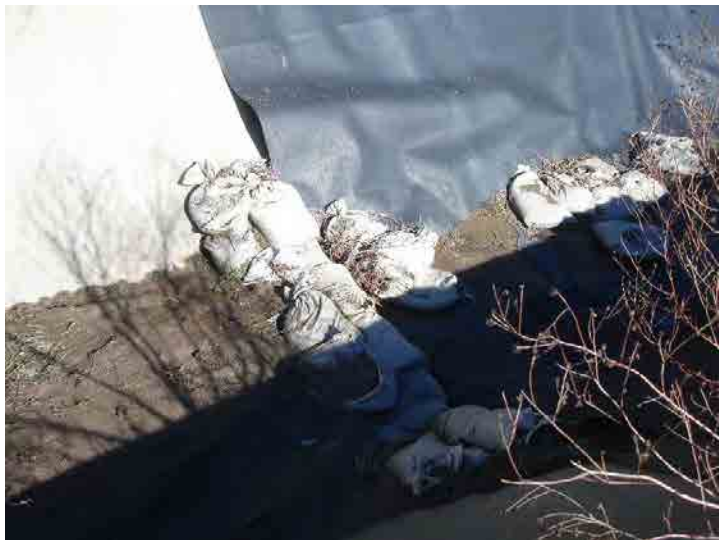
**Photo 131: Basin D Outlet Channel: January 7, 2016**

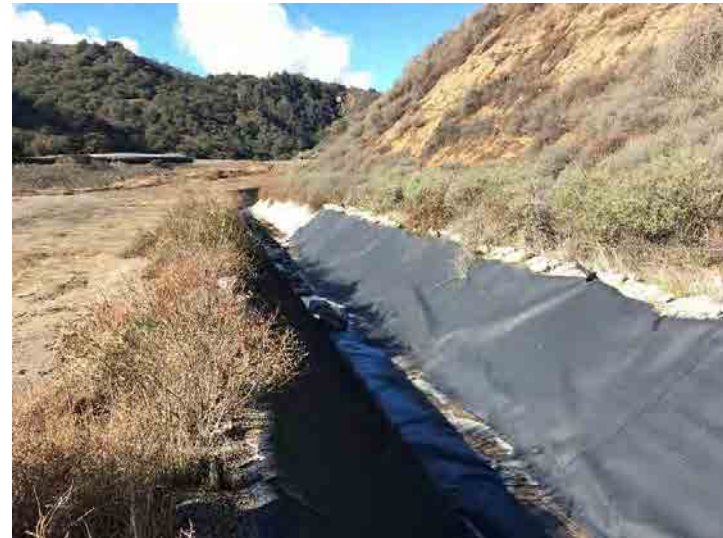
**Photo 132: Basin D Outlet Channel: January 7, 2016**

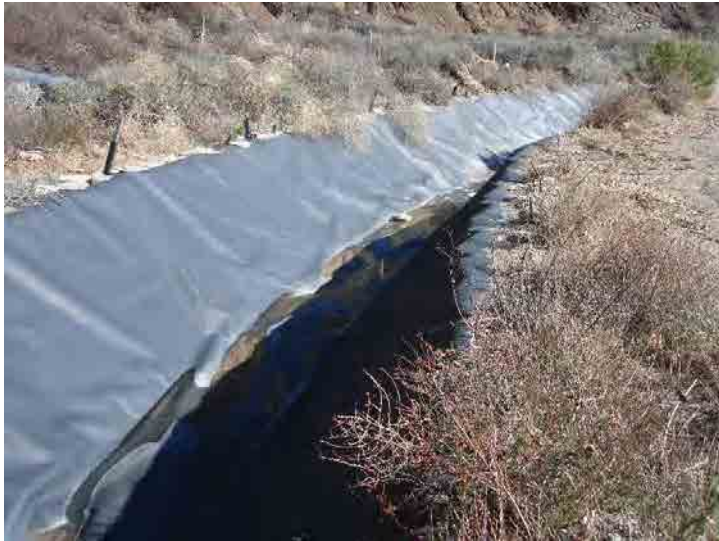
**Photo 133: Basin D Outlet Channel: January 7, 2016**

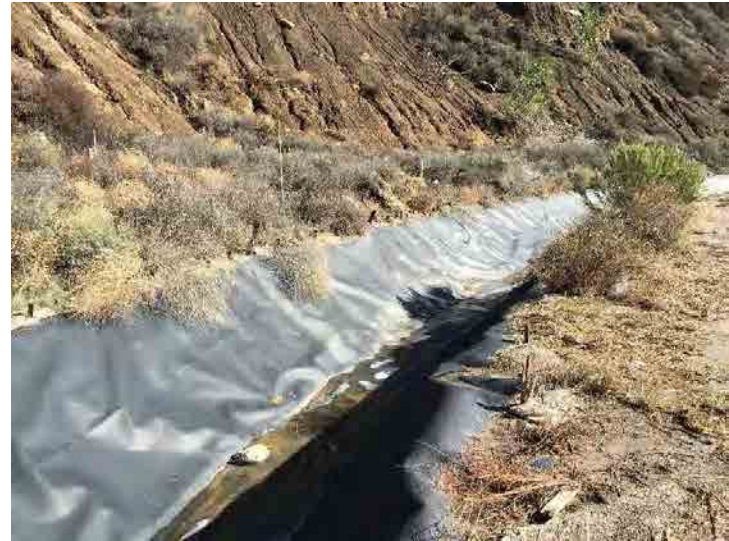
**Photo 134: Basin D Outlet Channel: January 7, 2016**

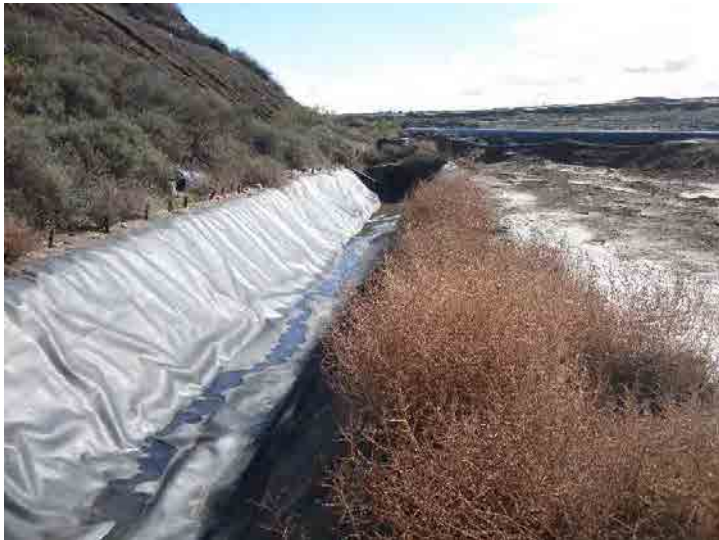
**Photo 135: Basin D Outlet Channel: January 7, 2016**

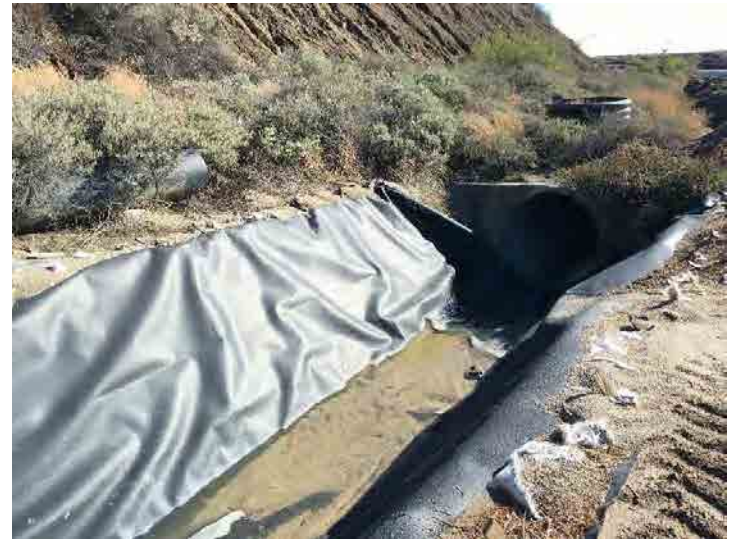
**Photo 136: Basin D Outlet Channel: January 7, 2016**

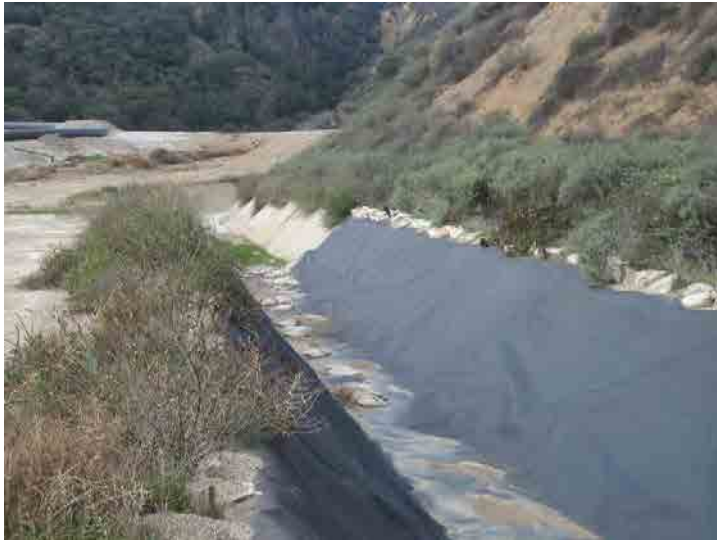
**Photo 137: Basin D Outlet Channel: January 27, 2016**

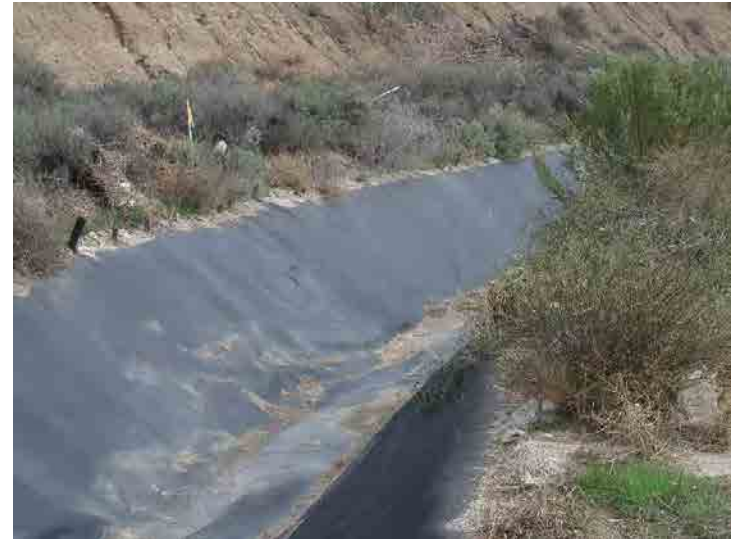
**Photo 138: Basin D Outlet Channel: January 27, 2016**

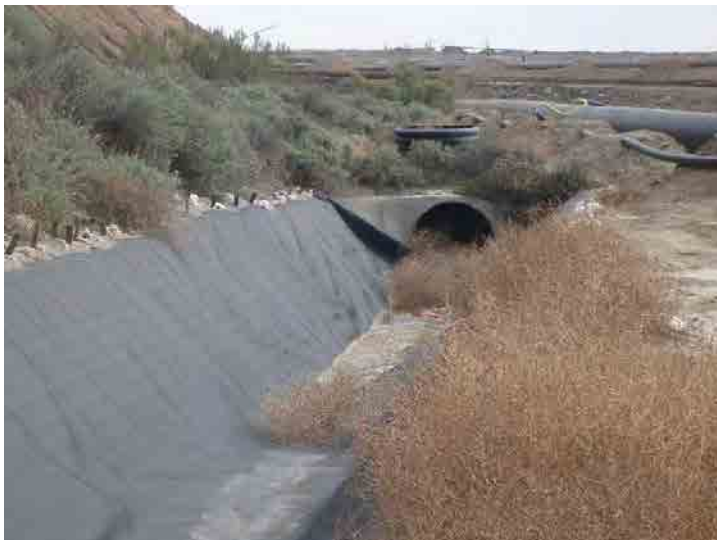
**Photo 139: Basin D Outlet Channel: January 27, 2016**

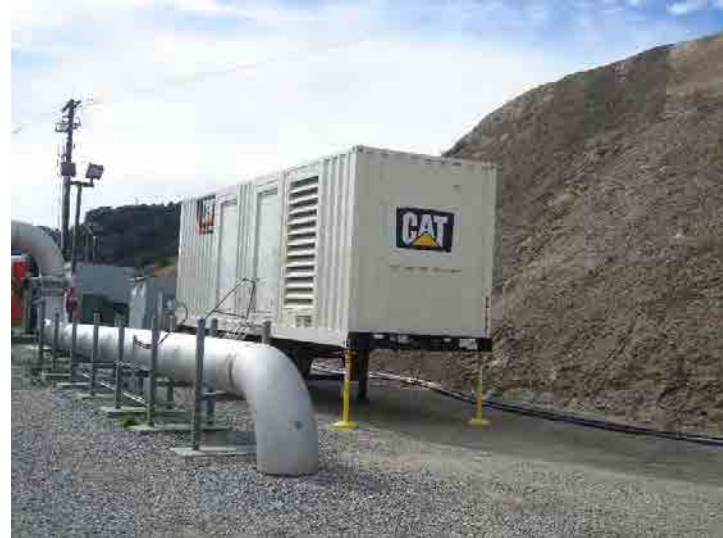
**Photo 156: 35 Flare 9 & 10 Portable Generator: January 27, 2016**

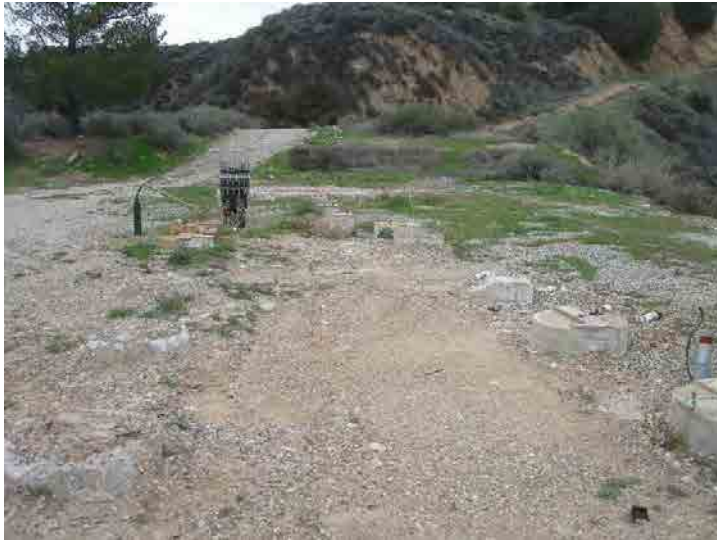
**Photo 157: Flare 8 Vacuum Leak: January 27, 2016**

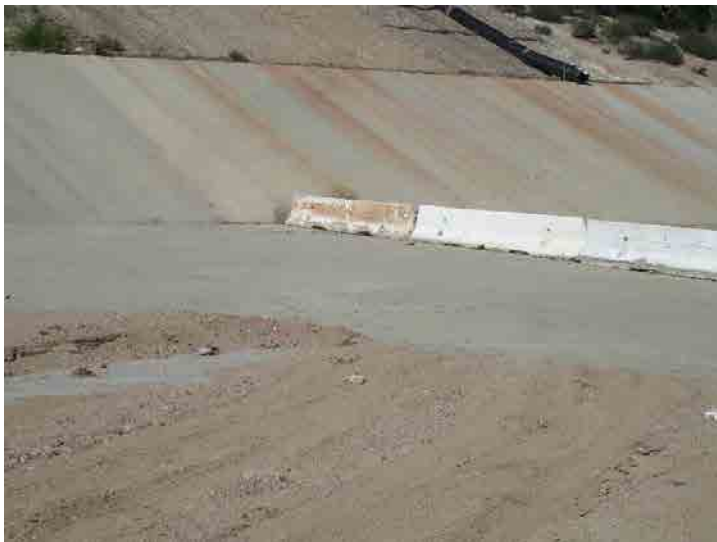
**Photo 239: Terminal Basin: February 24, 2016**

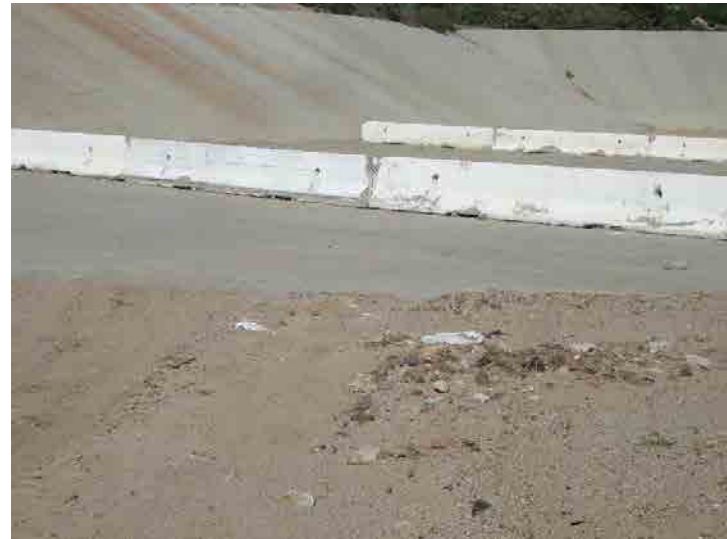
**Photo 240: Terminal Basin: February 24, 2016**

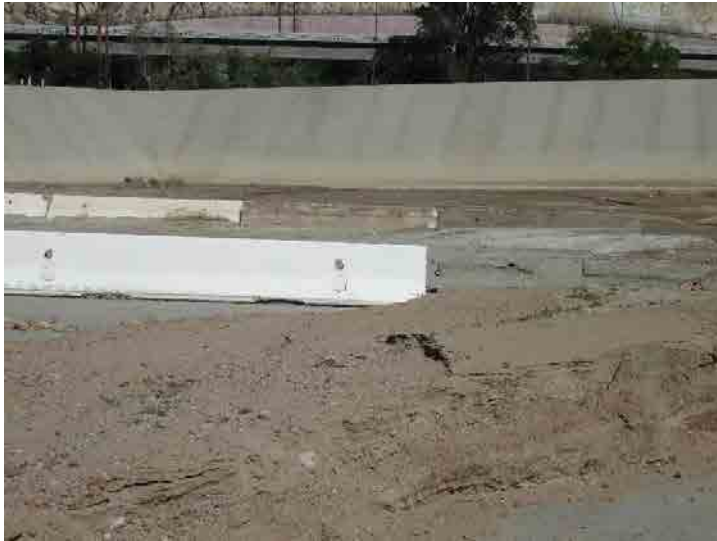
**Photo 241: Terminal Basin: February 24, 2016**

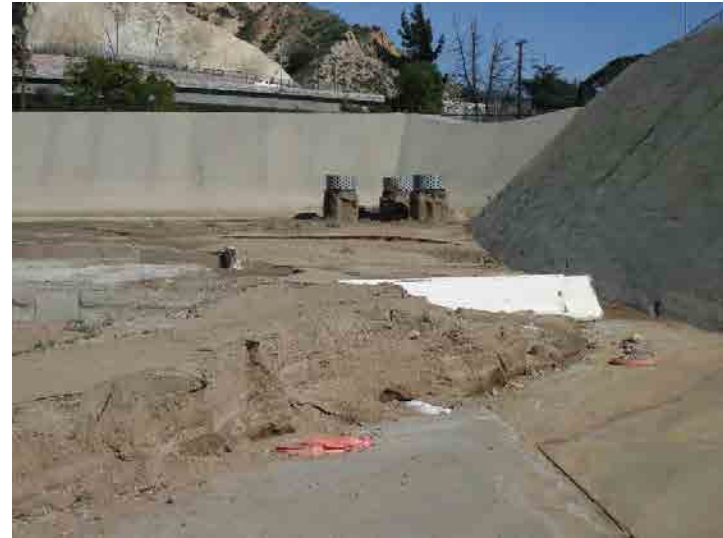
**Photo 242: Terminal Basin: February 24, 2016**

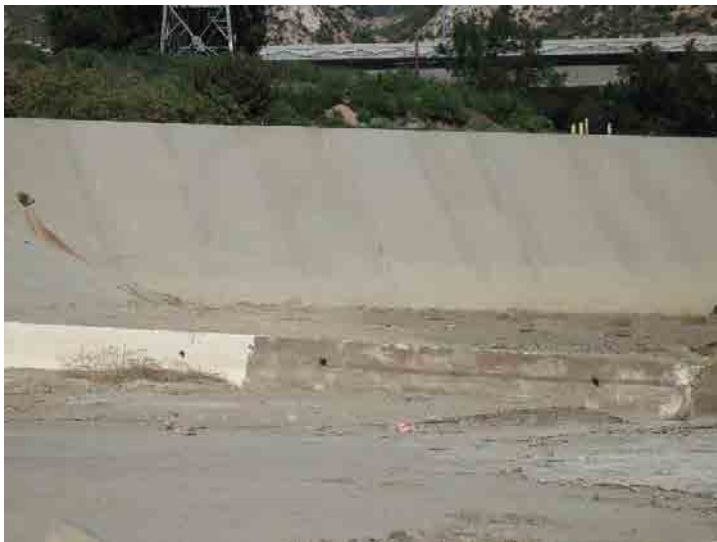
**Photo 243: Terminal Basin: February 24, 2016**

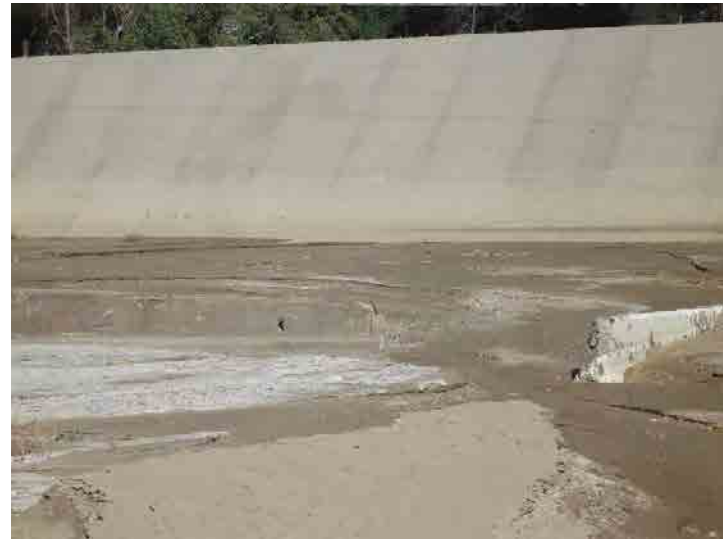
**Photo 244: Terminal Basin: February 24, 2016**

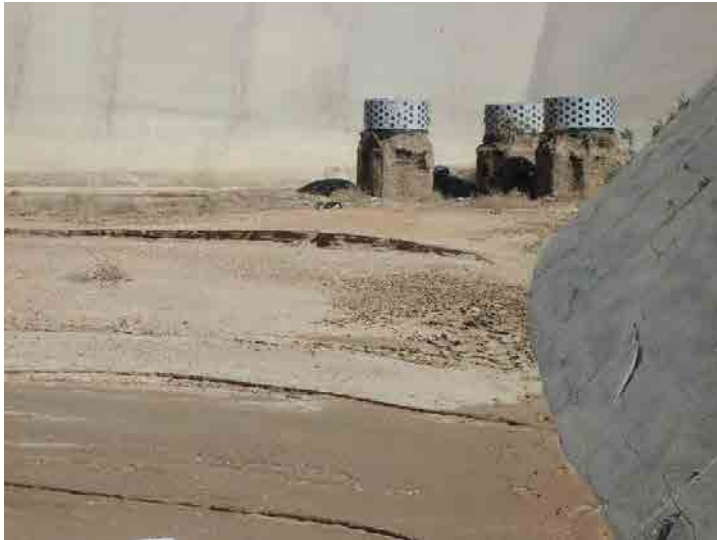
**Photo 245: Terminal Basin: February 24, 2016**

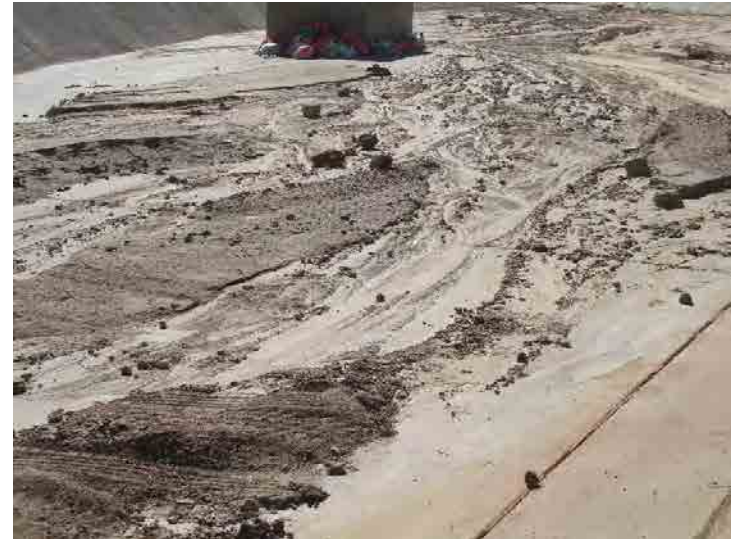
**Photo 246: Terminal Basin: February 24, 2016**

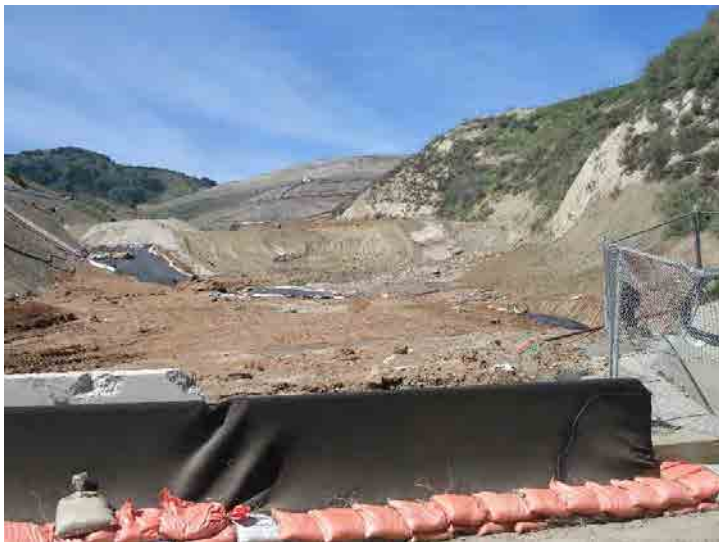
**Photo 251: Drainage into Terminal Basin: March 9, 2016**

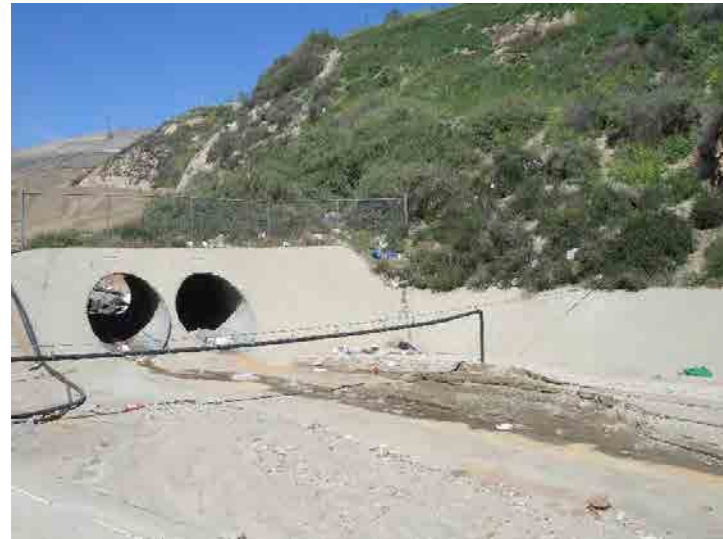
**Photo 252: Terminal Basin Inlet: March 23, 2016**

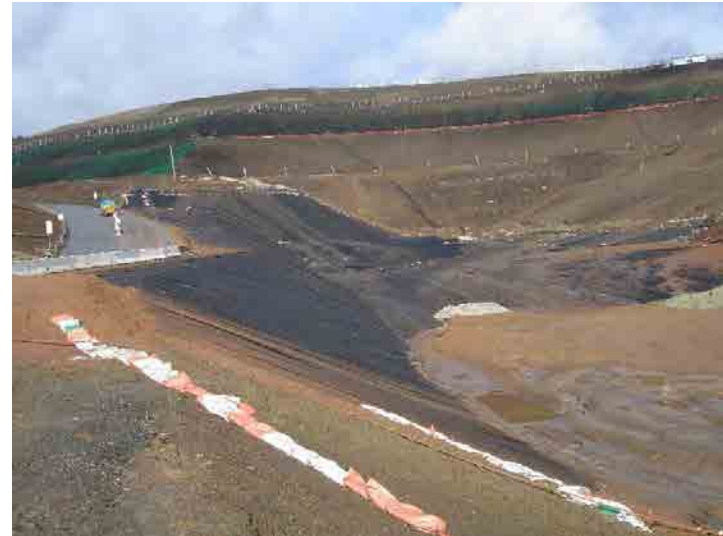
**Photo 258: City Cell CC3B Construction: January 7, 2016**

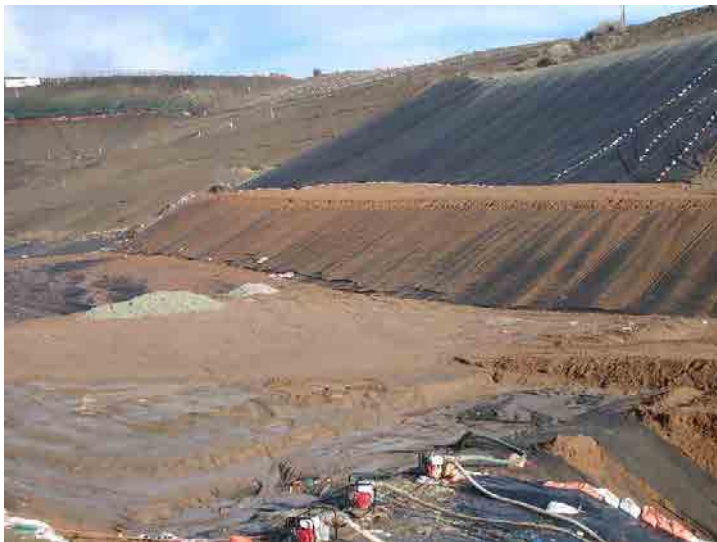
**Photo 259: City Cell CC3B Construction: January 7, 2016**

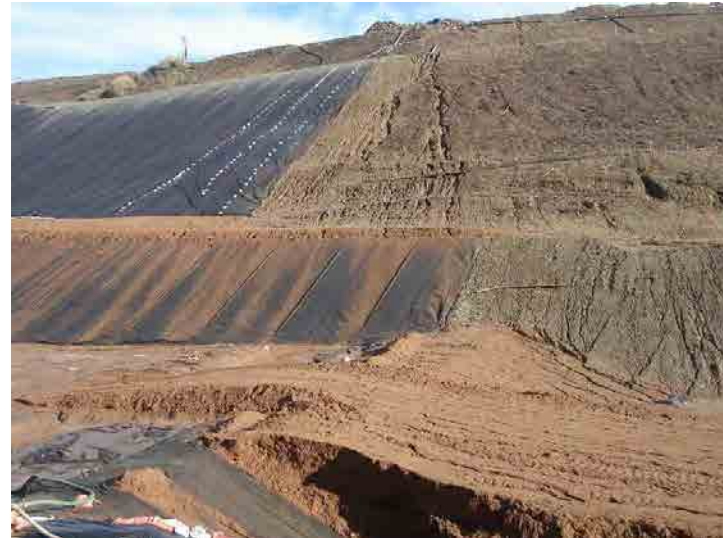
**Photo 260: City Cell CC3B Construction: January 7, 2016**

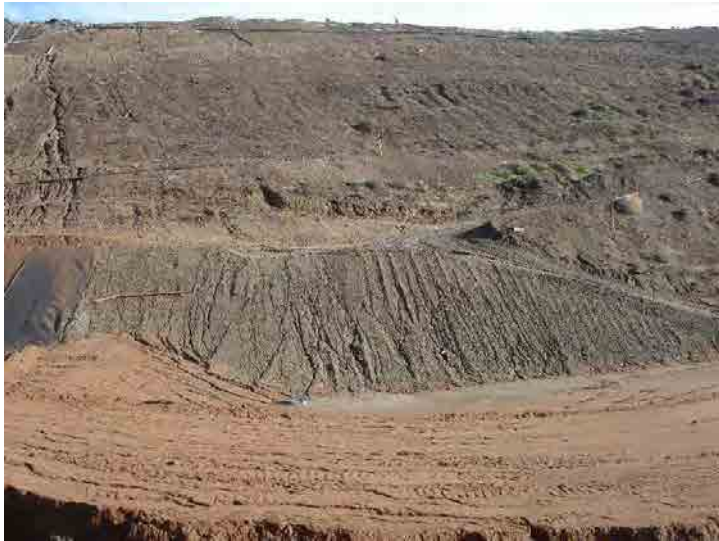
**Photo 261: City Cell CC3B Construction: January 7, 2016**

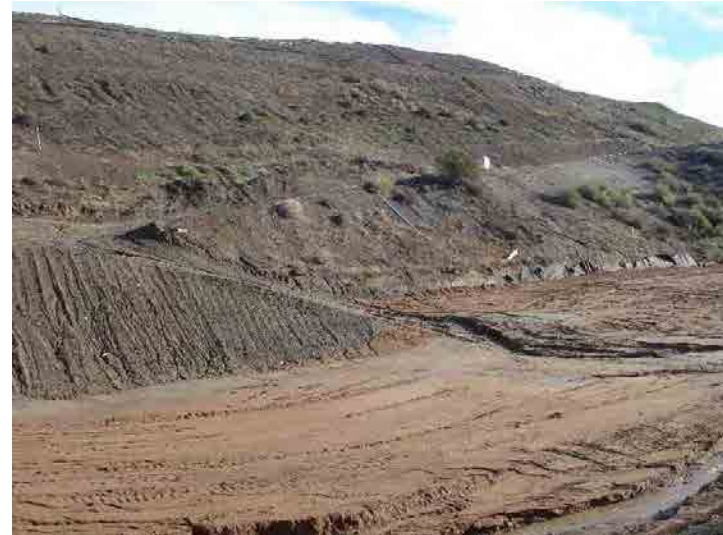
**Photo 262: City Cell CC3B Construction: January 7, 2016**

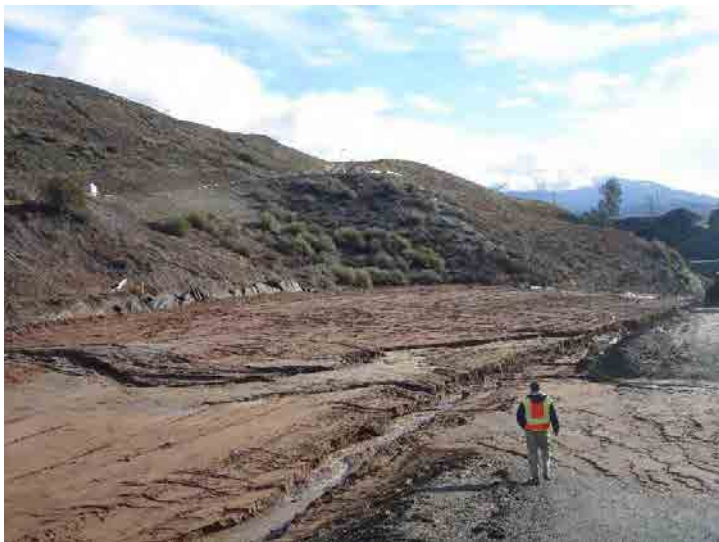
**Photo 263: City Cell CC3B Construction: January 7, 2016**

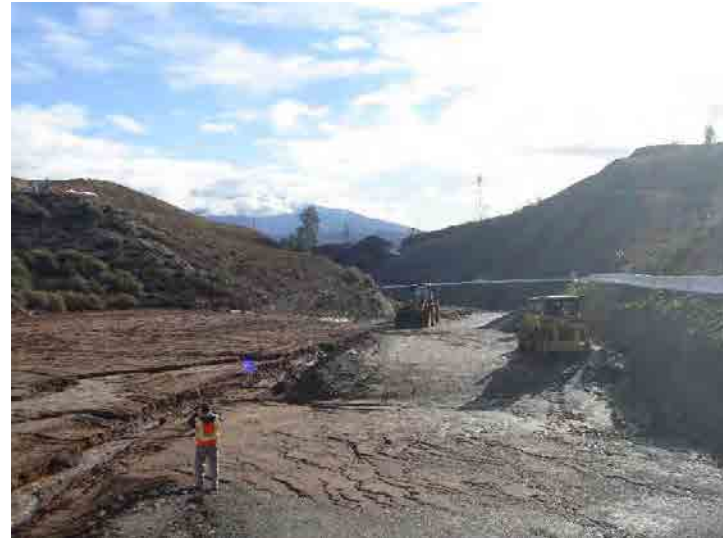
**Photo 264: City Cell CC3B Construction: January 7, 2016**

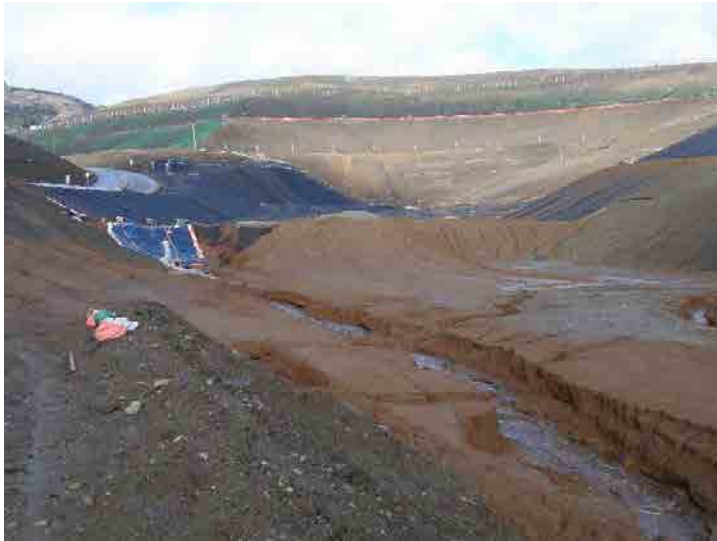
**Photo 265: City Cell CC3B Construction: January 7, 2016**

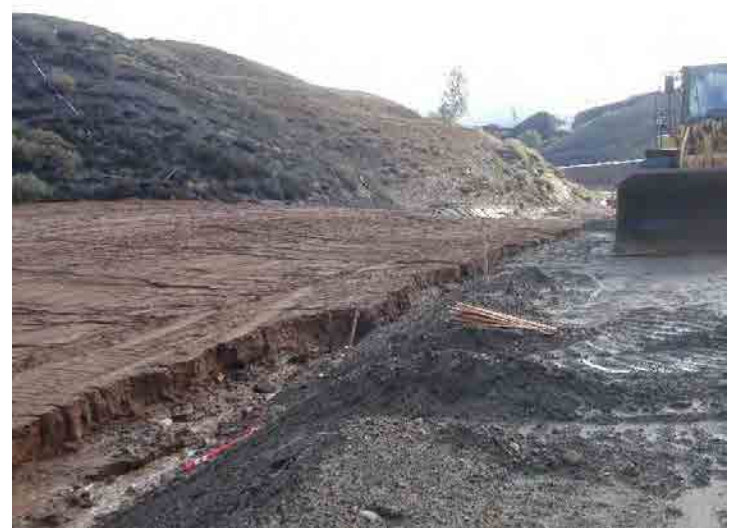
**Photo 266: City Cell CC3B Construction: January 7, 2016**

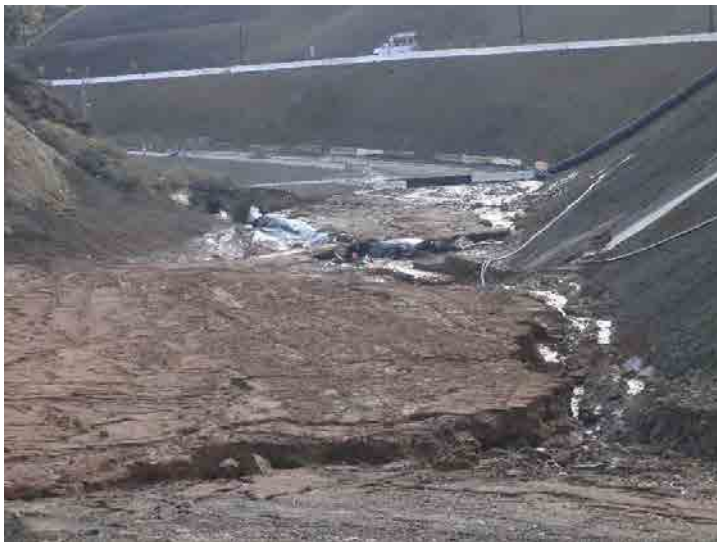
**Photo 267: City Cell CC3B Construction: January 7, 2016**

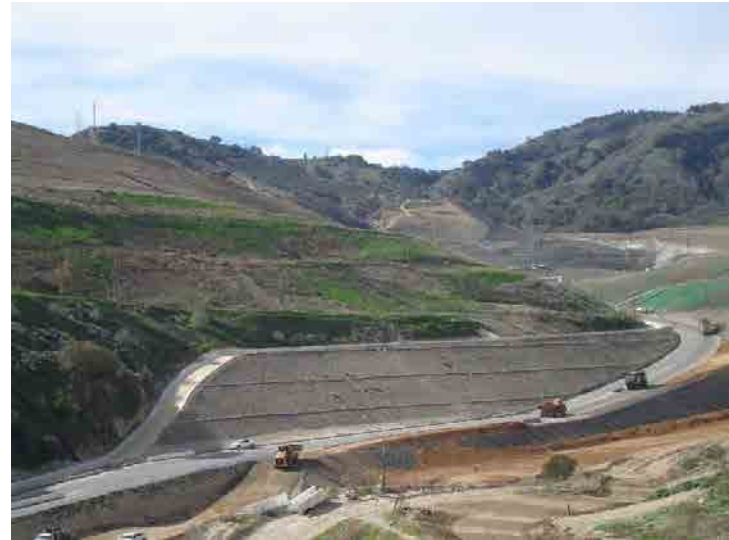
**Photo 268: City Cell CC3B Construction: January 27, 2016**

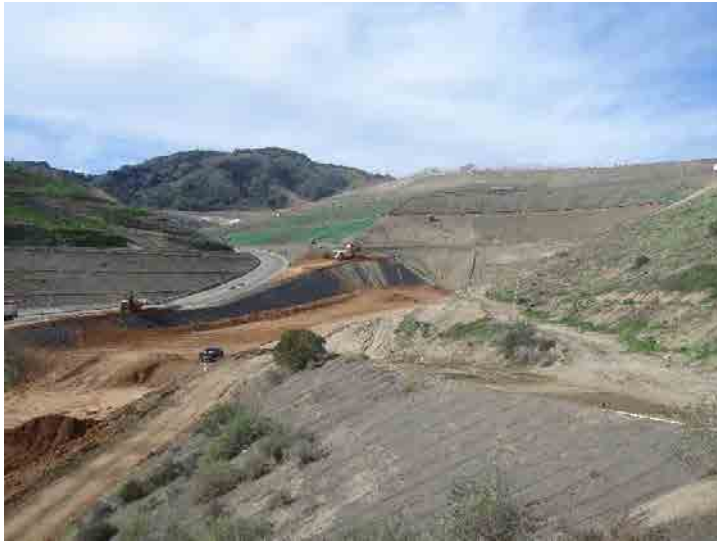
**Photo 269: City Cell CC3B Construction: January 27, 2016**

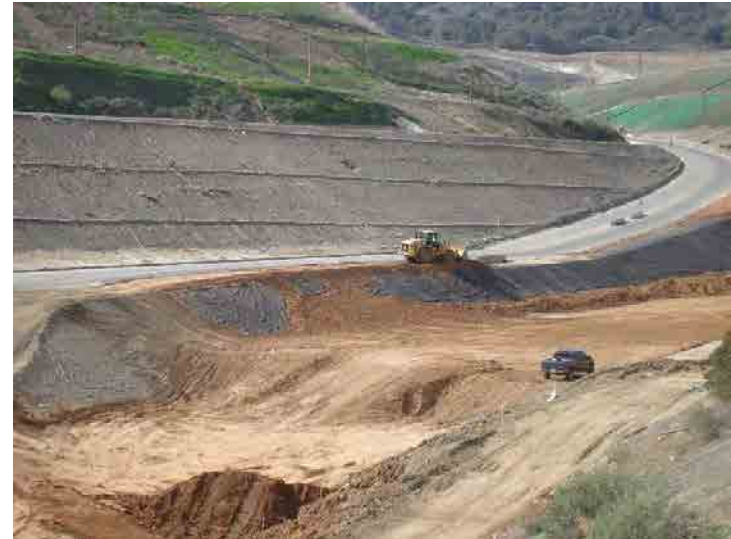
**Photo 270: City Cell CC3B Construction: January 27, 2016**

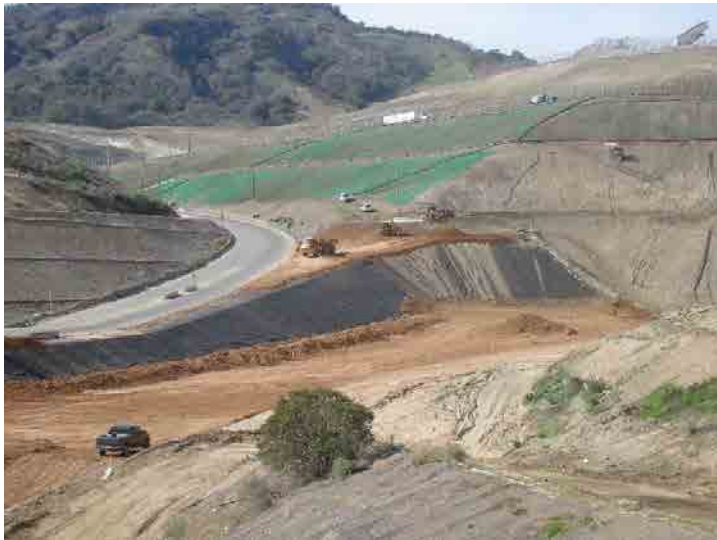
**Photo 271: City Cell CC3B Construction: January 27, 2016**

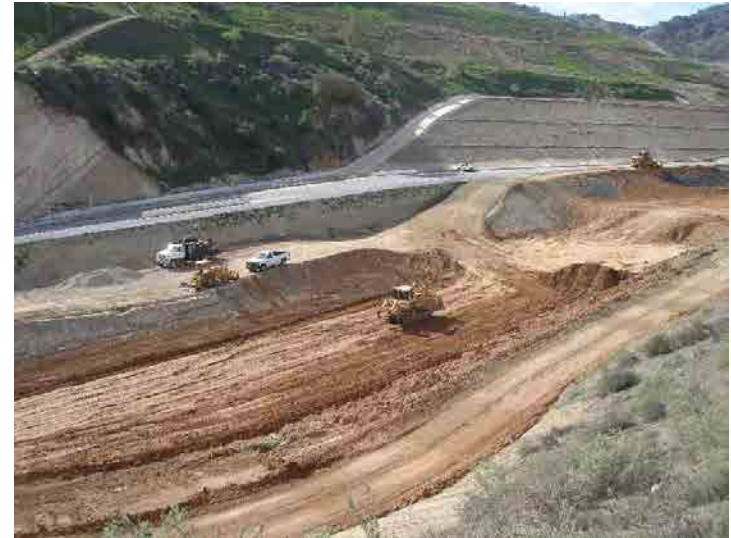
**Photo 272: City Cell CC3B Construction: January 27, 2016**

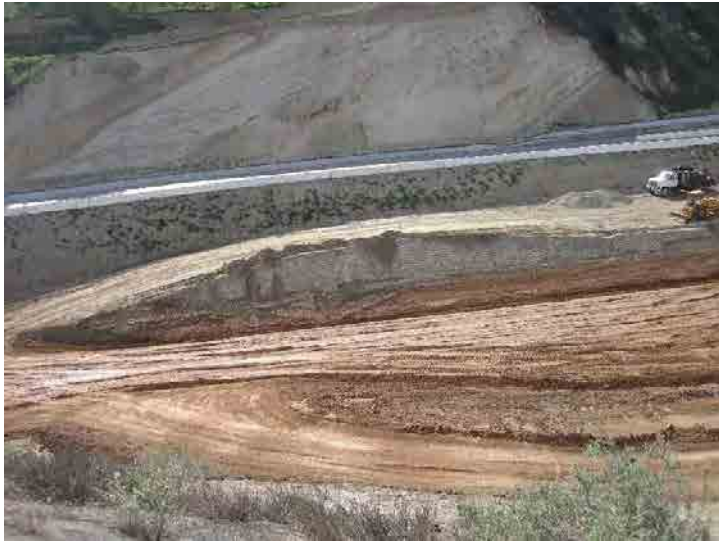
**Photo 273: City Cell CC3B Construction: January 27, 2016**
