**Sunshine Canyon Landfill  
Independent Monitor  
Quarterly Site Monitoring Status Report  
January 1, 2016 – March 31, 2016**

**City of Los Angeles Department of City Planning**

**County of Los Angeles Department of Regional Planning**

May 16, 2016

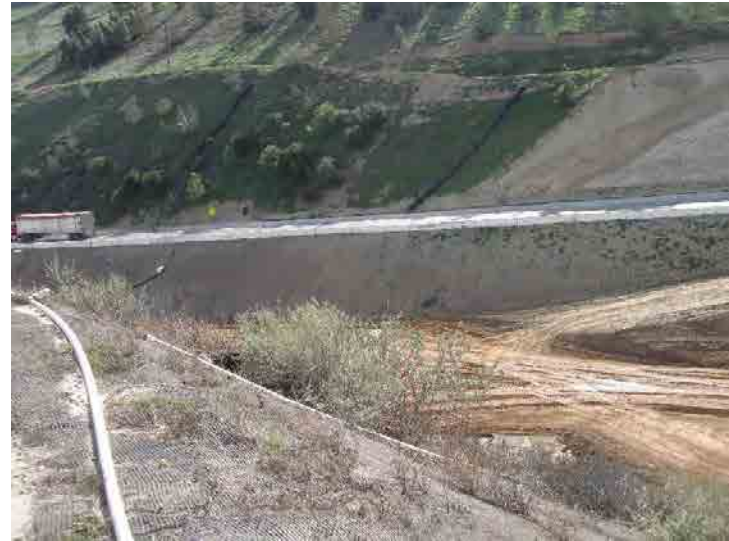
**Photo 274: City Cell CC3B Construction: January 27, 2016**

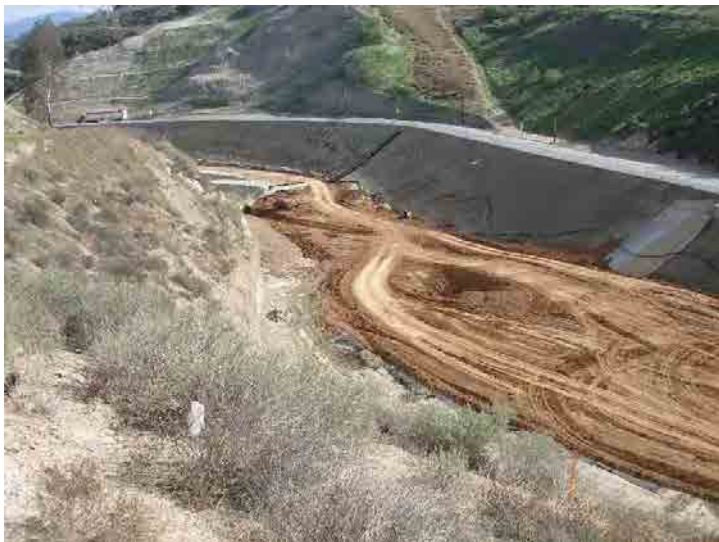
**Photo 275: City Cell CC3B Construction: January 27, 2016**

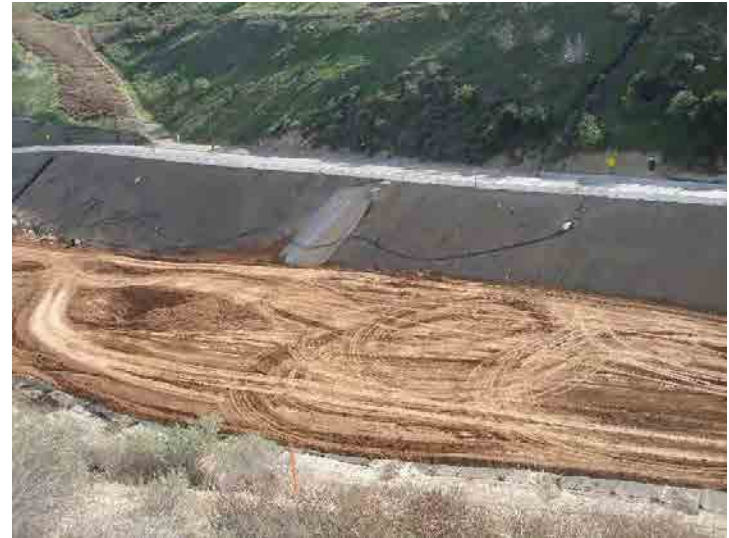
**Photo 276: City Cell CC3B Construction: January 27, 2016**

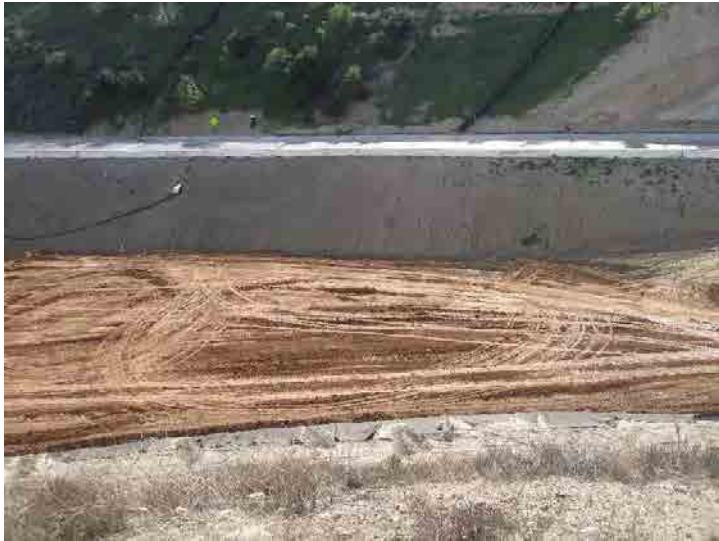
**Photo 277: City Cell CC3B Construction: January 27, 2016**

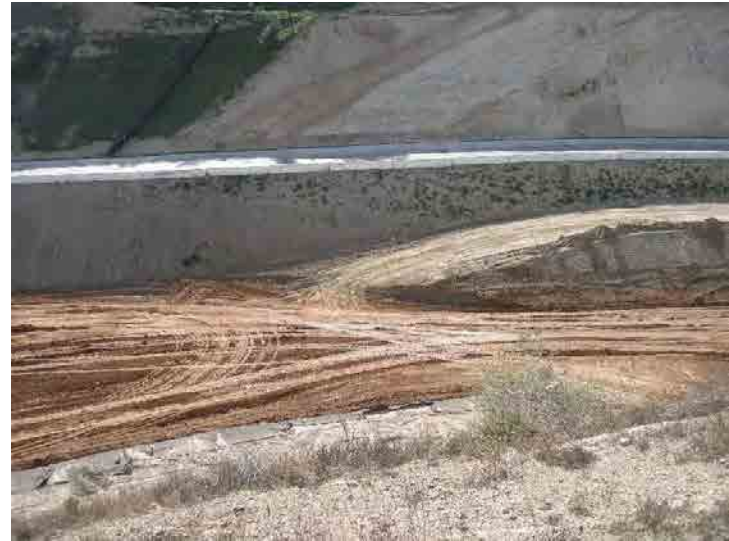
**Photo 278: City Cell CC3B Construction: January 27, 2016**

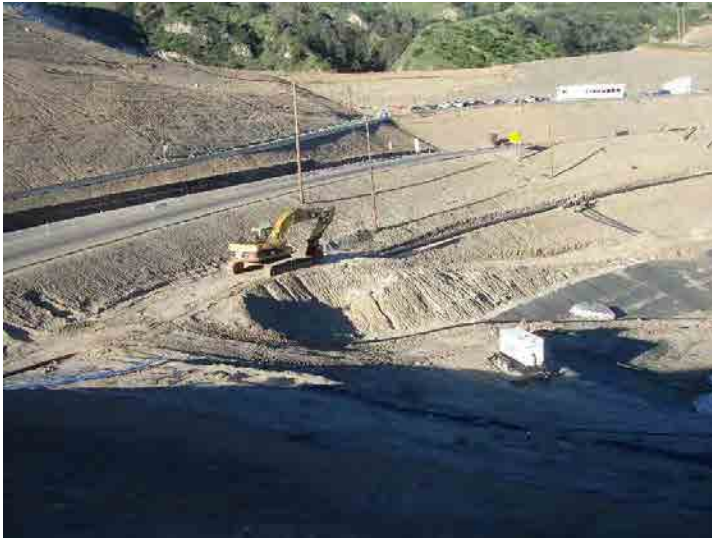
**Photo 298: City Cell CC3B Slope Litter: March 23, 2016**

**Photo 299: City Cell CC3B Slope Litter: March 23, 2016**

**Photo 300: City Cell CC3B Slope Litter: March 23, 2016**

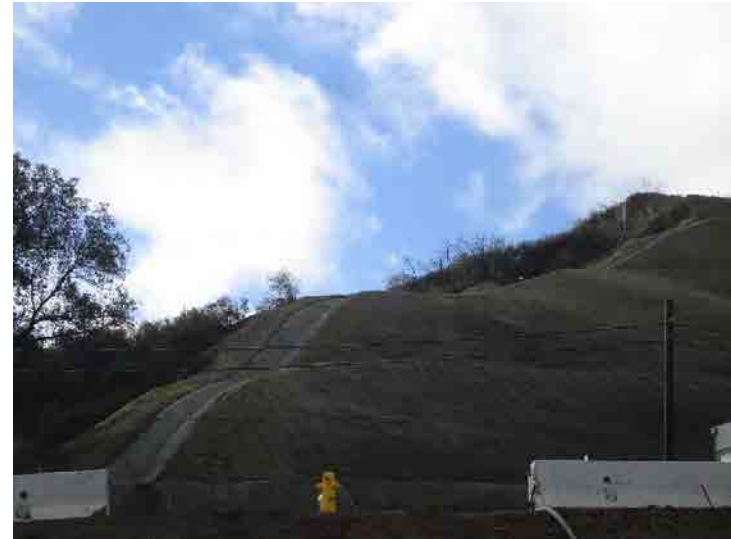
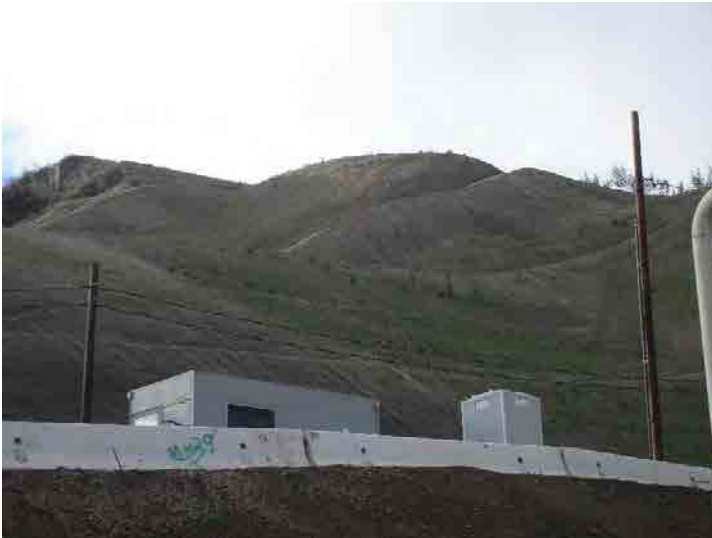
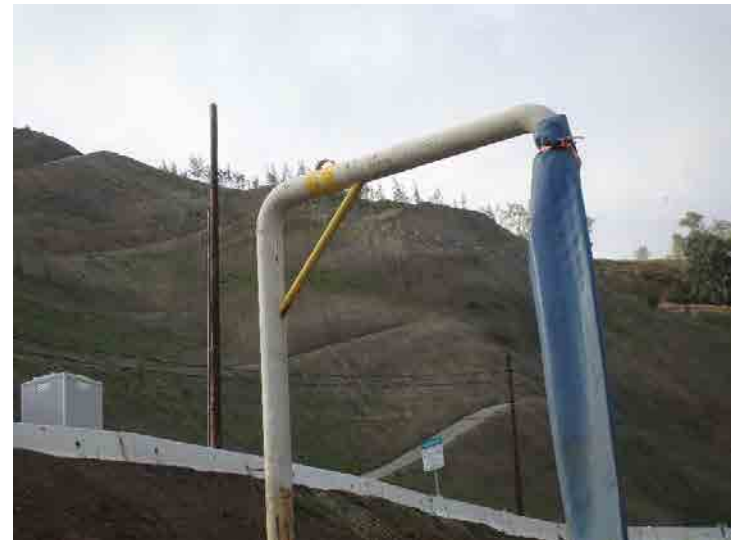
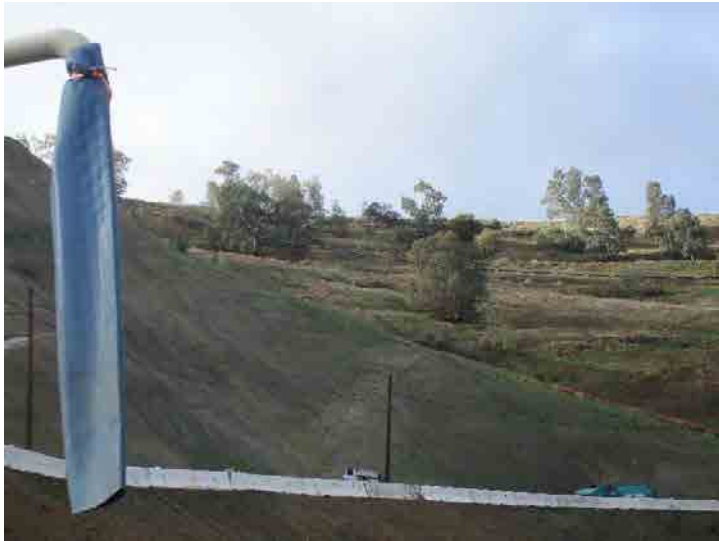
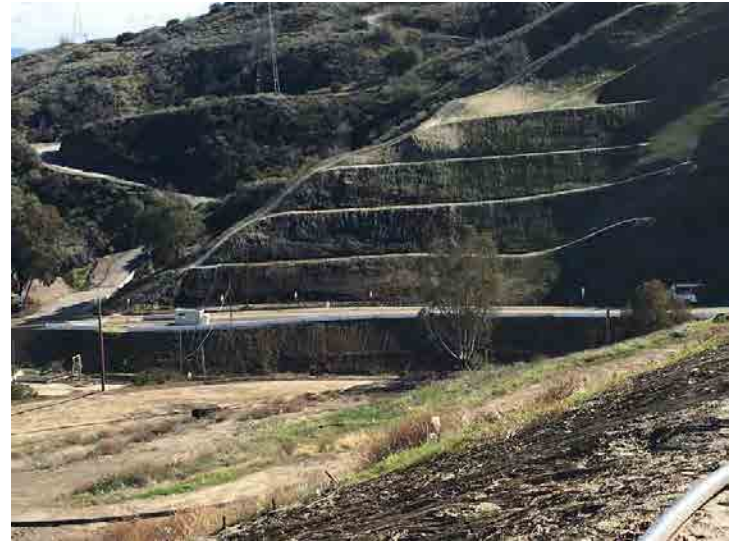
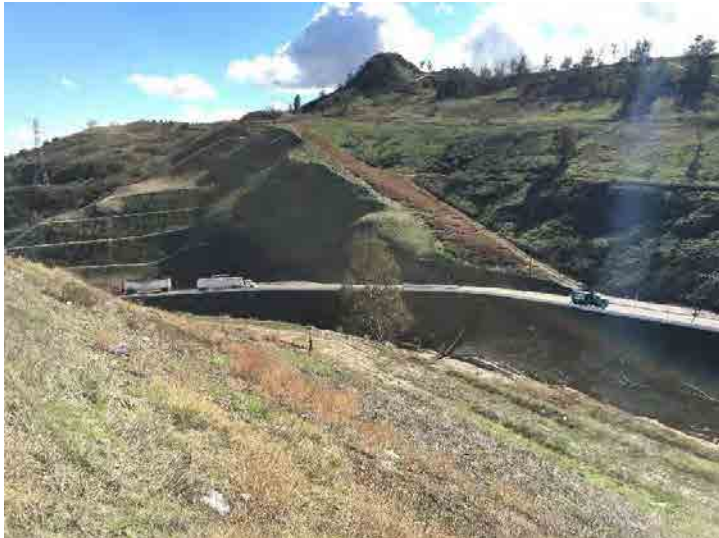
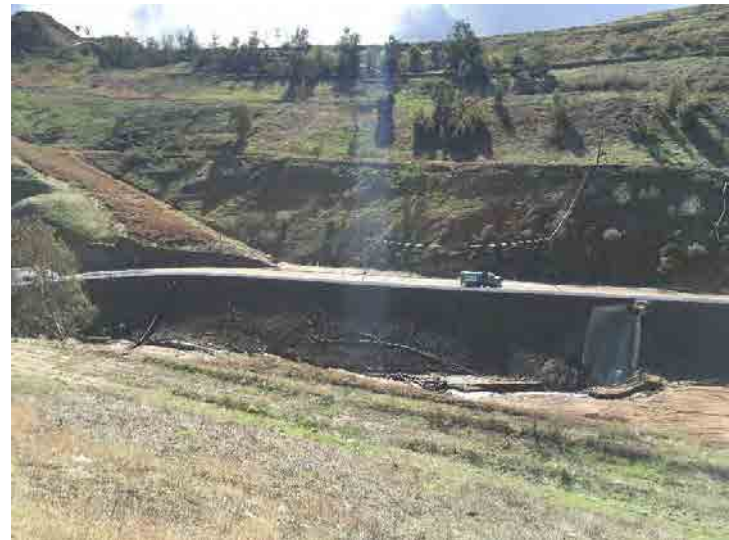
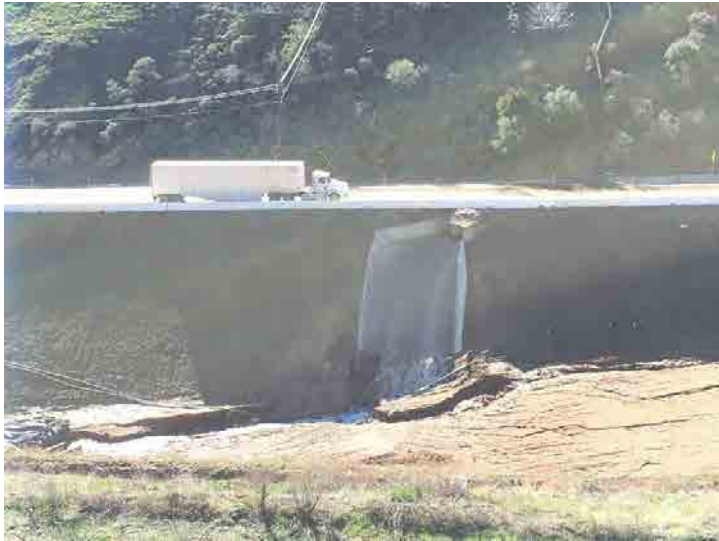
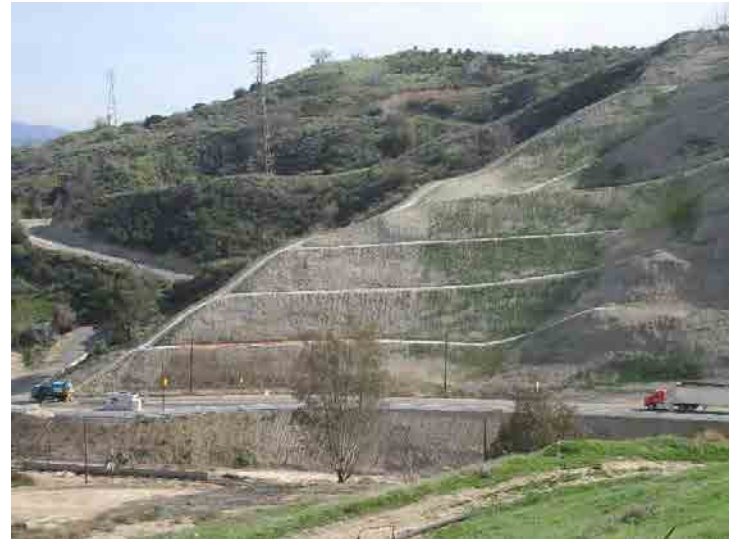
**Photo 301: City South Access Road Drainage Control: January 7, 2016**

**Photo 302: City South Access Road Drainage Control: January 7, 2016**

**Photo 303: City South Access Road Drainage Control: January 7, 2016**

**Photo 304: City South Access Road Drainage Control: January 7, 2016**

**Photo 305: City South Access Road Drainage Control: January 7, 2016**

**Photo 306: City South Access Road Drainage Control: January 7, 2016**

**Photo 307: City South Access Road Drainage Control: January 7, 2016**

**Photo 308: City South Access Road Drainage Control: January 7, 2016**

**Photo 309: City South Access Road Drainage Control: January 7, 2016**

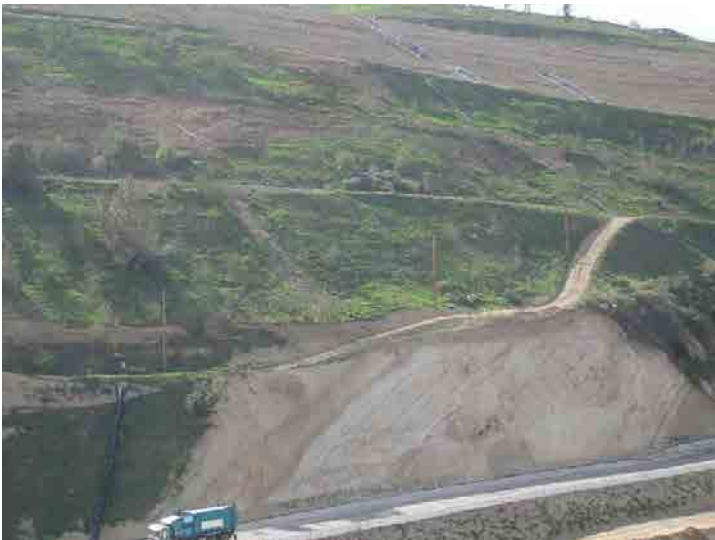
**Photo 318: Main Access Road: January 27, 2016**

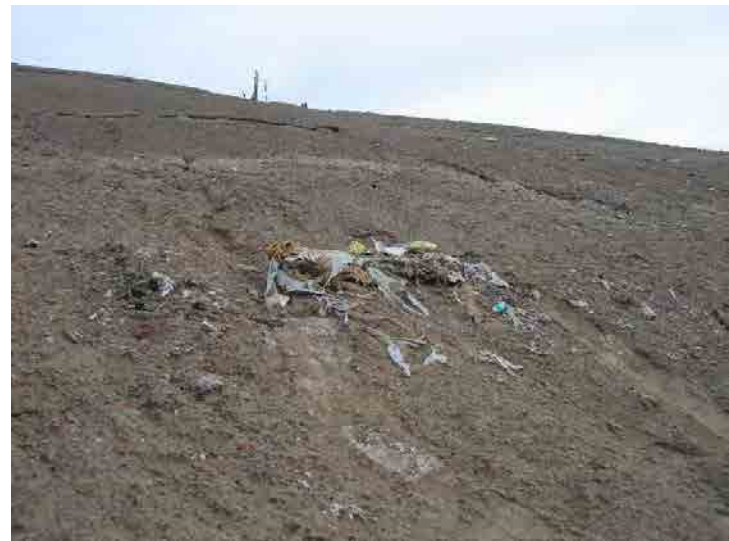
**Photo 331: County South Slope Inert Waste Exposed: January 27, 2016**

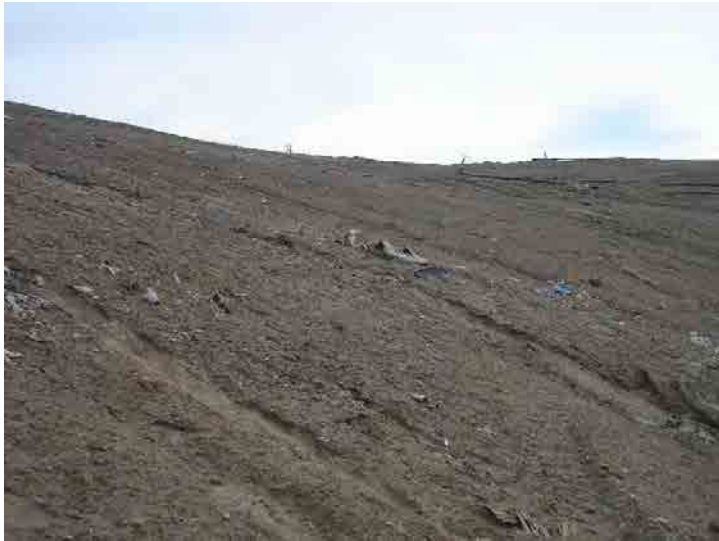
**Photo 332: County South Slope Inert Waste Exposed: January 27, 2016**

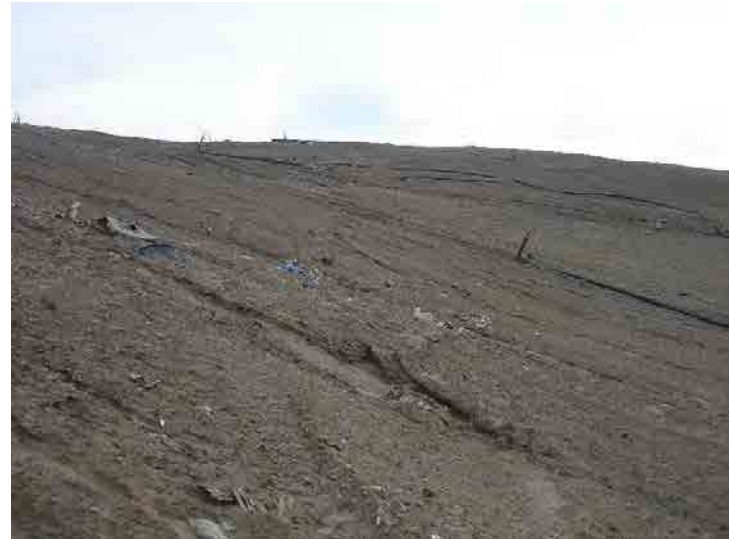
**Photo 333: County South Slope Inert Waste Exposed: January 27, 2016**

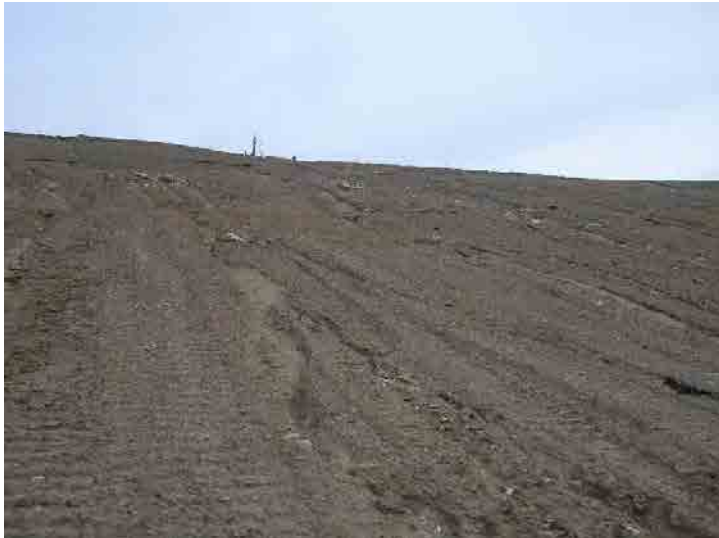
**Photo 334: County South Slope Inert Waste Exposed: January 27, 2016**

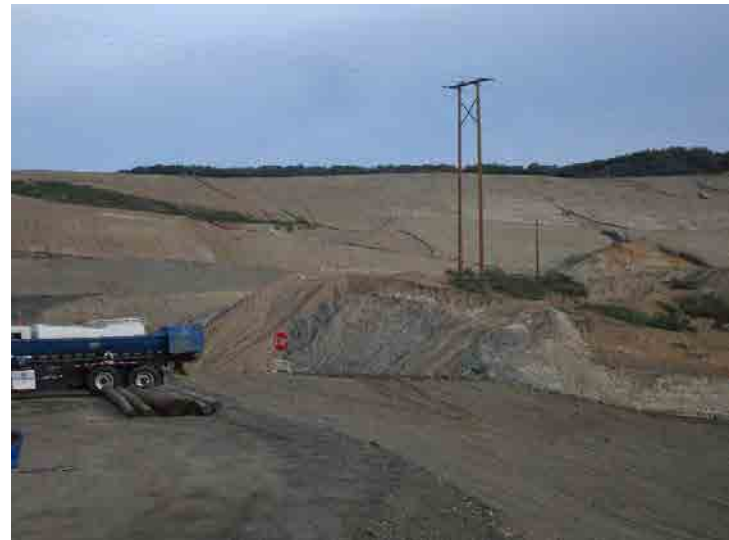
**Photo 335: County South Slope Inert Waste Exposed: January 27, 2016**

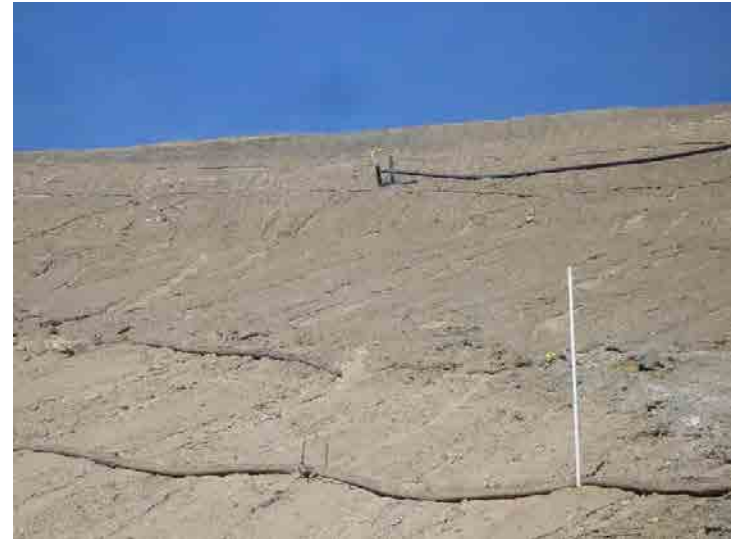
**Photo 353: Localized Condensate Odor February 24, 2016**

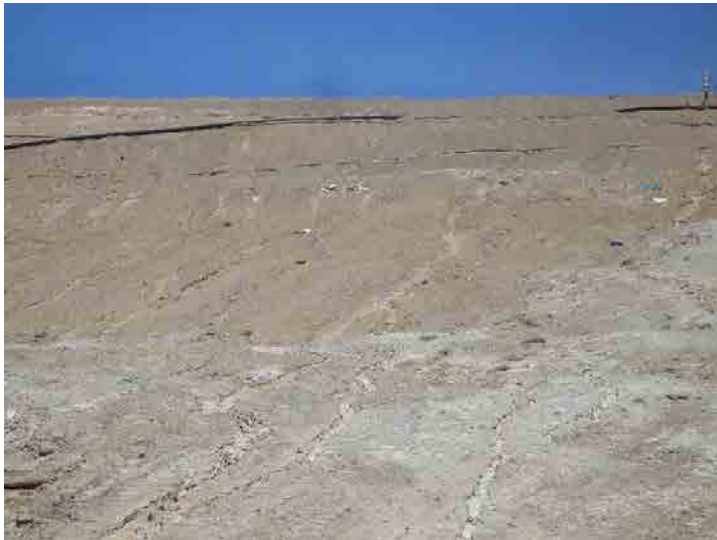
**Photo 354: City Slope Erosion: February 24, 2016**

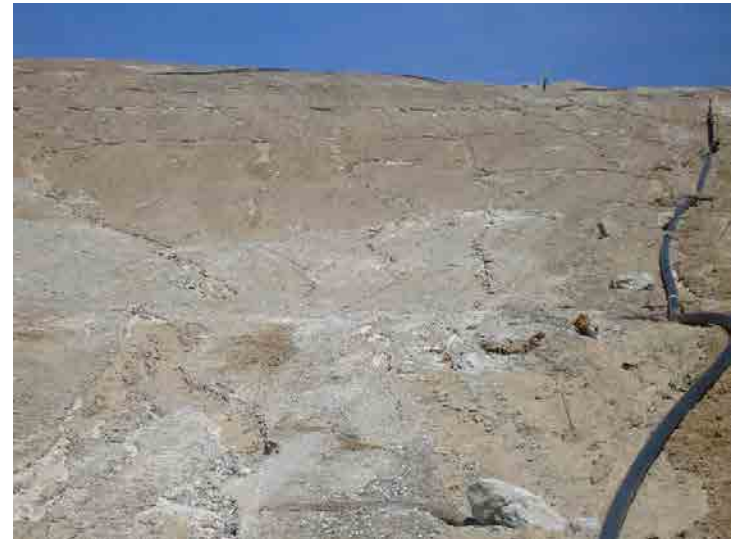
**Photo 355: City Slope Erosion, Inert Waste Exposed: February 24, 2016**

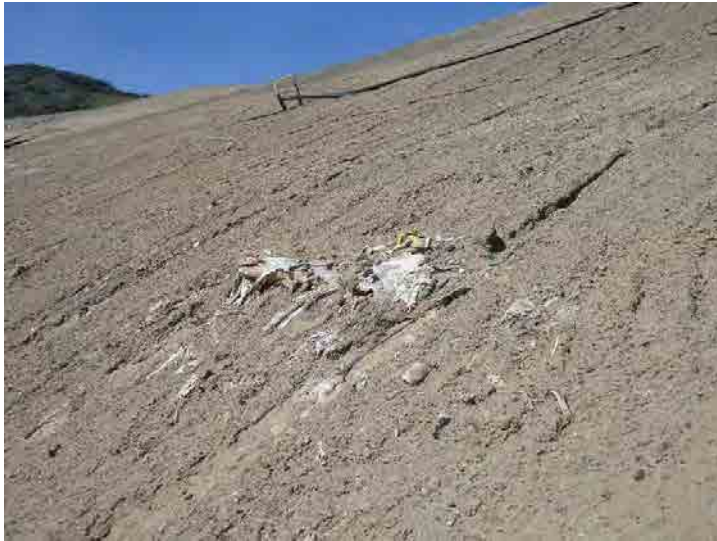
**Photo 356: City Slope Erosion, Inert Waste Exposed: February 24, 2016**

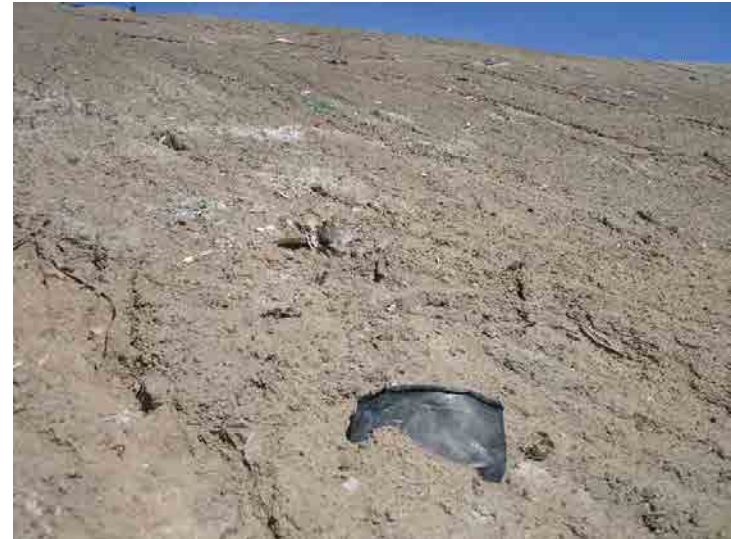
**Photo 357: City Slope Erosion, Inert Waste Exposed: February 24, 2016**

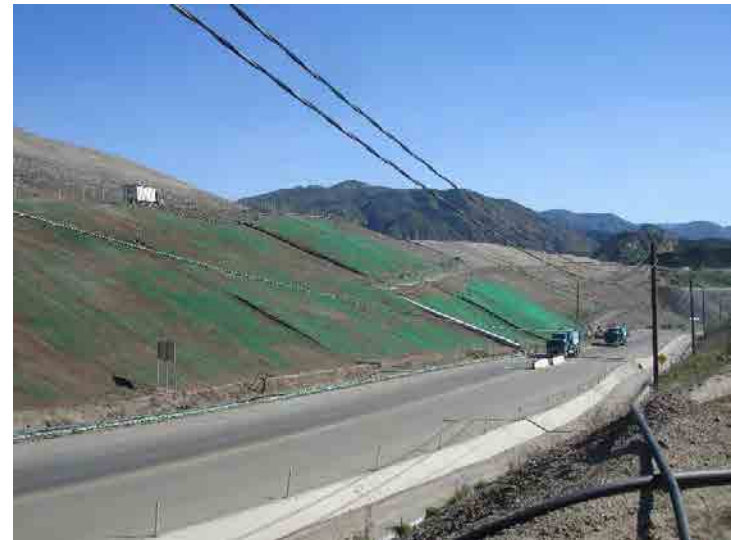
**Photo 359: City Slope Erosion Repair, Inert Waste Exposed: February 24, 2016**

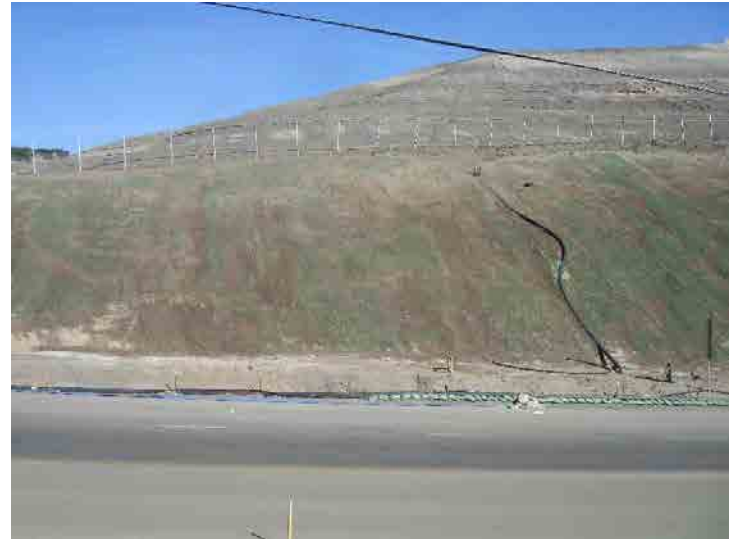
**Photo 361: City Slope Erosion Control: February 24, 2016**

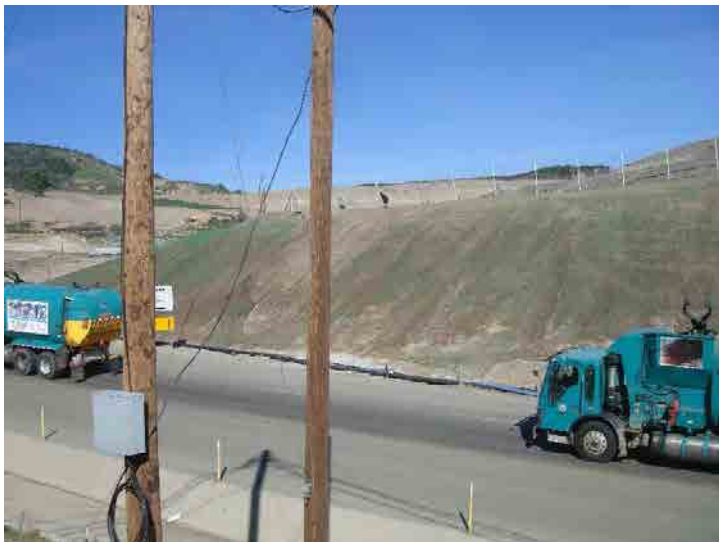
**Photo 362: City Slope Erosion Control: February 24, 2016**

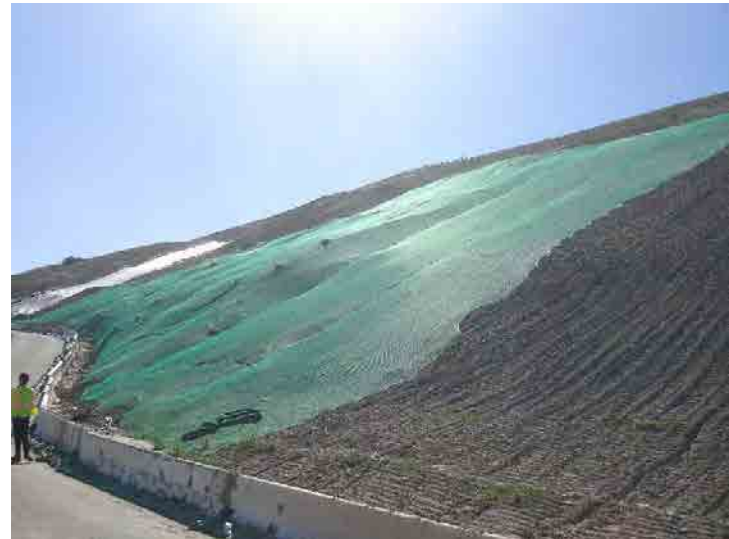
**Photo 363: City Slope Erosion Control: February 24, 2016**

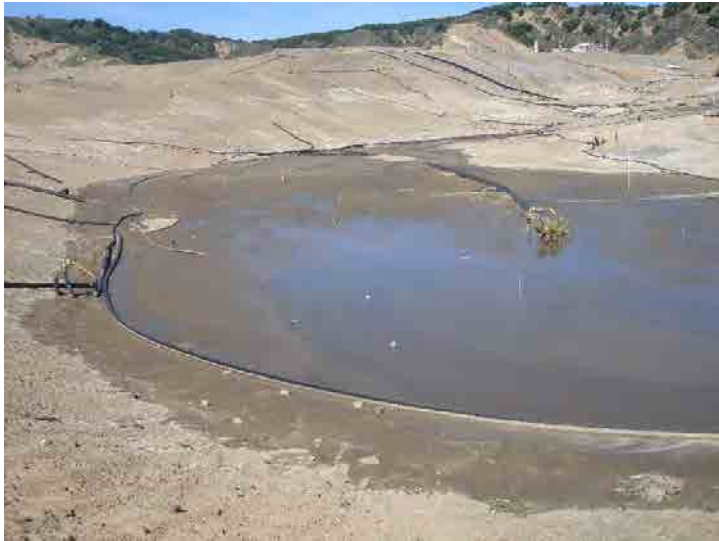
**Photo 364: City Slope Erosion Control: February 24, 2016**

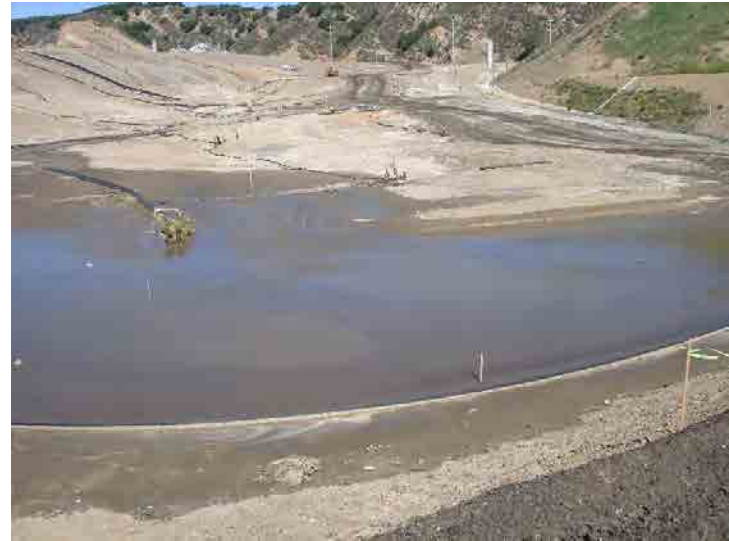
**Photo 365: Ponding on City Top Deck: March 9, 2016**

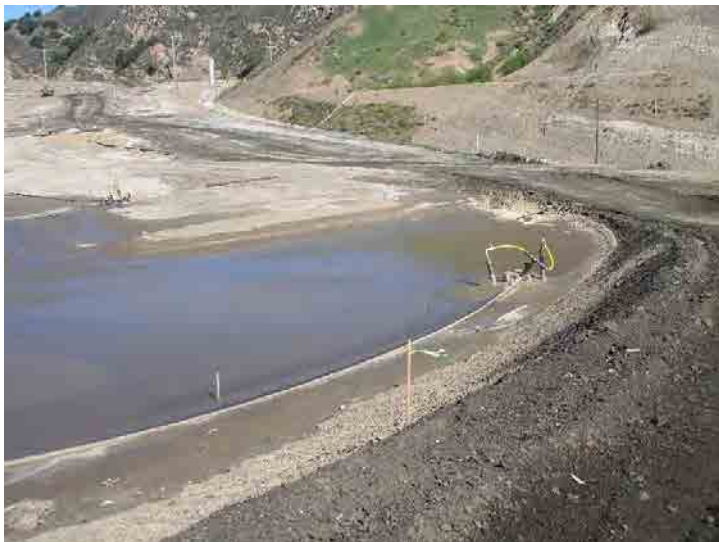
**Photo 366: Ponding on City Top Deck: March 9, 2016**

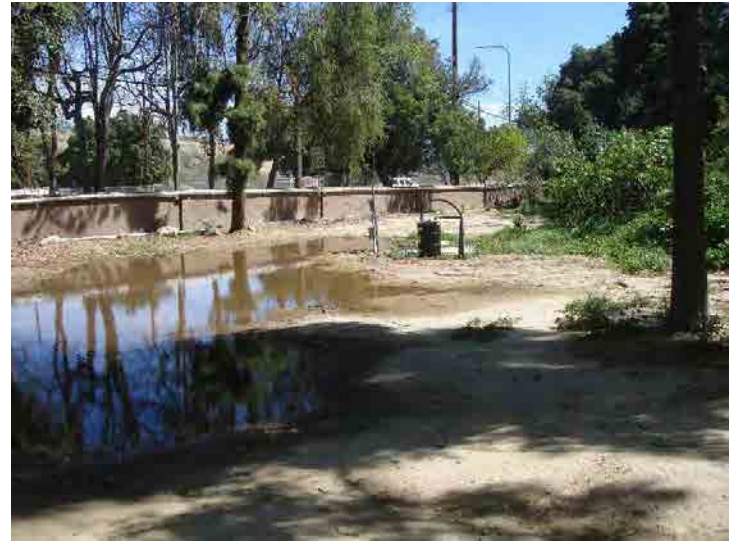
**Photo 514: Soil in Front of Frontage Retaining Wall on San  
Fernando Road: January 27, 2016**

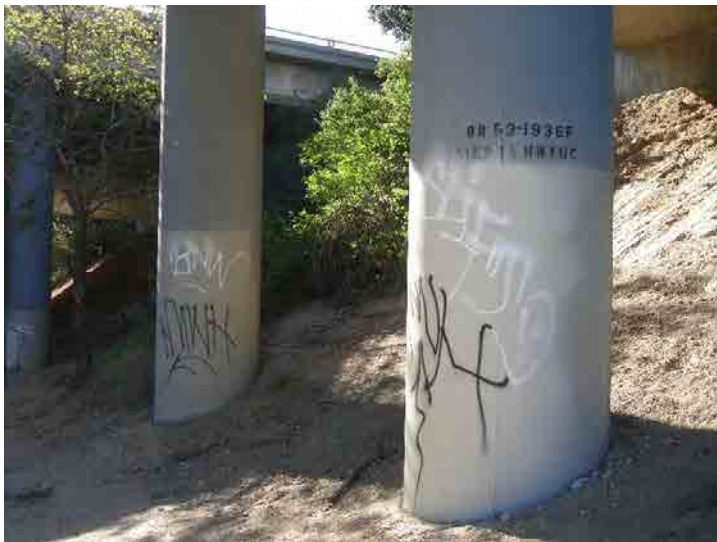
**Photo 562: San Fernando Road Near I-5 Overpass: March 23, 2016**

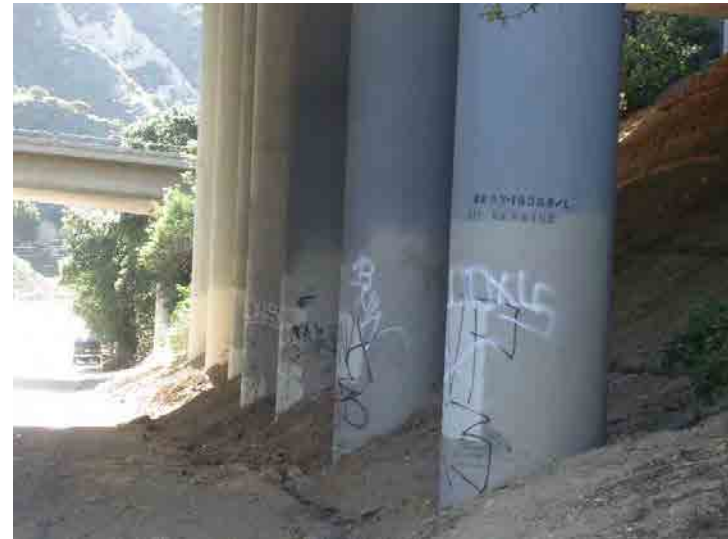
**Photo 563: San Fernando Road Near I-5 Overpass: March 23, 2016**

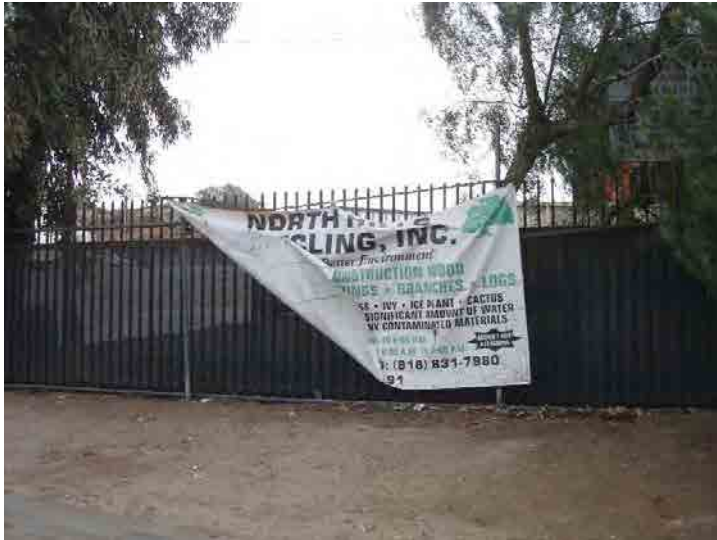
**Photo 564: San Fernando Road Near I-5 Overpass: March 9, 2016**

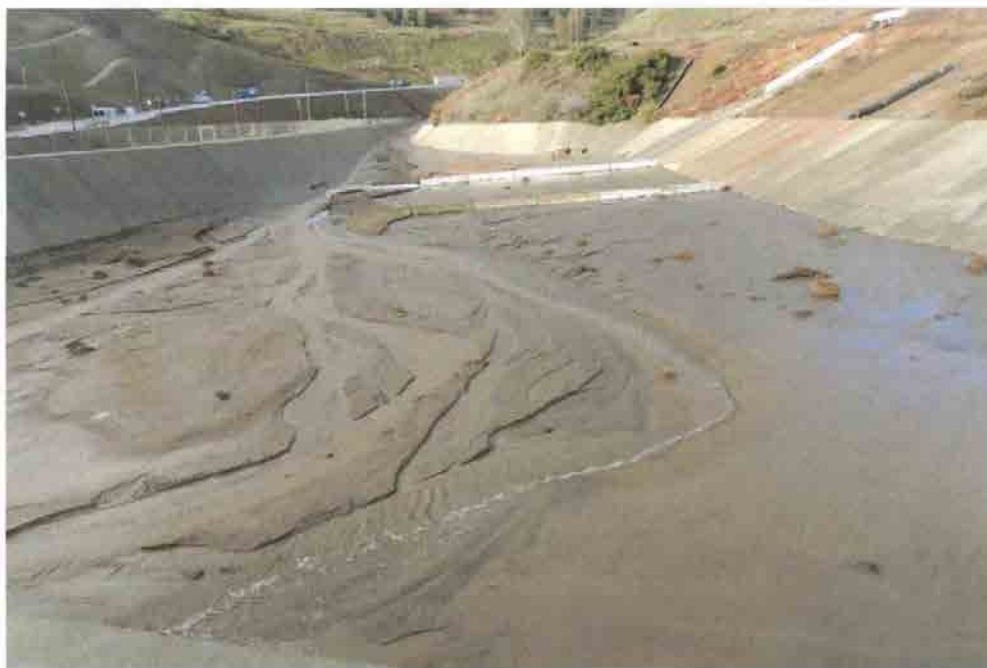
| <ul style="list-style-type: none"> <li>• tour the neighborhood to detect potential odors – None</li> <li>• it was the tail end of rainstorm, water still flowing down the main western ditch into the terminal basin, water is clear (Photo 1). A large amount of fines have accumulated in the basin (Photo 2). Source of the fines is runoff from cell CC3B under construction. The temporary lined diversion trench towards the remnants of the 96 inch-culvert draining into the basin failed (Photo 3) and muddy water flew into the basin. The K-rails (Photo 2) in the basin slowed down the muddy water leading to a limited build-out against the risers (Photo 4)</li> </ul> | |

Photo 2: Sediments accumulation in terminal basin

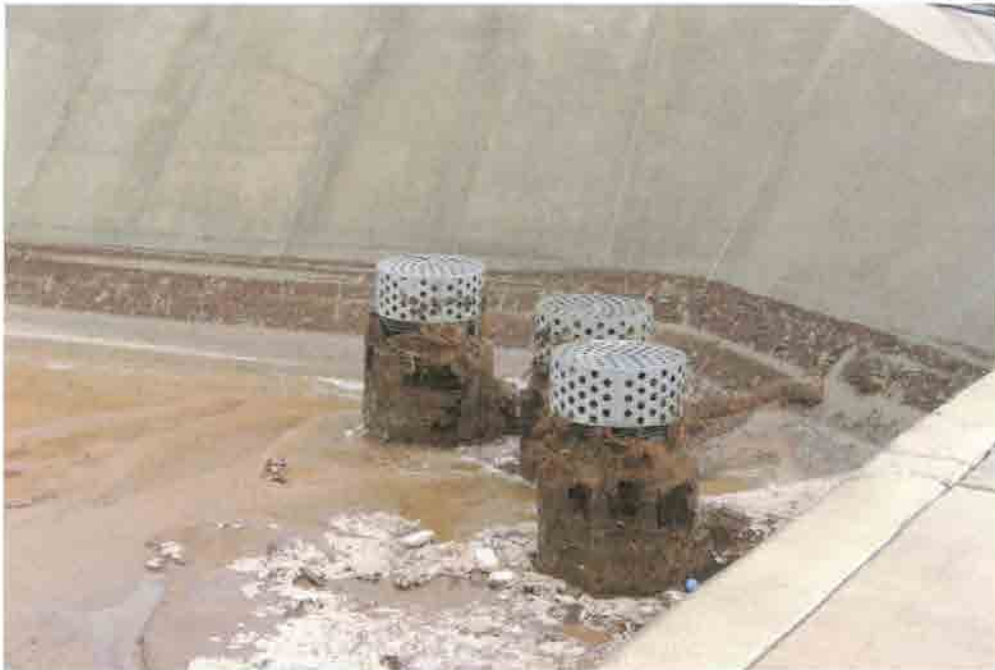
Figure 4: Risers in Terminal Basin
