**Sunshine Canyon Landfill  
Independent Monitor  
Quarterly Site Monitoring Status Report  
October 1, 2015 – December 31, 2015**

**City of Los Angeles Department of City Planning**

**County of Los Angeles Department of Regional Planning**

February 12, 2016

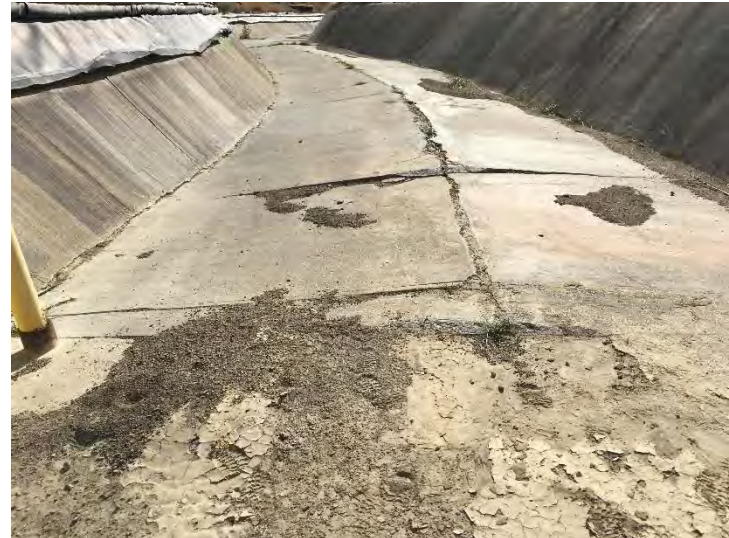
**Photo 51: Westside Drainage Channel: December 9, 2015**

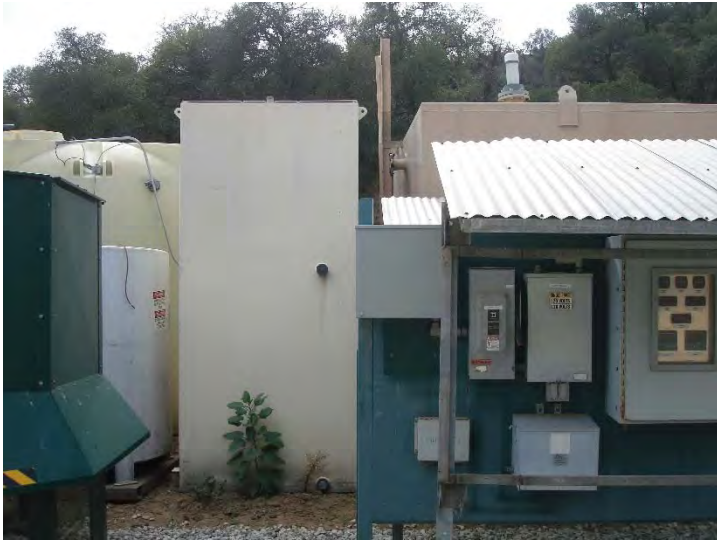
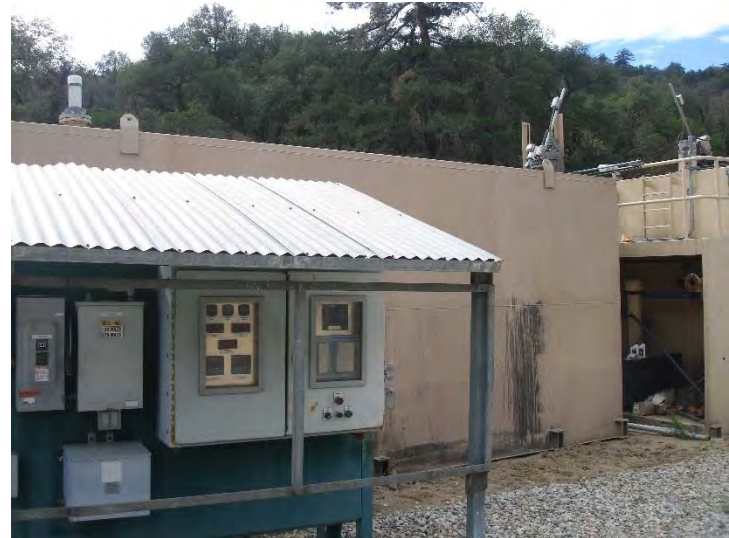
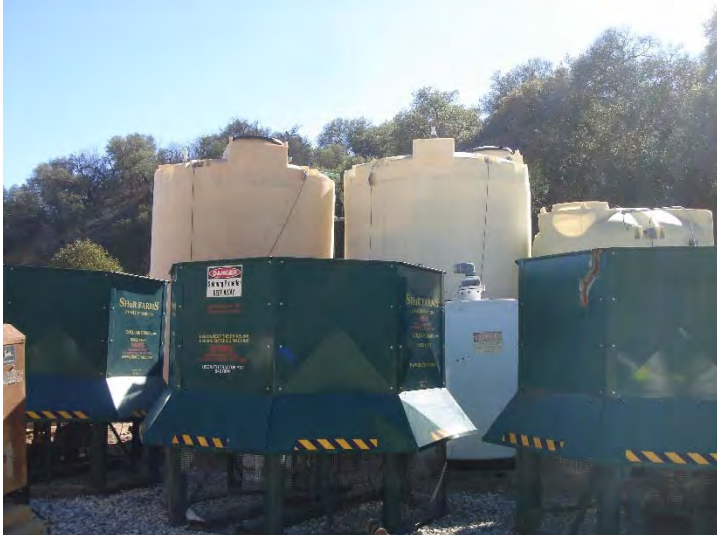
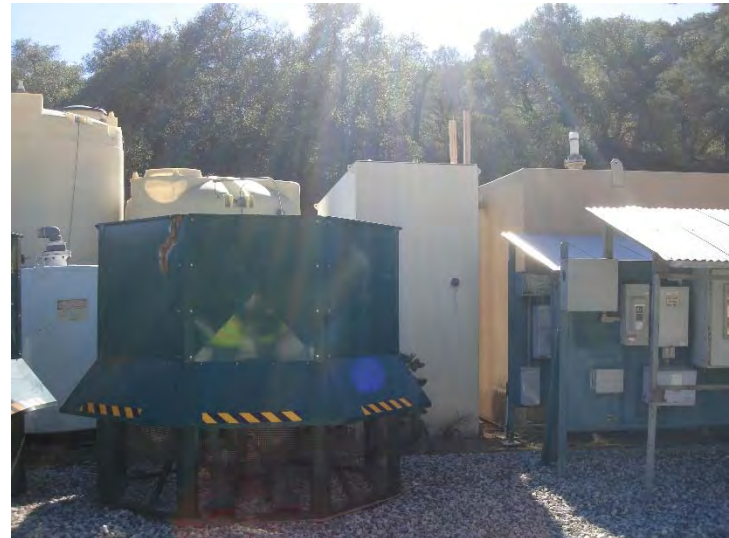
**Photo 59: Condensate Equipment in Storage Yard: October 14, 2015**

**Photo 60: Condensate Equipment in Storage Yard: October 14, 2015**

**Photo 61: Condensate Equipment in Storage Yard: October 28, 2015**

**Photo 62: Condensate Equipment in Storage Yard: October 28, 2015**

**Photo 63: Condensate Equipment in Storage Yard: November 11, 2015**

**Photo 64: Condensate Equipment in Storage Yard: November 11, 2015**

**Photo 65: Condensate Equipment in Storage Yard: November 11, 2015**

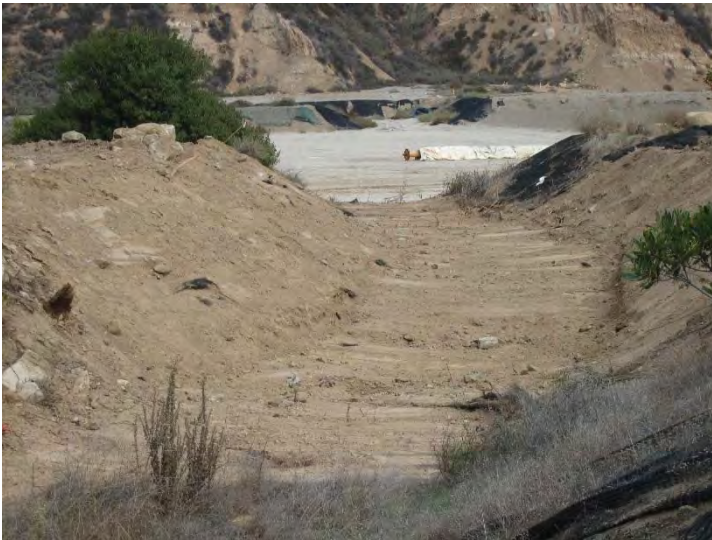
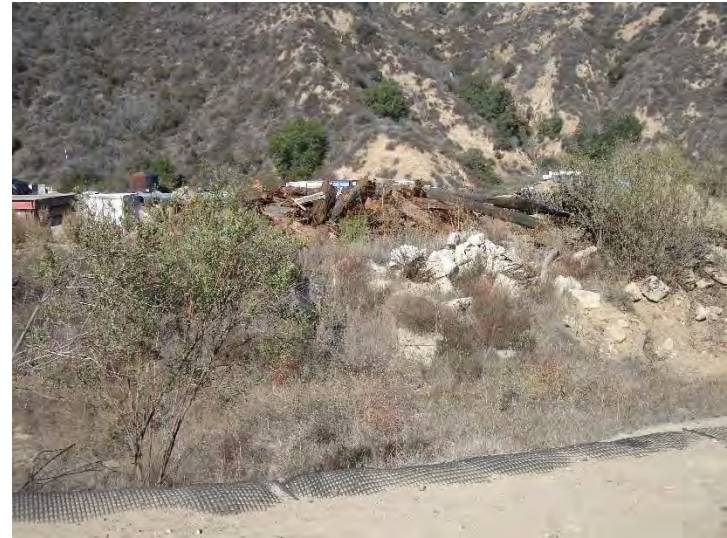
| Discipline | City Condition Reference # / Mitigation # | County Condition Reference # / Mitigation # | Responsible Agency | Further Review Needed-Comments |
|---|---|---|---|---|
| | | Surface Water - 2.15 | County DPW EPD/<br>LARWQCB, SCL- LEA | <p>I-n: The monitors observed that the native hillside drainage channel south of the material storage area and Basin D has the discharge into Basin D blocked by soil placed to have an access road. The hillside water in the channel has no controlled outlet. This blockage should be removed. Basin A riser drain rock was plugged with sediment. Drainage into the outlet risers may be impeded. The drainage channel out of Basin A was partially blocked with soil. The main westside concrete drainage channel in one section has the floor continuing to lift and the sidewall cracks worsening.</p> <p>Also, the geomembrane liner on a section of the Basin D outlet channel needed to be fixed because the large membrane flap at entry to the channel needs to be affixed to the shotcrete so water will not flow under and affect the flow pattern in the channel. In addition, the membrane is not affixed to the side of the channel at the beginning of the lined portion, and there is a gap between the shotcrete and the membrane. Water will flow between the membrane and shotcrete and will eventually rip it, thereby voiding its role. Batten strips can be used to secure the membrane to the shotcrete. Tumbleweed should be removed from the channel.</p> <p>I-o: The monitors observed that the terminal basin was ready for fall and winter rains. K-rails were placed in the basin to help control any sediment. There was minor sediment from the prior rain events. The sidewalls of the terminal sedimentation basin had horizontal cracks with vegetation growing out of the cracks. Vegetation should be removed and the crack sealed.</p> |

| Discipline | City Condition Reference # / Mitigation # | County Condition Reference # / Mitigation # | Responsible Agency | Further Review Needed-Comments |
|---|---|---|---|---|
| Hydrologist | M - 4.3.1/ 46 | | City Planning/<br>LARWQCB<br>CalRecycle<br>PW-BOE | <p>I-n: The monitors observed that the native hillside drainage channel south of the material storage area and Basin D has the discharge into Basin D blocked by soil placed to have an access road. The hillside water in the channel has no controlled outlet. This blockage should be removed. Basin A riser drain rock was plugged with sediment. Drainage into the outlet risers may be impeded. The drainage channel out of Basin A was partially blocked with soil. The main westside concrete drainage channel in one section has the floor continuing to lift and the sidewall cracks worsening.</p> <p>Also, the geomembrane liner on a section of the Basin D outlet channel needed to be fixed because the large membrane flap at entry to the channel needs to be affixed to the shotcrete so water will not flow under and affect the flow pattern in the channel. In addition, the membrane is not affixed to the side of the channel at the beginning of the lined portion, and there is a gap between the shotcrete and the membrane. Water will flow between the membrane and shotcrete and will eventually rip it, thereby voiding its role. Batten strips can be used to secure the membrane to the shotcrete. Tumbleweed should be removed from the channel.</p> <p>I-o: The monitors observed that the terminal basin was ready for fall and winter rains. K-rails were placed in the basin to help control any sediment. There was minor sediment from the prior rain events. The sidewalls of the terminal sedimentation basin had horizontal cracks with vegetation growing out of the cracks. Vegetation should be removed and the crack sealed.</p> <p>The native canyons above the office facilities drain into two shallow dirt basins. Each basin has two 24-inch corrugated HDPE drain lines draining them onto a sloping deck that drains to the slope uphill from the offices. These drains could flood the offices with mud and water during a heavy rain. There is a hazard to the facilities. Basin A had approximately one foot of standing water that was not draining through the rock into the outlet risers. The drainage channel out of Basin A was blocked with soil with a 20-inch HDPE pipe being the only flow to the westside channel. The blocked native drainage channel south of the material storage area noted on the October 14 monitoring visit had the road and rock removed, and now drains into Basin D. The Basin D outlet channel has tumbleweed blocking a portion of the channel. Additional sandbags were placed on the leading edge of the channel's HDPE liner to prevent the liner from uplifting. Basin B was clean with minor water puddles.</p> <p>I-p: The monitors observed that the Basin A outlet channel was blocked with dirt and sand bags except for a 12-inch HDPE line. There was a temporary road crossing at this location.</p> <p>I-q: The monitors noted that the removal of the soil on the top of the retaining wall along San Fernando Road south of the entrance had not been scheduled. The wall had the top drainage channel blocked, and the soil and rock topped the wall's fence in some locations. Also, two oak trees above the retaining wall were losing soil around their roots, and if they slide it would impact San Fernando Road and the powerlines. An arborist should look at the condition of these trees.</p> <p>Basin A was clean and free of sediment. The westside concrete drainage channel had not been scheduled for repair. Portions of one section of the floor continue to lift and sidewall cracks were worsening. Basin D had grading done to build berms to direct stormwater flow into the northern outlet; before, flow would go to the westside channel. This basin was ready for winter storms. The Basin D outlet channel had sections of it blocked with tumbleweed.</p> <p>Basin B was clean and free of sediment and ready for winter storms.</p> |

**Photo 66: Native Hillside Drainage into Basin D: October 14, 2015**

**Photo 67: Native Hillside Drainage into Basin D: October 14, 2015**

**Photo 68: Native Hillside Drainage into Basin D: October 14, 2015**

**Photo 69: Native Hillside Drainage into Basin D: October 14, 2015**

**Photo 70: Native Hillside Drainage into Basin D: October 14, 2015**

**Photo 71: Native Hillside Drainage into Basin D: October 14, 2015**

**Photo 72: Native Hillside Drainage into Basin D: October 28, 2015**

**Photo 73: Native Hillside Drainage into Basin D: October 28, 2015**

**Photo 74: Native Hillside Drainage into Basin D: October 28, 2015**

**Photo 75: Native Hillside Drainage into Basin D: October 28, 2015**

**Photo 76: Native Hillside Drainage into Basin D: October 28, 2015**

**Photo 77: Native Hillside Drainage into Basin D: October 28, 2015**

**Photo 78: Native Hillside Drainage into Basin D: October 28, 2015**

**Photo 79: Native Hillside Drainage into Basin D: October 28, 2015**

**Photo 80: Native Hillside Drainage into Basin D: November 16, 2015**

**Photo 81: Native Hillside Drainage into Basin D: November 16, 2015**

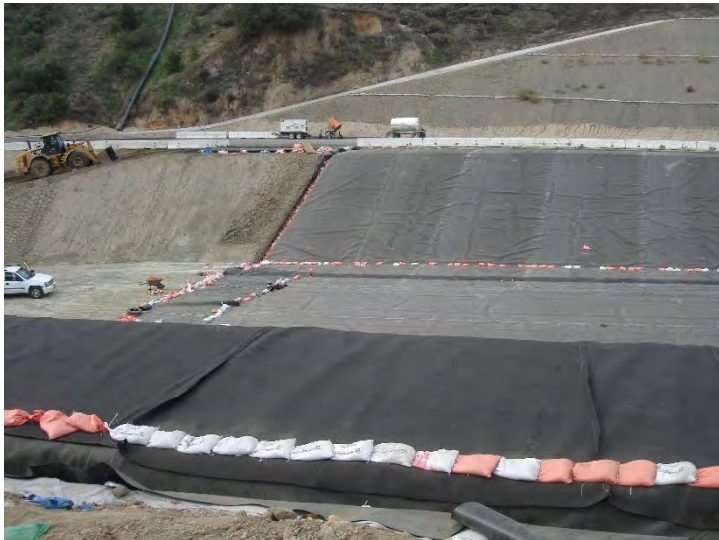
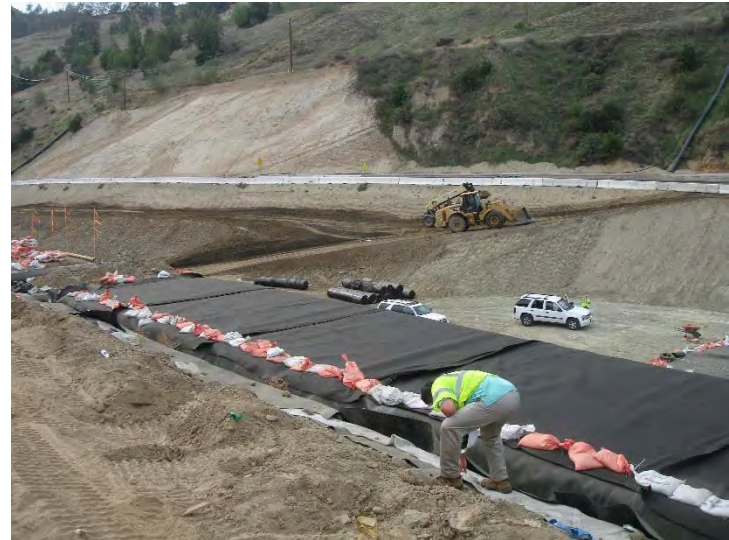
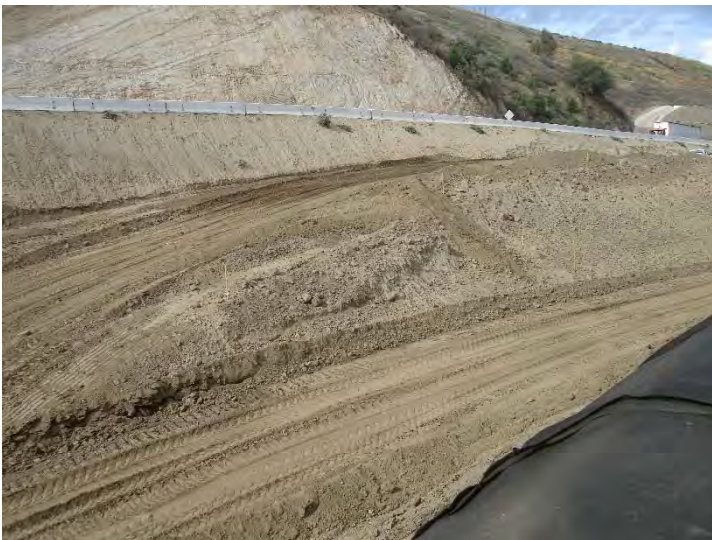
| Discipline | City Condition Reference # / Mitigation # | County Condition Reference # / Mitigation # | Responsible Agency | Further Review Needed-Comments |
|---|---|---|---|---|
| <b>Hydrologist</b> | M - 4.3.1 / 37, 38 | | City Planning/<br>LARWQCB<br>CalRecycle<br>SCL-LEA<br>PW-BOE | I-n through I-q: It is assumed by UltraSystems that the permanent drainage V-ditches and channels are designed in accordance with the referenced regulations. The design drawings and reports should be available for review and use.<br><br>I-q: The monitors observed that temporary drainage controls were installed downstream of Cell CC-3B with their discharge into the terminal basin. |

**Photo 183: City Cell CC3B Construction: October 14 2015**

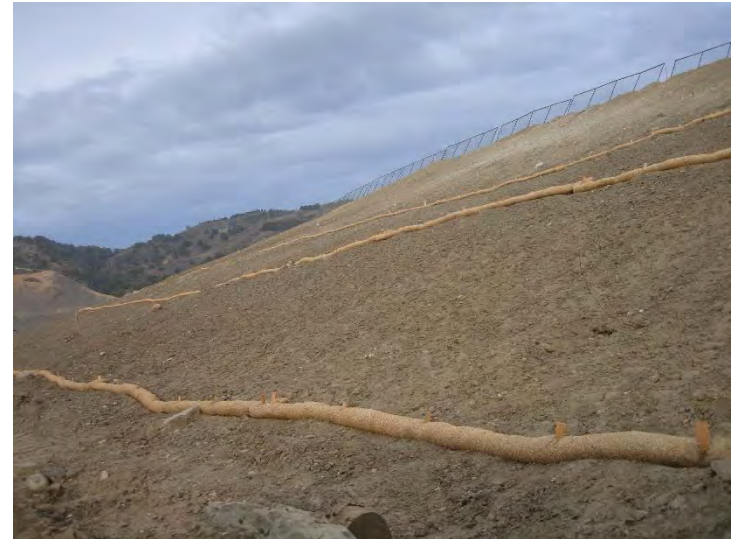
**Photo 246: City Slope Erosion Control: October 14, 2015**

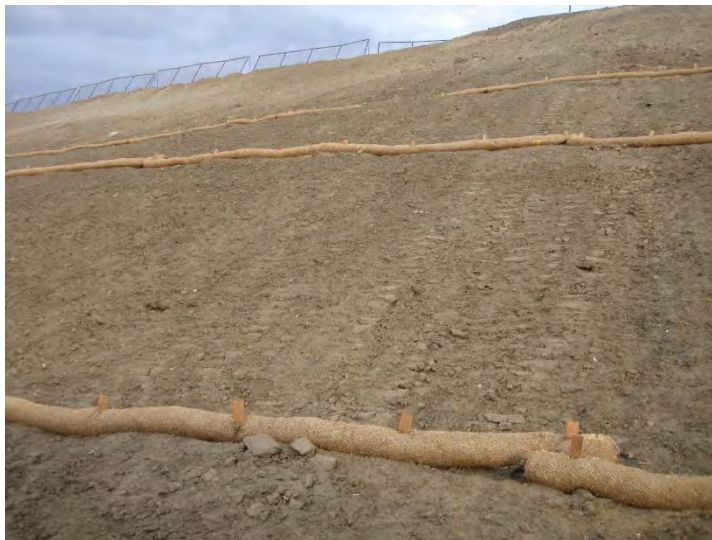
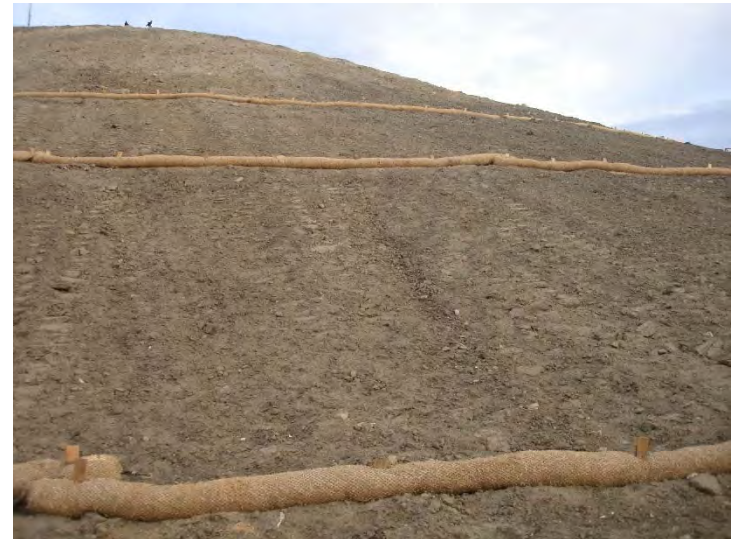
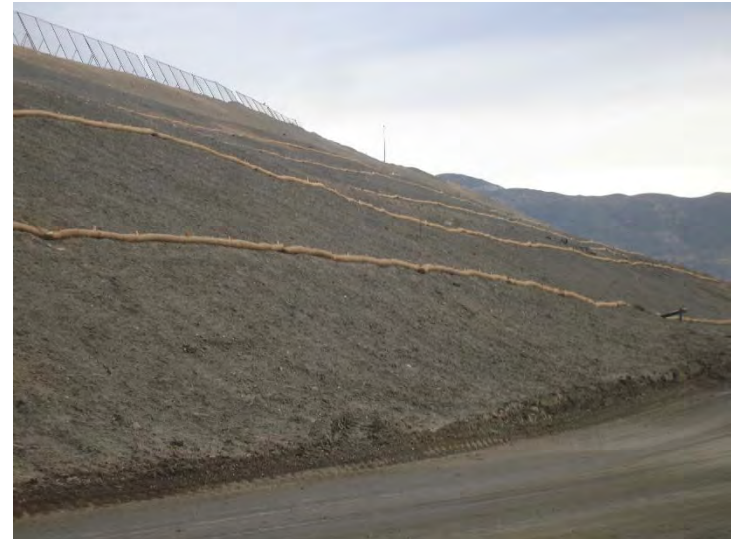
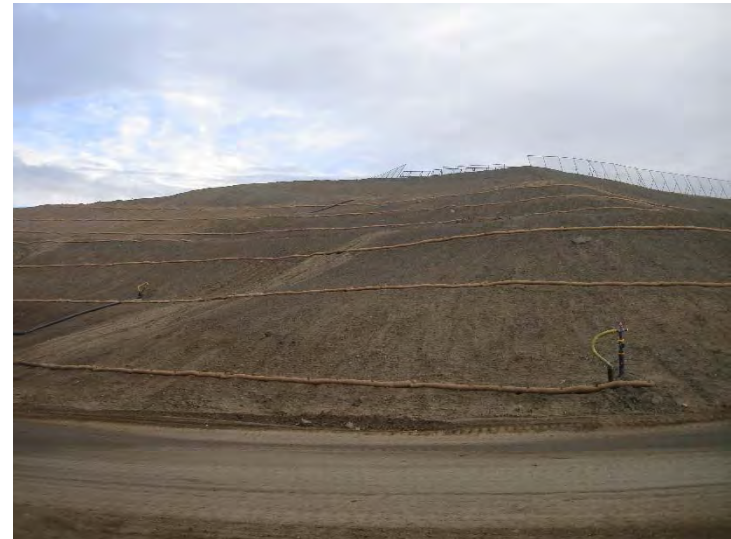
**Photo 254: City Slope Erosion Control: October 28, 2015**

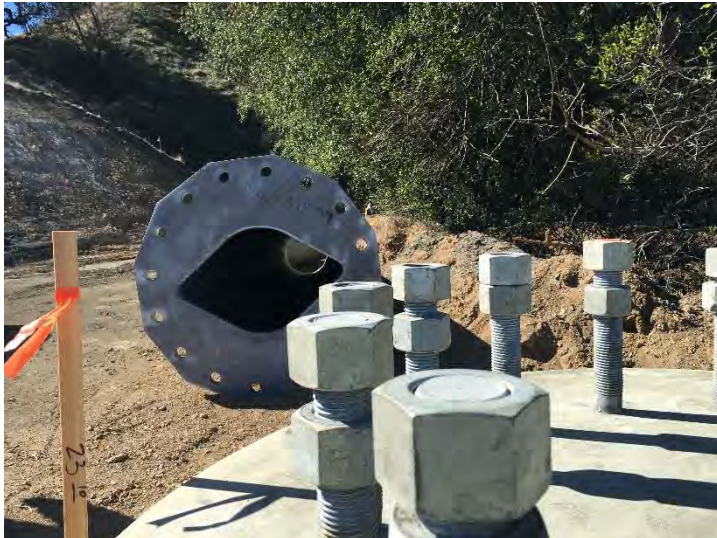
**Photo 274: Edison Westside Ridge New Pole: November 16, 2015**
