February 4, 2020

Mr. Martins Aiyetiwa, P.E.
Senior Civil Engineer
County of Los Angeles, Department of Public Works
900 South Fremont Avenue
Alhambra, CA 91803-1331

Subject: Sunshine Canyon Landfill, Quarterly Vegetation Report
Fourth Quarter 2019 Vegetation Report

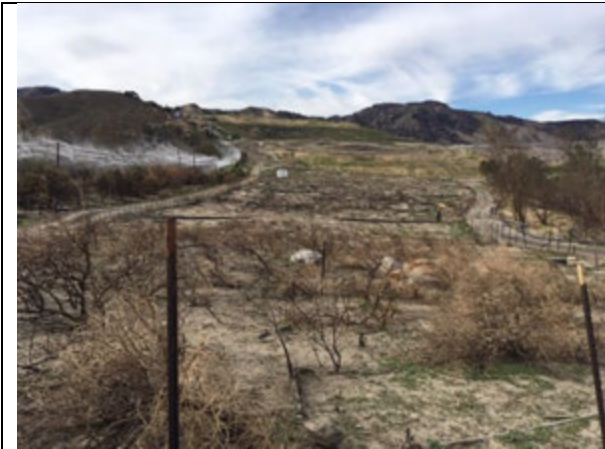
Photo 1. Facing west at lower deck. View of eastern limits that was dominated with *Atriplex* species and California sunflower (*Encelia californica*) prior to the October 2019 Saddleridge Fire.

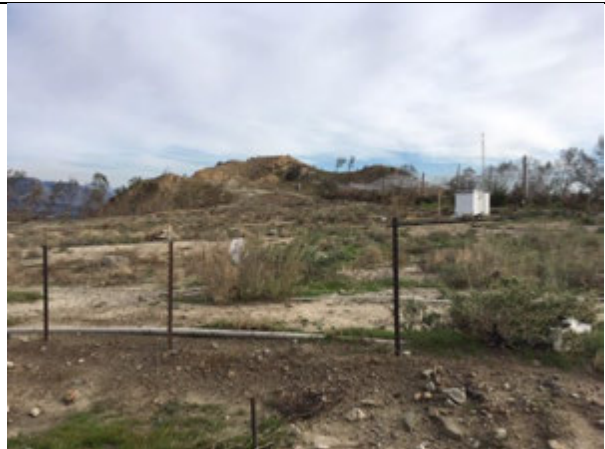
Photo 2. Facing east at lower deck from western boundary.

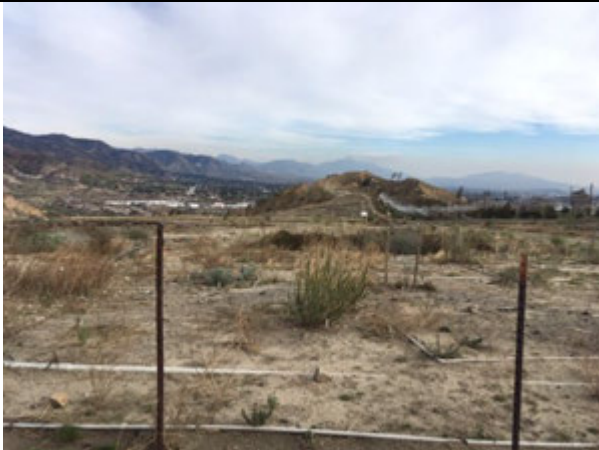
Photo 3. Facing east at the Middle Deck from the western boundary.

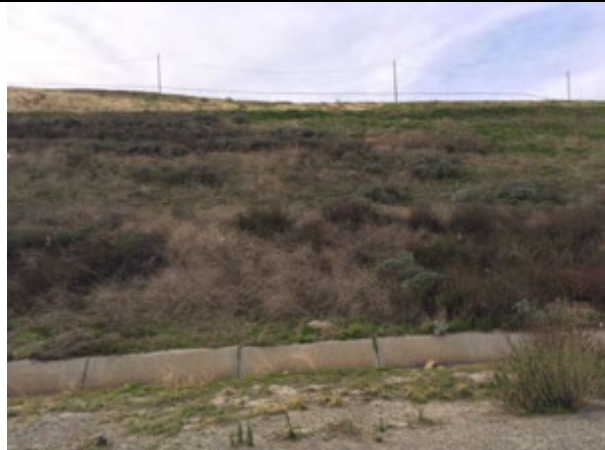
Photo 4. Facing west at the easterly-facing slope located between middle and upper decks. The vegetation on the slopes below the upper deck is dominated with CA buckwheat and annual non-native grasses.

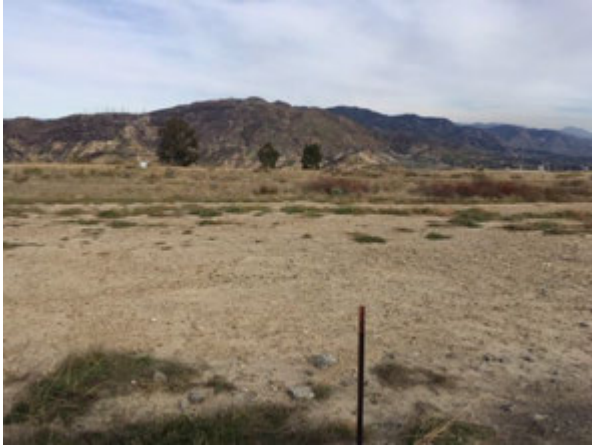
Photo 5. Facing northeast at upper deck. This area is compacted and gravelly and continues to be problematic for supporting vegetation. Annual non-native grasses and some CA buckwheat shrubs are evident in the background.

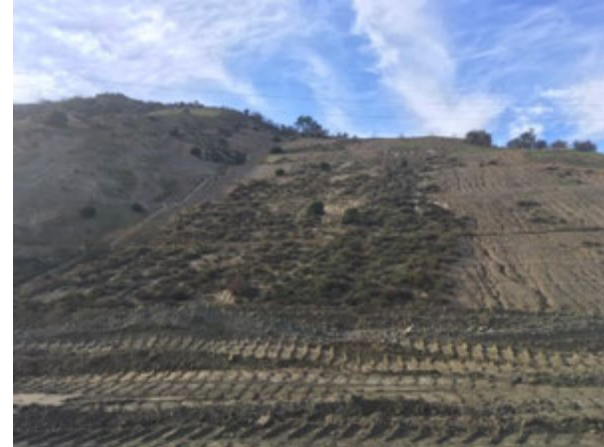
Photo 1. Facing west at the county sage slope. This area is dominated with California buckwheat and California sunflower.
