**CONSOLIDATED SEWER MAINTENANCE DISTRICT
CONDITION ASSESSMENT PROGRAM REPORT
PROJECT NO. Y0TV0809B**

**CONDITION ASSESSMENT REPORT
COUNTY OF LOS ANGELES DEPARTMENT OF PUBLIC WORKS
CONSOLIDATED SEWER MAINTENANCE DISTRICT**

PROJECT NAME:	Y0TV0809B	PROJECT MGR:	Kari Eskridge
PROJECT DATE:	01/23/2009	CONTACT NO:	(626) 300-3369
SUP. DISTRICT(s):	4	MAP PAGE(S):	1867, 1921, 1912
Report By:	Eric Liu	Report Date:	10/25/2014

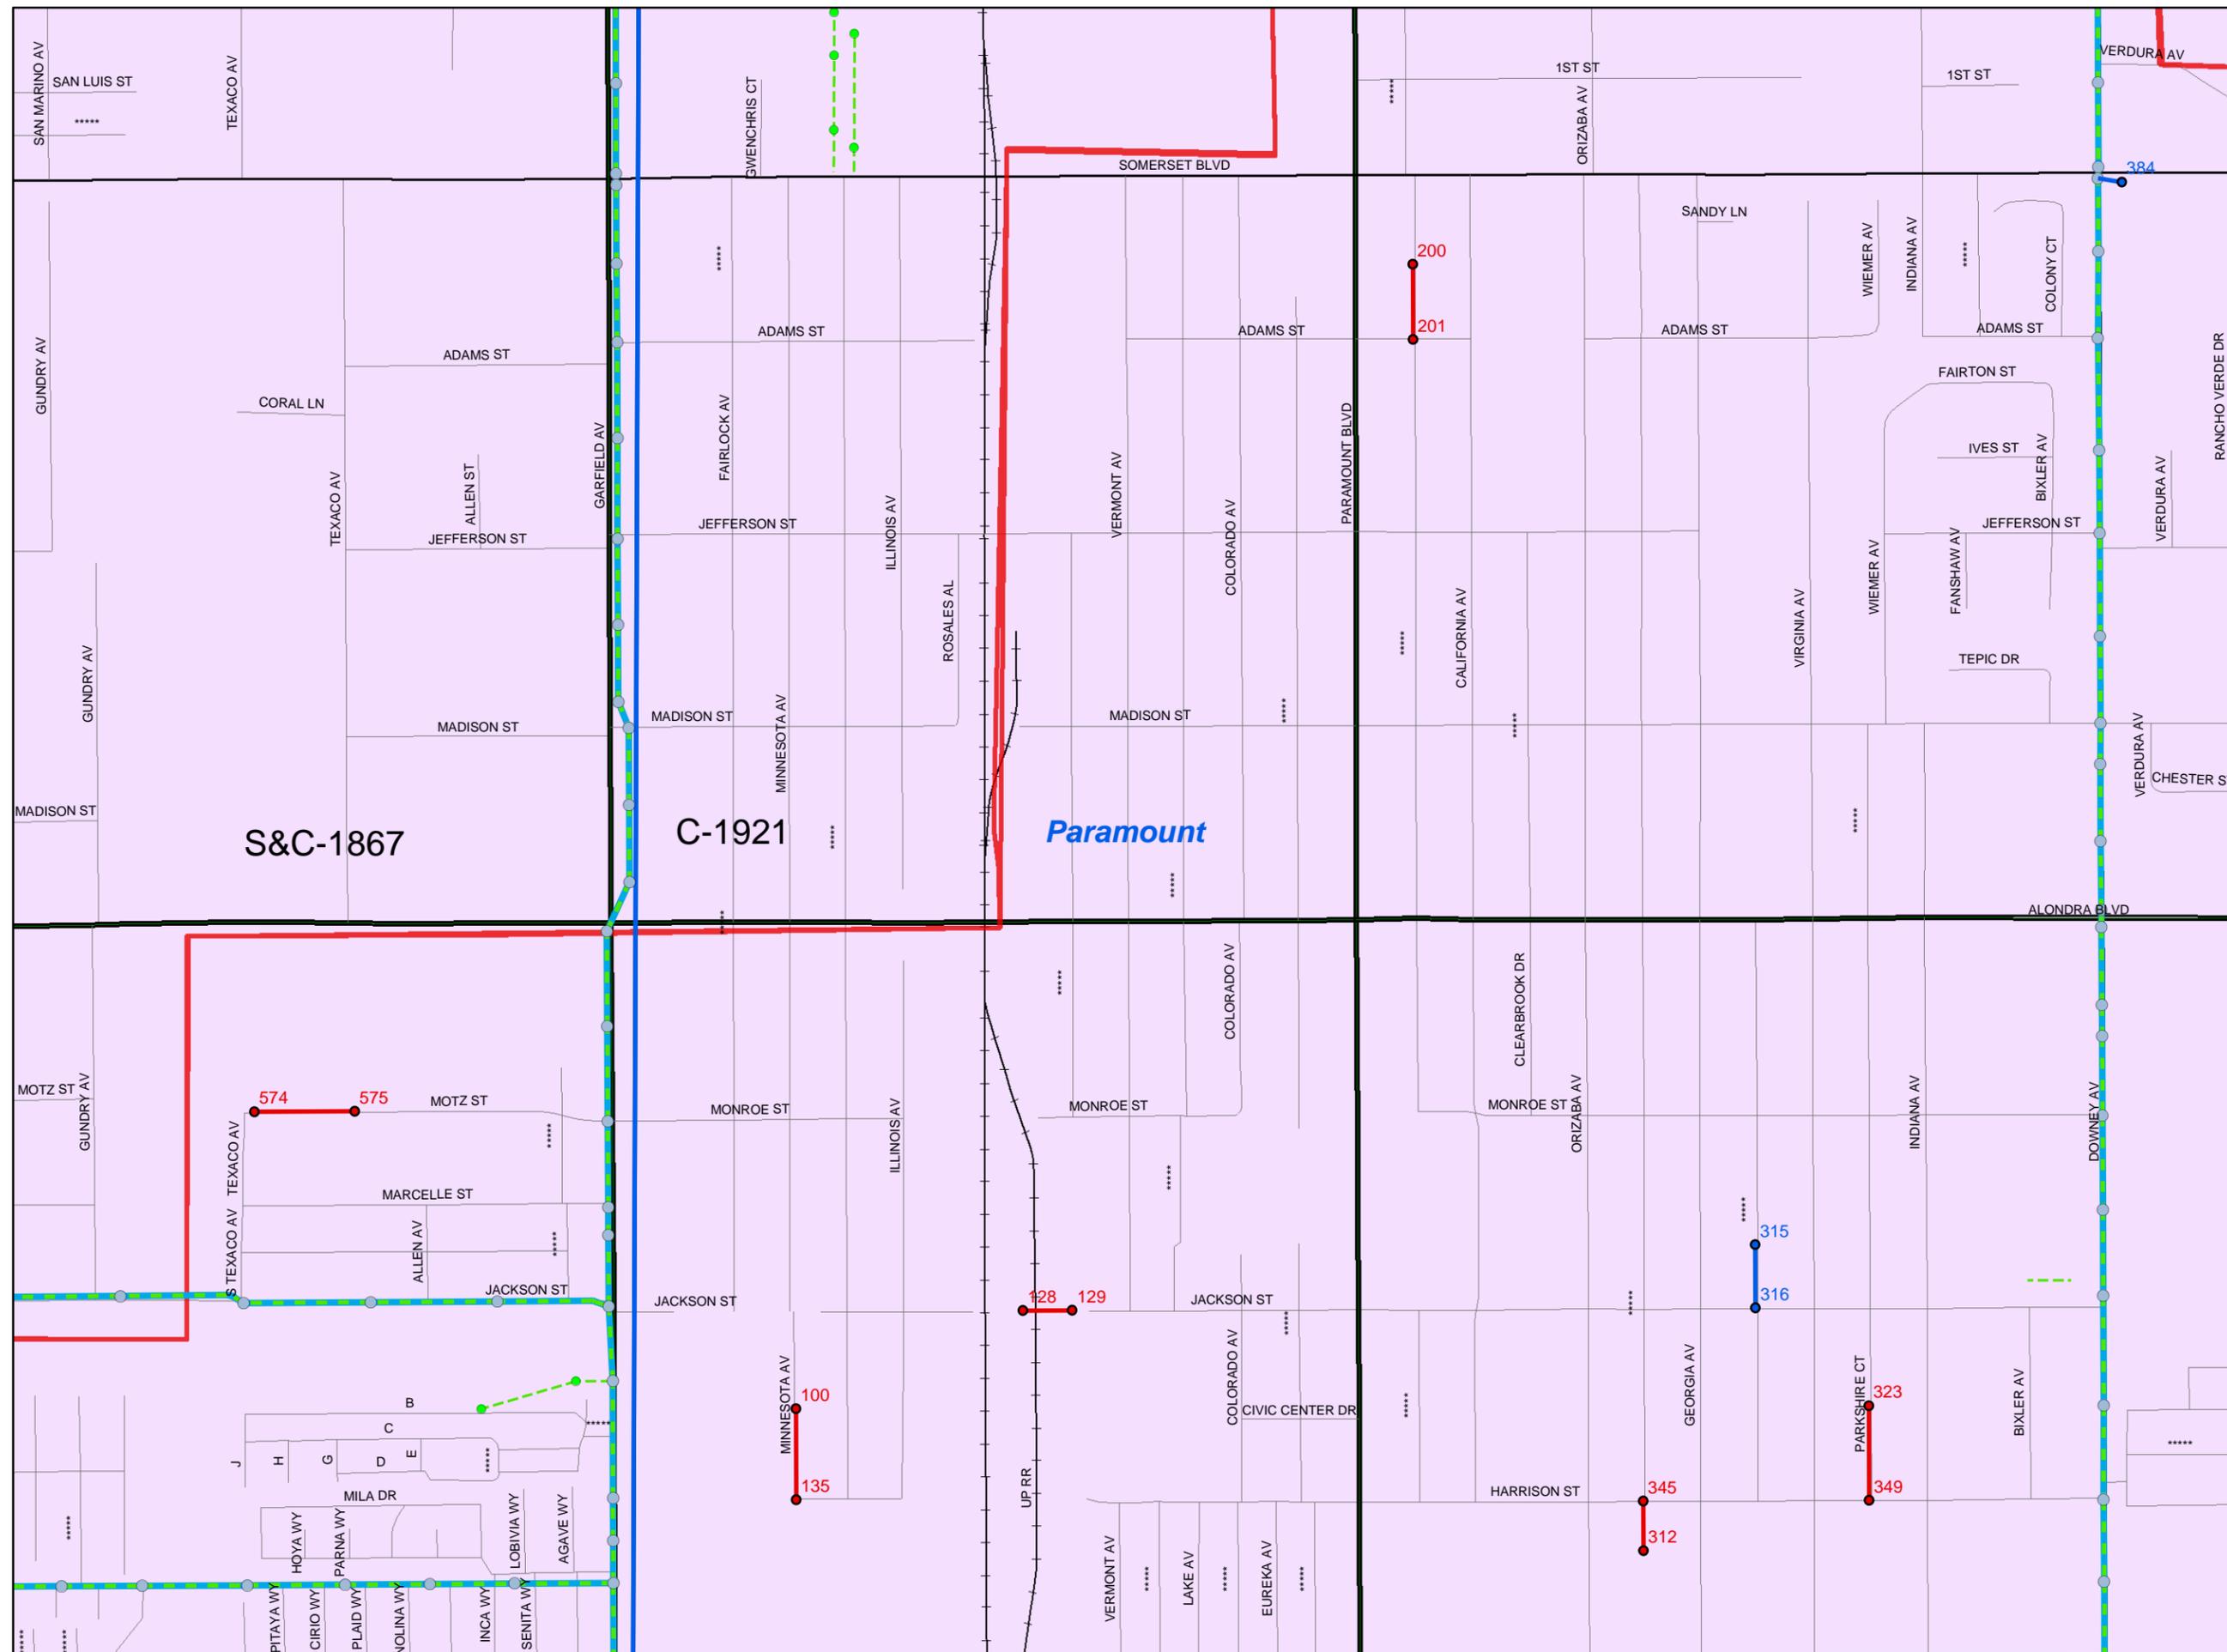
LINING & POINT REPAIR

10	4200	1921-0384	1921-TRNK	SOMERSET	Fractures: 27', 41' (at flowline)	Lining: MH to MH	50
11	413E	1921-0413	1921-0422	PERILLA AV	Fractures: 276'	Structural integrity in tact. No action needed.	
12	4132	1921-0280	1921-0281	ALONDRA BV	Fractures: 77'; cracks: multiple joint locations	Structural integrity in tact. No action needed.	
13	4132	1921-0323	1921-0349	PARKSHIRE CT	Broken: 311' (below flowline); cracks: multiple locations	Point Repair	
14	4131	1921-0100	1921-0135	MINNESOTA AV	Broken: 319' (below flowline); cracks: multiple locations	Point Repair	
15	4121	1921-0200	1921-0201	ALLEY E/O PARAMOUNT BL	Fractures: 264' (below flowline); cracks: multiple locations	Point Repair	
16	4121	1921-0815	1921-TRNK	ADAMS ST	Fracture: 45'	Structural integrity in tact. No action needed.	
17	4100	1921-0477	1921-0485	ALONDRA BV	Fracture: 46'	Structural integrity in tact. No action needed.
