DEPARTMENT OF PUBLIC WORKS

CONSOLIDATED SEWER MAINTENANCE DISTRICT CONDITION ASSESSMENT PROGRAM REPORT PROJECT NO. Y0TV0910A

**CONDITION ASSESSMENT REPORT
COUNTY OF LOS ANGELES DEPARTMENT OF PUBLIC WORKS
CONSOLIDATED SEWER MAINTENANCE DISTRICT**

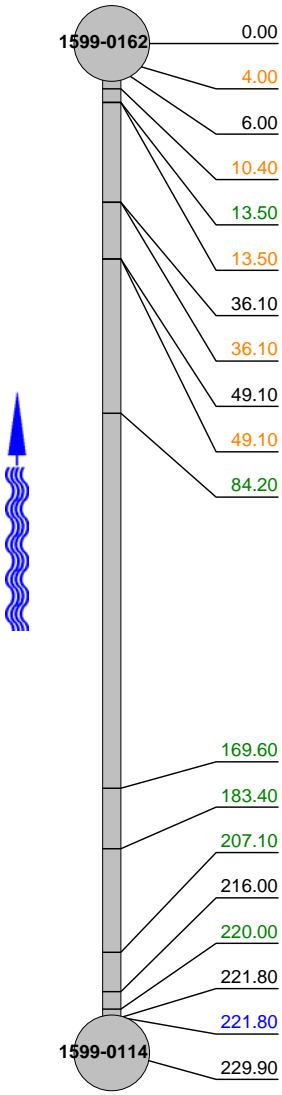
221.80	Tap Factory Active, at 3 o'clock, 4", within 8 inch: NO	00:15:21	481	
	221.80	Roots Tap Connection, from 2 to 6 o'clock, 15 %, within 8 inch: NO	00:15:41	482, b	M 2

229.90	Manhole, within 8 inch: NO, Remarks: 1599-0114	00:16:43	484

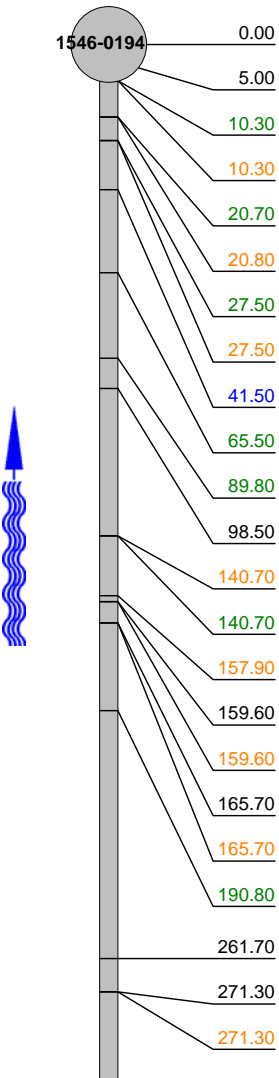
0.00	Manhole, within 8 inch: NO, Remarks: 1546-0194	00:00:32	5726	
	5.00	Water Level, 10 %, within 8 inch: NO	00:01:02	5727

10.30	Roots Fine Joint, from 7 to 5 o'clock, within 8 inch: YES	00:02:05	5728, b	M 1
	10.30	Crack Multiple, from 7 to 5 o'clock, within 8 inch: YES	00:02:15	5730, b	S 3

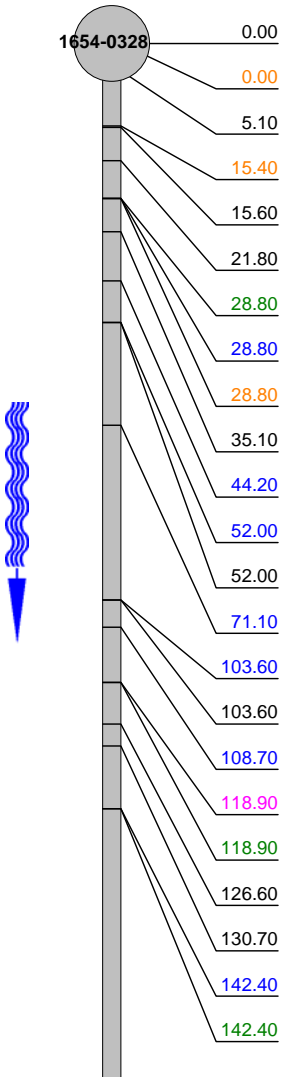
126.60	Water Level, 15 %, within 8 inch: NO	00:12:18	10248	
	130.70	Tap Factory Active, at 3 o'clock, 6", within 8 inch: NO	00:12:37	10249	
	142.40	Fracture Circumferential, from 1 to 5 o'clock, within 8 inch: YES	00:13:24	10250, b	S 2

142.40	Roots Fine Joint, from 2 to 3 o'clock, within 8 inch: YES	00:13:47	10252, b	M 1

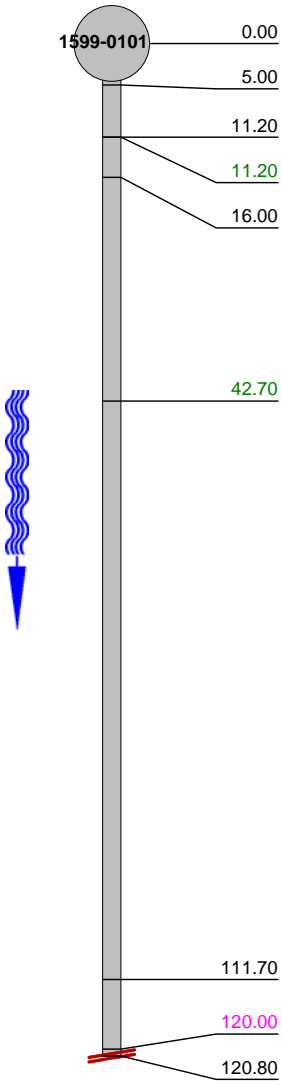
1:275	position	observation	MPEG	photo	grade
	0.00	Manhole, within 8 inch: NO, Remarks: 1599-0101	00:00:20	3788	
	5.00	Water Level, 5 %, within 8 inch: NO	00:05:03	3789	
	11.20	Tap Factory Active, at 9 o'clock, 4", within 8 inch: NO	00:05:32	3790	
	11.20	Roots Fine Connection, at 9 o'clock, within 8 inch: NO	00:05:48	3791, b	M 1
	16.00	General Observation, within 8 inch: NO, Remarks: Pipe Joint Length 3'	00:06:39	3793	
	42.70	Roots Fine Joint, from 7 to 8 o'clock, within 8 inch: YES	00:07:39	3794, b	M 1
	111.70	Tap Factory Active, at 9 o'clock, 4", within 8 inch: NO	00:10:08	3796	
	120.00	Roots Ball Joint, from 12 to 4 o'clock, 75 %, within 8 inch: YES	00:11:12	3797, b	M 4
	120.80	Abandoned Survey, within 8 inch: NO, Remarks: Due To Roots Ball Joint	00:12:46	3799, b

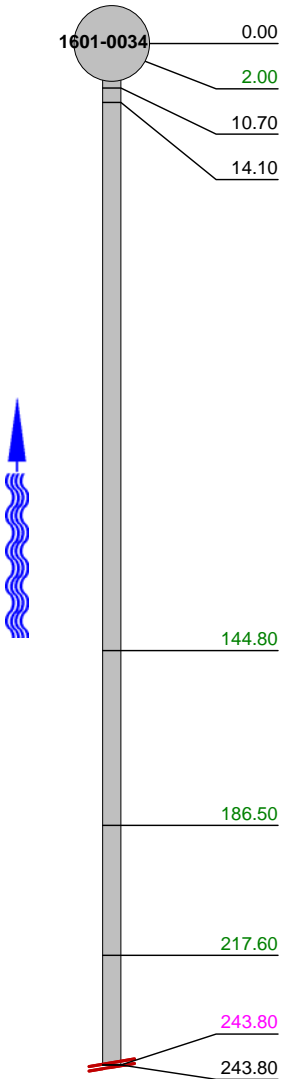
1:550	position	observation	MPEG	photo	grade
	0.00	Manhole, within 8 inch: NO, Remarks: 1601-0034	00:00:26	5200	
	2.00	Roots Fine Joint, from 2 to 8 o'clock, within 8 inch: YES	00:00:56	5201, b	M 1
	10.70	Water Level, 5 %, within 8 inch: NO	00:01:43	5203	
	14.10	General Observation, within 8 inch: NO, Remarks: Pipe joint Length 3'	00:02:09	5204	
	144.80	Roots Fine Joint, from 7 to 10 o'clock, within 8 inch: YES	00:05:56	5205, b	M 1
	186.50	Roots Fine Joint, from 10 to 1 o'clock, within 8 inch: YES	00:07:26	5207, b	M 1
	217.60	Roots Fine Joint, at 9 o'clock, within 8 inch: YES	00:08:34	5209, b	M 1
	243.80	Deposits Attached Other, from 5 to 7 o'clock, 25 %, within 8 inch: NO	00:09:57	5211, b	M 4
	243.80	Abandoned Survey, within 8 inch: NO, Remarks: Due To Deposits Attached	00:10:56	5213, b

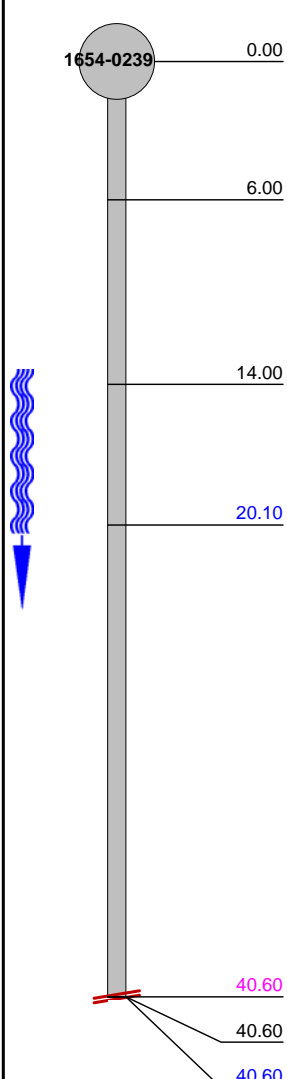
0.00	Manhole, within 8 inch: NO, Remarks: 1654-0239	00:00:29	4680	
	6.00	Water Level, 5 %, within 8 inch: NO	00:01:16	4681	
	14.00	Tap Break-in Active, at 2 o'clock, 4", within 8 inch: NO	00:02:03	4682	
	20.10 S1	Water Level Sag, 30 %, within 8 inch: NO, Start	00:02:53	4683, b	M 2
	40.60	Camera Underwater, within 8 inch: NO	00:09:20	4685	M 4
	40.60	Abandoned Survey, within 8 inch: NO, Remarks: Due To Possible Offset AI	00:10:23	4686	
	40.60 F1	Water Level Sag, 30 %, within 8 inch: NO, End	00:10:31	4687	M 2

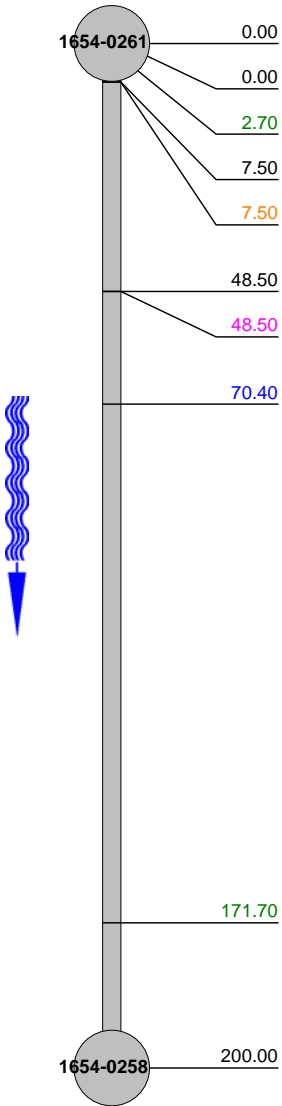
1:450	position	observation	MPEG	photo	grade
	0.00	Manhole, within 8 inch: NO, Remarks: 1654-0261	00:00:45	8973	
	0.00	Water Level, 10 %, within 8 inch: NO	00:00:58	8974	
	2.70 S1	Roots Fine Joint, from 7 to 5 o'clock, within 8 inch: YES, Start	00:01:30	8975, b	M 1
	7.50	Tap Factory Active, at 3 o'clock, 6", within 8 inch: NO	00:02:25	8977	
	7.50	Roots Medium Connection, from 12 to 4 o'clock, 35 %, within 8 inch: NO	00:03:06	8978, b	M 3
	48.50	Tap Factory Active, at 9 o'clock, 6", within 8 inch: NO	00:05:19	8980	
	48.50	Roots Ball Lateral, at 9 o'clock, 55 %, within 8 inch: NO	00:05:34	8981, b	M 4
	70.40	Roots Tap Joint, from 8 to 10 o'clock, 15 %, within 8 inch: YES	00:06:59	8983, b	M 2
	171.70 F1	Roots Fine Joint, from 7 to 5 o'clock, within 8 inch: YES, End	00:10:02	8985	M 1
	200.00	Manhole, within 8 inch: NO, Remarks: 1654-0258	00:11:21	8986

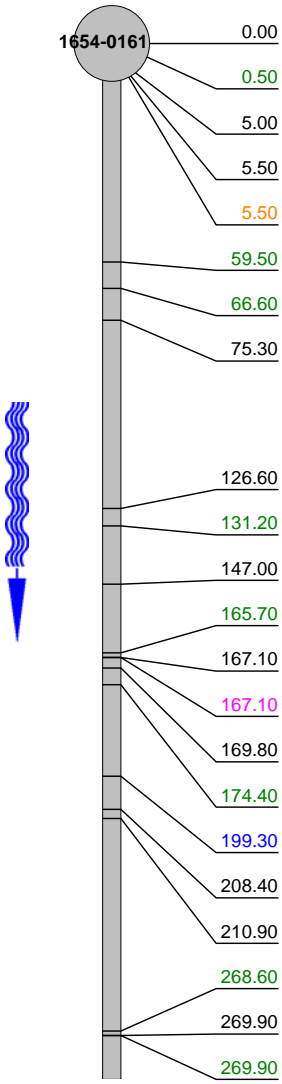
208.40	Water Level, 15 %, within 8 inch: NO	00:12:12	8620	
	210.90	Tap Factory Active, at 9 o'clock, 6", within 8 inch: NO	00:12:31	8621	
	268.60	Roots Fine Joint, from 2 to 4 o'clock, within 8 inch: YES	00:14:12	8622, b	M 1

269.90	Tap Factory Active, at 3 o'clock, 6", within 8 inch: NO	00:14:36	8624	
	269.90	Roots Fine Lateral, at 3 o'clock, within 8 inch: NO	00:14:50	8625, b	M 1

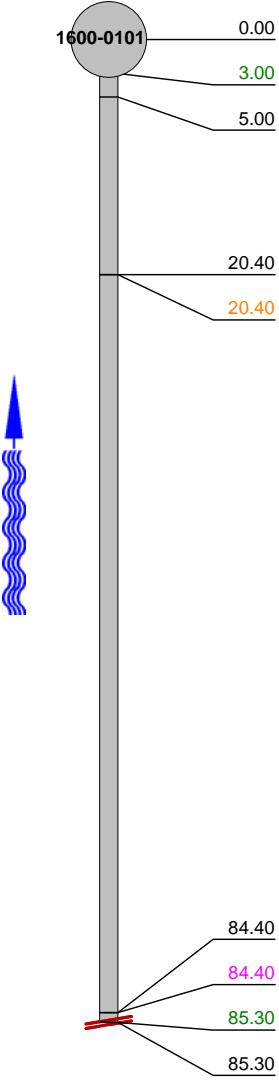
0.00	Manhole, within 8 inch: NO, Remarks: 1600-0101	00:00:30	6414	
	3.00 S1	Roots Fine Joint, from 7 to 5 o'clock, within 8 inch: YES, Start	00:01:00	6415, b	M 1
	5.00	Water Level, 5 %, within 8 inch: NO	00:01:48	6417	
	20.40	Tap Factory Active, at 3 o'clock, 6", within 8 inch: NO	00:02:19	6418	
	20.40	Roots Medium Lateral, at 3 o'clock, 25 %, within 8 inch: NO	00:02:50	6419, b	M 3
	84.40	Tap Factory Active, at 3 o'clock, 6", within 8 inch: NO	00:04:51	6421	
	84.40	Roots Ball Connection, from 2 to 6 o'clock, 55 %, within 8 inch: NO	00:05:20	6422, b	M 4
	85.30 F1	Roots Fine Joint, from 7 to 5 o'clock, within 8 inch: YES, End	00:06:25	6424	M 1
	85.30	Abandoned Survey, within 8 inch: NO, Remarks: CAMERA BLOCKED BY BALL RO	00:06:56	6425

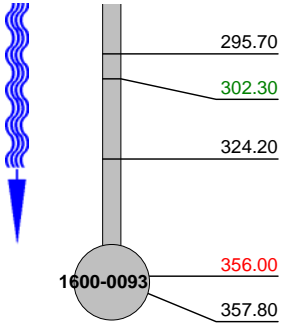
1:627	position	observation	MPEG	photo	grade
	295.70	Tap Factory Active, at 3 o'clock, 6", within 8 inch: NO	00:19:42	6376	
	302.30	Roots Fine Joint, from 7 to 5 o'clock, within 8 inch: YES	00:20:12	6377, b	M 1
	324.20	Tap Factory Active, at 9 o'clock, 6", within 8 inch: NO	00:21:08	6379	
	356.00	Broken Void Visible, from 4 to 8 o'clock, within 8 inch: YES	00:23:08	6380, b	S 5
	357.80	Manhole, within 8 inch: NO, Remarks: 1600-0093	00:23:56	6382

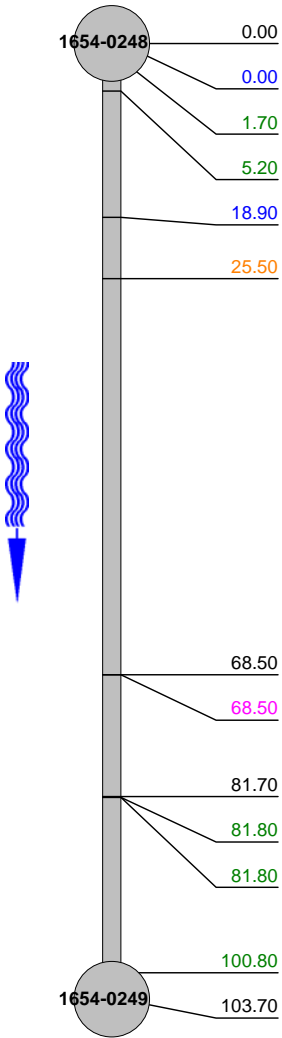
81.80	Roots Fine Connection, at 10 o'clock, within 8 inch: NO	00:41:55	3043	M 1
	100.80 F1	Roots Fine Joint, from 7 to 5 o'clock, within 8 inch: YES, End	00:42:54	3044	M 1

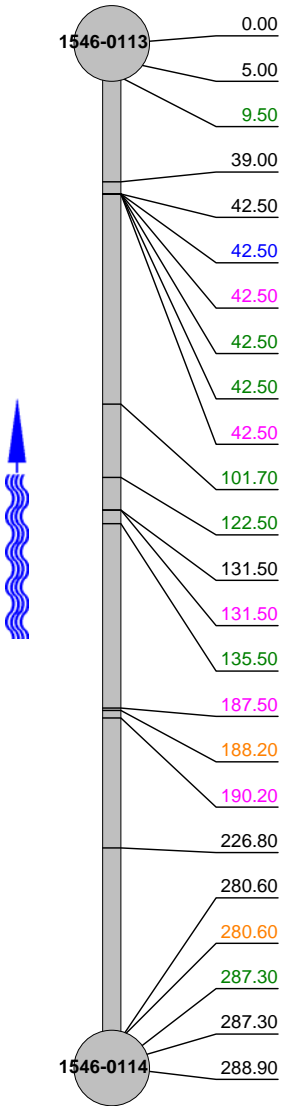
42.50	Tap Break-in Active, at 2 o'clock, 6", within 8 inch: NO	00:12:22	3529	
	42.50	Fracture Circumferential, from 7 to 11 o'clock, within 8 inch: YES	00:13:14	3530, b	S 2

42.50	Broken, from 11 to 1 o'clock, within 8 inch: YES	00:13:34	3532, b	S 4
	42.50	Joint Offset Medium, within 8 inch: YES	00:13:43	3534, b	S 1
	42.50	Roots Fine Joint, from 7 to 5 o'clock, within 8 inch: YES	00:13:54	3536, b	M 1

42.50	Broken, from 1 to 3 o'clock, within 8 inch: YES	00:14:16	3538, b	S 4
	101.70	Roots Fine Joint, from 7 to 5 o'clock, within 8 inch: YES	00:16:45	3540, b	M 1

187.50	Fracture Multiple, from 7 to 6 o'clock, within 8 inch: YES, Start	00:22:49	3549, b	S 4
	188.20	Tap Break-in Defective, at 3 o'clock, 6", 3, within 8 inch: NO	00:23:38	3551, b	M 3

190.20	Fracture Multiple, from 7 to 6 o'clock, within 8 inch: YES, End	00:24:34	3553	S 4
	226.80	Tap Factory Capped, at 3 o'clock, 6", within 8 inch: NO	00:25:56	3554

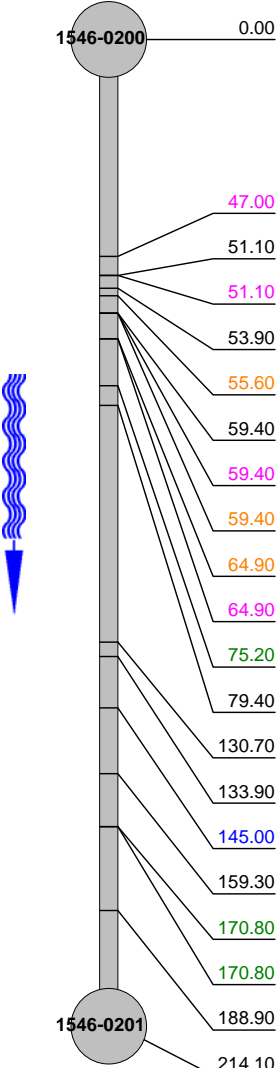
0.00	Manhole, within 8 inch: NO, Remarks: 1546-0200	00:00:28	436	
	47.00	Fracture Multiple, from 9 to 3 o'clock, within 8 inch: YES	00:03:30	437, b	S 4

51.10	Tap Factory Capped, at 9 o'clock, 4", within 8 inch: NO	00:04:42	439	
	51.10	Roots Ball Lateral, at 9 o'clock, 90 %, within 8 inch: NO	00:05:02	440, b	M 4

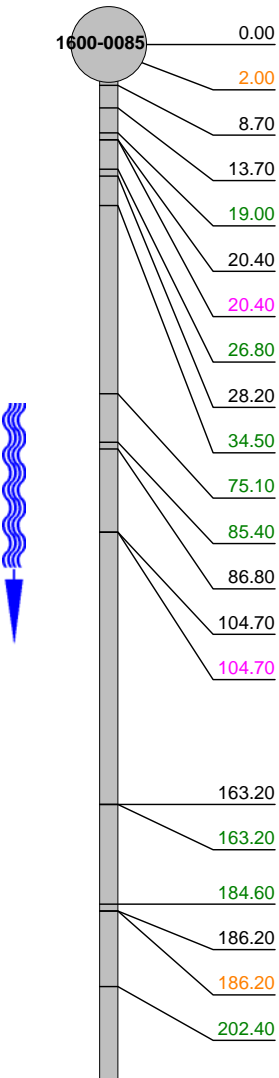
0.00	Manhole, within 8 inch: NO, Remarks: 1600-0085	00:00:24	1047	
	2.00	Roots Medium Joint, from 8 to 4 o'clock, 50 %, within 8 inch: YES	00:01:16	1048, b	M 3

8.70	Water Level, 5 %, within 8 inch: NO	00:02:11	1050	
	13.70	General Observation, within 8 inch: NO, Remarks: Pipe Joint Length 5'	00:02:42	1051	
	19.00	Roots Fine Joint, from 8 to 4 o'clock, within 8 inch: YES	00:03:03	1052, b	M 1

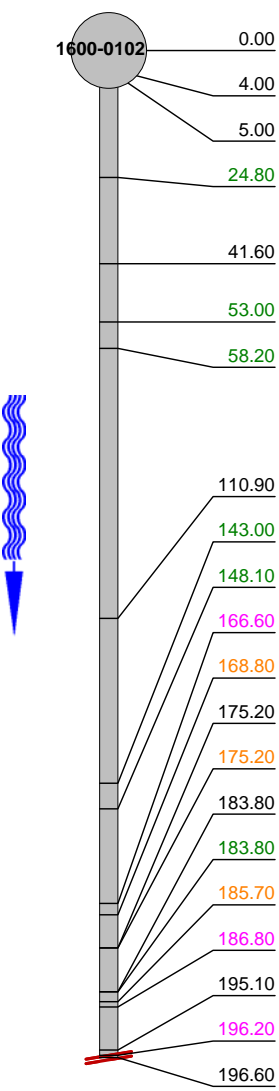
0.00	Manhole, within 8 inch: NO, Remarks: 1600-0102	00:00:31	6383			
	4.00	Tap Factory Active, at 9 o'clock, 6", within 8 inch: NO	00:01:00	6384

5.00	Water Level, 5 %, within 8 inch: NO	00:01:22	6385			
	24.80 S1	Roots Fine Joint, from 7 to 5 o'clock, within 8 inch: YES, Start	00:01:58	6386, b	M 1

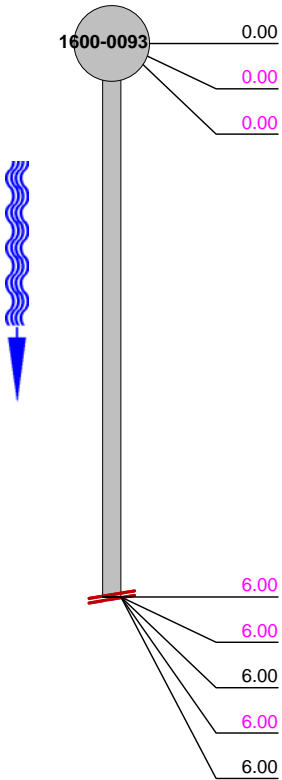
1:25	position	observation	MPEG	photo	grade
	0.00	Manhole, within 8 inch: NO, Remarks: 1600-0093	00:00:34	6717	
	0.00 S2	Water Level Sag, 75 %, within 8 inch: NO, Start	00:00:48	6718	M 4
	0.00 S1	Camera Underwater, within 8 inch: NO, Start	00:00:58	6719	M 4
	6.00 F1	Camera Underwater, within 8 inch: NO, End	00:09:20	6720	M 4
	6.00 F2	Water Level Sag, 75 %, within 8 inch: NO, End	00:09:43	6721	M 4
	6.00	Water Level, 30 %, within 8 inch: NO	00:09:54	6722	
	6.00	Deposits Ingressed Other, from 4 to 8 o'clock, 25 %, within 8 inch: NO, Remarks: DEBRIS	00:11:49	6723	M 4
	6.00	Abandoned Survey, within 8 inch: NO, Remarks: CAMERA BLOCKED BY HEAVY D	00:12:11	6724

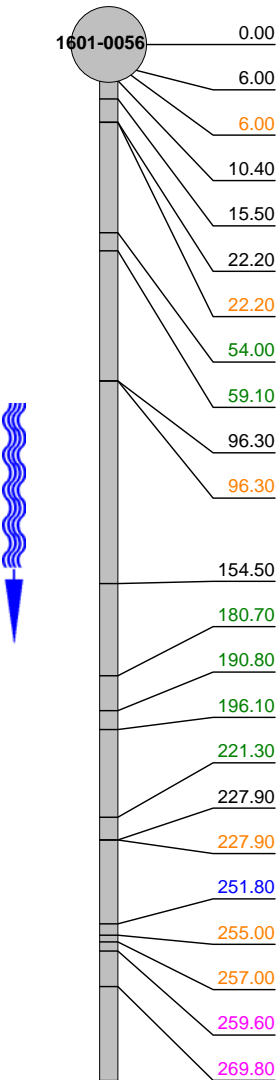
0.00	Manhole, within 8 inch: NO, Remarks: 1601-0056	00:00:27	1694	
	6.00	Tap Factory Active, at 2 o'clock, 6", within 8 inch: NO	00:02:18	1695

6.00	Roots Medium Lateral, at 2 o'clock, 30 %, within 8 inch: NO	00:02:33	1696, b	M 3
	10.40	Water Level, 5 %, within 8 inch: NO	00:02:57	1698	
	15.50	General Observation, within 8 inch: NO, Remarks: Pipe Joint Length 5'	00:06:30	1699

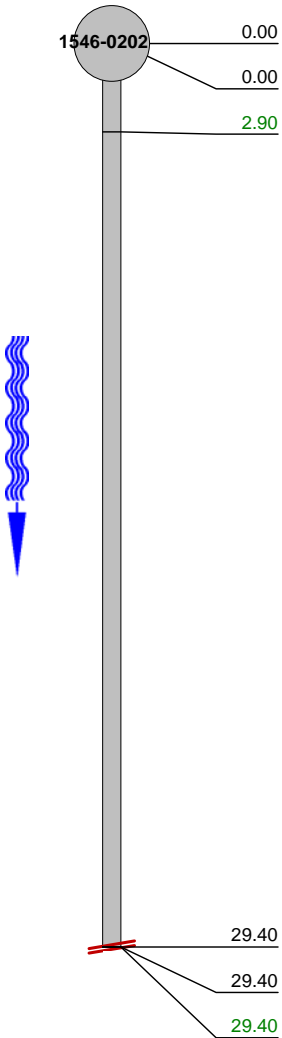
1:75	position	observation	MPEG	photo	grade
	0.00	Manhole, within 8 inch: NO, Remarks: 1546-0202	00:00:34	481	
	0.00	Obstacle Other, from 3 to 9 o'clock, 50 %, within 8 inch: NO	00:01:33	482, b	M 5
	2.90 S1	Roots Fine Joint, from 8 to 4 o'clock, within 8 inch: YES, Start	00:04:14	486, b	M 1
	29.40	Water Level, 100 %, within 8 inch: NO	00:06:50	488	
	29.40	Abandoned Survey, within 8 inch: NO, Remarks: DUE TO WATER BEING HELD	00:08:24	489	
	29.40 F1	Roots Fine Joint, from 8 to 4 o'clock, within 8 inch: YES, End	00:08:48	490	M 1

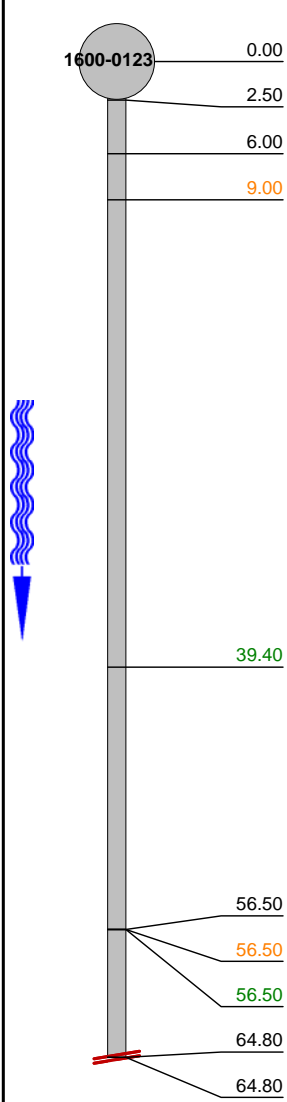
0.00	Manhole, within 8 inch: NO, Remarks: 1600-0123	00:00:25	898	
	2.50	Tap Factory Capped, at 9 o'clock, 4", within 8 inch: NO	00:01:41	899	
	6.00	Water Level, 5 %, within 8 inch: NO	00:02:18	900	
	9.00	Roots Medium Joint, from 4 to 8 o'clock, 30 %, within 8 inch: YES	00:02:55	901, b	M 3
	39.40	Roots Fine Joint, from 8 to 4 o'clock, within 8 inch: YES	00:04:42	903, b	M 1
	56.50	Tap Factory Active, at 3 o'clock, 4", within 8 inch: NO	00:06:12	905	
	56.50	Roots Medium Lateral, at 3 o'clock, 25 %, within 8 inch: NO	00:06:56	906, b	M 3
	56.50	Roots Fine Connection, at 3 o'clock, within 8 inch: NO	00:07:15	908, b	M 1
	64.80	Roots Ball Barrel, from 7 to 5 o'clock, 95 %, within 8 inch: NO	00:08:49	910	M 5
	64.80	Abandoned Survey, within 8 inch: NO, Remarks: Due To Roots Ball Barrel-	00:09:51	911

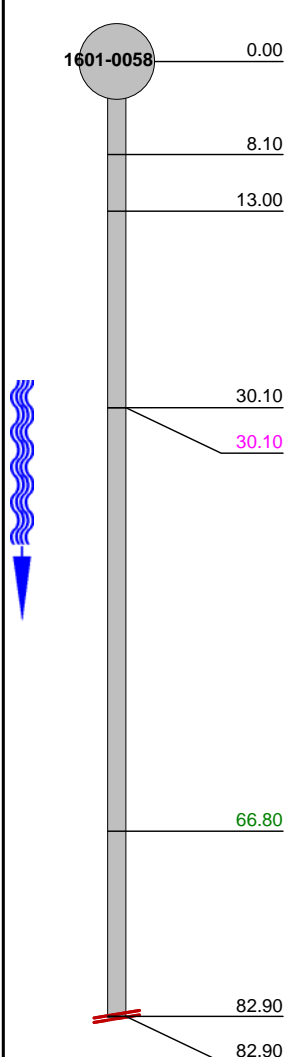
0.00	Manhole, within 8 inch: NO, Remarks: 1601-0058	00:00:28	1822	
	8.10	Water Level, 5 %, within 8 inch: NO	00:01:12	1823	
	13.00	General Observation, within 8 inch: NO, Remarks: Pipe Joint Length 5'	00:01:41	1824	
	30.10	Tap Factory Active, at 9 o'clock, 6", within 8 inch: NO	00:02:18	1825	
	30.10	Roots Ball Lateral, at 9 o'clock, 90 %, within 8 inch: NO	00:02:47	1826, b	M 4
	66.80	Roots Fine Joint, at 7 o'clock, within 8 inch: YES	00:04:04	1828, b	M 1
	82.90	Tap Factory Intruding, at 9 o'clock, 40 %, 6", 3, within 8 inch: NO	00:05:08	1830, b	M 5
	82.90	Abandoned Survey, within 8 inch: NO, Remarks: Due To Tap Factory Intrud	00:05:59	1832, b

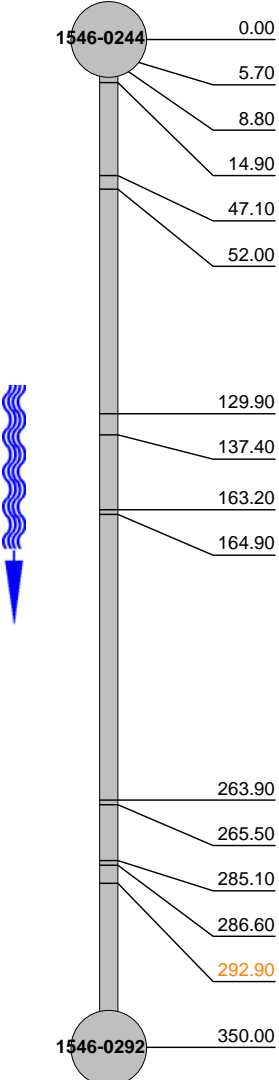
0.00	Manhole, within 8 inch: NO, Remarks: 1546-0244	00:00:35	1546	
	5.70	Tap Factory Active, at 10 o'clock, 4", within 8 inch: NO	00:01:28	1547

8.80	Water Level, 5 %, within 8 inch: NO	00:01:52	1548	
	14.90	General Observation, within 8 inch: NO, Remarks: Pipe Joint Length 6'	00:02:43	1549	
	47.10	Tap Factory Active, at 2 o'clock, 4", within 8 inch: NO	00:03:37	1550

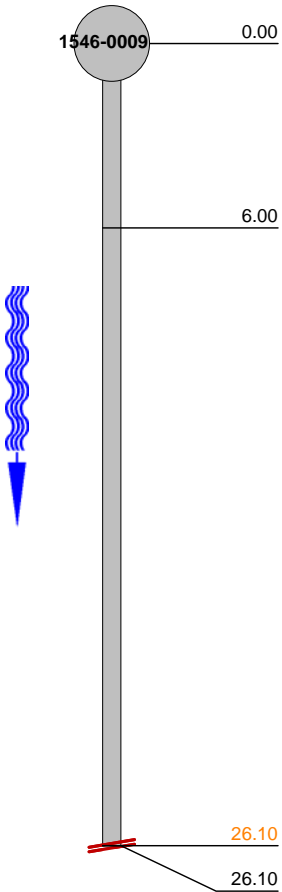
1:75	position	observation	MPEG	photo	grade
	0.00	Manhole, within 8 inch: NO, Remarks: 1546-0009	00:00:29	1022	
	6.00	Water Level, 25 %, within 8 inch: NO	00:01:47	1023	
	26.10	Tap Break-in Defective, at 1 o'clock, 6", 4, within 8 inch: NO	00:04:17	1024, b	M 3
	26.10	Abandoned Survey, within 8 inch: NO, Remarks: Due To Tap Break In Defec	00:05:30	1026, b

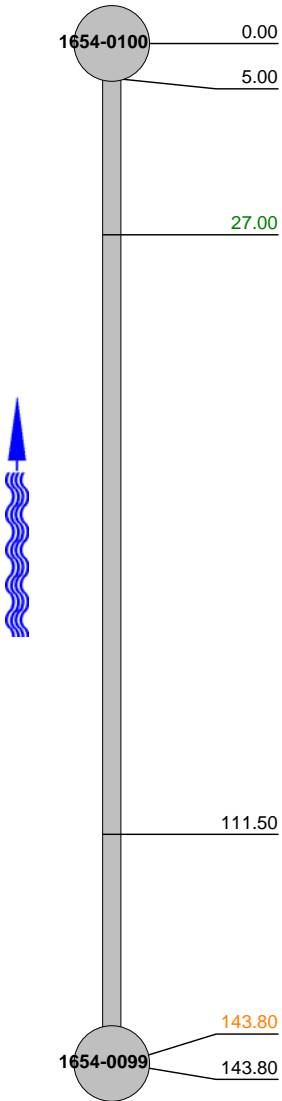
1:325	position	observation	MPEG	photo	grade
	0.00	Manhole, within 8 inch: NO, Remarks: 1654-0100	00:00:29	10024	
	5.00	Water Level, 5 %, within 8 inch: NO	00:01:22	10025	
	27.00	Alignment Up, 10 %, within 8 inch: NO	00:02:24	10026	M 1
	111.50	Tap Factory Active, at 3 o'clock, 6", within 8 inch: NO	00:05:14	10027	
	143.80	Roots Tap Barrel, from 7 to 5 o'clock, 15 %, within 8 inch: NO	00:08:01	10028, b	M 3
	143.80	Manhole, within 8 inch: NO, Remarks: 1654-0099, BURIED	00:08:42	10030

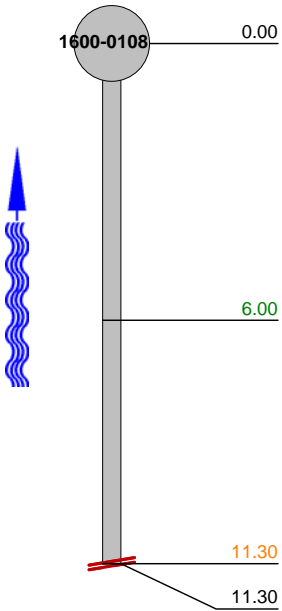
1:50	position	observation	MPEG	photo	grade
	0.00	Manhole, within 8 inch: NO, Remarks: 1600-0108	00:00:27	5902	
	6.00	Roots Fine Joint, from 5 to 9 o'clock, within 8 inch: YES	00:01:15	5903, b	M 1
	11.30	Roots Medium Joint, from 3 to 9 o'clock, 45 %, within 8 inch: YES	00:02:25	5905, b	M 3
	11.30	Abandoned Survey, within 8 inch: NO, Remarks: Due To Roots Medium Joint	00:03:17	5907

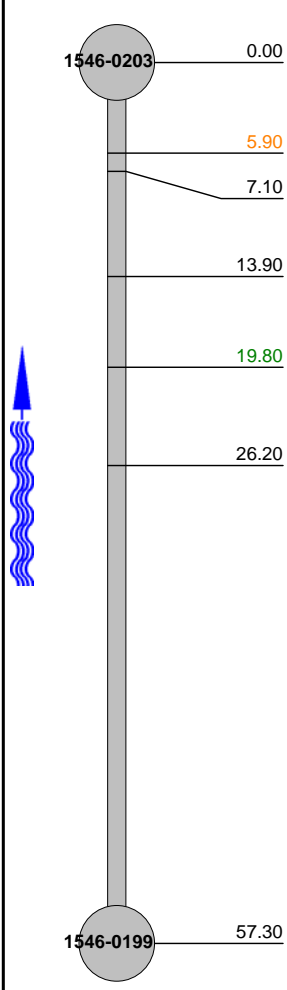
0.00	Manhole, within 8 inch: NO, Remarks: 1546-0203	00:01:01	3621	
	5.90	Roots Medium Joint, from 3 to 9 o'clock, 25 %, within 8 inch: YES	00:02:56	3622, b	M 3
	7.10	Tap Factory Active, at 3 o'clock, 4", within 8 inch: NO	00:03:28	3624	
	13.90	Water Level, 5 %, within 8 inch: NO	00:04:09	3625	
	19.80	Roots Fine Joint, at 5 o'clock, within 8 inch: YES	00:04:32	3626, b	M 1
	26.20	General Observation, within 8 inch: NO, Remarks: Pipe Joint Length 6'	00:5:10	3628	
	57.30	Manhole, within 8 inch: NO, Remarks: 1546-0199	00:06:18	3629

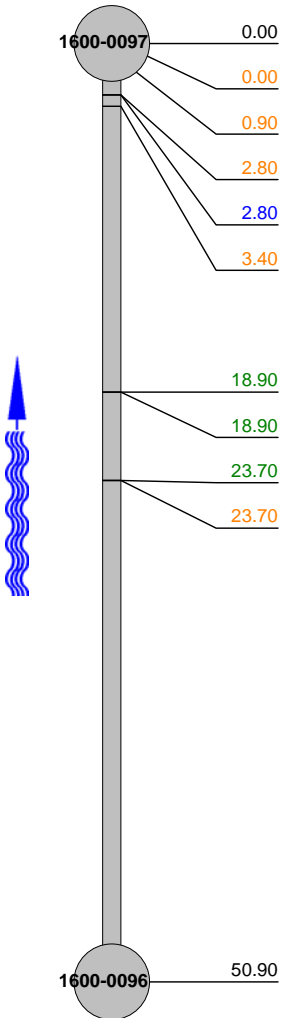
1:125	position	observation	MPEG	photo	grade
	0.00	Manhole, within 8 inch: NO, Remarks: 1600-0097	00:00:42	6831	
	0.00	Crack Multiple, from 7 to 6 o'clock, within 8 inch: NO	00:01:37	6832, b	S 3

0.90 S1	Fracture Longitudinal, at 7 o'clock, within 8 inch: YES, Start	00:02:22	6834, b	S 3
	2.80	Roots Medium Joint, from 7 to 10 o'clock, 25 %, within 8 inch: YES	00:05:10	6836, b	M 3

2.80	Crack Longitudinal, at 7 o'clock, within 8 inch: YES	00:05:23	6838, b	S 2
	3.40 F1	Fracture Longitudinal, at 7 o'clock, within 8 inch: YES, End	00:06:01	6840	S 3

18.90	Roots Fine Joint, from 3 to 5 o'clock, within 8 inch: YES	00:07:29	6841, b	M 1
	18.90	Crack Circumferential, from 2 to 4 o'clock, within 8 inch: YES	00:07:52	6843, b	S 1

23.70	Roots Fine Joint, from 3 to 9 o'clock, within 8 inch: YES	00:08:56	6845, b	M 1
	23.70	Crack Multiple, from 7 to 5 o'clock, within 8 inch: YES	00:09:19	6847, b	S 3

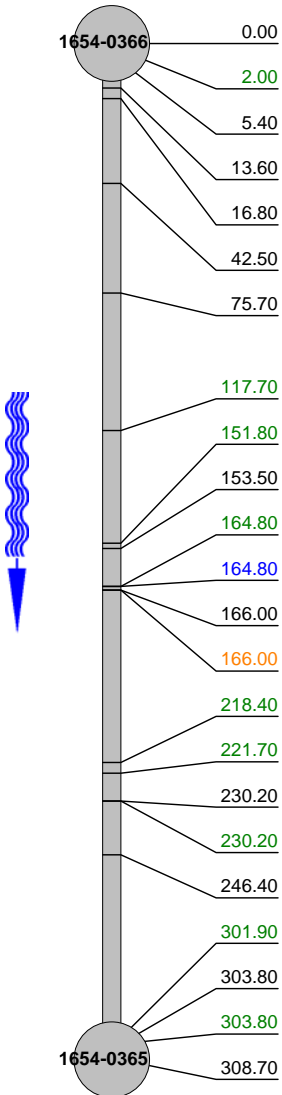
301.90	Roots Fine Joint, from 8 to 4 o'clock, within 8 inch: YES	00:13:33	528, b	M 1
	303.80	Tap Factory Active, at 9 o'clock, 6", within 8 inch: NO	00:13:58	530

303.80	Roots Fine Lateral, at 9 o'clock, within 8 inch: NO	00:14:11	531, b	M 1
	308.70	Manhole, within 8 inch: NO, Remarks: 1654-0365	00:14:55	533

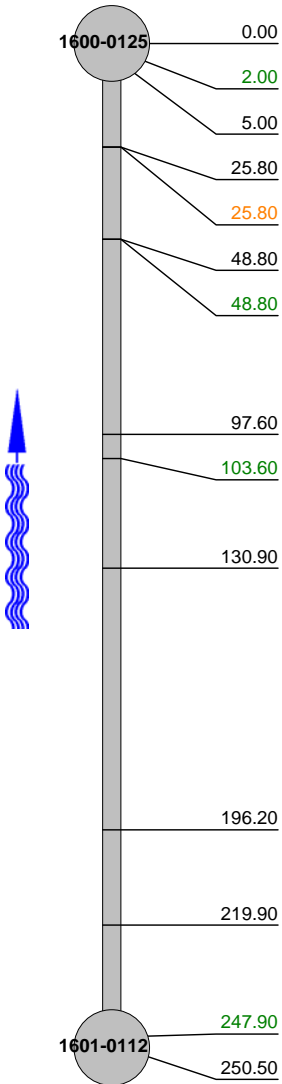
196.20	Tap Factory Active, at 3 o'clock, 6", within 8 inch: NO	00:10:54	6943	
	219.90	Tap Factory Active, at 9 o'clock, 6", within 8 inch: NO	00:12:09	6944

247.90 F1	Roots Fine Joint, from 4 to 8 o'clock, within 8 inch: YES, End	00:14:12	6945	M 1
	250.50	Manhole, within 8 inch: NO, Remarks: 1601-0112	00:14:53	6946

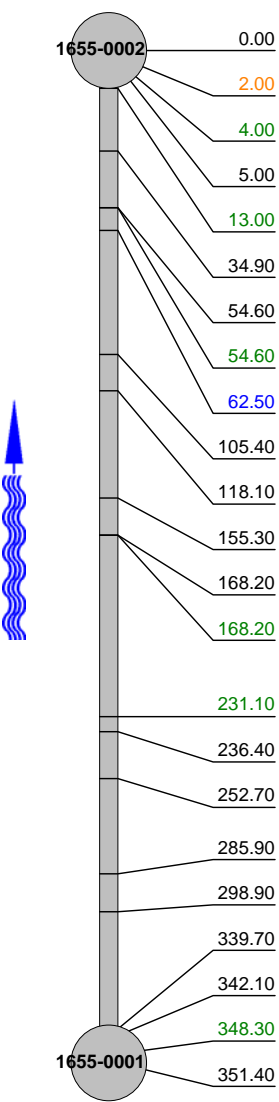
0.00	Manhole, within 8 inch: NO, Remarks: 1655-0002	00:00:31	10052	
	2.00	Roots Medium Joint, from 6 to 10 o'clock, 30 %, within 8 inch: YES	00:00:59	10053, b	M 3

4.00	Roots Fine Joint, from 7 to 5 o'clock, within 8 inch: YES	00:03:09	10055, b	M 1
	5.00	Water Level, 5 %, within 8 inch: NO	00:03:50	10057	
	13.00 S1	Roots Fine Joint, from 8 to 10 o'clock, within 8 inch: YES, Start	00:04:13	10058, b	M 1

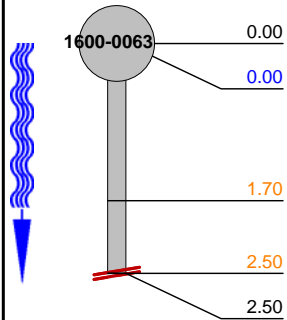
1:25	position	observation	MPEG	photo	grade
	0.00	Manhole, within 8 inch: NO, Remarks: 1600-0063	00:00:38	6037	
	0.00	Roots Tap Joint, from 7 to 5 o'clock, 15 %, within 8 inch: YES	00:01:08	6038, b	M 2
	1.70 S1	Roots Medium Joint, from 7 to 5 o'clock, 30 %, within 8 inch: YES, Start	00:01:51	6040, b	M 3
	2.50 F1	Roots Medium Joint, from 7 to 5 o'clock, 30 %, within 8 inch: YES, End	00:02:56	6042	M 3
	2.50	Abandoned Survey, within 8 inch: NO, Remarks: CAMERA BLOCKED BY MEDIUM	00:03:14	6043

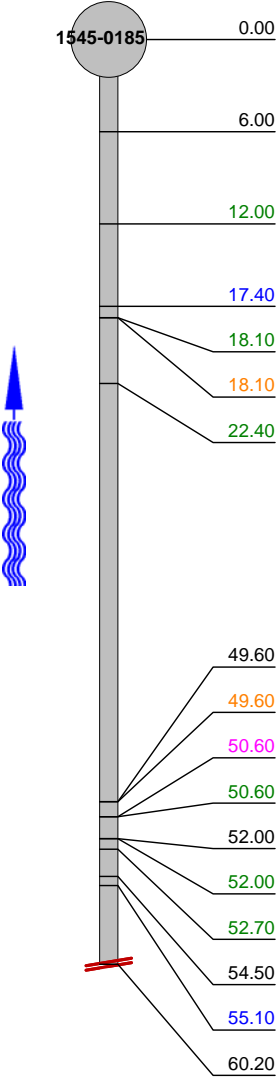
0.00	Manhole, within 8 inch: NO, Remarks: 1545-0185	00:00:42	3468	
	6.00	Water Level, 5 %, within 8 inch: NO	00:01:38	3469

12.00	Roots Fine Joint, from 7 to 5 o'clock, within 8 inch: YES	00:02:25	3470, b	M 1
	17.40	Crack Longitudinal, at 10 o'clock, within 8 inch: YES	00:03:12	3472, b	S 2

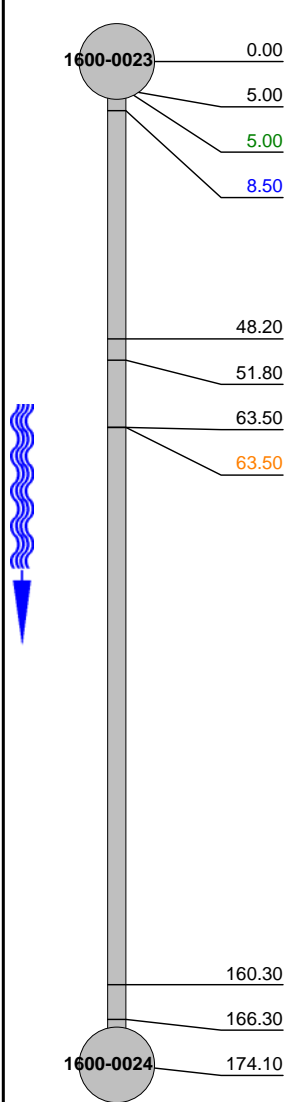
0.00	Manhole, within 8 inch: NO, Remarks: 1600-0023	00:00:29	15	
	5.00	Tap Factory Active, at 3 o'clock, 6", within 8 inch: NO	00:01:20	16

5.00	Roots Fine Lateral, at 3 o'clock, within 8 inch: NO	00:01:30	17, b	M 1
	8.50	Obstacle Other, at 6 o'clock, 5 %, within 8 inch: NO, Remarks: Plumber Snake	00:03:09	19, b	M 2

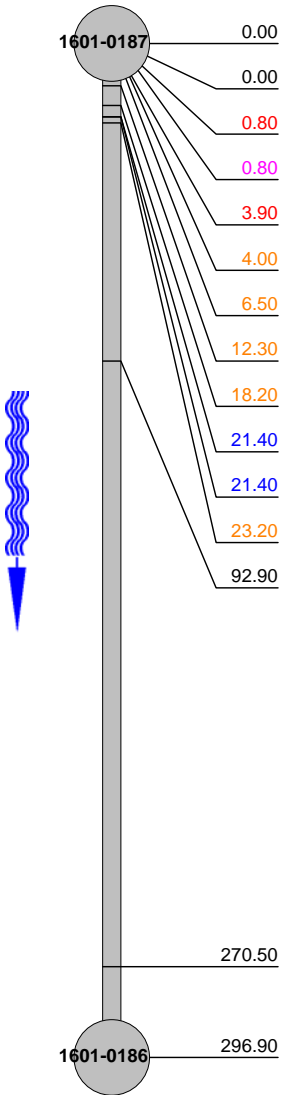
23.20	Crack Multiple, from 7 to 10 o'clock, within 8 inch: YES	00:08:20	10180, b	S 3
	92.90	Tap Factory Active, at 3 o'clock, 6", within 8 inch: NO	01:13:59	10182

270.50	Tap Factory Active, at 3 o'clock, 6", within 8 inch: NO	01:19:08	10183	
	296.90	Manhole, within 8 inch: NO, Remarks: 1601-0186	01:20:37	10184

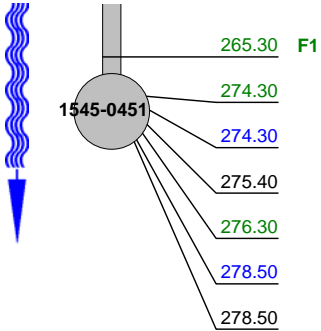
1:561	position	observation	MPEG	photo	grade
	<u>265.30</u> F1	Alignment Right, 10 %, within 8 inch: NO, End	00:19:17	2155	M 1
	<u>274.30</u>	Joint Offset Medium, within 8 inch: YES	00:20:07	2156, b	S 1
	<u>274.30</u>	Roots Tap Joint, from 7 to 5 o'clock, 15 %, within 8 inch: YES	00:20:21	2158, b	M 2
	<u>275.40</u>	Tap Factory Active, at 9 o'clock, 6", within 8 inch: NO	00:21:15	2160	
	<u>276.30</u>	Joint Offset Medium, within 8 inch: YES	00:21:55	2161, b	S 1
	<u>278.50</u>	Roots Fine Barrel, from 3 to 9 o'clock, within 8 inch: NO	00:23:03	2163, b	M 2
	<u>278.50</u>	Manhole, within 8 inch: NO, Remarks: 1545-0451	00:24:08	2165

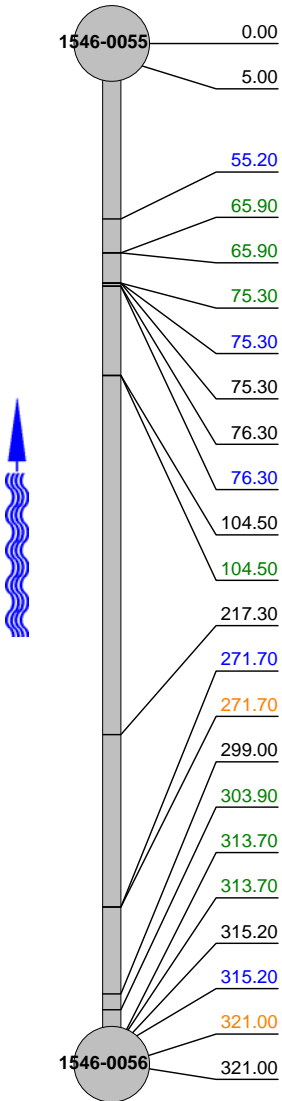
315.20	Roots Tap Connection, from 7 to 9 o'clock, 20 %, within 8 inch: NO	00:18:04	3408, b	M 2
	321.00	Deposits Settled Compacted, from 4 to 8 o'clock, 20 %, within 8 inch: NO	00:19:28	3410, b	M 3

321.00	Manhole, within 8 inch: NO, Remarks: 1546-0056	00:19:57	3412

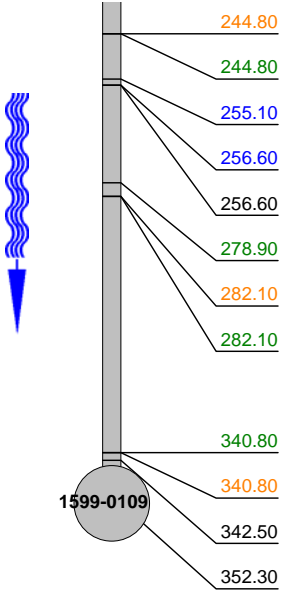
1:528	position	observation	MPEG	photo	grade
	<u>244.80</u>	Crack Multiple, from 7 to 5 o'clock, within 8 inch: YES	00:15:12	832, b	S 3
	<u>244.80</u> S2	Roots Fine Joint, from 7 to 5 o'clock, within 8 inch: YES, Start	00:15:27	834, b	M 1
	<u>255.10</u>	Fracture Circumferential, from 3 to 6 o'clock, within 8 inch: YES	00:16:30	836, b	S 2
	<u>256.60</u> F1	Water Level Sag, 25 %, within 8 inch: NO, End	00:16:51	838	M 2
	<u>256.60</u>	Water Level, 15 %, within 8 inch: NO	00:17:01	839	
	<u>278.90</u> F2	Roots Fine Joint, from 7 to 5 o'clock, within 8 inch: YES, End	00:17:38	840	M 1
	<u>282.10</u> S4	Crack Multiple, from 7 to 5 o'clock, within 8 inch: YES, Start	00:18:07	841, b	S 3
	<u>282.10</u> S3	Roots Fine Joint, from 7 to 5 o'clock, within 8 inch: YES, Start	00:18:16	843, b	M 1
	<u>340.80</u> F3	Roots Fine Joint, from 7 to 5 o'clock, within 8 inch: YES, End	00:21:13	845	M 1
	<u>340.80</u> F4	Crack Multiple, from 7 to 5 o'clock, within 8 inch: YES, End	00:21:27	846	S 3

<u>342.50</u>	Tap Factory Active, at 9 o'clock, 6", within 8 inch: NO	00:21:48	847	
	<u>352.30</u>	Manhole, within 8 inch: NO, Remarks: 1599-0109, BURIED DMH	00:23:13	848

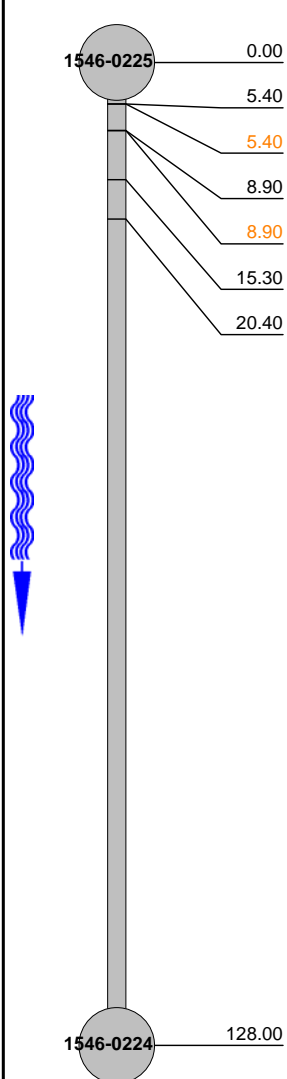
0.00	Manhole, within 8 inch: NO, Remarks: 1546-0225	00:00:21	3630	
	5.40	Tap Factory Active, at 9 o'clock, 6", within 8 inch: NO	00:01:34	3631	
	5.40	Roots Medium Lateral, at 9 o'clock, 45 %, within 8 inch: NO	00:01:51	3632, b	M 3
	8.90	Tap Factory Abandoned, at 9 o'clock, 6", within 8 inch: NO	00:02:34	3634	
	8.90	Roots Medium Connection, at 9 o'clock, 30 %, within 8 inch: NO	00:02:49	3635, b	M 3
	15.30	Water Level, 5 %, within 8 inch: NO	00:03:23	3637	
	20.40	General Observation, within 8 inch: NO, Remarks: Pipe Joint Length 5'	00:03:47	3638	
	128.00	Manhole, within 8 inch: NO, Remarks: 1546-0224	00:06:40	3639

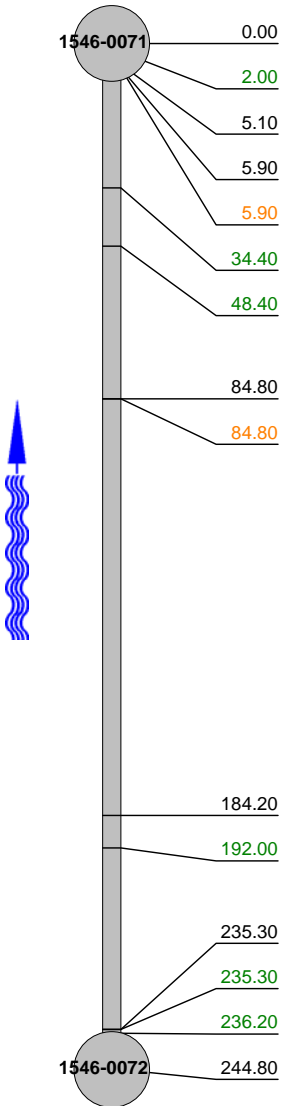
235.30	Tap Factory Active, at 9 o'clock, 6", within 8 inch: NO	00:09:50	2284	
	235.30	Roots Fine Lateral, at 9 o'clock, within 8 inch: NO	00:10:05	2285, b	M 1

236.20	Roots Fine Joint, from 8 to 10 o'clock, within 8 inch: YES	00:10:42	2287, b	M 1
	244.80	Manhole, within 8 inch: NO, Remarks: 1546-0072	00:11:44	2289
