CONSOLIDATED SEWER MAINTENANCE DISTRICT CONDITION ASSESSMENT PROGRAM REPORT PROJECT Y0TV0607D

**CONDITION ASSESSMENT REPORT
COUNTY OF LOS ANGELES DEPARTMENT OF PUBLIC WORKS
CONSOLIDATED SEWER MAINTENANCE DISTRICT**

PROJECT NAME:	Y0TV0607D	PROJECT MGR:	Kari Eskridge
PROJECT DATE:	5/16/07-8/20/07	CONTACT NO:	(626) 300-3390
SUP. DISTRICT(s):	4	MAP PAGE(S):	1490, 1491, 1544, 1545
Report By:	Phyo Kyaw	Report Date:	07/29/09

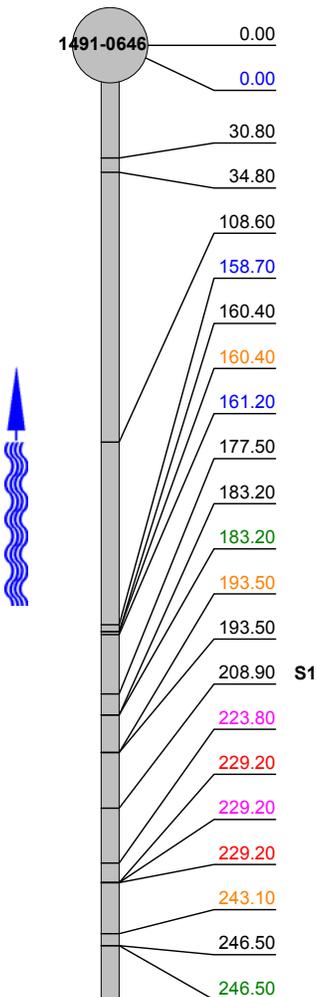
223.80	Fracture Multiple, from 6 to 1 o'clock, within 8 inch: YES	00:16:59	9530, b	S 4
	229.20	Broken, from 7 to 5 o'clock, within 8 inch: YES	00:18:05	9532, b	S 5

229.20	Fracture Multiple, from 7 to 5 o'clock, within 8 inch: YES	00:18:31	9534, b	S 4
	229.20	Deformed, 15", within 8 inch: NO	00:18:54	9536, b	S 5
	243.10	Crack Multiple, from 7 to 6 o'clock, within 8 inch: NO	00:20:38	9538, b	S 3

246.50	Tap Factory Active, at 3 o'clock, 4", within 8 inch: NO	00:21:25	9540	
	246.50	Roots Fine Lateral, at 3 o'clock, within 8 inch: NO	00:21:44	9541, b	M 1

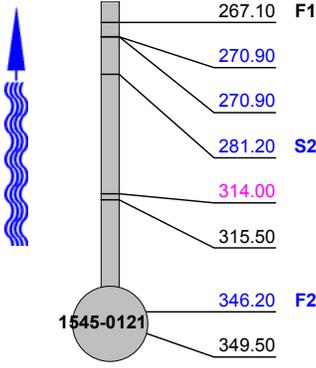
1:627	position	observation	MPEG	photo	grade
	267.10 F1	Roots Fine Joint, from 8 to 1 o'clock, within 8 inch: YES, End	00:22:45	9543	
	270.90	Fracture Circumferential, from 7 to 6 o'clock, within 8 inch: NO	00:23:35	9544, b	S 2
	270.90	Roots Fine Barrel, from 3 to 9 o'clock, within 8 inch: NO	00:23:58	9546, b	M 2
	281.20 S2	Fracture Circumferential, from 7 to 6 o'clock, within 8 inch: YES, Start	00:25:10	9548, b	S 2
	314.00	Fracture Multiple, from 2 to 1 o'clock, within 8 inch: YES	00:27:04	9550, b	S 4
	315.50	Tap Factory Active, at 3 o'clock, 4", within 8 inch: NO	00:27:37	9552	
	346.20 F2	Fracture Circumferential, from 7 to 6 o'clock, within 8 inch: YES, End	00:28:36	9553	S 2
	349.50	Manhole, within 8 inch: NO, Remarks: Upstream Survey Ends	00:29:21	9554

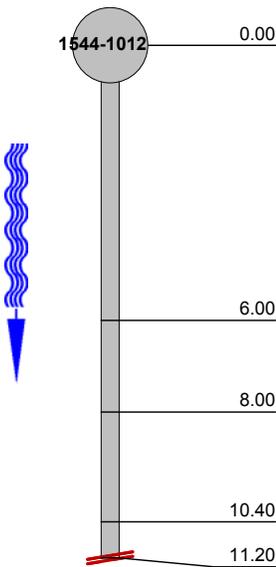
1:50	position	observation	MPEG	photo	grade
	0.00	Manhole, within 8 inch: NO, Remarks: UPSTREAM MH 1544-1012-SUR	00:00:28	12582	
	6.00	Roots Medium Joint, from 11 to 7 o'clock, 10", within 8 inch: YES	00:01:37	12583	
	8.00	Roots Ball Joint, from 7 to 5 o'clock, 90", within 8 inch: YES	00:02:53	12584	
	10.40	Tap Factory Active, at 9 o'clock, 4", within 8 inch: NO	00:03:51	12585	
	11.20	Abandoned Survey, within 8 inch: NO, Remarks: UNABLE TO GET BY ROOTS	00:06:37	12586

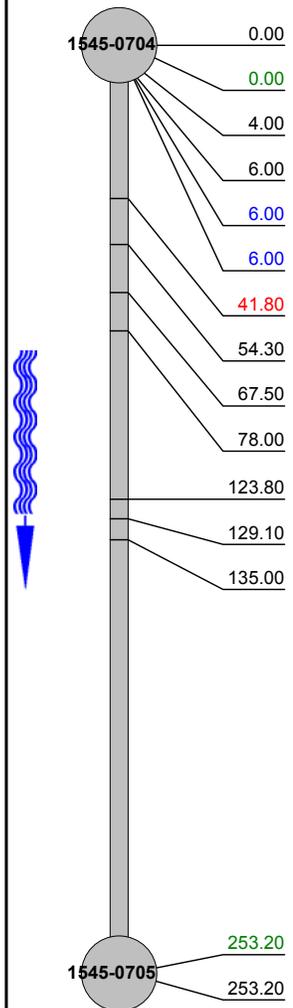
129.10	Roots Medium Joint, from 12 to 1 o'clock, 5 ☐, within 8 inch: YES	00:12:26	15153	
	135.00	Tap Factory Active, at 3 o'clock, 6", within 8 inch: NO	00:13:17	15154

253.20	Vermin Cockroach, within 8 inch: NO	00:16:40	15155	M 1
	253.20	Manhole, within 8 inch: NO, Remarks: DOWNSTREAM MH, END SURVEY	00:17:08	15156

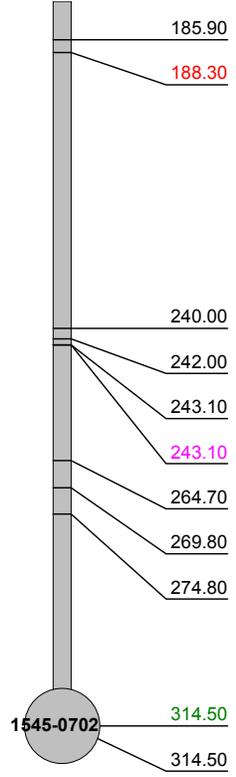
274.80	Roots Medium Joint, from 10 to 2 o'clock, 5 °, within 8 inch: YES	00:25:08	15283	
	314.50	Vermin Cockroach, within 8 inch: NO	00:27:04	15284	M 1

314.50	Manhole, within 8 inch: NO, Remarks: DOWNSTREAM MH, END SURVEY	00:27:33	15285

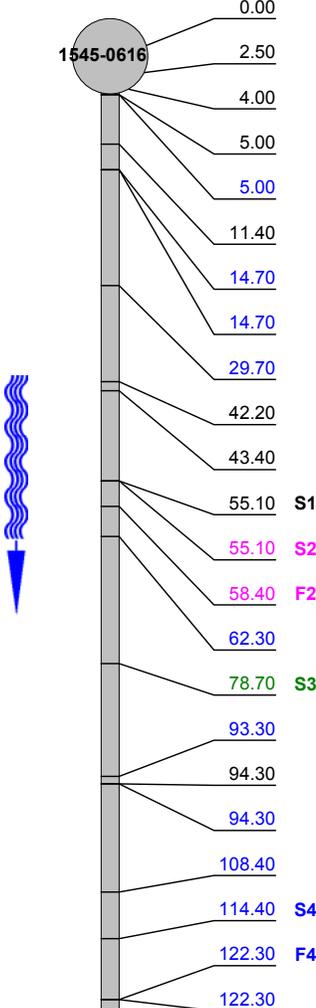
108.40	Water Level, 15 ☐, within 8 inch: NO	00:15:27	4746	M 2
	114.40	Water Level Sag, 25 ☐, within 8 inch: NO, Start	00:15:51	4747	M 2
	122.30	Water Level Sag, 25 ☐, within 8 inch: NO, End	00:16:40	4748	M 2

122.30	Water Level, 5 ☐, within 8 inch: NO	00:17:03	4749	M 2
