### **CONSOLIDATED SEWER MAINTENANCE DISTRICT CONDITION ASSESSMENT PROGRAM REPORTS PROJECTS Y0TV0708E AND Y0TV0809A**

**CONDITION ASSESSMENT REPORT  
COUNTY OF LOS ANGELES DEPARTMENT OF PUBLIC WORKS  
CONSOLIDATED SEWER MAINTENANCE DISTRICT**

PROJECT NAME:	Y0TV0809A	PROJECT MGR:	Kari Eskridge
PROJECT DATE:	August 2008	CONTACT NO:	(626) 300-3390
SUP. DISTRICT(s):	1	MAP PAGE(S):	T.G. 636, 596
Report By:	Kari Eskridge	Report Date:	05/27/2009

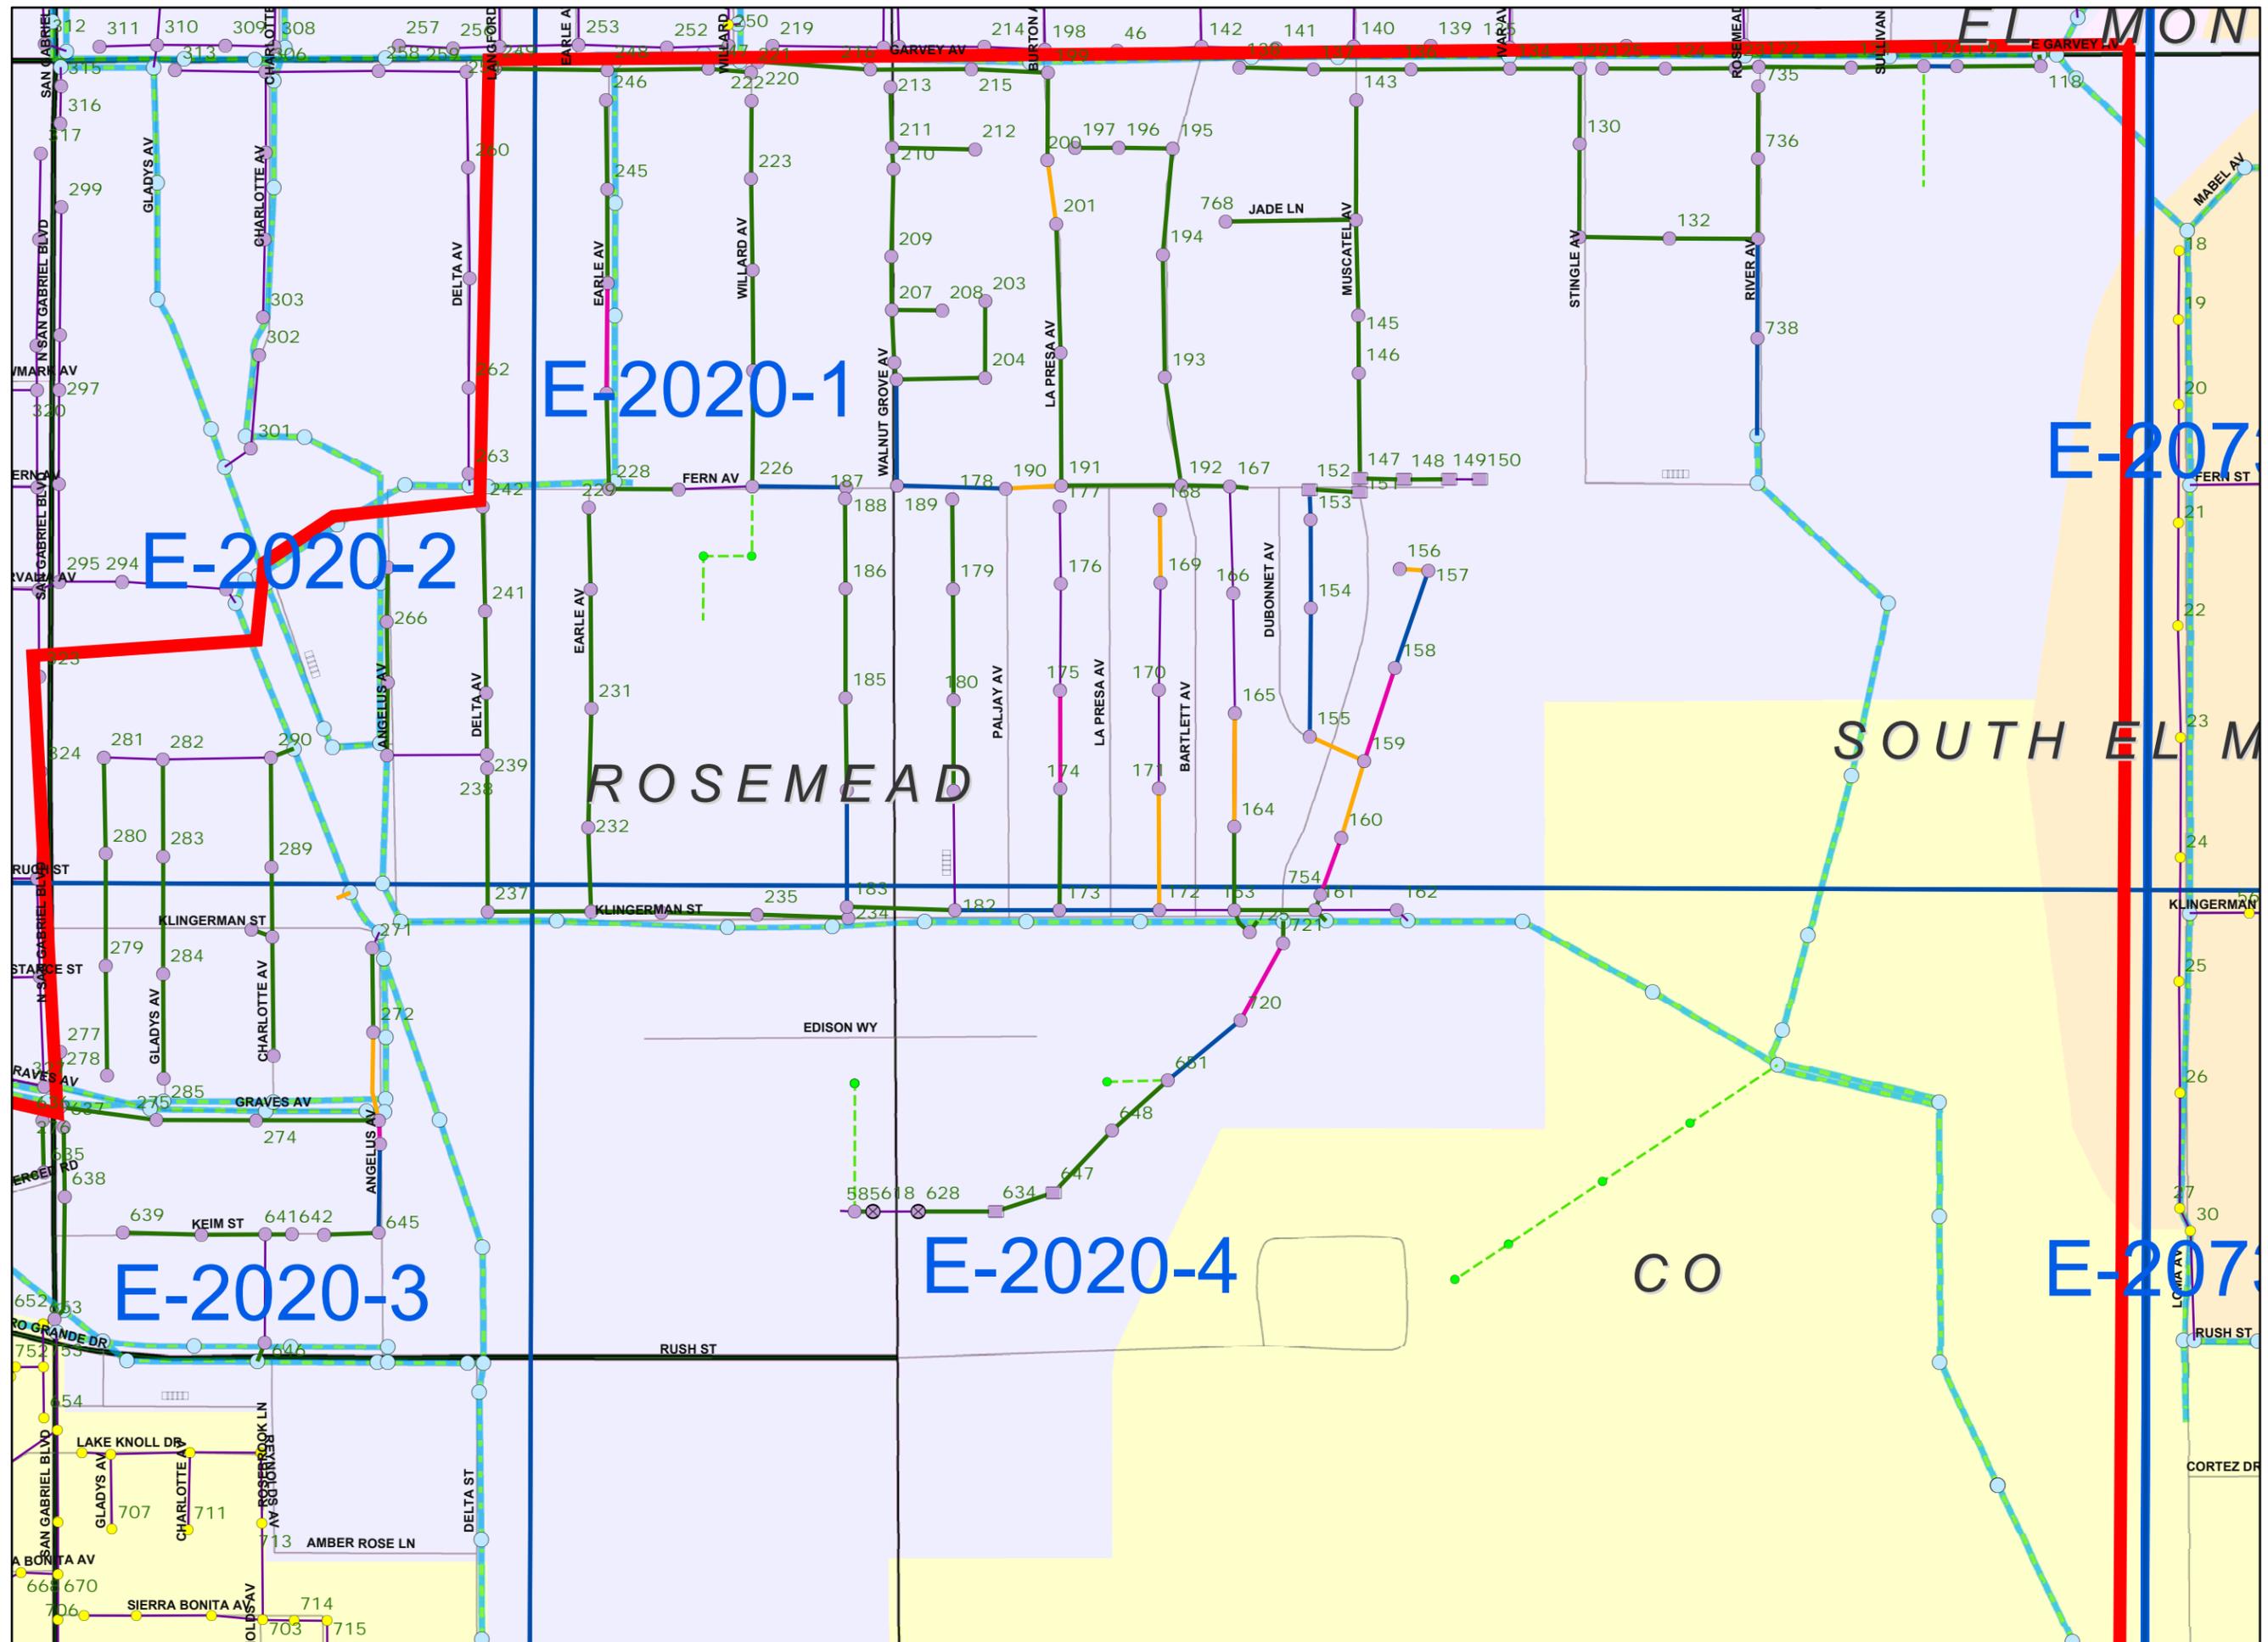
Our inspection revealed that approximately 94.9 percent of the system televised was free of blockages or restrictions that would impede sewer flows. However, the remaining 5.1 percent of the inspected pipe segments within the City of Rosemead area had a PACP maintenance grade of 4 or 5 as indicated in the Quick Maintenance Rating Table shown below. These segments have been incorporated into our routine cleaning schedule with corrective action taken as noted on the Quick Maintenance Rating Report Priority List (Enclosure 2). Also included is a color-coded map showing the quick maintenance rating for each pipe segment.

ITEM NO.	SECTION NO.	QMR	START MH	END MH	STREET	OBSERVATION	DATE MAINTAINED	EQUIPMENT USED
1	846	4100	2020-0273	2020-0644	ANGELUS	DEPOSITS - OTHER	03/24/2009	Rodder
2	266	4100	2020-0721	2020-0720	EASEMEN	OBSTACLE	03/24/2009	Rodder
3	299	4100	2020-0754	2020-0160	EASEMEN	ROOTS - LATERAL BALL	03/24/2009	Rodder
4	1116	4112	2021-0103	2021-0101	VILLAGE L	INFILTRATION RUNNER	03/24/2009	Rodder
5	771	4112	2020-0243	2020-0244	EARLE AV	ROOTS - BALL & ROOTS -FINE	03/24/2009	Hydro
6	280	4131	2020-0174	2020-0175	EASEMEN	OBJECT - PROTRUDING & ROOTS - LATERAL FINE & ROOTS - LATERAL MEDIUM	03/25/2009	Hand Rodded
7	297	4131	2020-0158	2020-0159	EASEMEN	ROOTS -FINE & ROOTS - LATERAL MEDIUM & ROOTS - LATERAL BALL	03/27/2009	Rodder
8	252	4132	2020-0170	2020-0171	EASEMEN	ROOTS -FINE & ROOTS - LATERAL MEDIUM & ROOTS - LATERAL BALL	03/25/2009	Hydro
9	248	4231	2020-0166	2020-0167	EASEMEN	ROOTS - MEDIUM & ROOTS -FINE & ROOTS - LATERAL BALL	03/24/2009	Rodder

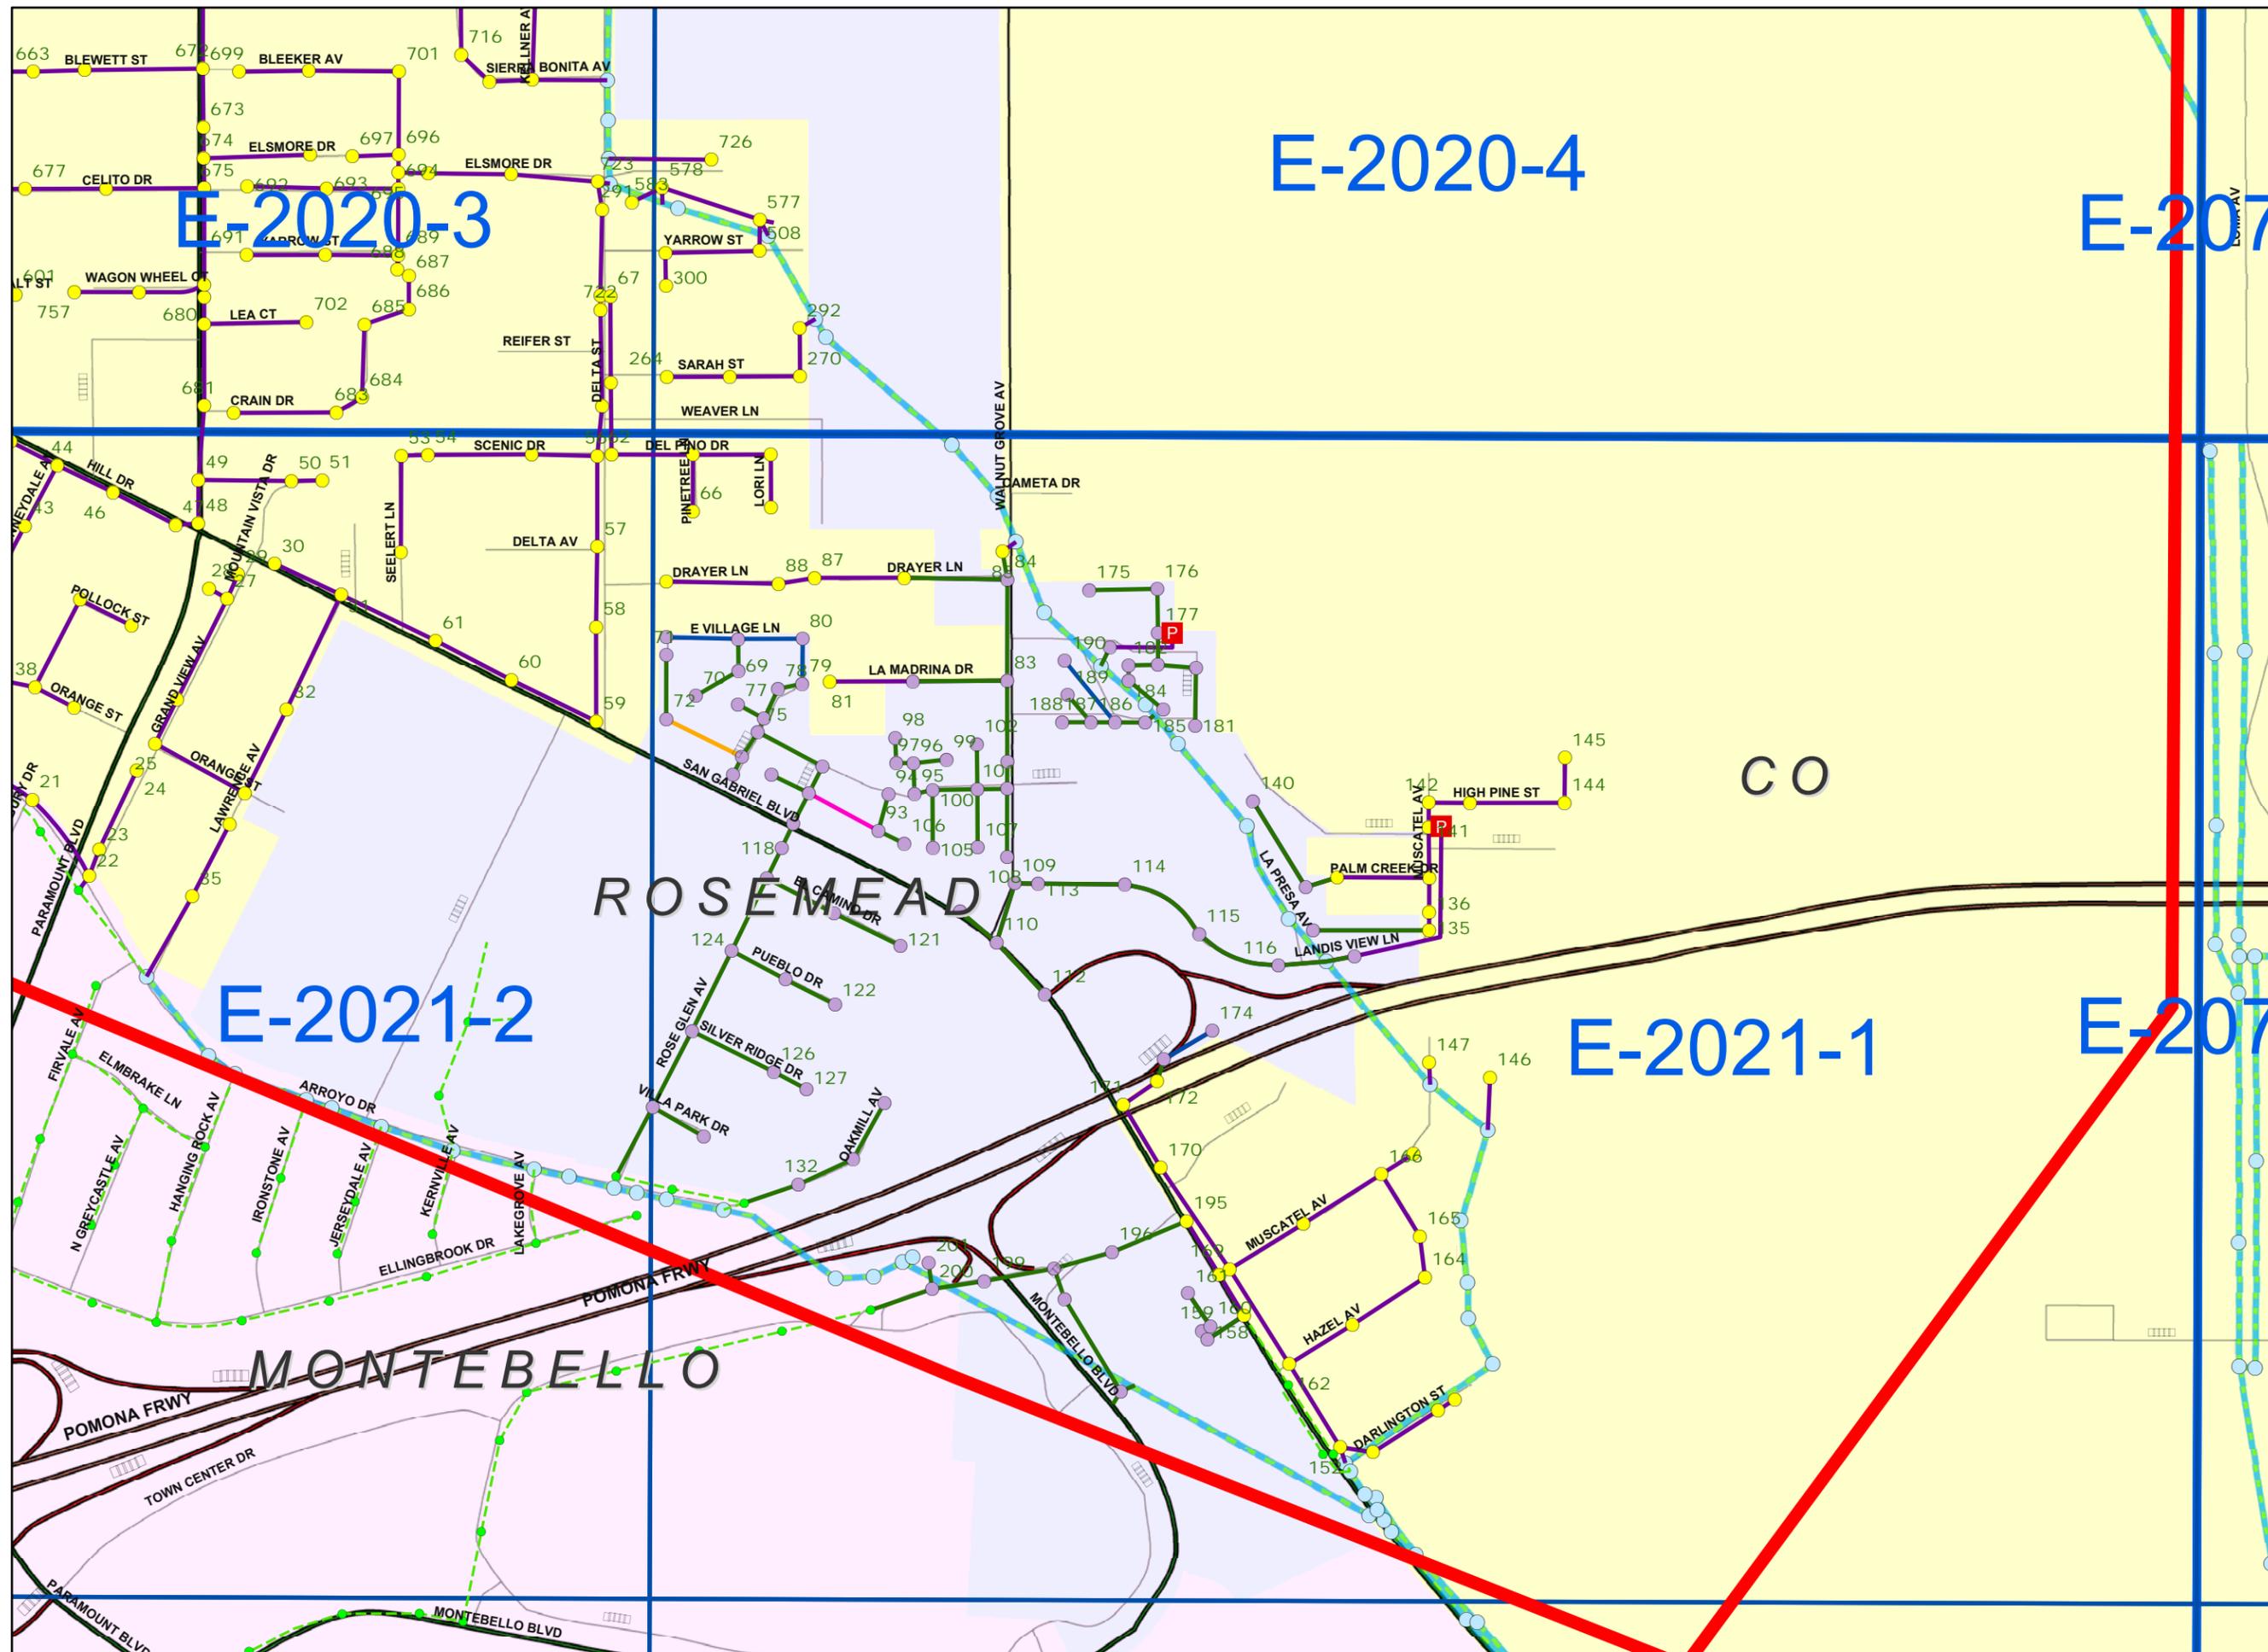
Our inspection revealed that approximately 97 percent of the inspected pipe segments within the City of Rosemead were free of severe structural defects. However, the remaining 3 percent of the inspected pipe segments had a PACP structural grade of 4 or 5 as indicated in the Quick Structural Rating Table shown below. These segments have been placed on a priority list based on the severity and the need for action. For Items 1 through 10 in the Quick Structural Rating Report Priority List (Enclosure 3) which require a corrective action, the proposed corrective method will be scheduled in the next 24 months as part of the ongoing Accumulative Capital Outlay Project. A color-coded map showing the Quick Structural Rating for each pipe segment is located in Enclosure 3. Copies of the actual inspection reports for these 10 segments are included in Enclosure 4.

ITEM NO.	QSR	START MH	END MH	STREET	OBSERVATION: LOCATION	PROPOSED CORRECTIVE ACTION	LENGTH OF REPAIR (FT)
1	5200	2020-0190	2020-0189	FERN AV	Hole (patched): 51', 68'	Structural integrity in tact. No action needed.	
2	5111	2020-0151	2020-0152	FERN AV	Broken with gasket visible: 115'	Structural integrity in tact. No action needed.	
3	5121	2020-0187	2020-0186	ALLEY W/O WALNUT GROVE AV	Broken with soil visible (inside lateral): 191'	Lateral Connection Lining	
4	5131	2020-0184	2020-0183	ALLEY W/O WALNUT GROVE AV	Broken with soil visible (inside lateral): 70', 189', 259'	Lateral Connection Lining	
5	511A	2020-0183	2020-0182	KLINGERMAN ST	Hole with void visible: 175'	Lining: MH to MH	338
6	5123	2020-0190	2020-0191	FERN AV	Hole with void visible: 212'	Structural integrity in tact. No action needed.	
7	5131	2020-0277	2020-0276	SAN GABRIEL BV	Broken with soil visible (inside lateral): 16'	Lateral Connection Lining

8	5122	2020-0175	2020-0174	EASEMENT E/O PALJAY AV	Hole (intrusion of pipe / grounding rod): 261'	Point Repair	
9	4121	2020-0225	2020-0226	WILLARD AV	Fracture Multiple: 302'	Lining: MH to MH	329
10	4100	2021-0093	2021-0091	VILLAGE LN	Fracture Multiple: 198'	Lining: MH to MH	267
