Bulk Asbestos, Lead Metal, Lead-Based Paint, Limited Hexavalent Chromium,
and Poly Chlorinated Biphenyls Survey

Los Angeles County Department Of Public Works
Morris Dam
Located Five Miles North of Azuza

HSA Project Number 99LA018

May 19, 1999

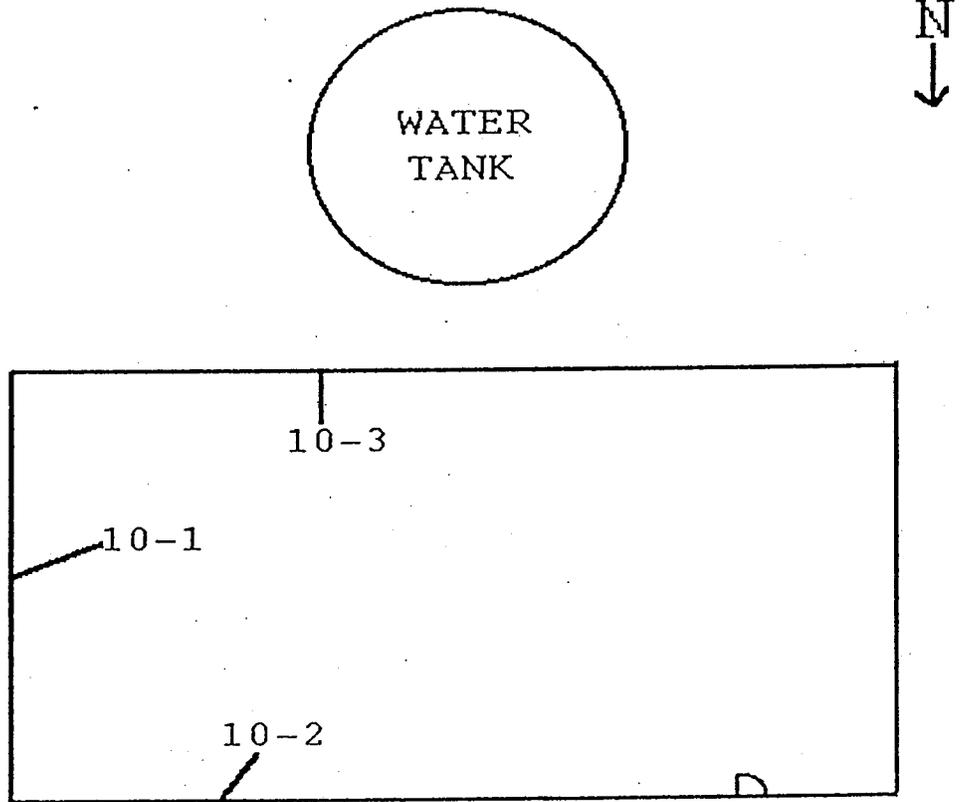
Morris Dam
Trailer
ACM Sample Locations

The roof mastics on the Temporary Trailer were determined to be ACM. These roof materials were observed to be non-friable and in good condition on the date of the survey. No other ACMs were located at the Temporary Trailer during our survey.
