# GEOTECHNICAL INVESTIGATION MASTER PLAN REVISION CHIQUITA CANYON LANDFILL CASTAIC, CALIFORNIA FOR

CHIQUITA CANYON LANDFILL

JANUARY 27, 2012

JOB NO. 2002-036-004

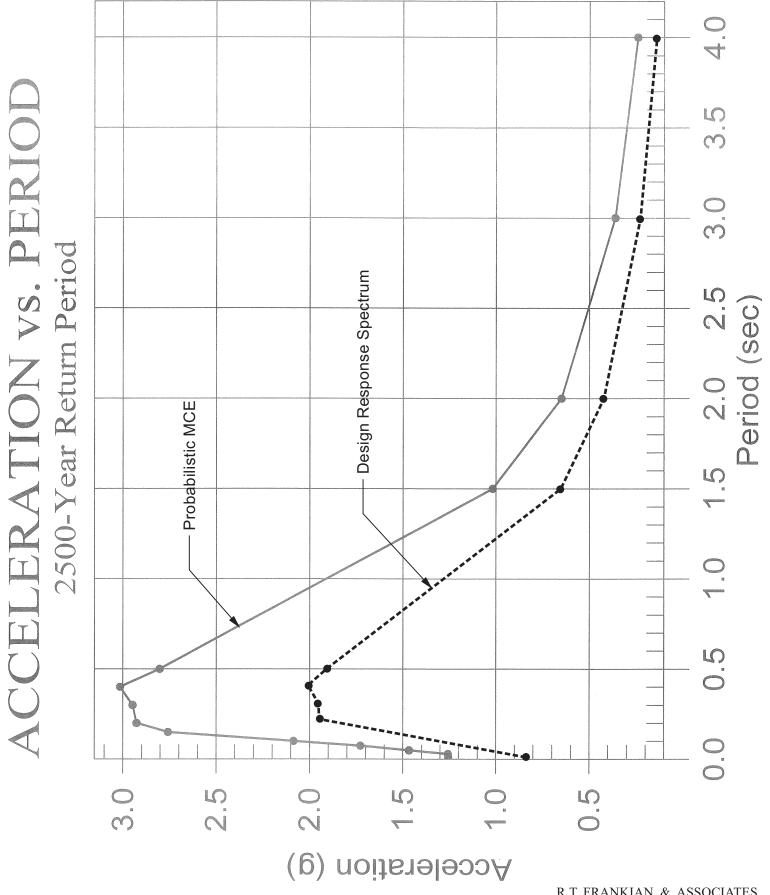
R.T. FRANKIAN & ASSOCIATES Figure 9

# PROBABILISTIC MCE

The probabilistic MCE was determined in accordance with Section 21.2.1 of ASCE Standard 7-05 for five percent damped acceleration response spectrum having approximately two percent probability of exceedance within a 50-year period (return interval 2,500 years) using the program FRISK for the Bozorgnia, Campbell, Niazi (1999) Holocene, Soil-pseudo, Rel Vel, with five percent damping attenuation relationship. The results are presented in Figure 9, and the factors are summarized below.

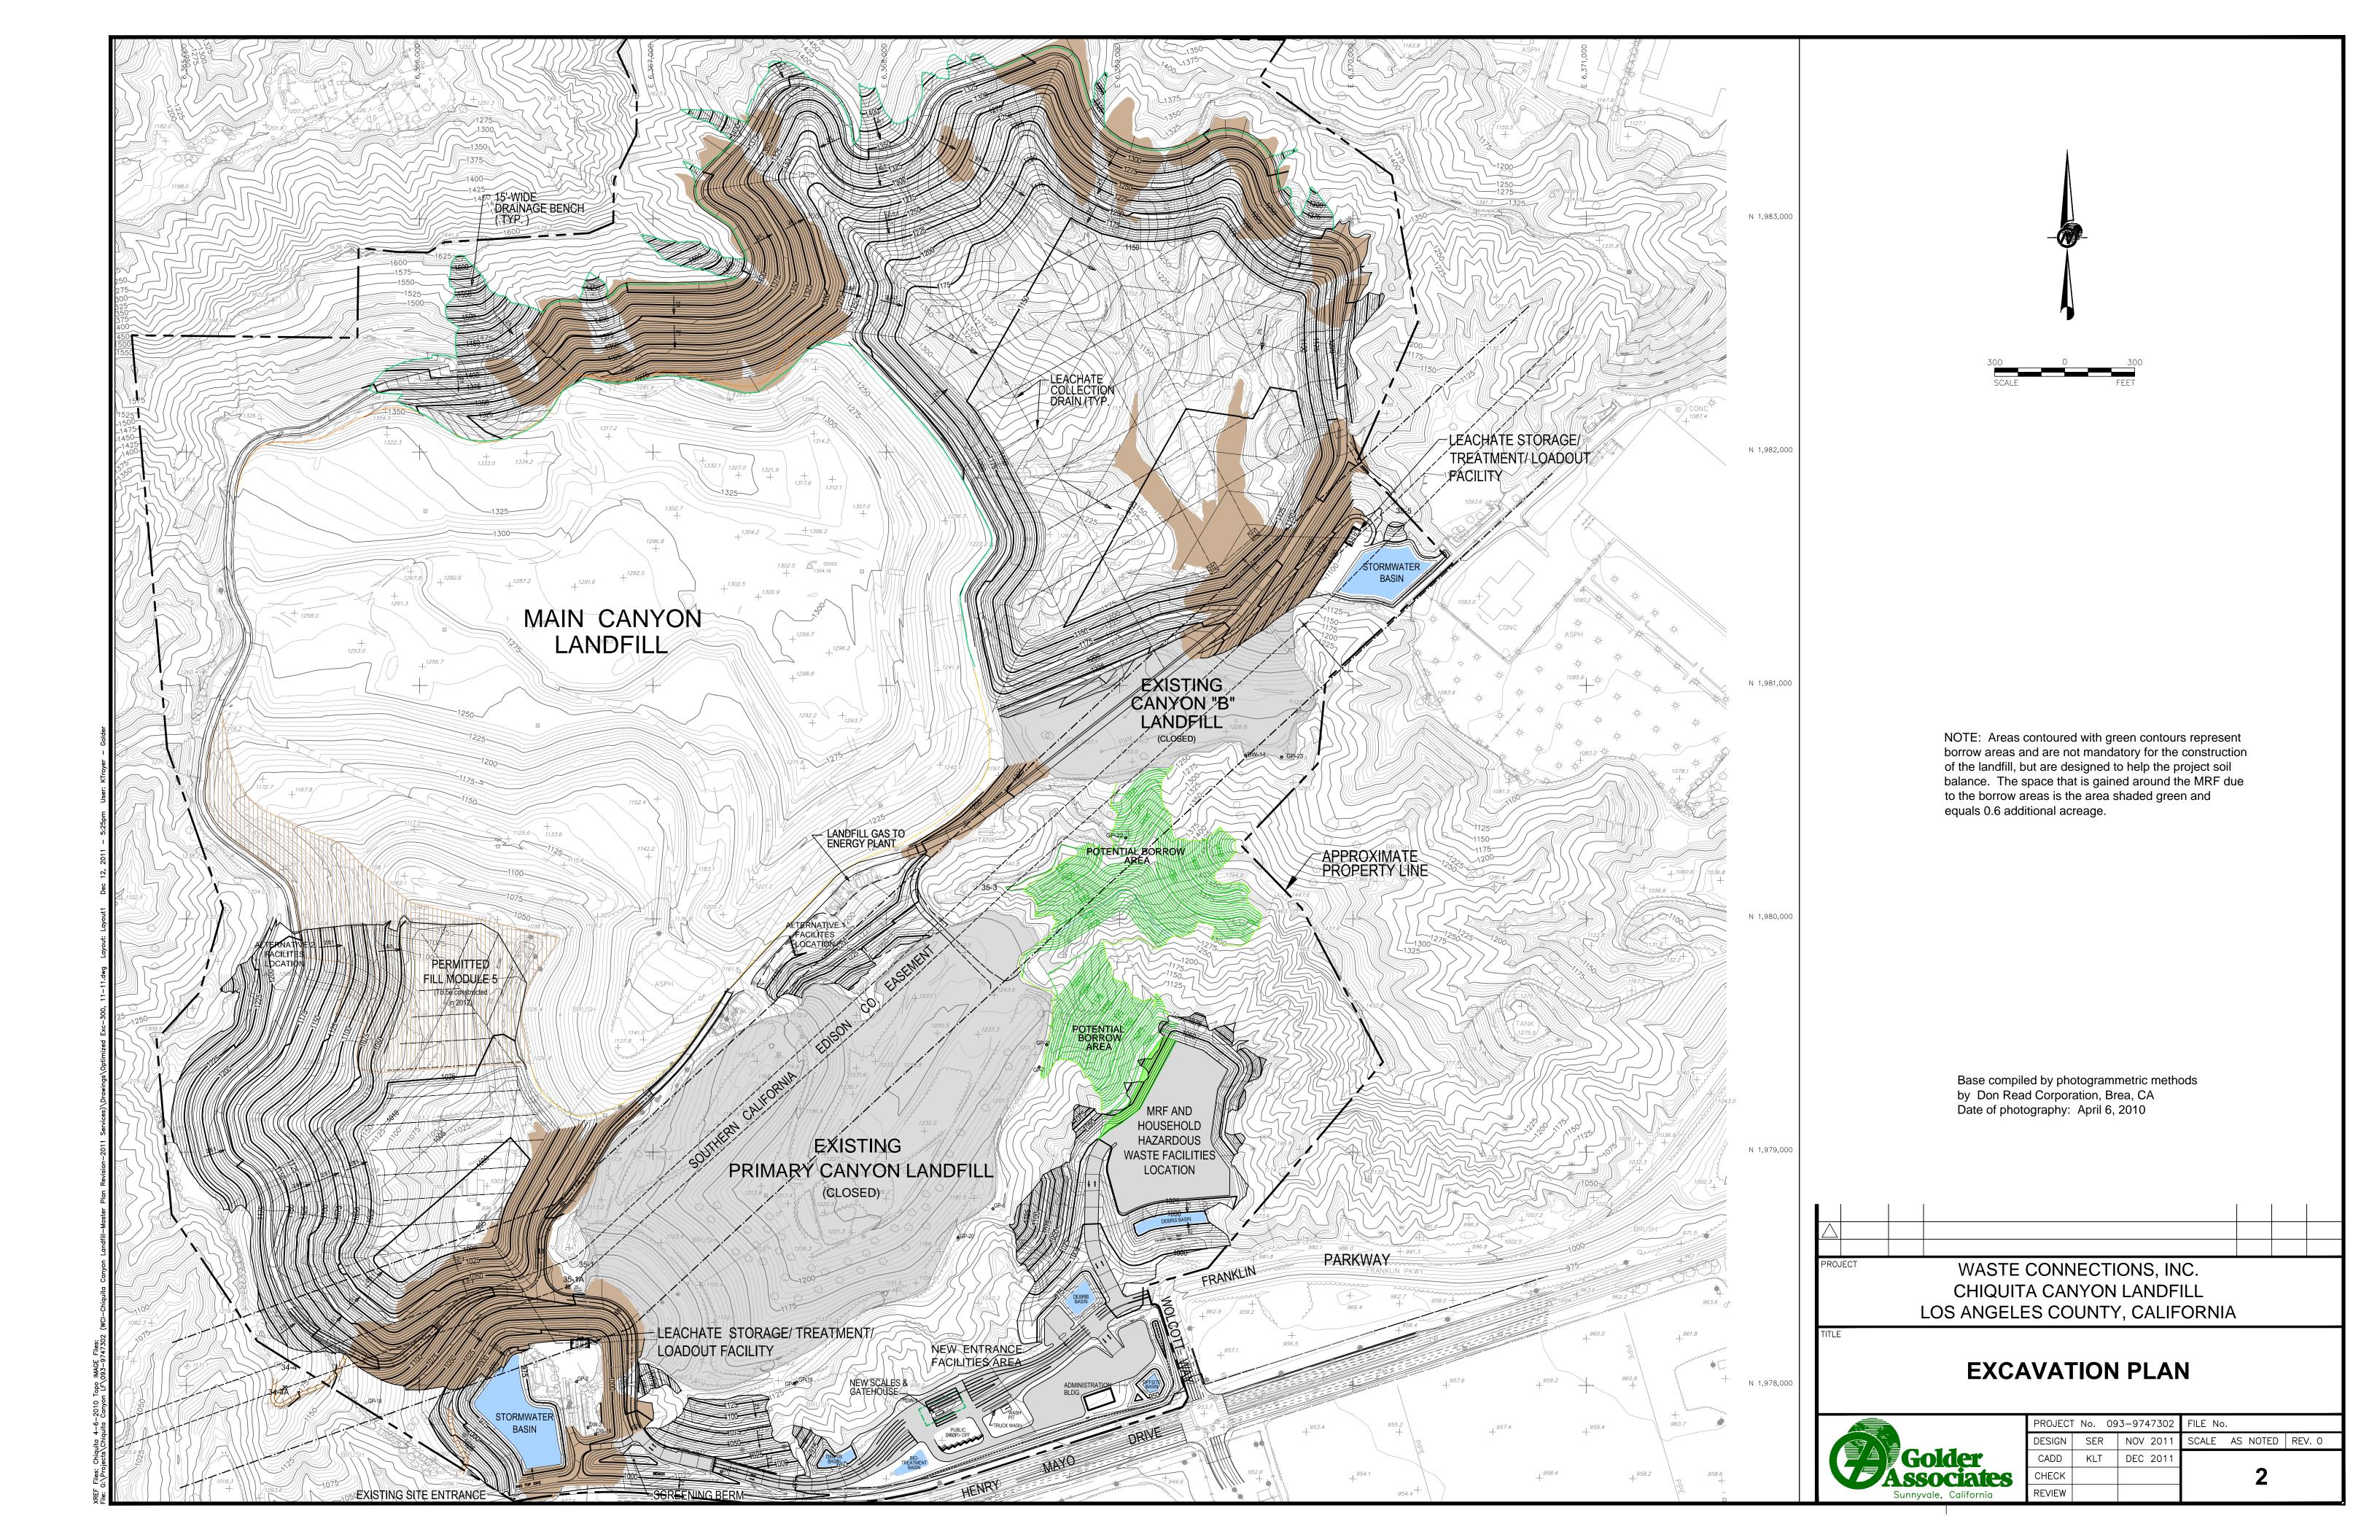
# **EXCAVATION PLAN (GOLDER ASSOCIATES, NOVEMBER 2011)**

Our report incorporates the latest Golder Associates (Golder) Excavation Plan, dated November 2011. This geotechnical report supersedes our August 12, 2011 report, which was based on Golder's April 2011 plan.

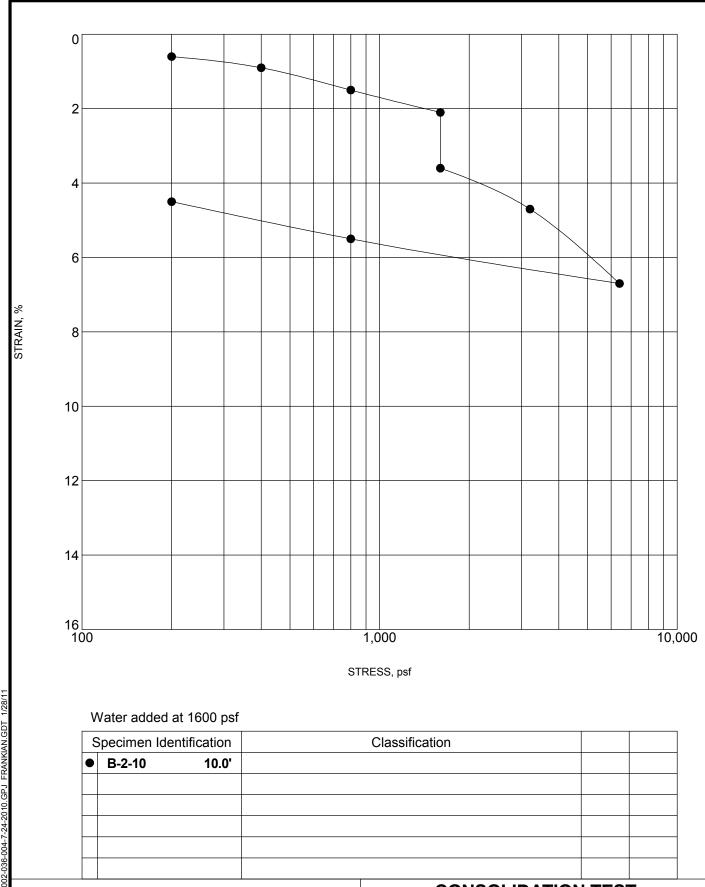
#### **CONSOLIDATION TEST**

Confined consolidation tests were performed on four undisturbed samples. Water was added during the tests to each of the samples to illustrate the effect of moisture on the compressibility. The results of the tests are presented on the Consolidation Test Data pages.

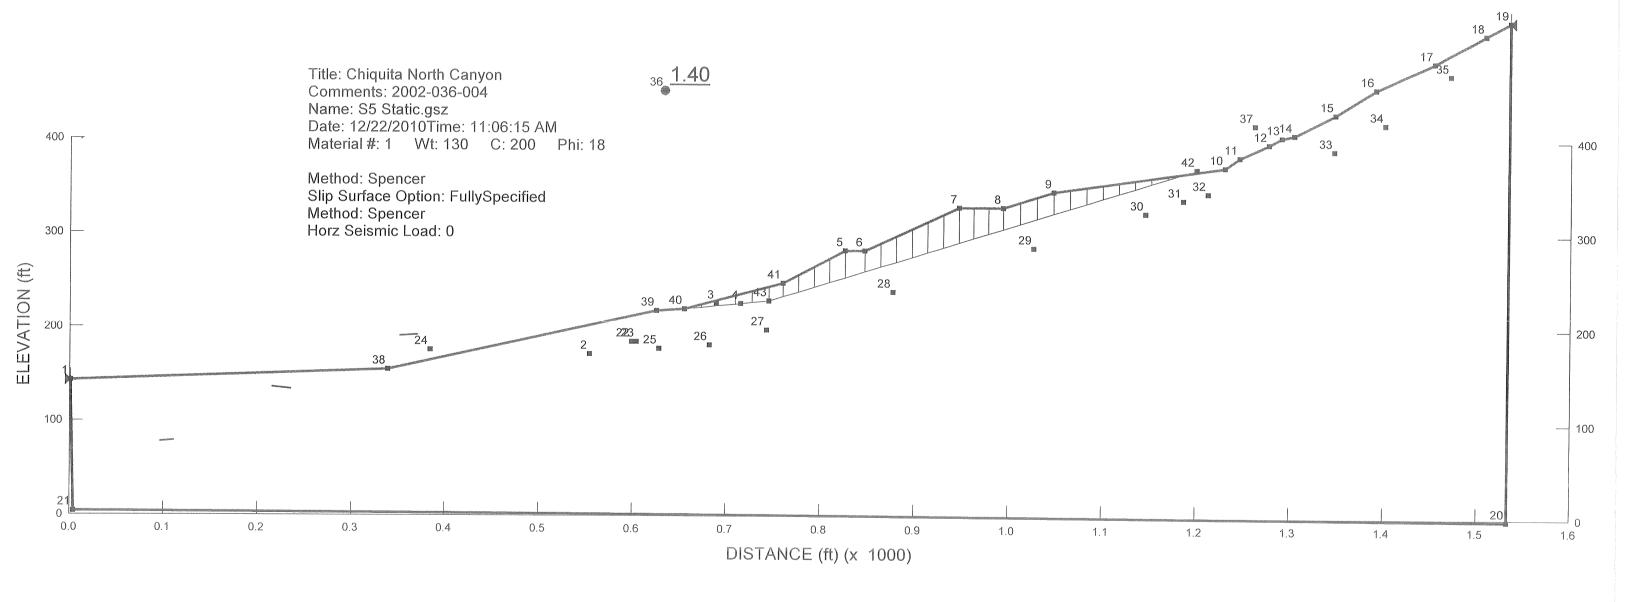
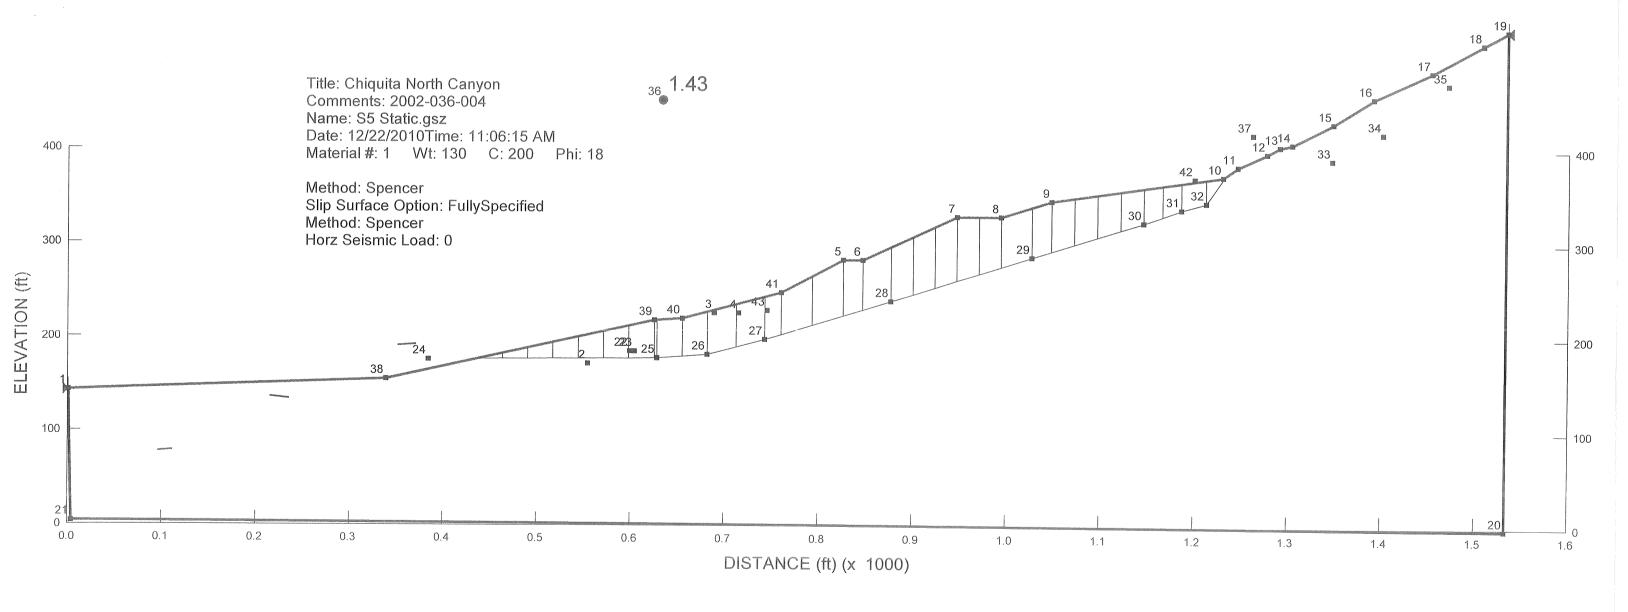
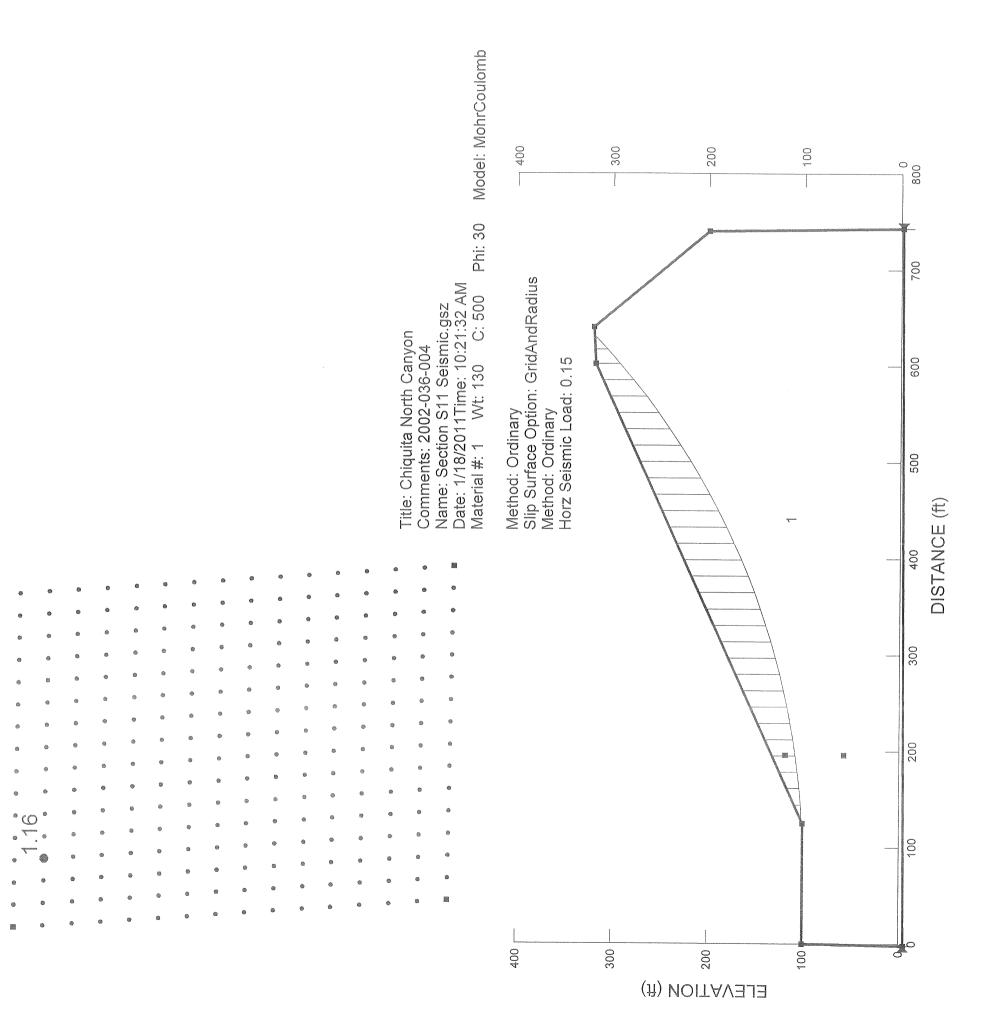
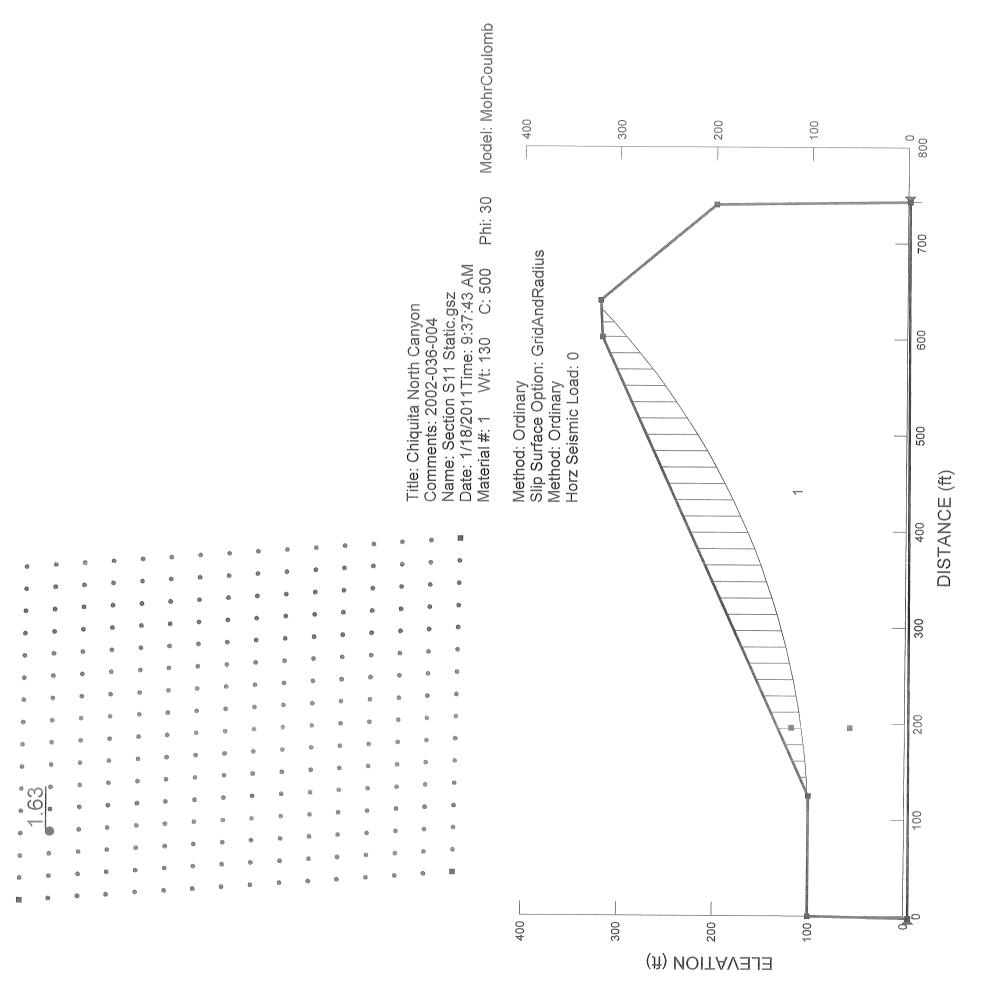
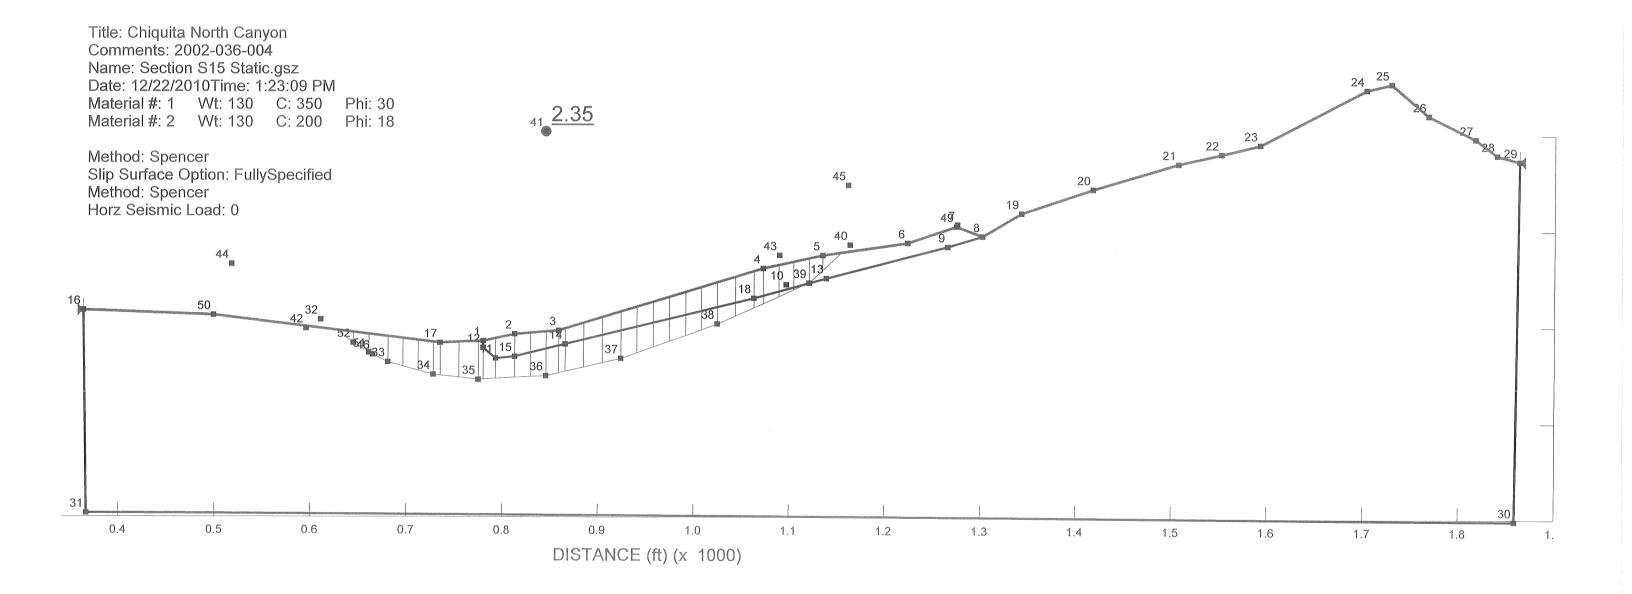
## APPENDIX D SLOPE STABILITY CALCULATIONS

## Summary of Slope Stability Calculations

Section	Case	File	Factor of Safety	Condition
S5	Static	S5 Static.gsz	1.4	Bedding through 1st bench
S5	Static	S5 Static.gsz	1.43	Bedding between toe & 1st bench
S11	Static	S11 Static.gsz	1.63	Tp Cross Bedding Failure
S11	Seismic	S11 Seismic.gsz	1.16	Tp Cross Bedding Failure
S15	Static	S15 Static.gsz	2.35	Failure along bedding
S17	Static	S17 Static.gsz	1.31	Bedding above first bench
S17	Static	S17 Static.gsz	1.41	Bedding near toe
S17	Static	S17 Static.gsz	1.42	Bedding below 1st bench
S19	Static	Section S19 Static.gsz	1.58	Bedding above first bench
S19	Static	Section S19 Static.gsz	1.32	Bedding between 1st and 2nd bench
S19	Static	Section S19 Static.gsz	1.29	Bedding above 2nd Bench
S20	Static	S20 Static.gsz	1.34	Bedding near toe
S23	Static	S23 Static.gsz	1.5	Bedding near toe
S25	Static	S25 Static.gsz	1.25	Bedding below 2nd bench
N/A	Static	130' Fill Slope Static.gsz	1.56	130' High 2:1 Slope
N/A	Seismic	130' Fill Slope Static.gsz	1.14	130' High 2:1 Slope

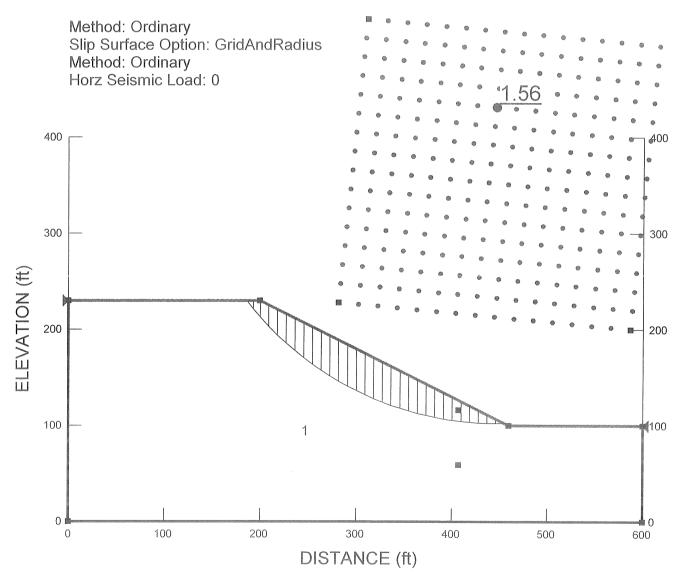
Title: Chiquita North Canyon Comments: 130' High, 2:1 Compacted Fill Slope Name: 130' Fill Slope Seismic.gsz Date: 1/18/2011Time: 10:14:07 AM

Material #: 1 Wt: 130 C: 350 Phi: 30 Model: MohrCoulomb
