CONSOLIDATED SEWER MAINTENANCE DISTRICT CONDITION ASSESSMENT PROGRAM REPORT PROJECT Y0TV0506D

**CONDITION ASSESSMENT REPORT
COUNTY OF LOS ANGELES DEPARTMENT OF PUBLIC WORKS
CONSOLIDATED SEWER MAINTENANCE DISTRICT**

As part of the Sewer Condition Assessment Program, the County of Los Angeles Department of Public Works Consolidated Sewer Maintenance District has completed the closed-circuit television (CCTV) inspection of 55,122 feet or 10.7 percent of the City of San Dimas' sewer system.

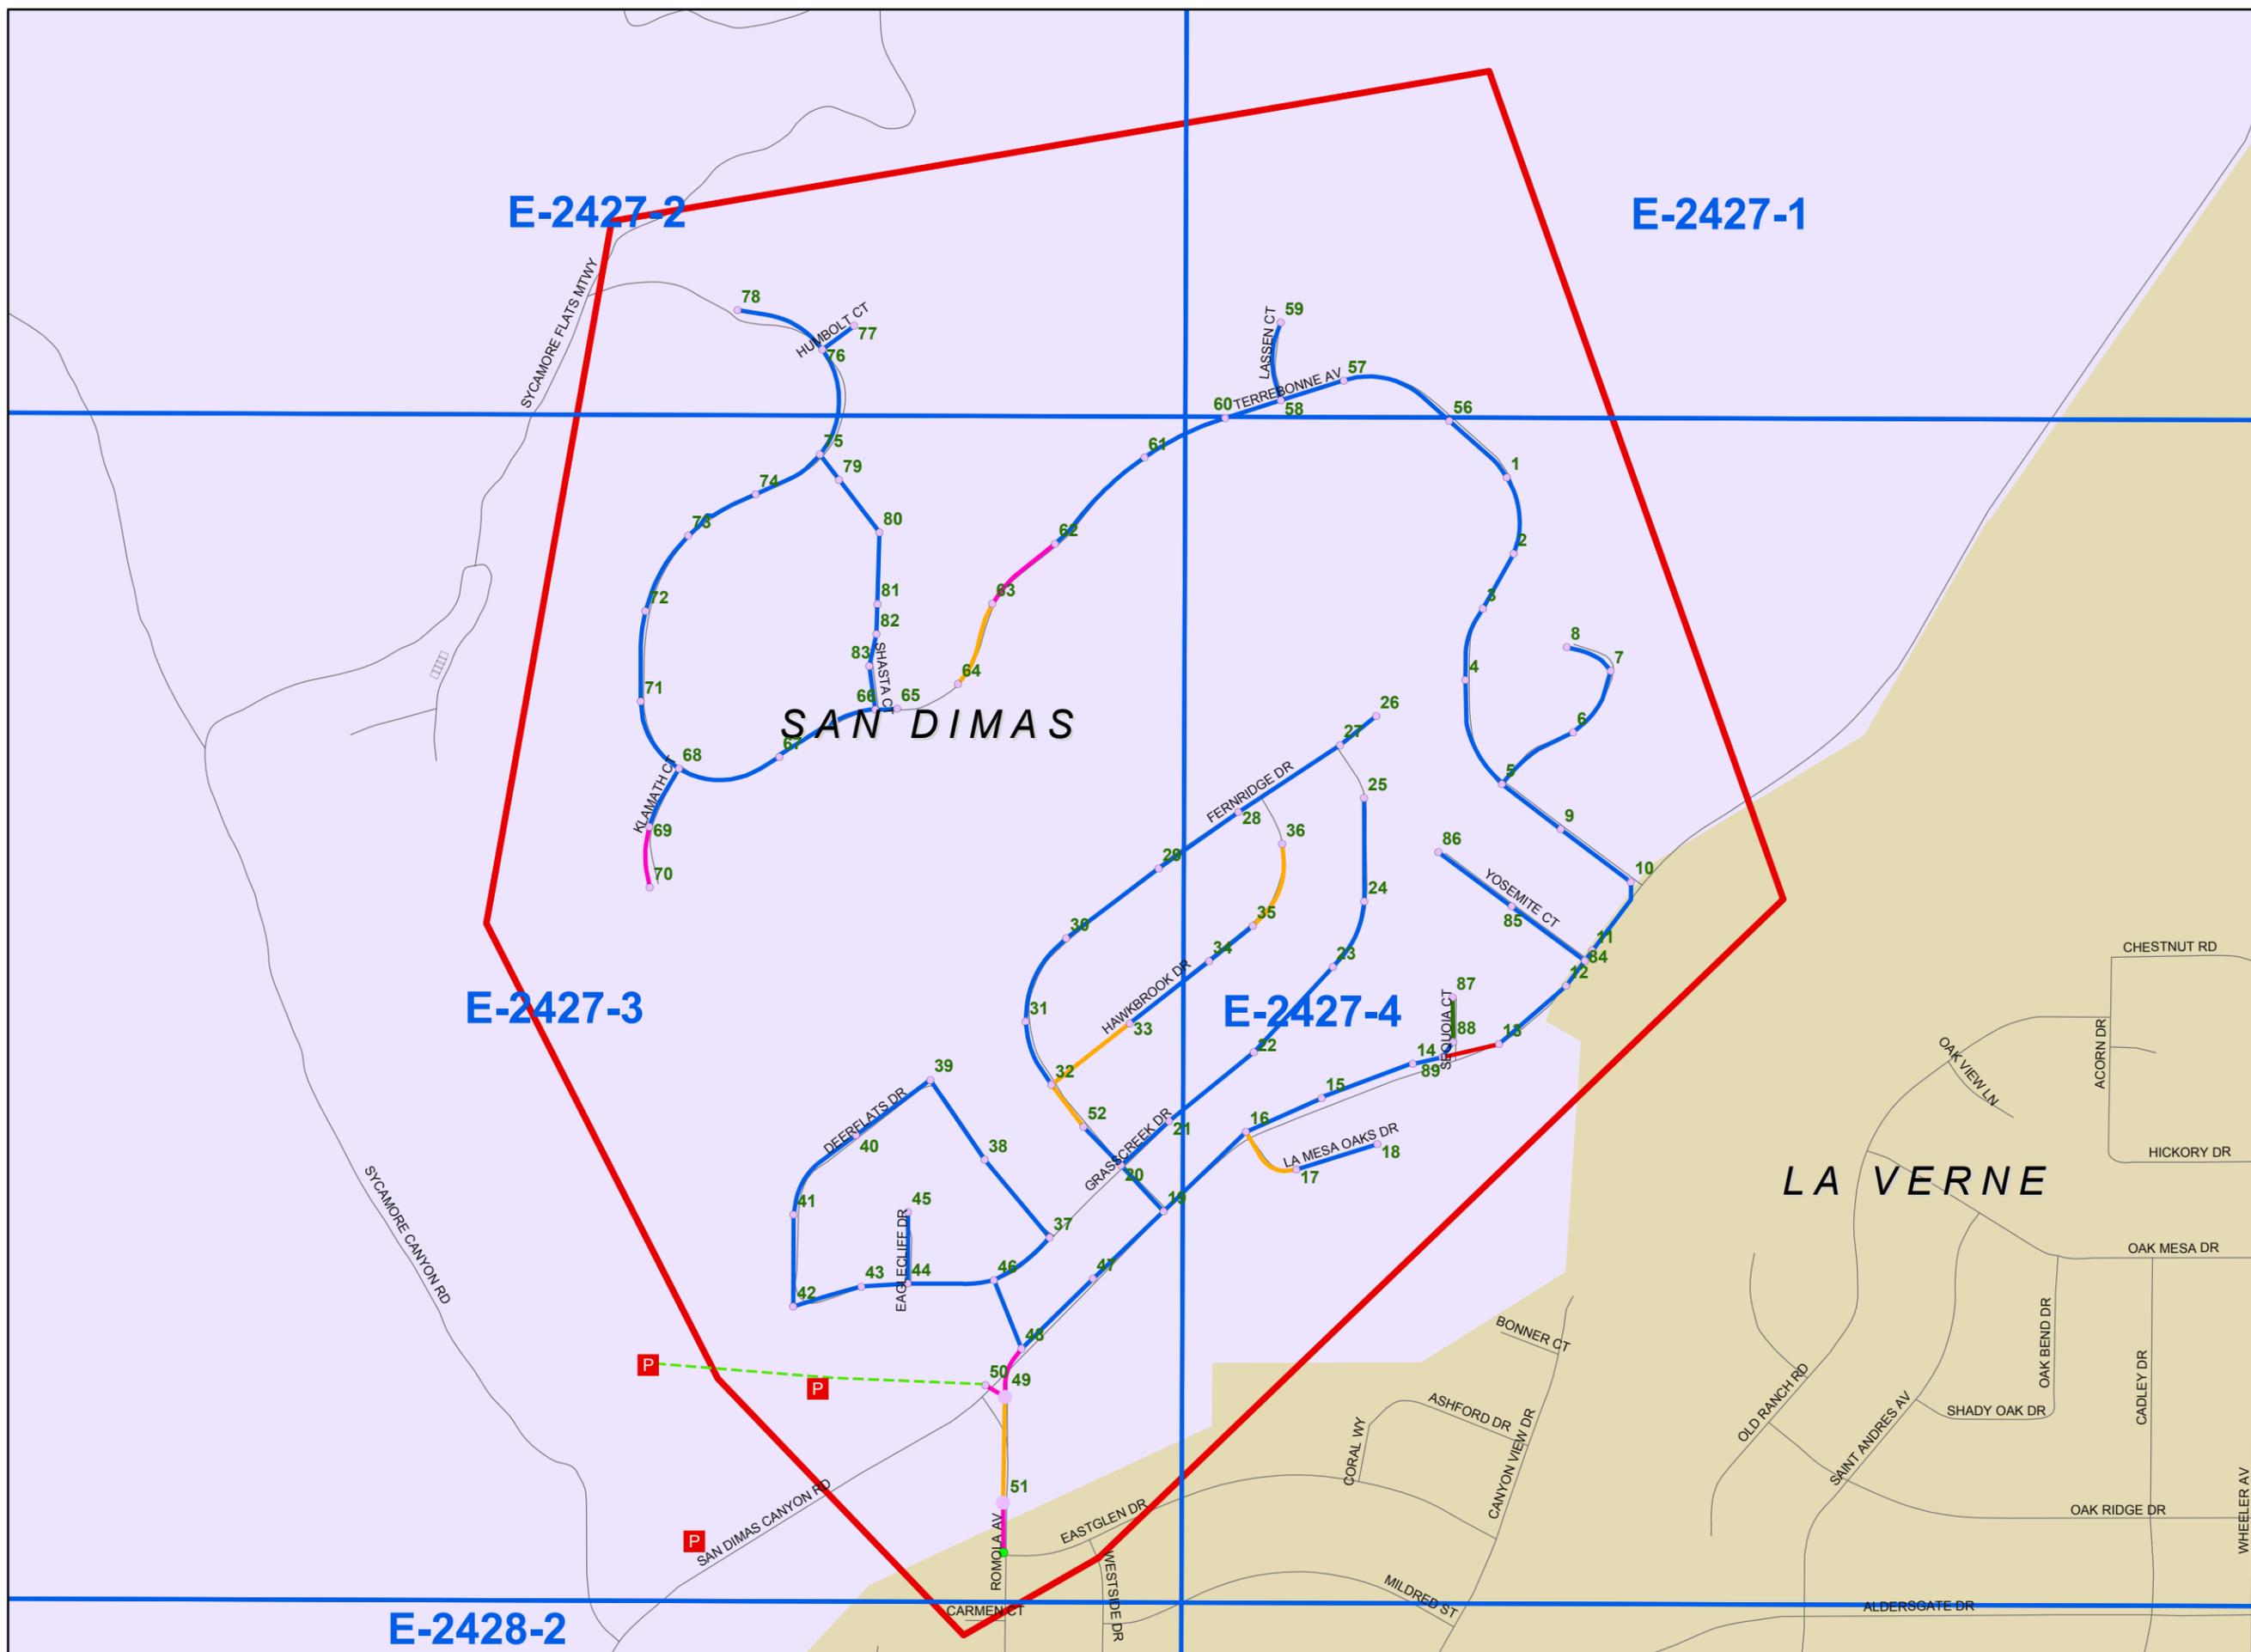
- Quick Maintenance Rating Report
Priority List
- Quick Maintenance Rating Map

Our inspection revealed that approximately 95.0 percent of the system televised was free of blockages or restrictions that would impede sewer flows. However, the remaining 5.0 percent of the inspected pipe segments within the City of San Dimas area had a PACP maintenance grade of 4 or 5 as indicated in the Quick Maintenance Rating Table shown below. These segments have been incorporated into our routine cleaning schedule with corrective action taken as noted on the Quick Maintenance Rating Report Priority List (Enclosure 2). Also included is a color-coded map showing the quick maintenance rating for each pipe segment.

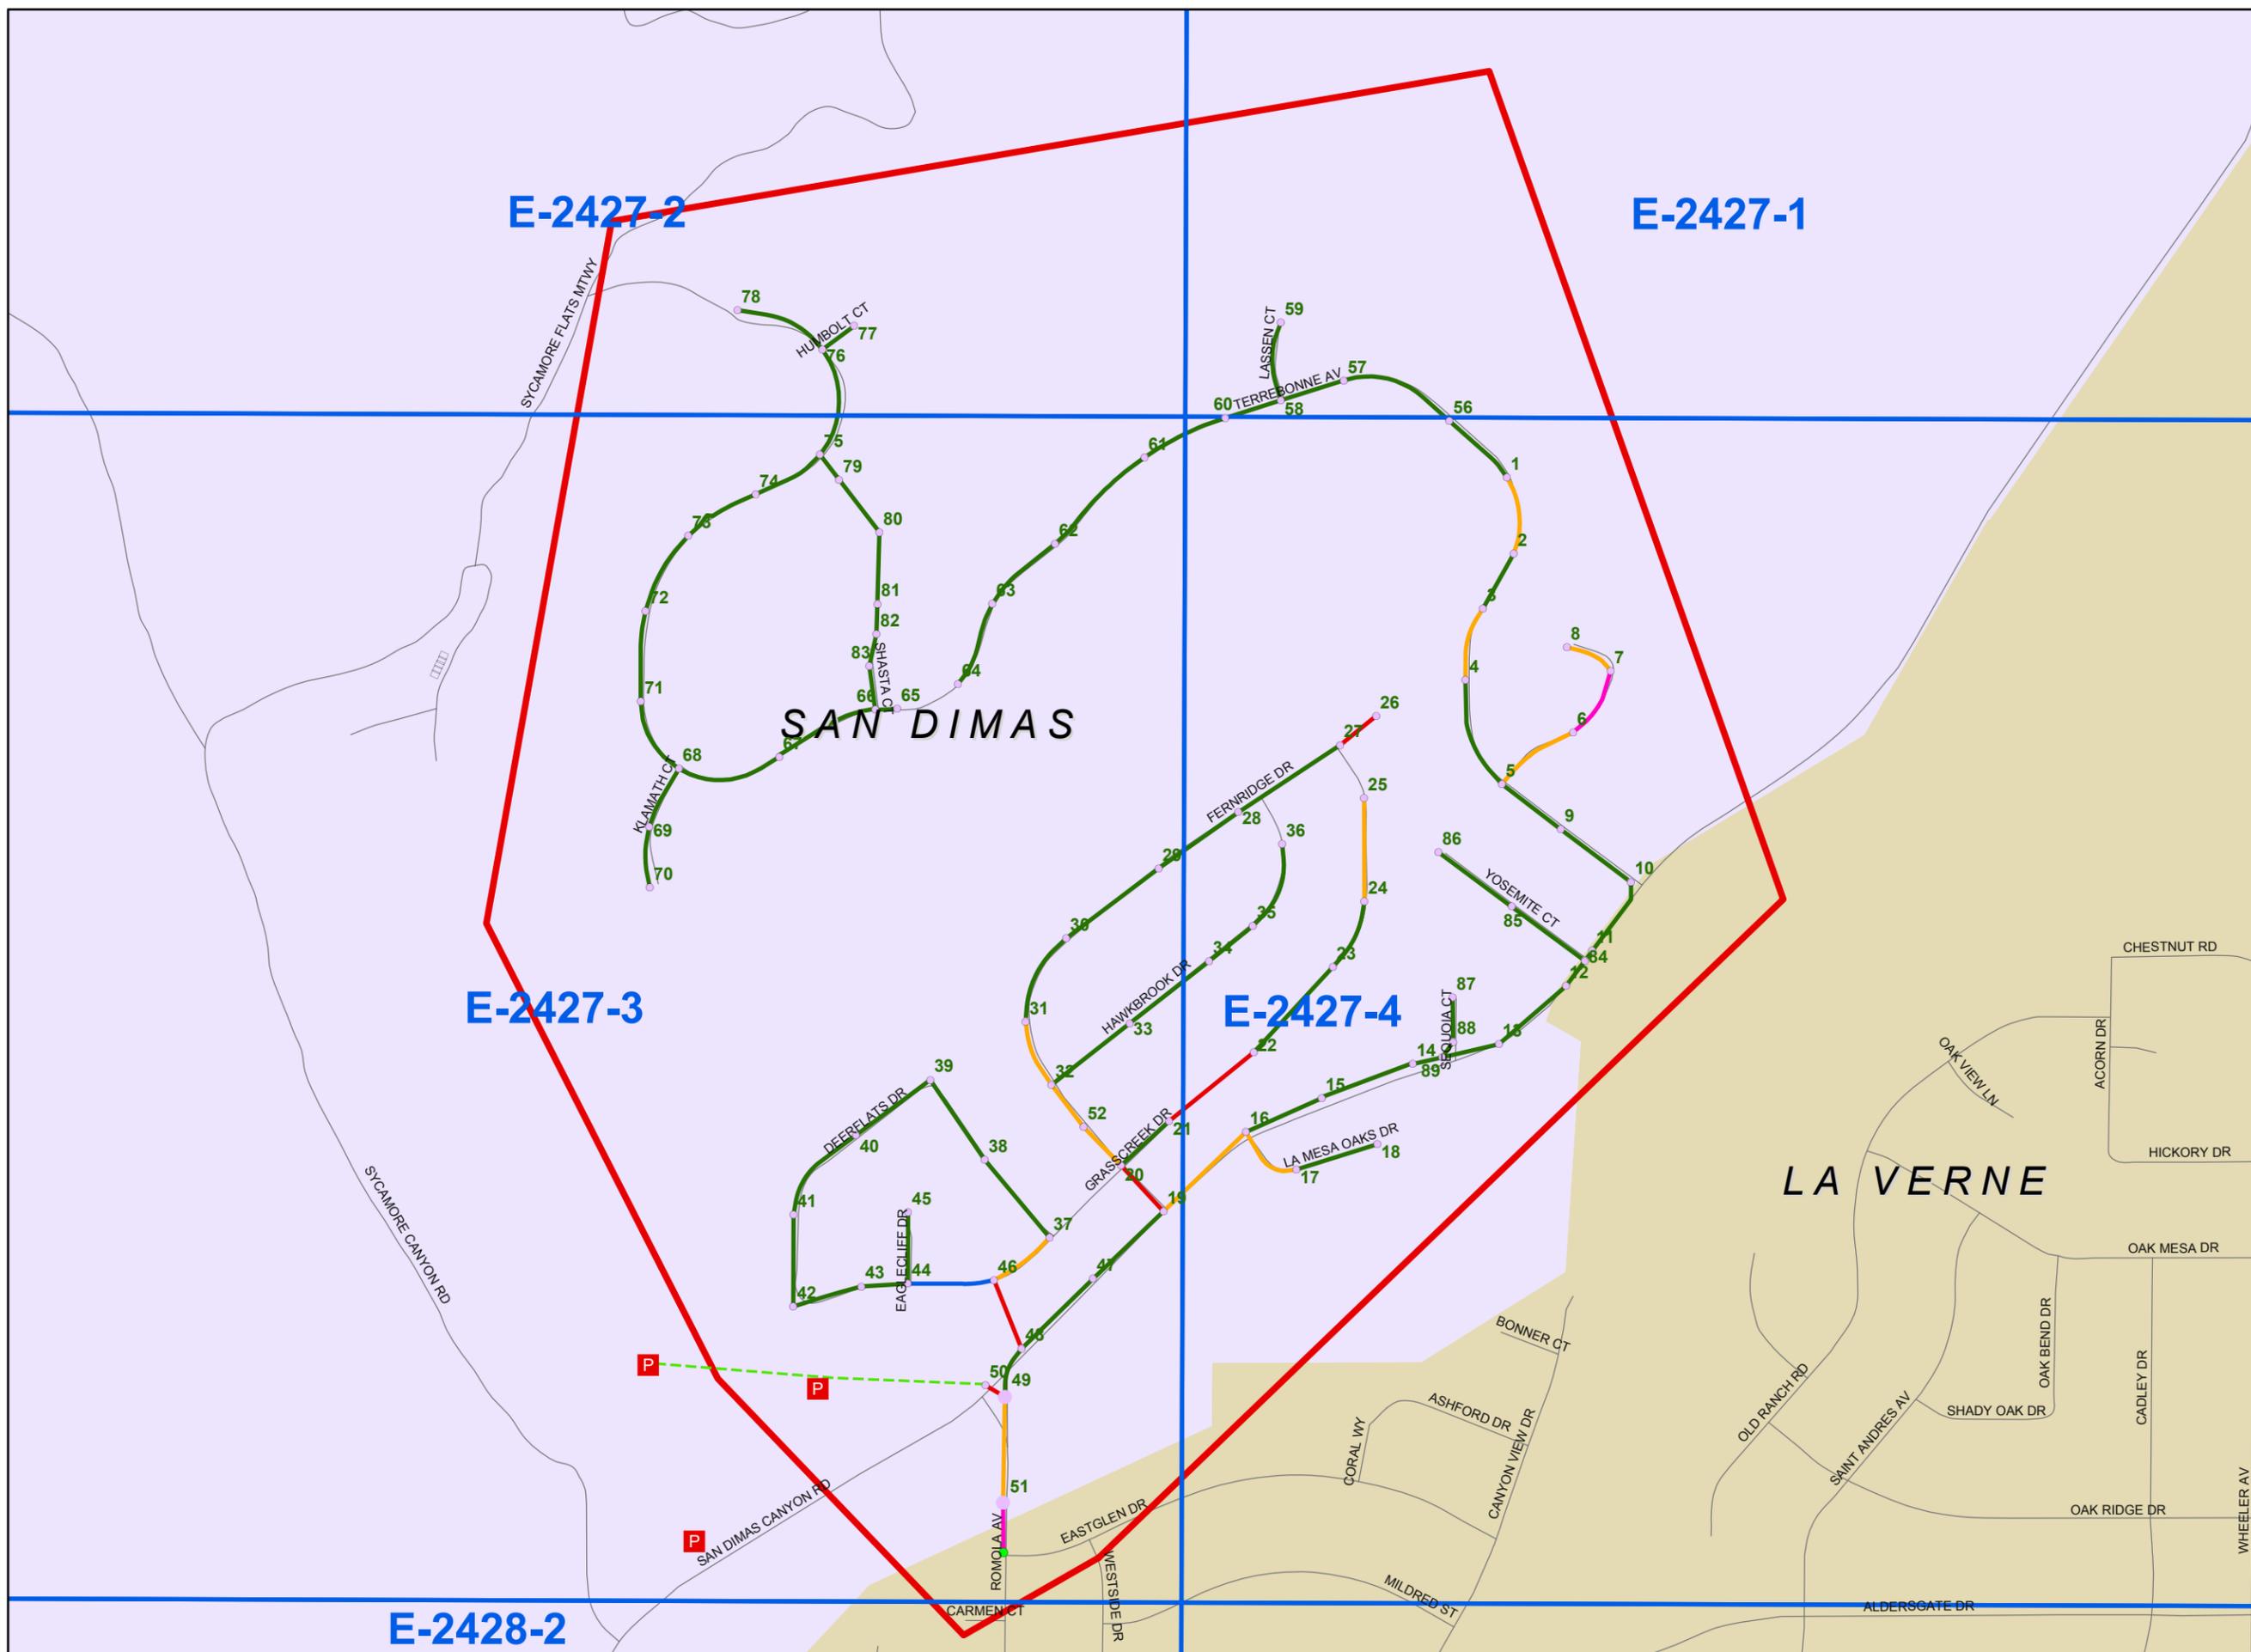
- Quick Structural Rating Report
Priority List
- Quick Structural Rating Map

Our inspection revealed that approximately 95.8 percent of the inspected pipe segments within the City of San Dimas were free of severe structural defects. However, the remaining 4.2 percent of the inspected pipe segments had a PACP structural grade of 4 or 5 as indicated in the Quick Structural Rating Table shown below. These segments have been placed on a priority list based on the severity and the need for action. For Items 1 through 10 in the Quick Structural Rating Report Priority List (Enclosure 3) which require a corrective action, the proposed corrective method will be scheduled in the next 24 months as part of the ongoing Accumulative Capital Outlay Project. A color-coded map showing the Quick Structural Rating for each pipe segment is located in Enclosure 3. Copies of the actual inspection reports for these ten segments are included in Enclosure 4.
