ASBESTOS & LEAD-BASED PAINT INSPECTION REPORT

CAMP GLENN ROCKEY DETENTION FACILITY

1900 Sycamore Canyon Road
San Dimas, California 91773

Inspection Date: July 20 - 22, 2020
ENCORP PROJECT NUMBER P20237.L34

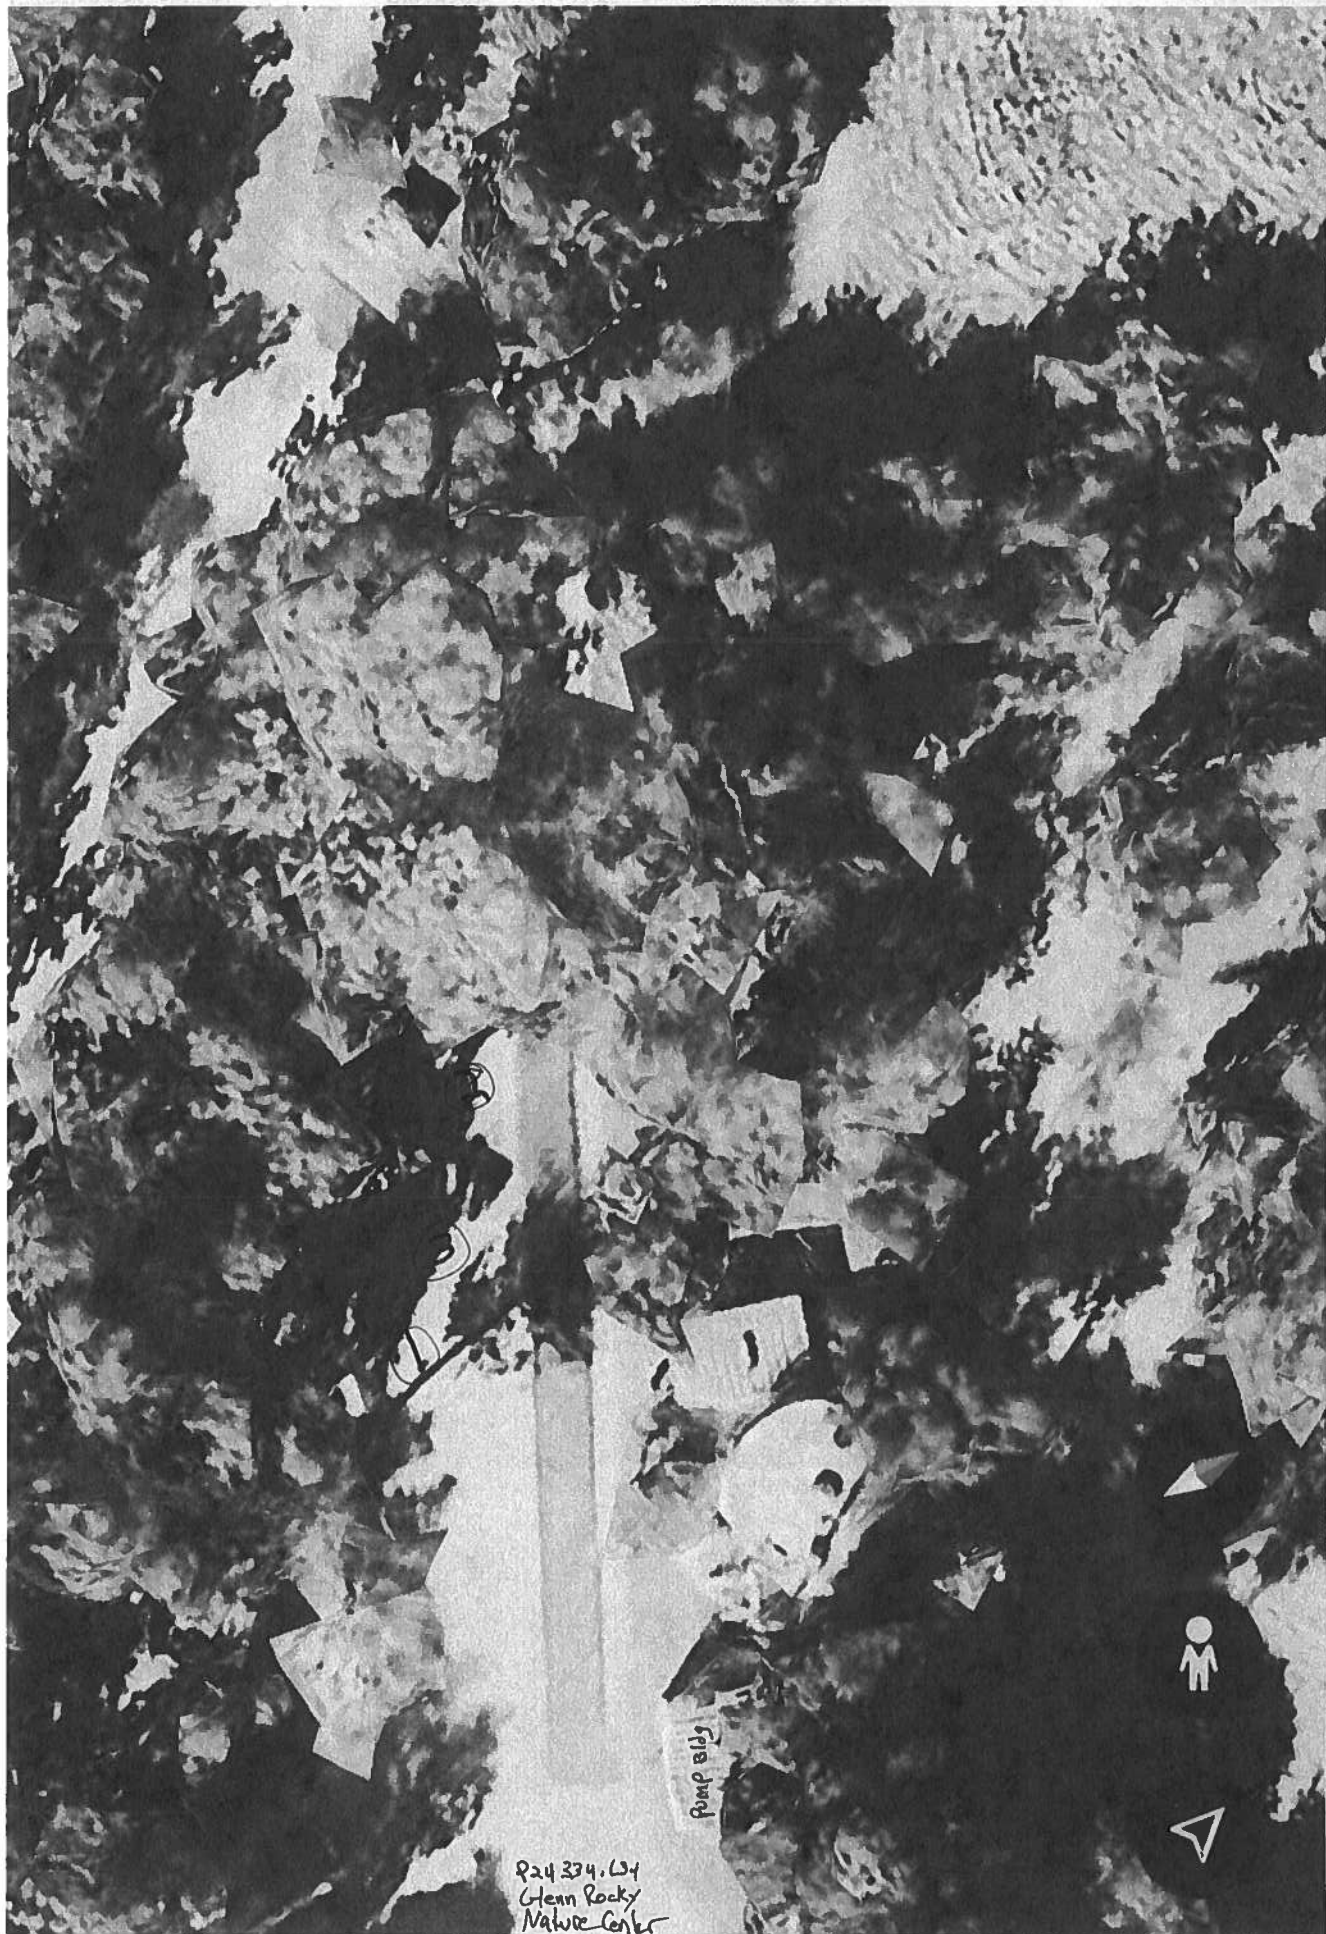
P24 334.634
Glenn Rocky
Nature Center
7/30/24

Pump Bldg
