## **Attachment N**

Closure and Post-Closure Plans

## 9. PRELIMINARY CLOSURE AND POST-CLOSURE PLANS

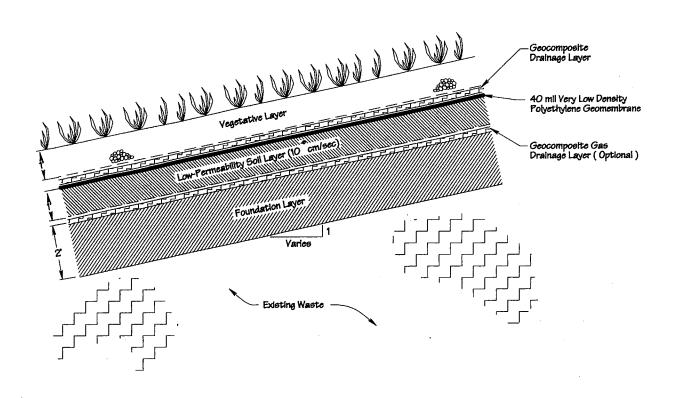
Final Cover System

A-MEHR, INC.	JID Pigures
SECURIE Count has began little Calledon County (140) 200-0187	- RM
Sunsitine Carryon County Extension Landfill	AM
Joint Technical Document	Jan 2006
Final Cover Cross-Section	nisure:
	9-2
