*** DAMAGE REPORT**

POLES OR STRUCTURES STRUCK BY VEHICLES

Location of Occurrence N/E CORNER OF MOUNTAIN VIEW DR, CALABASAS District THOUSAND OAKS

Pole No. 4744974E Height 30 Date Set 03/19/2010 Kind of Pole EC Vis. Strips No

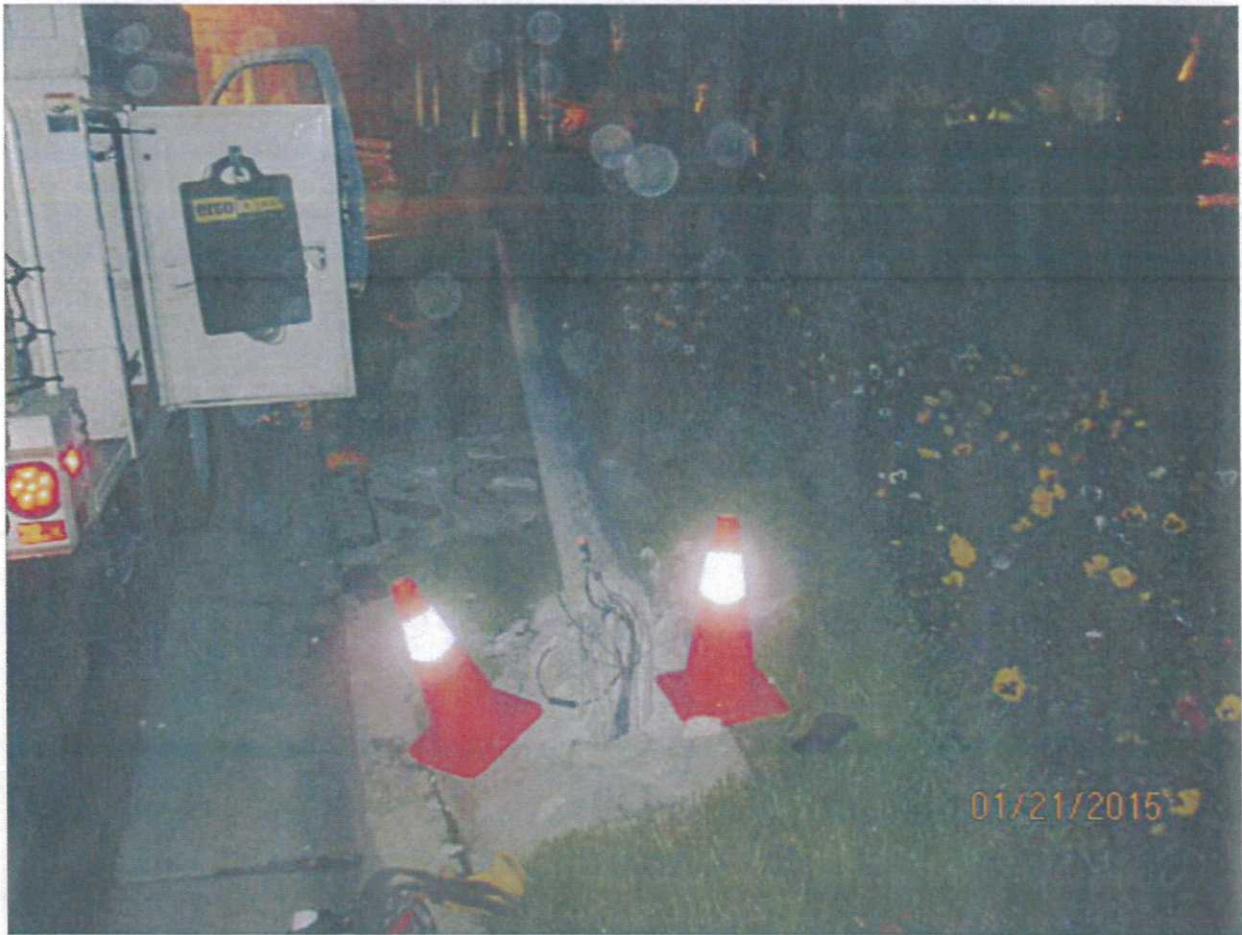
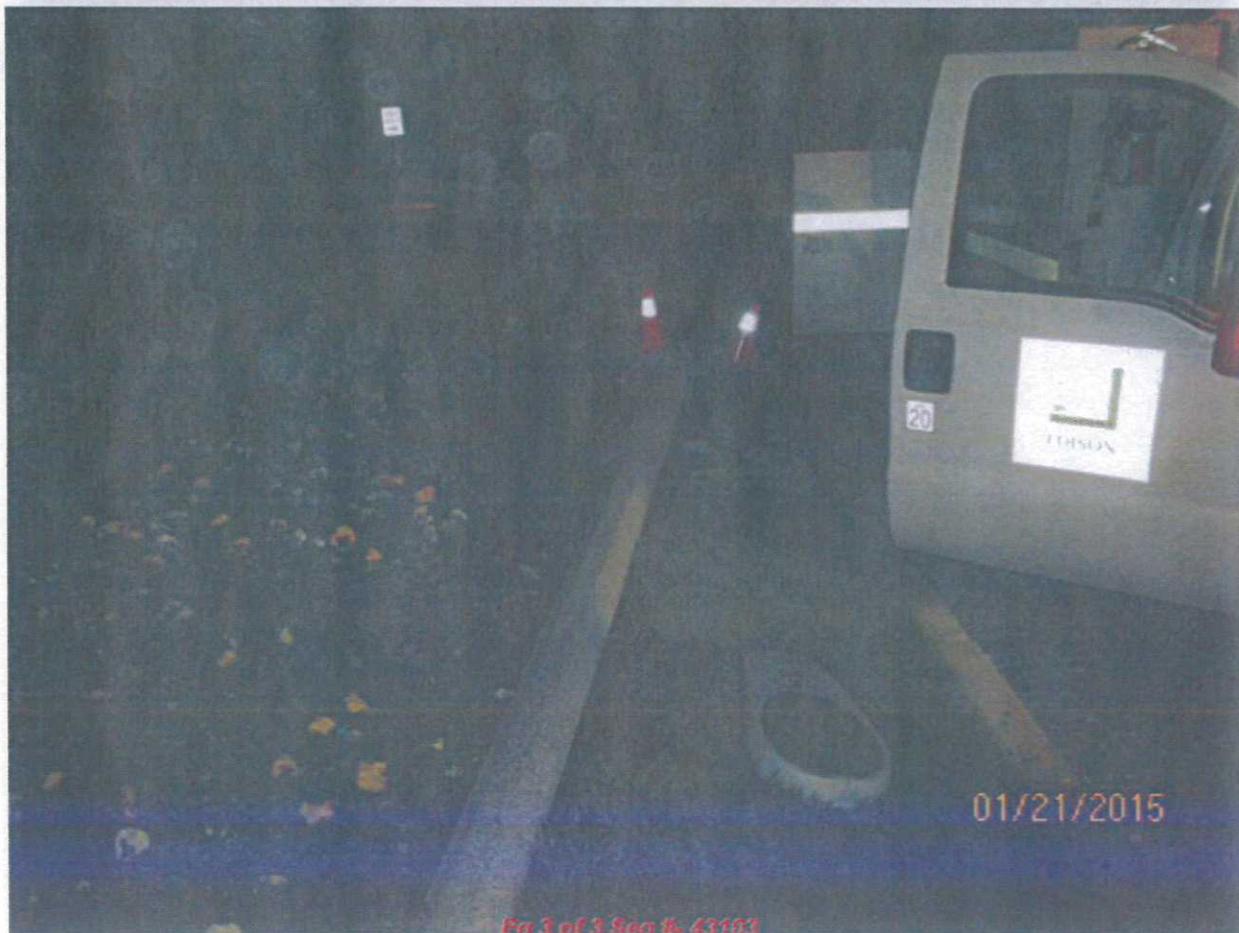
Damage to Pole BROKEN

Damage to Arms BROKEN

CALLED TO RESPOND TO CAR HIT POLE. FOUND STREETLIGHT ON GROUND. POLICE HAD LEFT THE SCENE AND VEHICLE WAS GONE PRIOR TO MY ARRIVAL

CAR HIT STREETLIGHT . CONDUCTOR SAFE AND INSTALLED HH OVER BASE.
