Memorandum

To: Christine Medak, USFWS
Project: Devil's Gate Reservoir Restoration Project
From: Lauren Simpson
Date: June 30, 2020

Subject: Weekly Least Bell's Vireo Survey and Noise Monitoring Summary for the Devil's Gate Reservoir Restoration Project; Week of June 22 – June 26, 2020

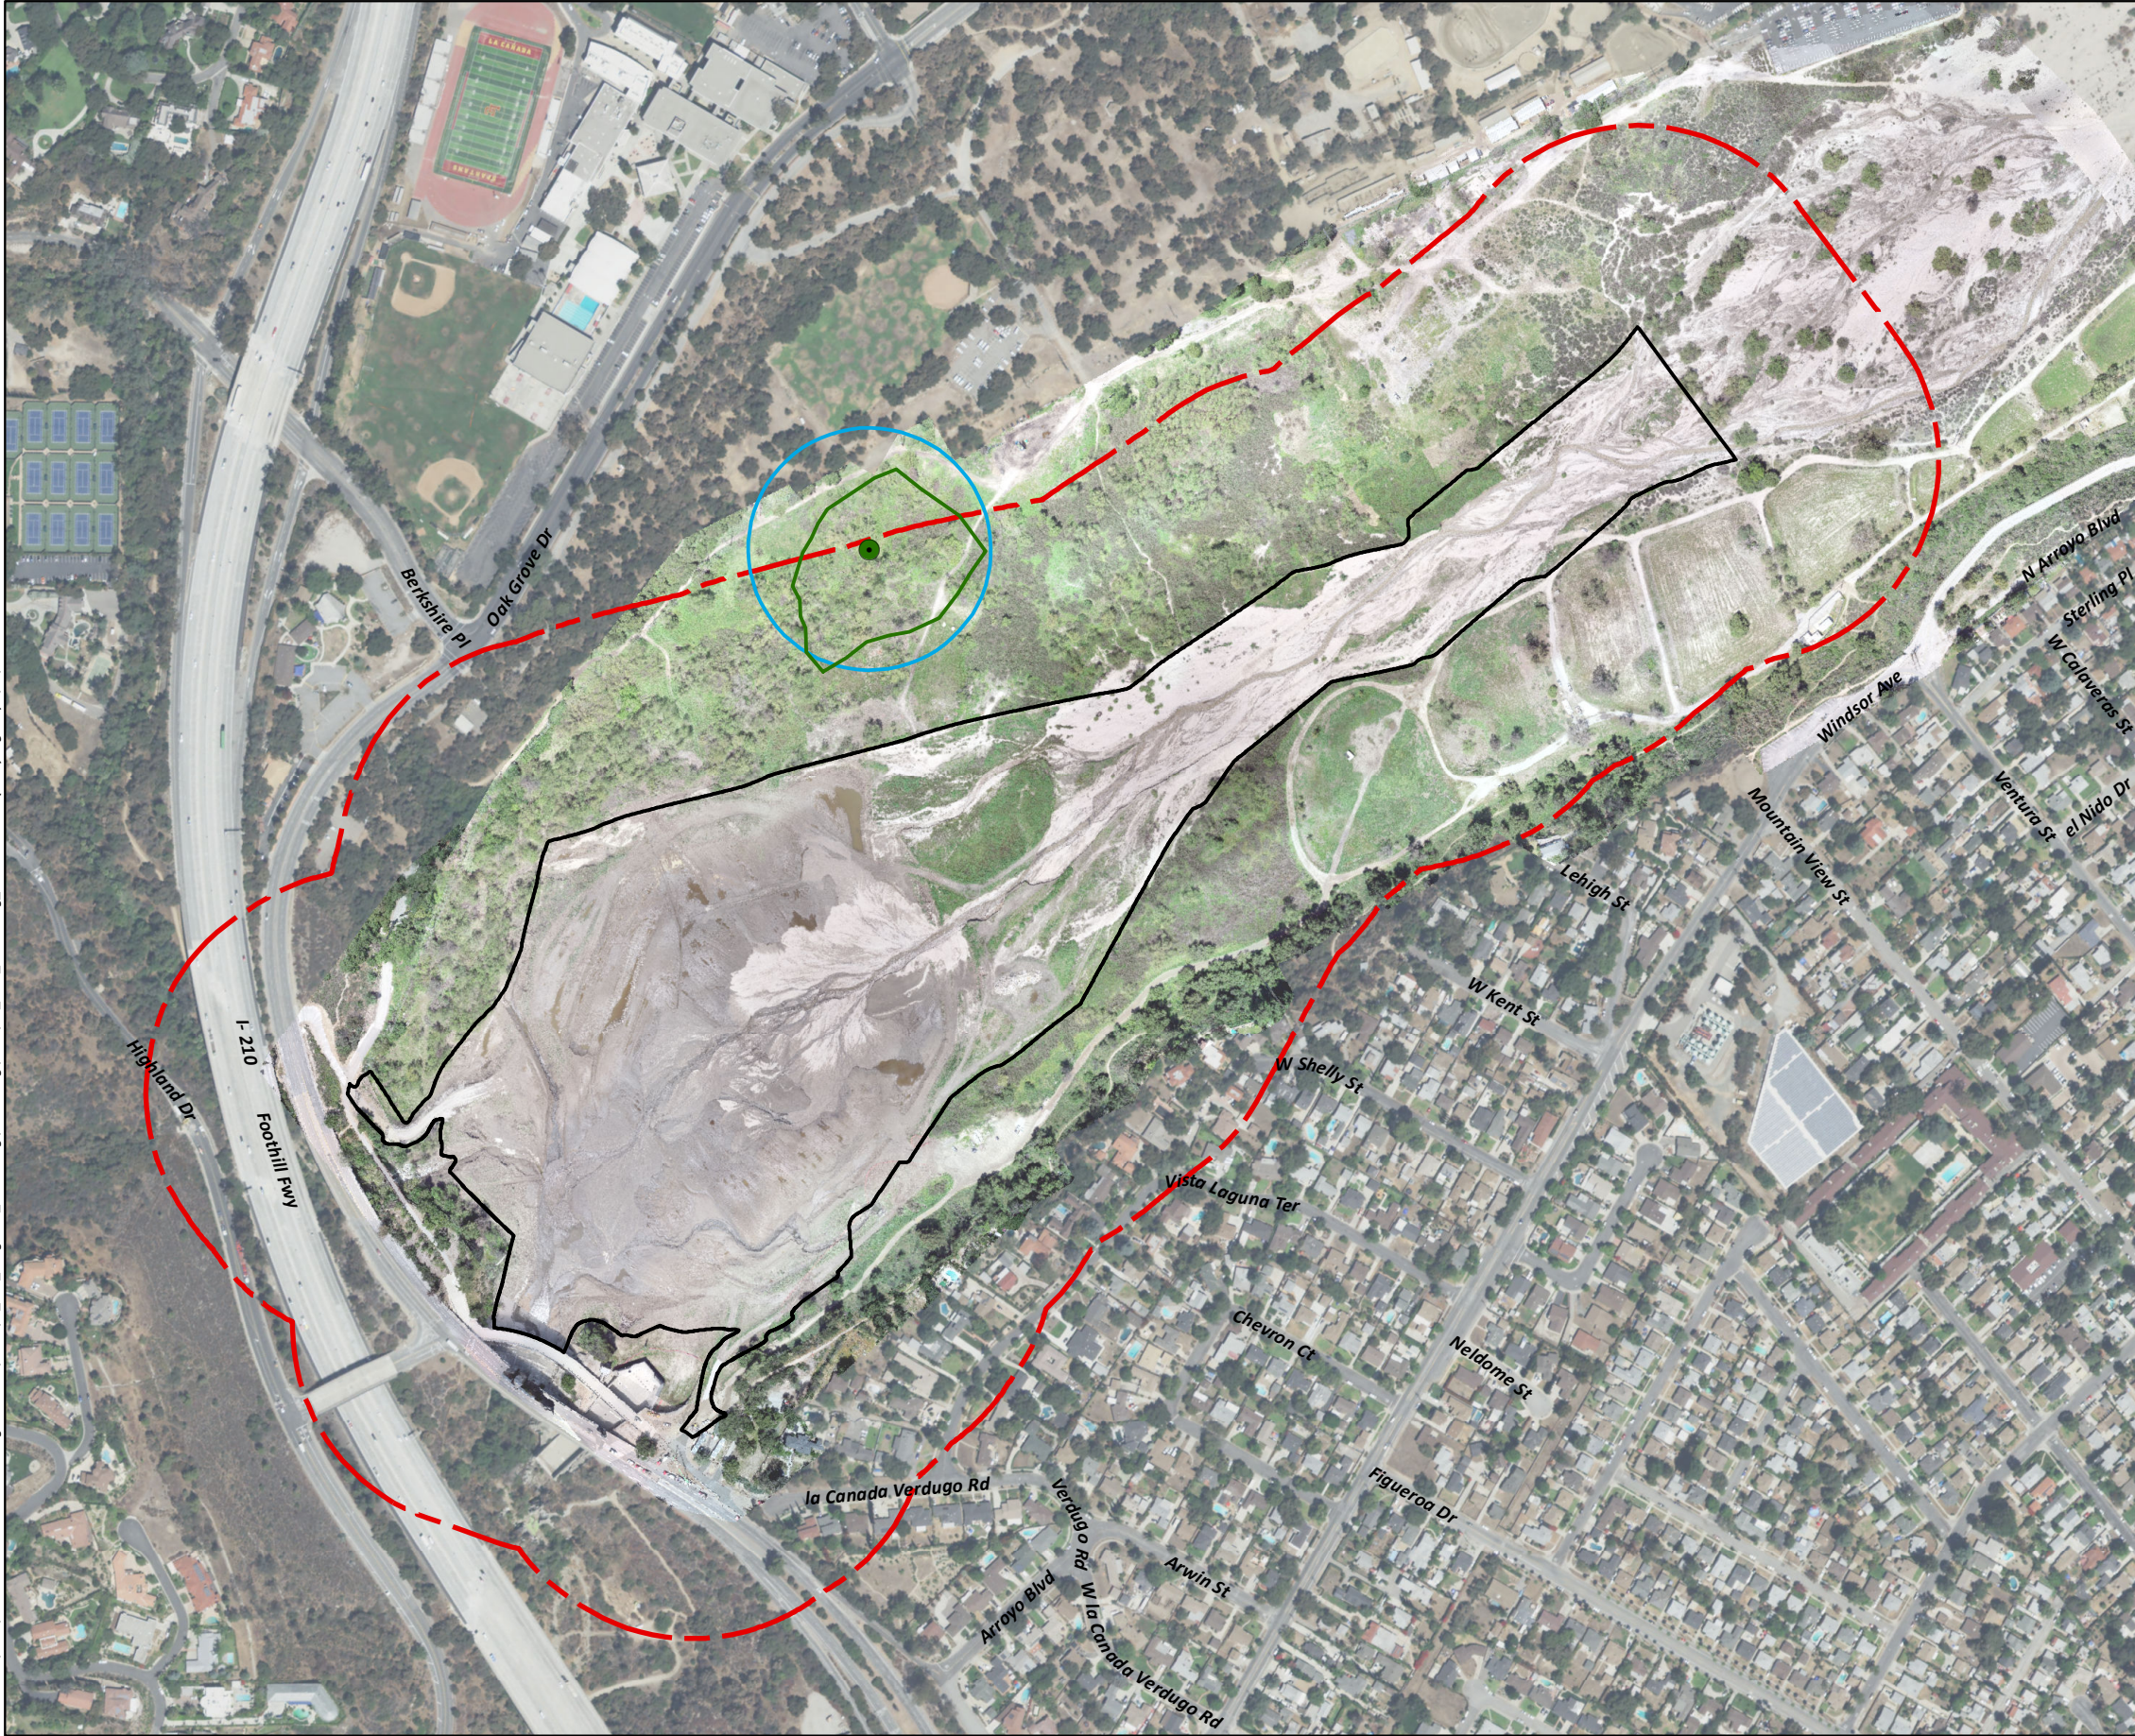
Figure 1.
Least Bell's Vireo Monitoring
June 22 - 26, 2020

The least Bell's vireos were documented during surveys conducted during the week of June 22, 2020. The location of the least Bell's vireo nest and territory are depicted in Attachment A. The male was observed singing within the previously documented territory. During the survey conducted on June 22, 2020, the Designated Biologist observed the pair feeding at least two fledglings. The least Bell's vireo were not observed and the male was not heard singing during the survey conducted on June 26, 2020. The reduced activity observed during surveys may indicate that the pair has completed breeding activities for the season. The 300-foot buffer will remain in place around the nesting location until the fledglings are independent of

Location of Least Bell's Vireo Nest and Territory

On-site restoration activities were ongoing during the week of June 22, 2020 and included the removal of non-native vegetation from on-site restoration areas using hand tools. No restoration activities occurred within the 300-foot buffer around the least Bell's vireo nest, which was enforced by the monitoring Designated Biologist.

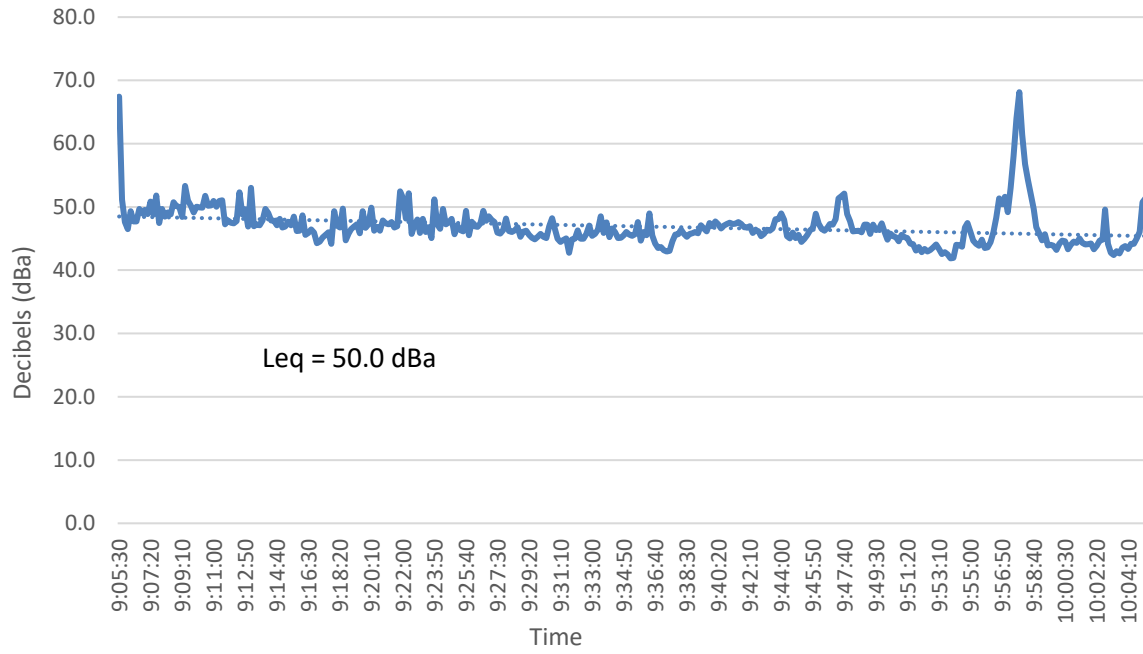
Devil's Gate Reservoir Restoration Project:
LBVI SM3 Leq June 24, 2020

Noise monitoring for the week of June 22, 2020 occurred on June 24, 2020. A noise monitoring station was established no less than 100 feet from the active least Bell's vireo nest under the direction of the least Bell's vireo Designated Biologist. Noise monitoring for Project activities occurred between 7:01 am and 2:58 pm. The monitor ensured that all construction hourly noise levels (Leq) remained below 60 dBa. All hourly Leq measurements were below 60 dBa during the noise monitoring (see Attachment B). Instances where noise levels momentarily exceeded 60 dBa were attributed to the movements of the noise monitor in close-proximity to the noise meter at the start of each hour to program the meter for hourly measurements and to low-flying helicopters that passed above the site regularly throughout the day due to the close proximity of a helicopter landing pad southeast of the Project site.
