**2013-2014 Wet Weather WQO Ratios
for S28 Dominguez Channel at Artesia Blvd.**

Figure 4-3.6 S28 Dominguez Channel at Artesia Blvd Wet Weather Ratio Plots

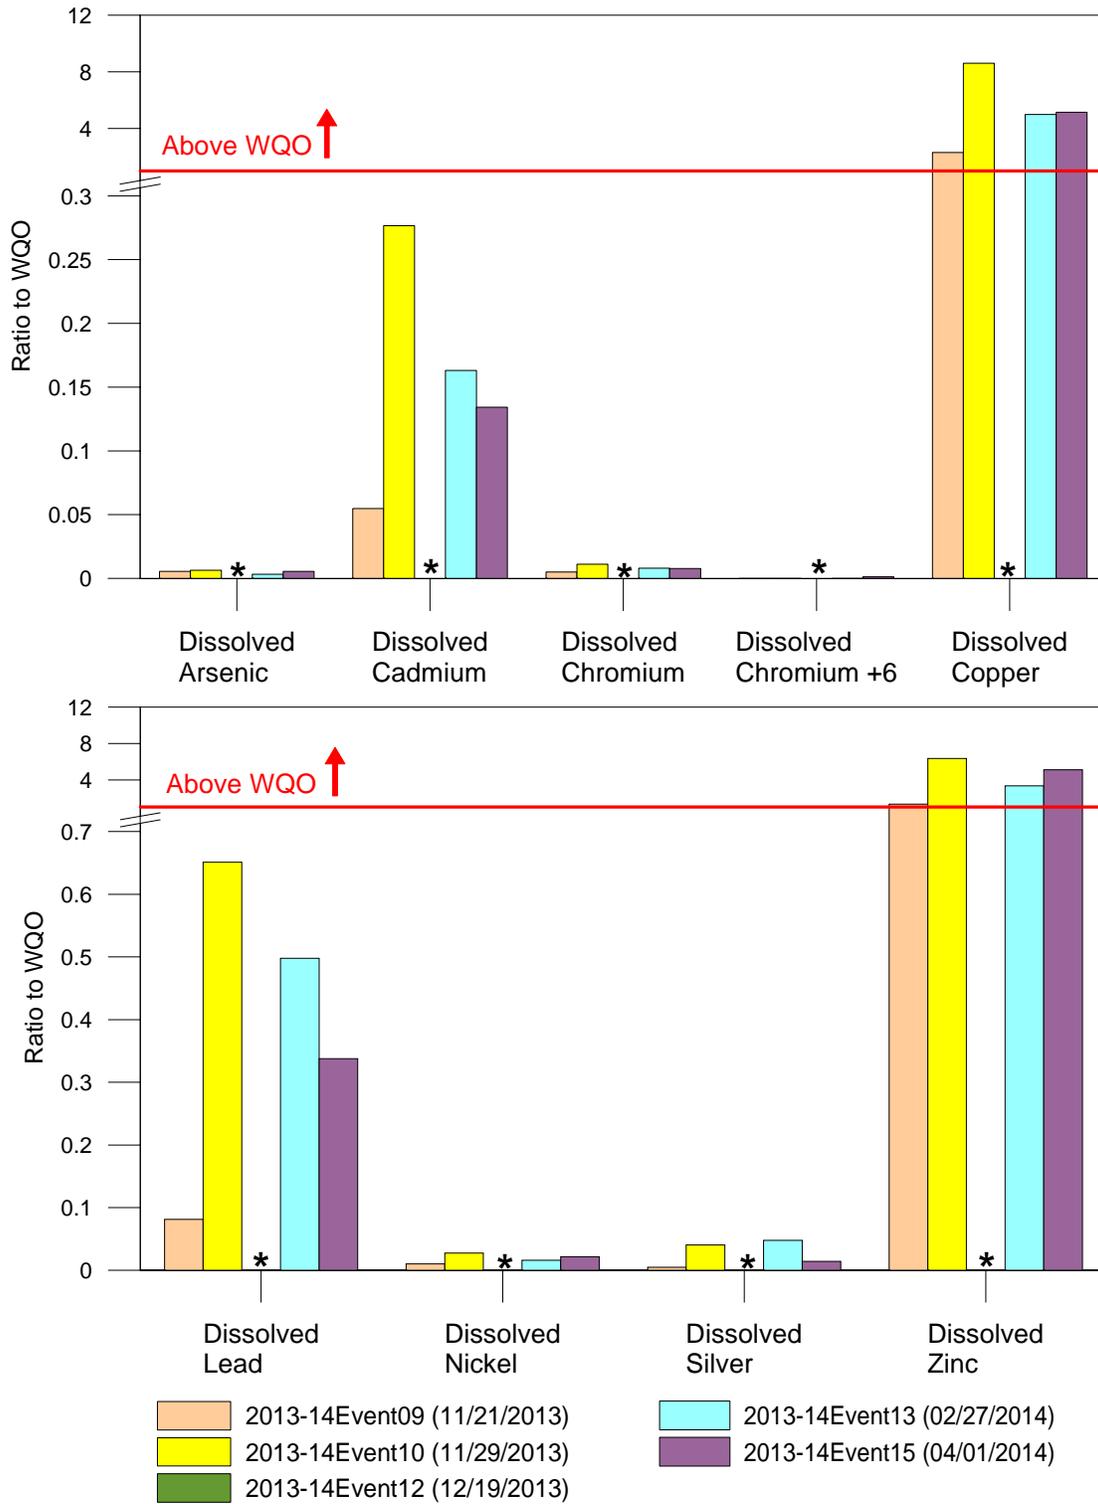
*Samples were not collected for dissolved metals during Event 12.

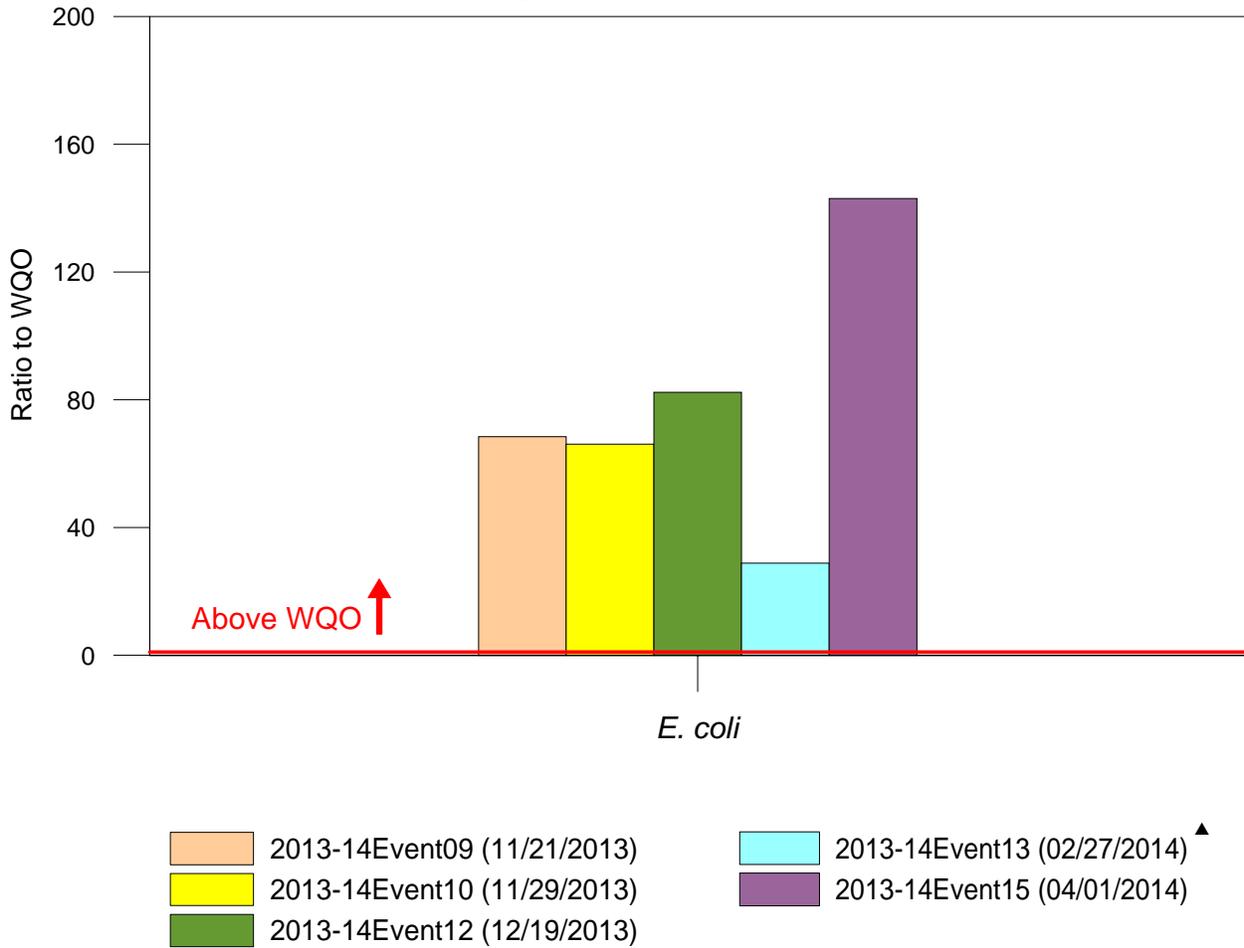
Figure 4-3.6 S28 Dominguez Channel at Artesia Blvd Wet Weather Ratio Plots

**2013-2014 Wet Weather WQO Ratios
for S28 Dominguez Channel at Artesia Blvd.**

▲Not an exceedance of the E. coli water quality objective due to the High Flow Suspension of Recreational Uses (LARWQCB, 2003).

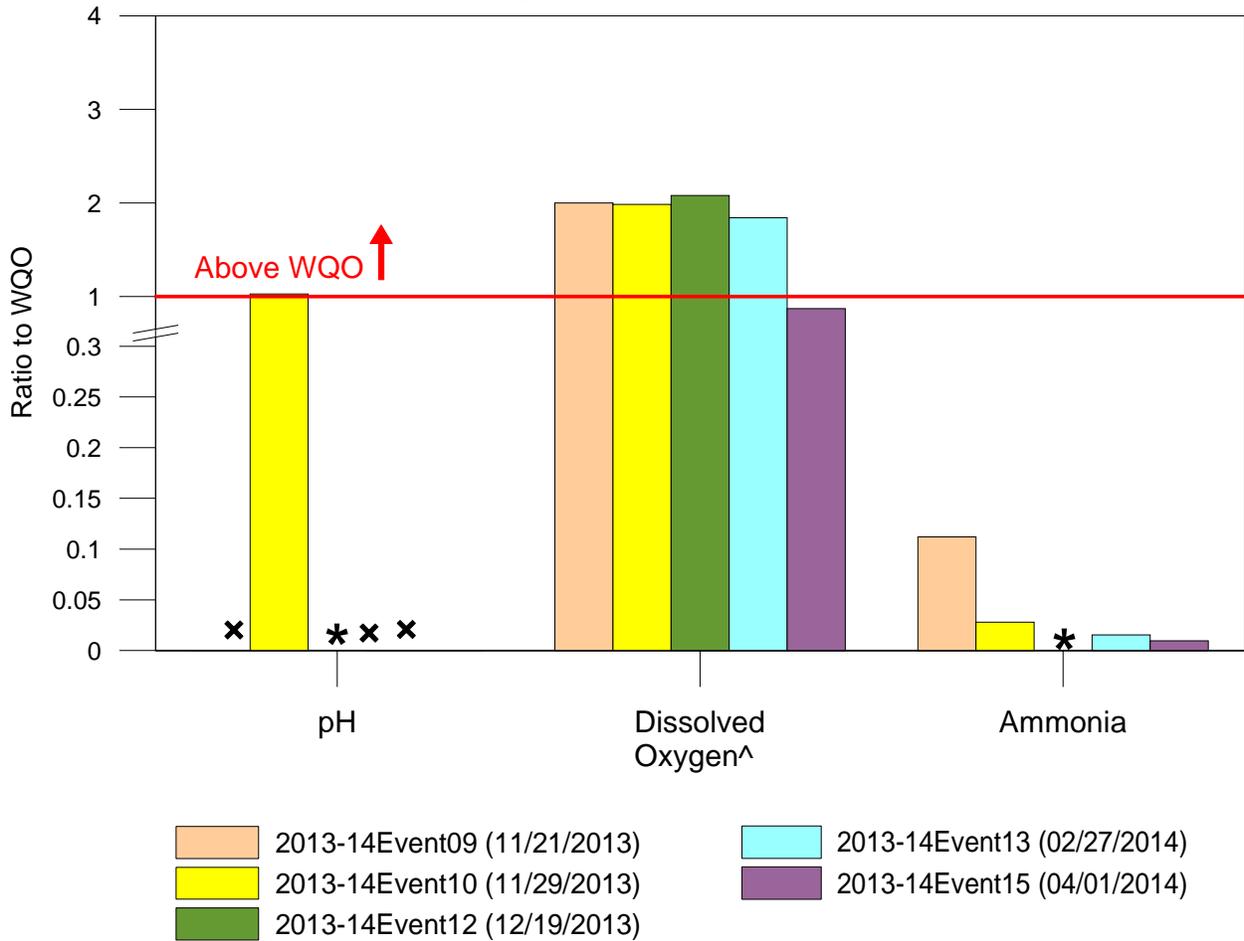
Figure 4-3.6 S28 Dominguez Channel at Artesia Blvd Wet Weather Ratio Plots

**2013-2014 Wet Weather WQO Ratios
for S28 Dominguez Channel at Artesia Blvd.**

[^]Dissolved oxygen is an exceedance if ratio to WQO is below 1.

x pH was within WQO range.

*Samples were not collected for ammonia or pH during Event 12.
