## **COMPREHENSIVE ASBESTOS, HAZMAT & XRF-LEAD ASSESSMENT**

### **High Desert Hospital**

44900 60th Street West, Various Buildings, Interior and Exterior

Project Number: Atch-211061

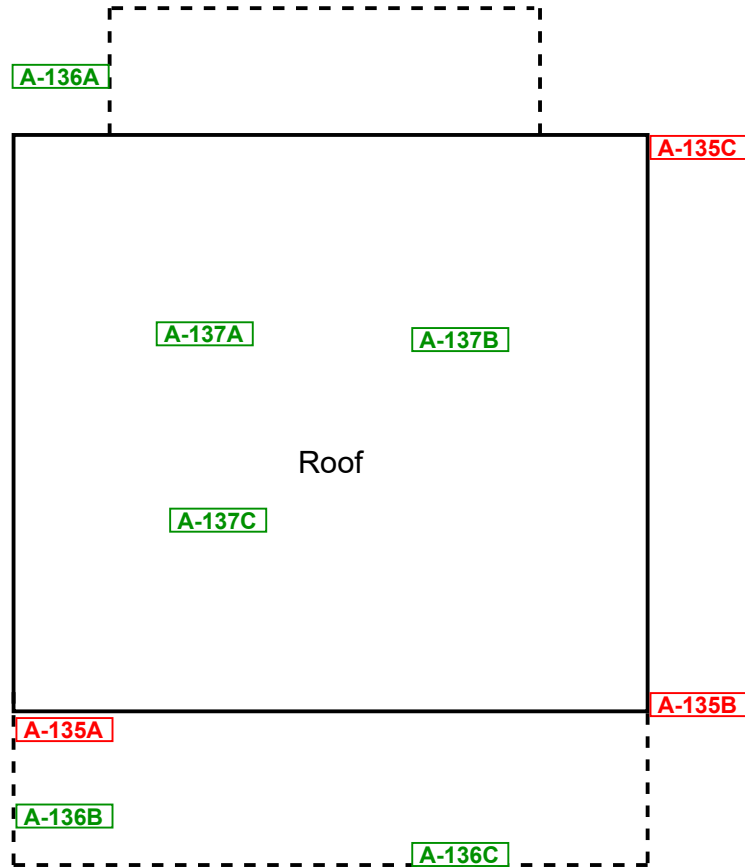
## Hazardous Waste Building, Exterior and Roof

| <u>Sample Number</u> | <u>Material</u> | <u>Sample Locations</u> | <u>Pos/Neg</u> | <u>Asbestos Type - Percentage</u> | <u>Classification</u> | <u>Friability</u> | <u>Cond.</u> | <u>Access.</u> | <u>Est. Qty.</u> |
|---|---|---|---|---|---|---|---|---|---|
| 211061-A-135A | Brick and Mortar | Hazardous Waste, Exterior, Exterior A | Positive | <b>White Sandy Material with Coating</b><br>Chrysotile - <1%<br>Point Count - <0.1% | Misc. | Non-Friable | Good | High | 500 SF |
| 211061-A-135B | Brick and Mortar | Hazardous Waste, Exterior, Exterior C | Positive | <b>White Sandy Material with Coating</b><br>Chrysotile - <1%<br>Point Count - <0.1% | Misc. | Non-Friable | Good | High | See 135A |
| 211061-A-135C | Brick and Mortar | Hazardous Waste, Exterior, Exterior D | Positive | <b>White Sandy Material with Coating</b><br>Chrysotile - <1%<br>Point Count - <0.1% | Misc. | Non-Friable | Good | High | See 135A |

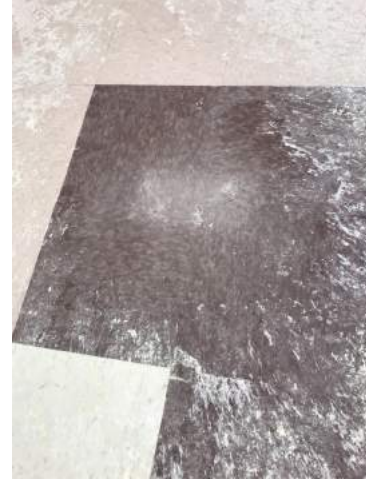
View of 12" x 12" Dark Brown Streaked Resilient Flooring/Resilient Floor Mastic

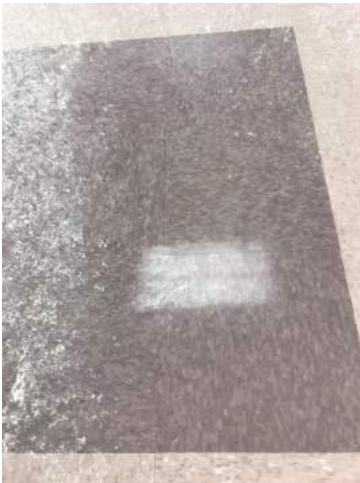
View of 12" x 12" Light Brown Streaked Resilient Flooring/Resilient Floor Mastic

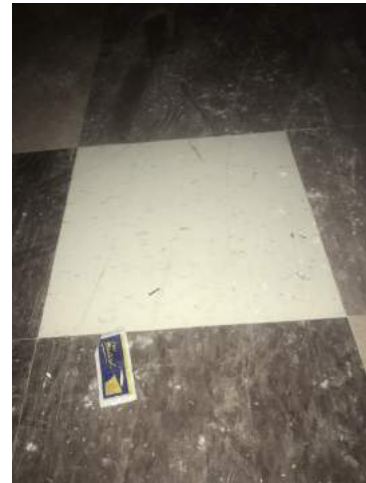
View of 12" x 12" White with Light Brown Streaked Resilient Flooring/Resilient Floor Mastic

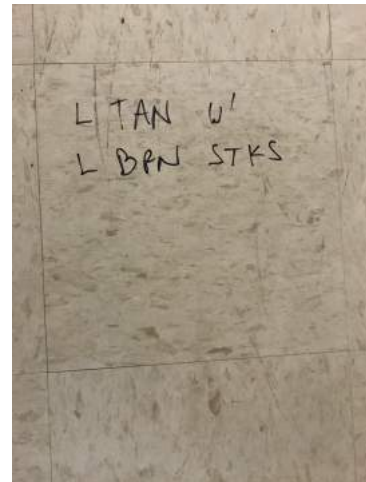
View of 9" x 9" Green with White Streaked Resilient  
Flooring/Resilient Floor Mastic

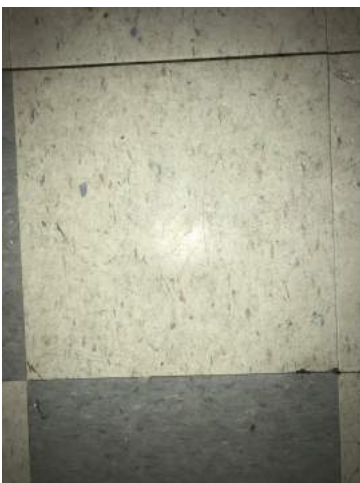
View of 12" x 12" Light Tan with Light Brown Streaked Resilient  
Flooring/Resilient Floor Mastic

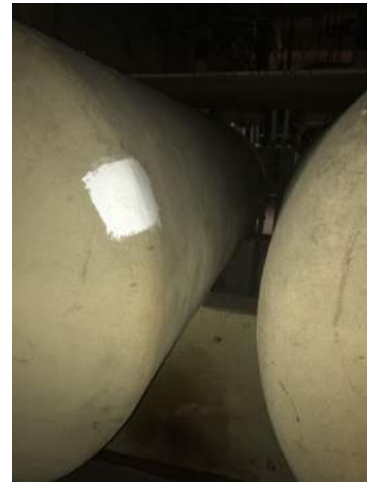
View of Fireproofing

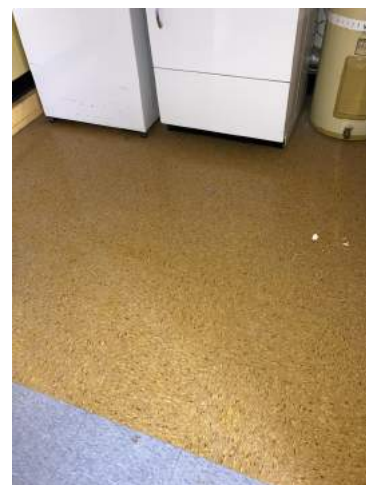
View of 12" x 12" Yellow with Red Stripes Resilient Floor Tile/Resilient Floor Mastic

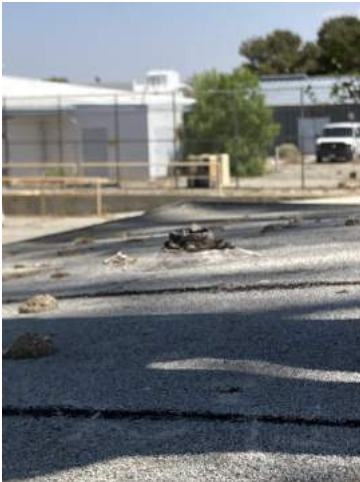
View of Black Mounting Mastic

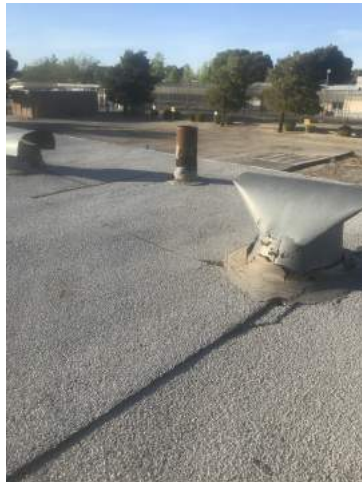
View of Woven Roof Material with Sealant

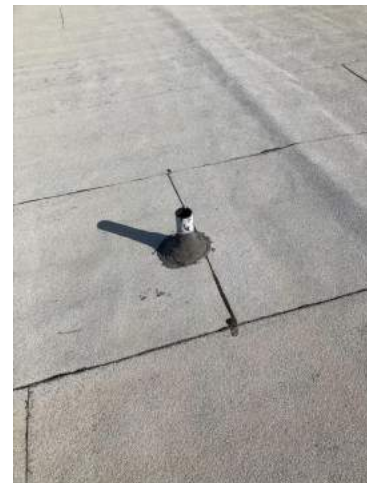
View of Black Penetration Mastic

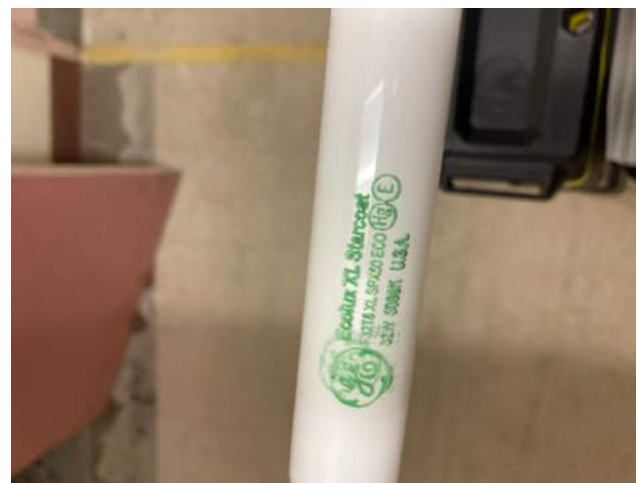
View of Mercury-Containing Light Bulb

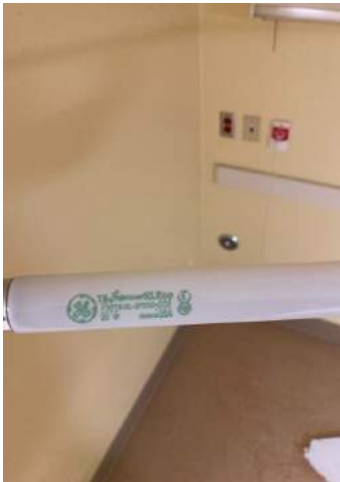
View of Mercury-Containing Light Bulb

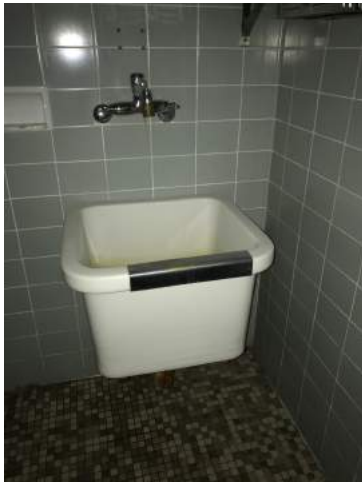
View of White Porcelain Sink
