**Sunshine Canyon Landfill  
Independent Monitor  
Quarterly Site Monitoring Status Report  
January 1, 2016 – March 31, 2016**

**City of Los Angeles Department of City Planning**

**County of Los Angeles Department of Regional Planning**

May 16, 2016

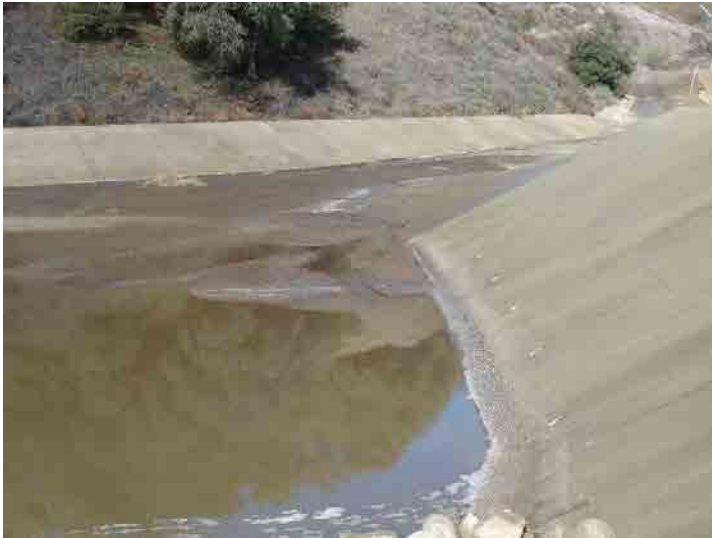
**Photo 5: Basin A Outlet: January 7, 2016**

- Basin A:
  - The drainage channel out of basin observed in previous visits to be partially filled up with soil was cleaned and flowing (Photo 5).
- Section of channel on west side between Basin A and Basin D previously noted:

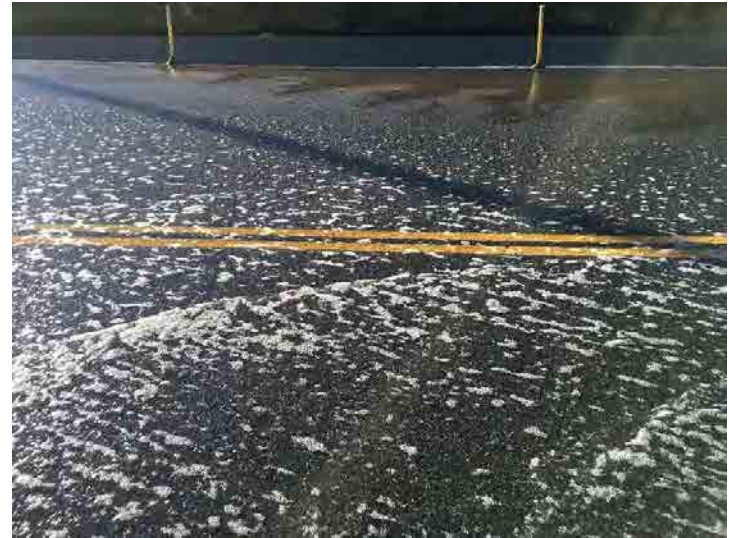
**Photo 77: Water Removal at City Lined Drainage Lift Area:  
January 7, 2016**

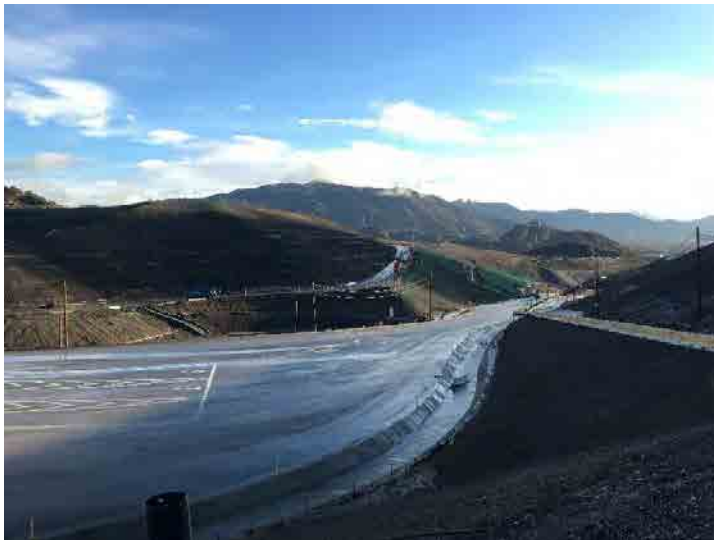
**Photo 78: Water Removal at City Lined Drainage Lift Area:  
January 7, 2016**

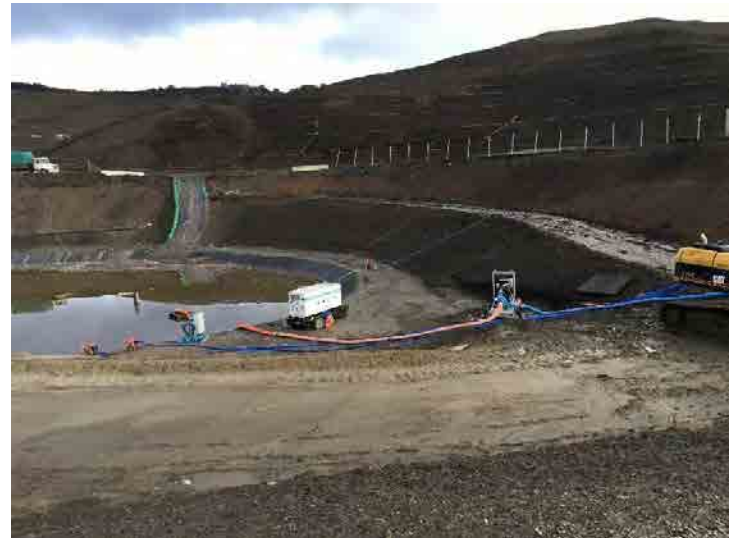
**Photo 79: Water Removal at City Lined Drainage Lift Area:  
January 7, 2016**

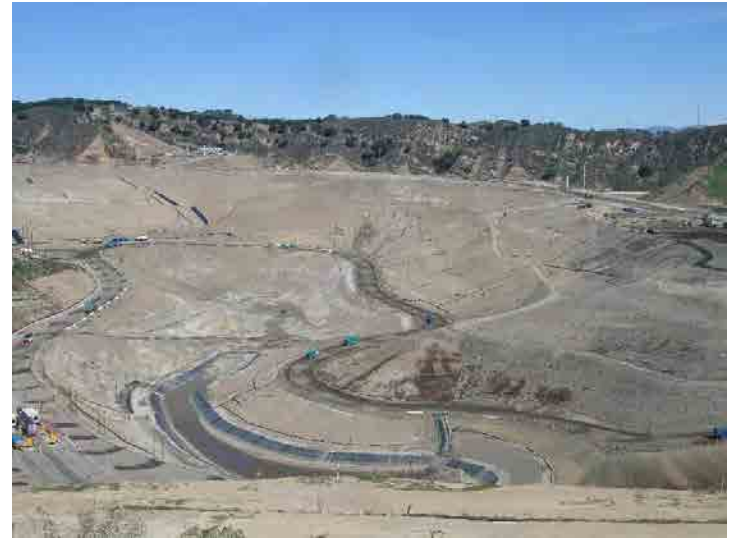
**Photo 89: City Lined Drainage Lift Area: February 24, 2016**

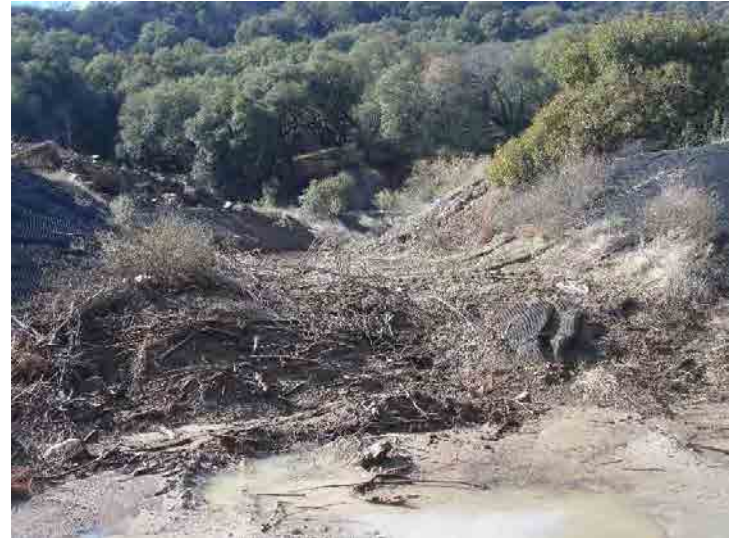
**Photo 118: Native Hillside Area Drainage into Basin D: January 7, 2016**

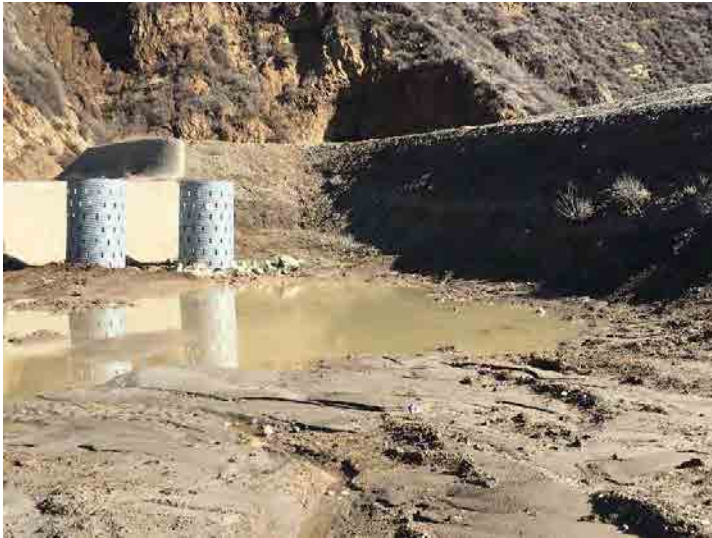
**Photo 121: Basin D: January 7, 2016**

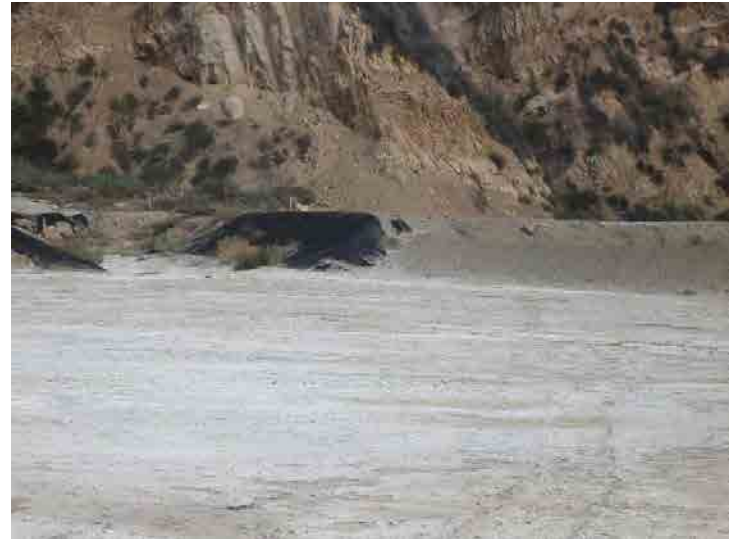
**Photo 122: Basin D: January 27, 2016**

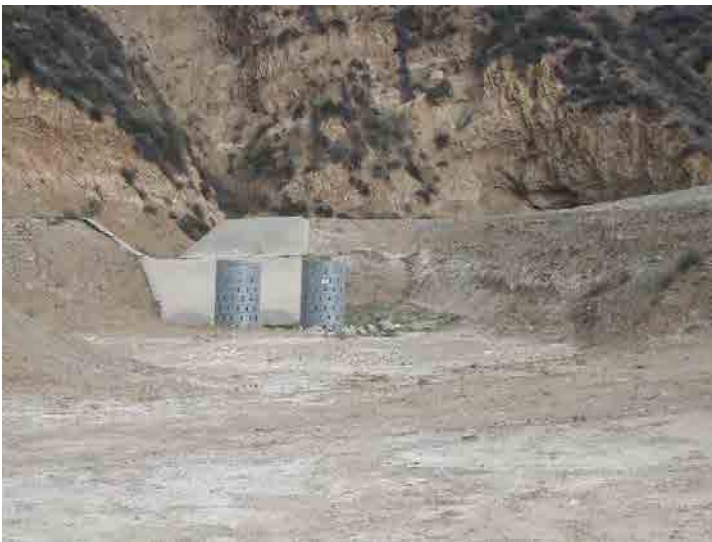
**Photo 123: Basin D: January 27, 2016**

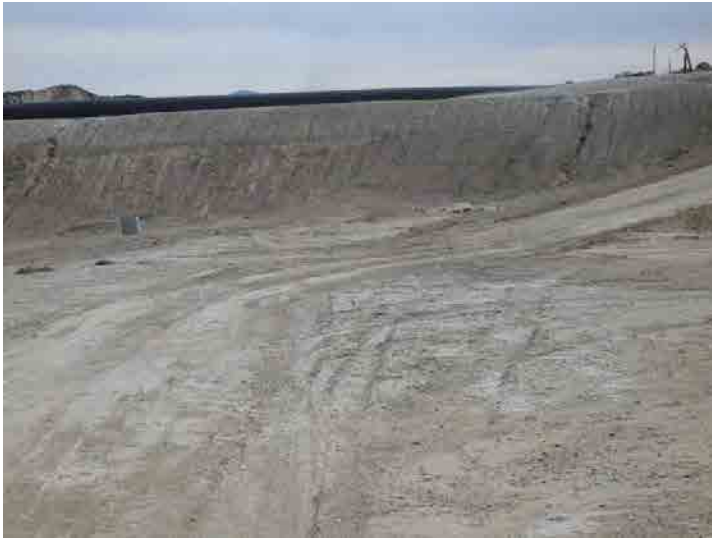
**Photo 125: Basin D: January 27, 2016**

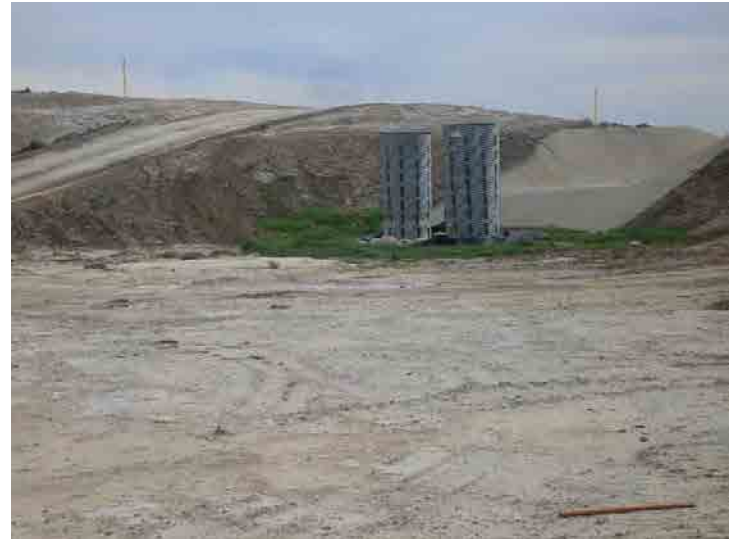
**Photo 126: Basin D: January 27, 2016**

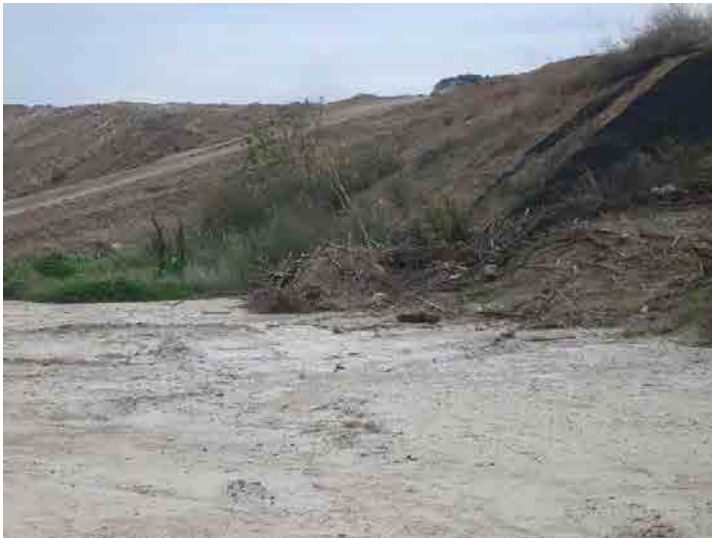
**Photo 127: Basin D: January 27, 2016**

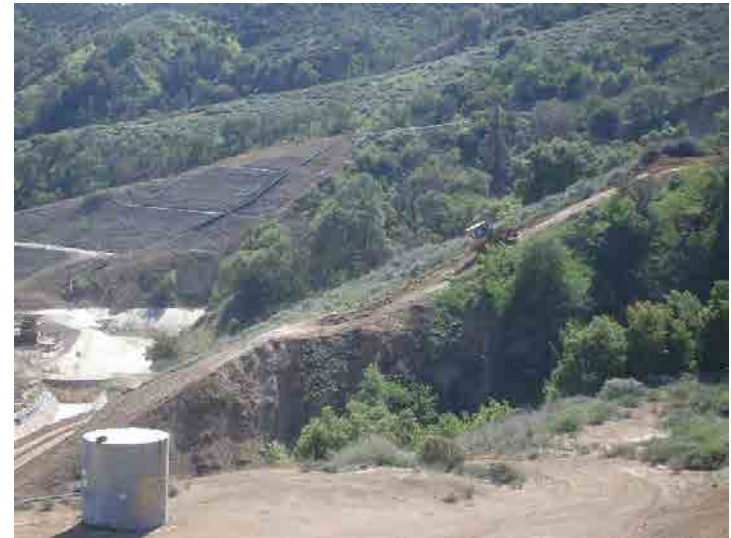
**Photo 140: Edison Pole Site Near County Sage Mitigation Area:  
February 24, 2016**

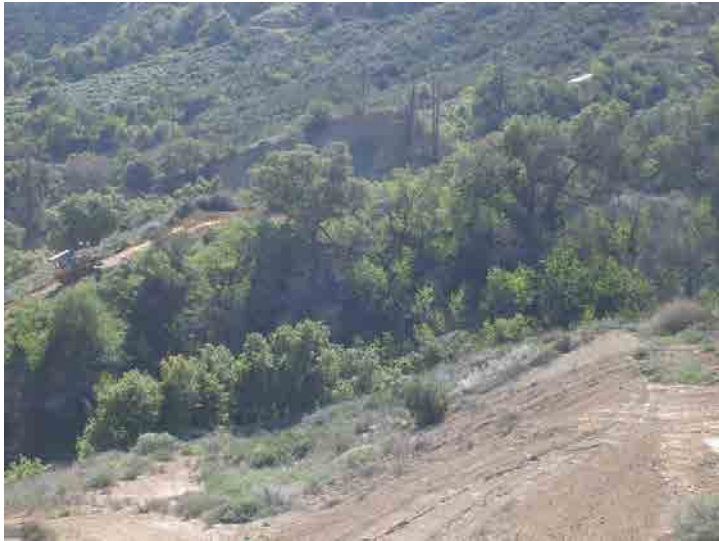
**Photo 141: Edison Pole Site Near County Sage Mitigation Area:  
February 24, 2016**

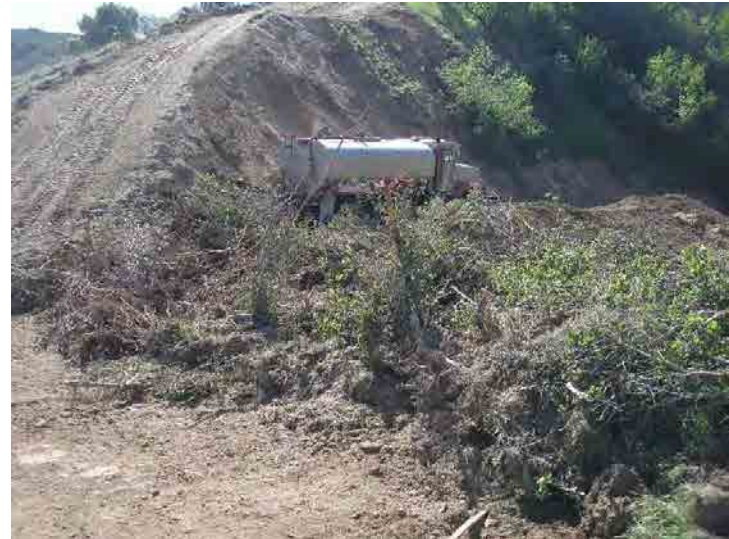
**Photo 142: Edison Pole Site Near County Sage Mitigation Area:  
February 24, 2016**

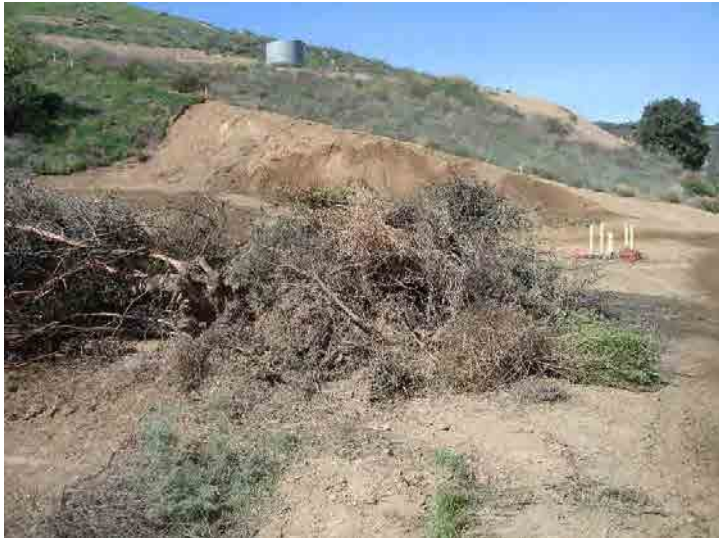
**Photo 143: Edison Pole Site Near County Sage Mitigation Area:  
February 24, 2016**

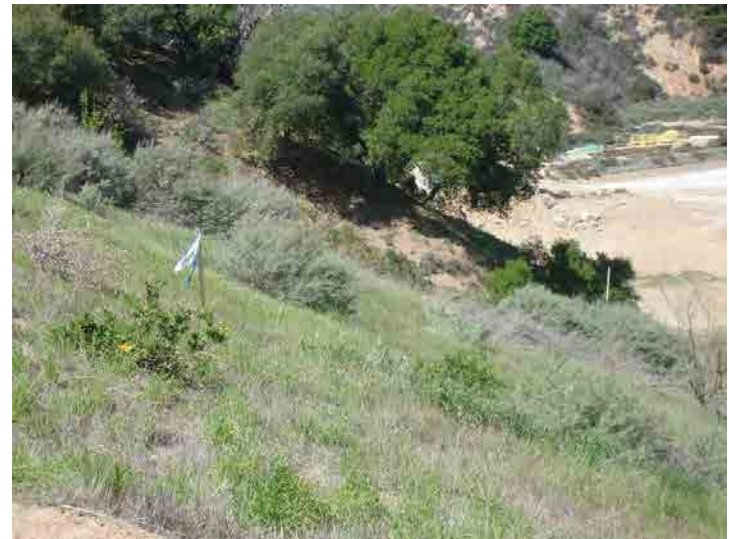
**Photo 144: Edison Pole Site Near County Sage Mitigation Area:  
February 24, 2016**

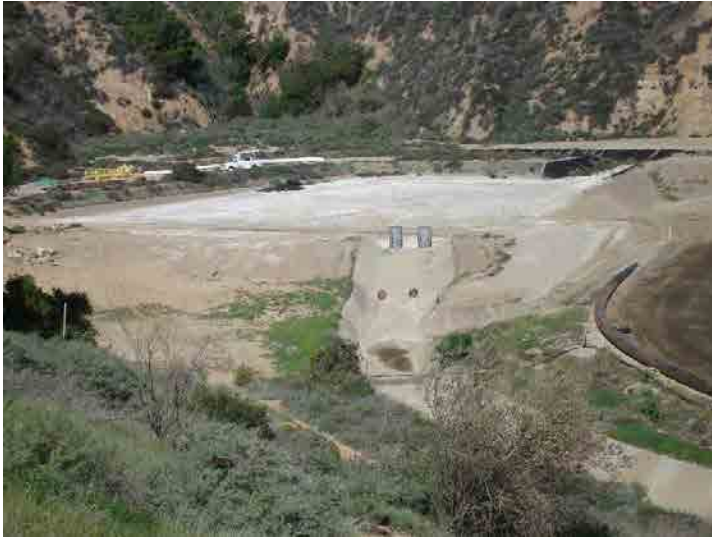
**Photo 145: Edison Pole Site Near County Sage Mitigation Area:  
February 24, 2016**

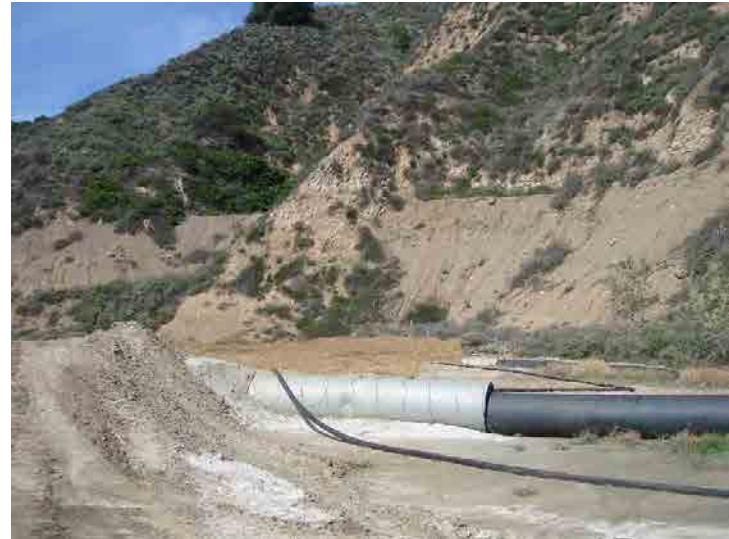
**Photo 146: Edison Pole Site Near Basin D Outlet: March 9, 2016**

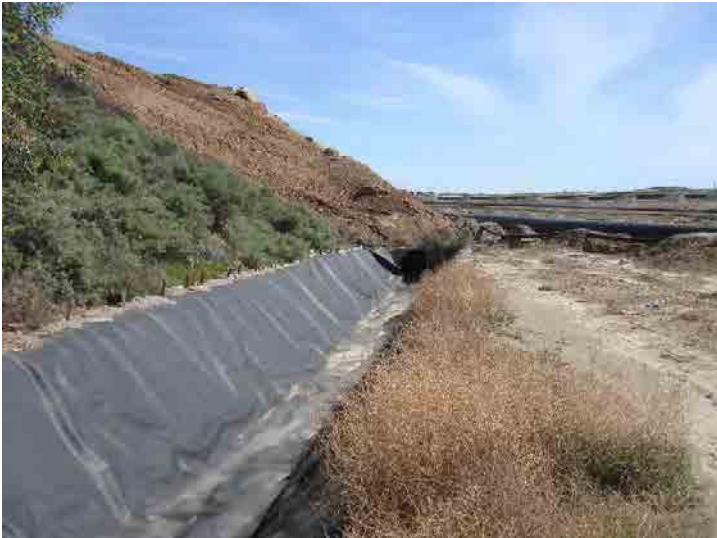
**Photo 147: Edison Pole Site Near Basin D Outlet: March 9, 2016**

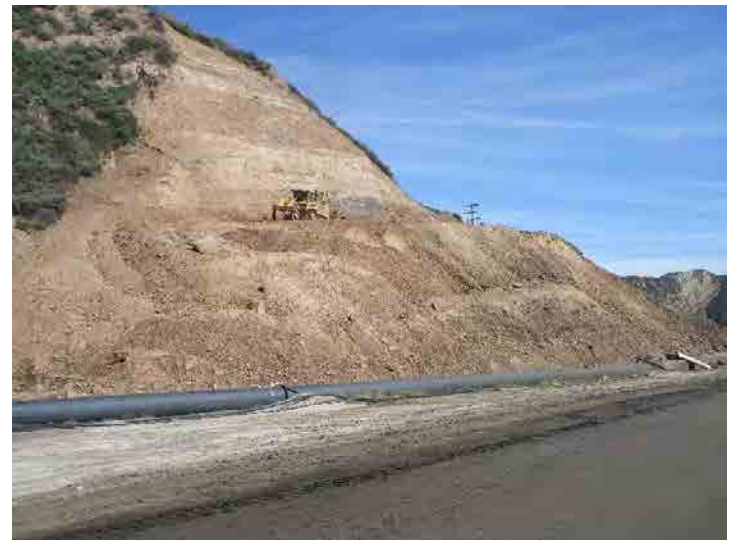
**Photo 148: Edison Pole Site Near Basin D Outlet: March 9, 2016**

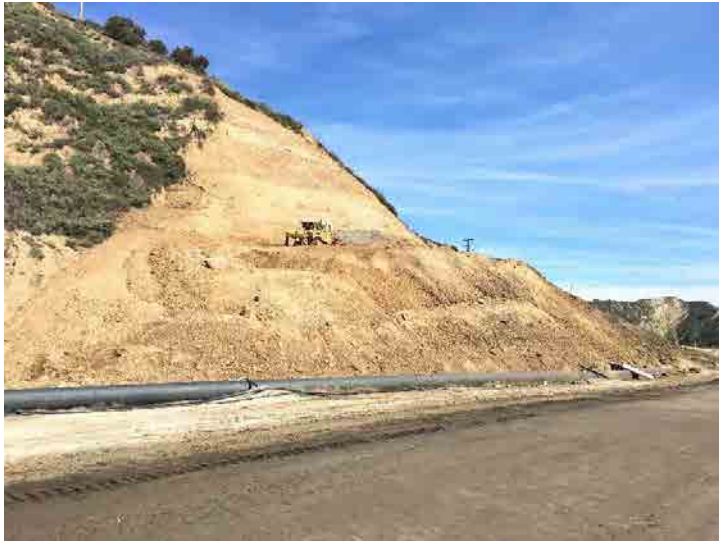
**Photo 149: Edison Pole Site Near Basin D Outlet: March 9, 2016**

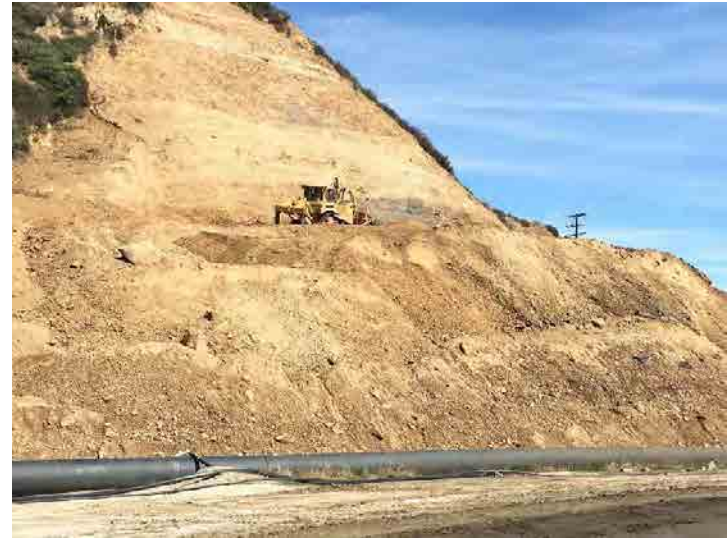
**Photo 150: Edison Pole Site Near Basin D Outlet: March 9, 2016**

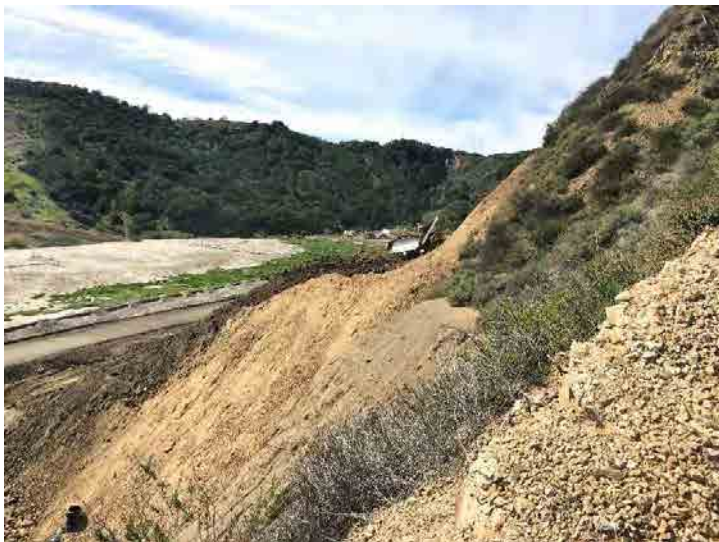
**Photo 151: Edison Pole Site Near Basin D Outlet: March 9, 2016**

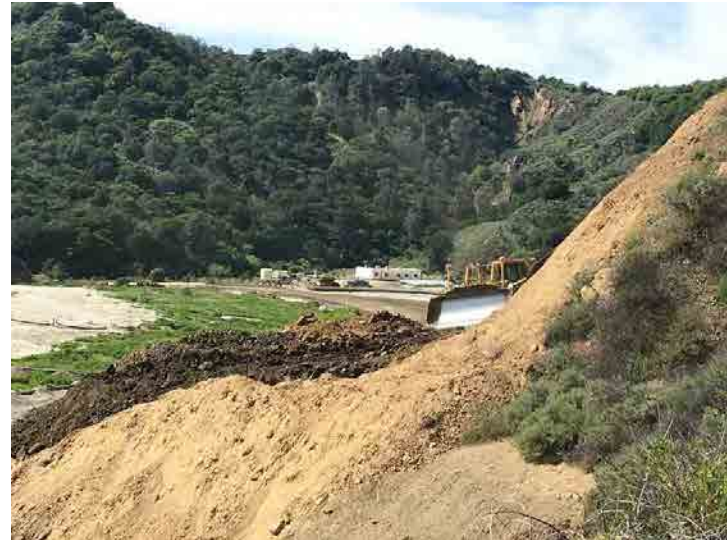
**Photo 152: Edison Pole Site Near Basin D Outlet: March 9, 2016**

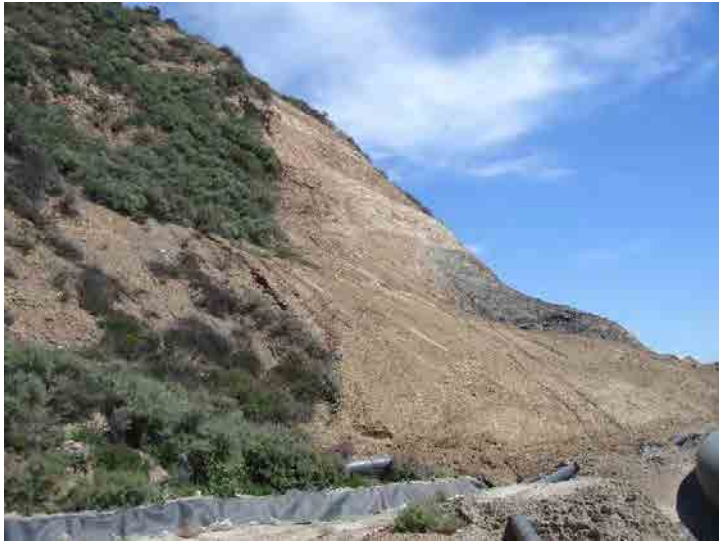
**Photo 153: Edison Pole Site Near Basin D Outlet: March 23, 2016**

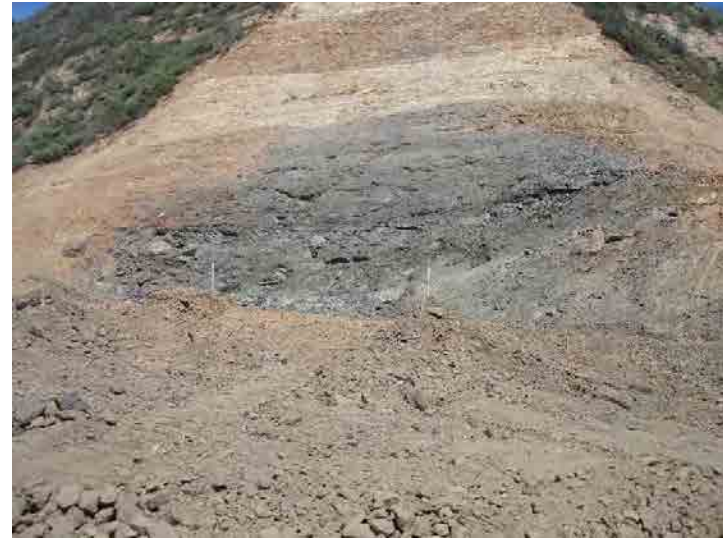
**Photo 154: Edison Pole Site Near Basin D Outlet: March 23, 2016**

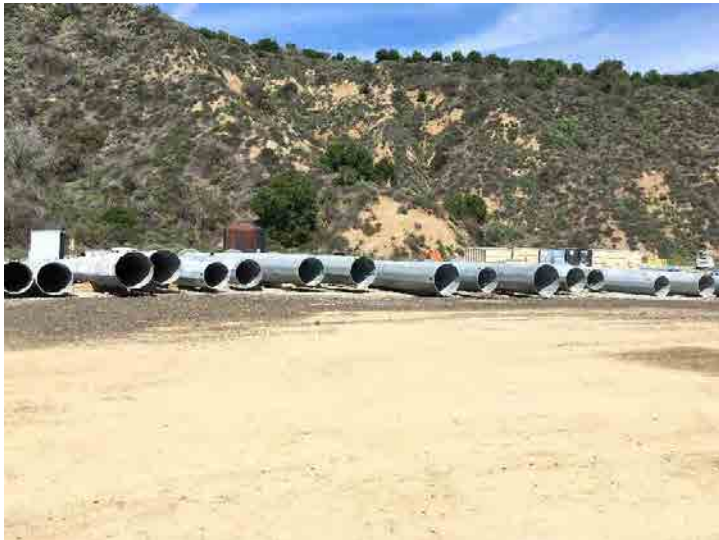
**Photo 155: Edison Poles in Material Storage Area: March 9, 2016**

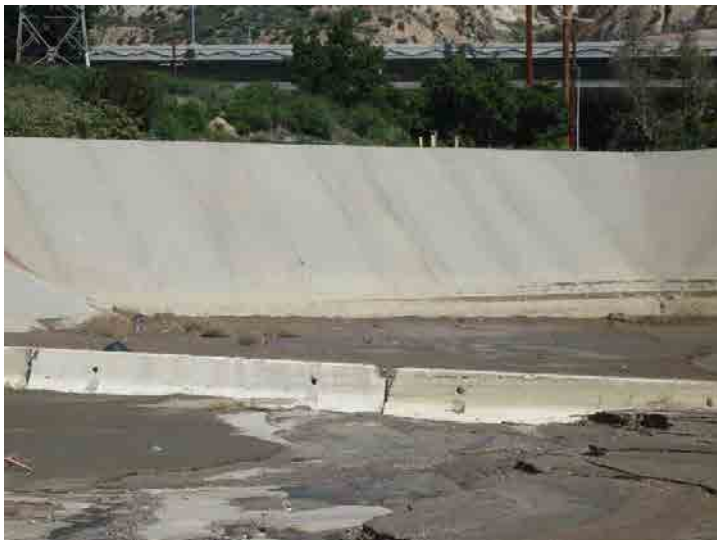
**Photo 247: Terminal Basin: March 9, 2016**

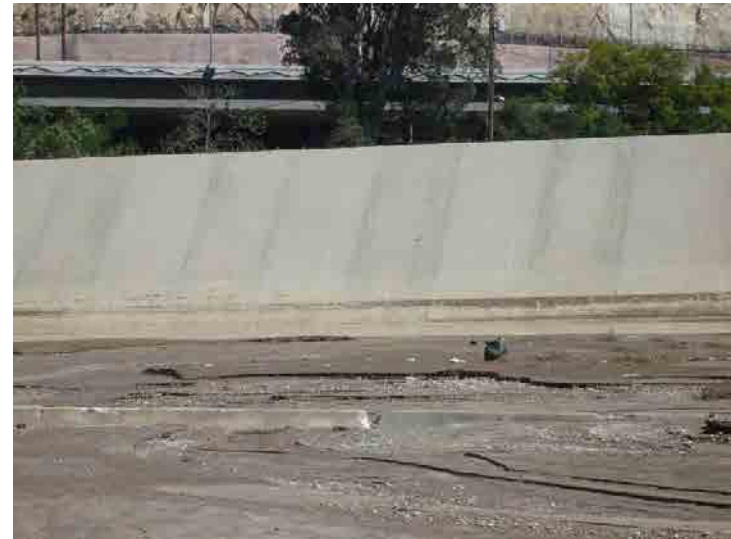
**Photo 248: Terminal Basin: March 9, 2016**

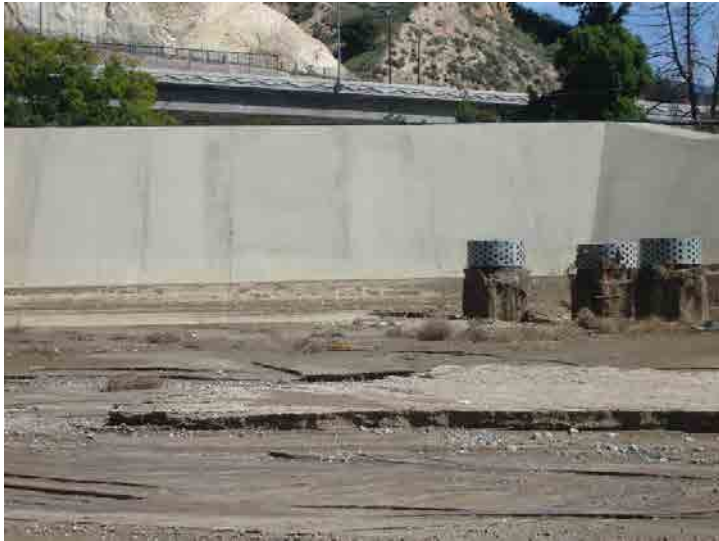
**Photo 249: Terminal Basin: March 9, 2016**

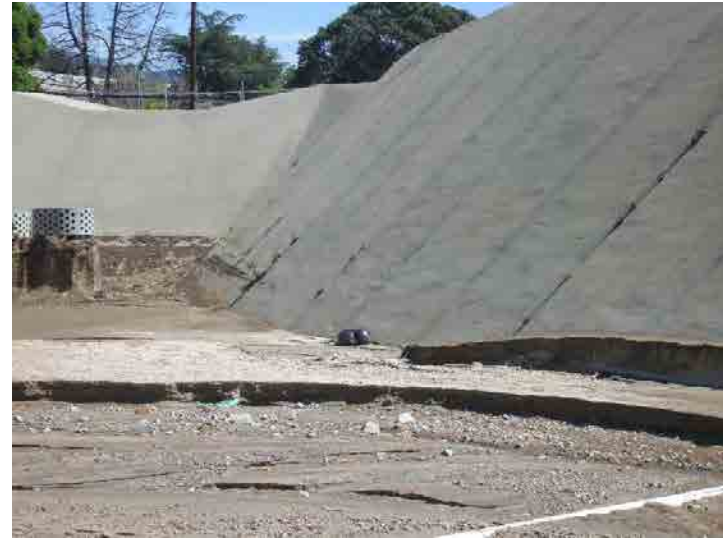
**Photo 250: Terminal Basin: March 9, 2016**

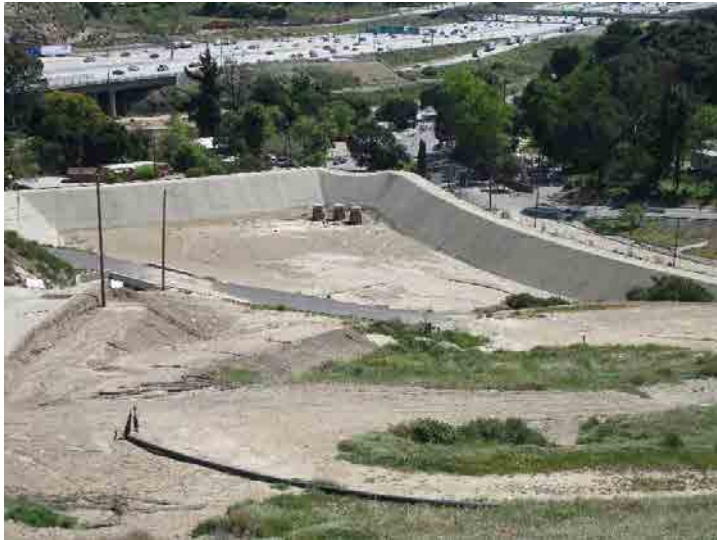
**Photo 253: Terminal Basin: March 23, 2016**

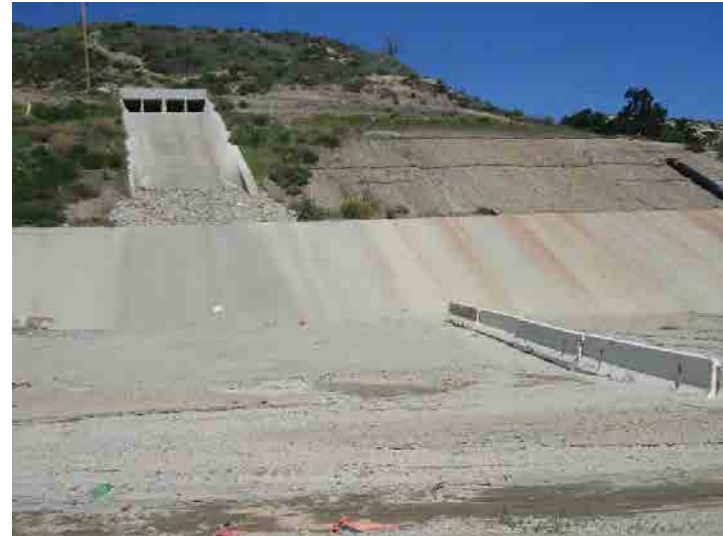
**Photo 254: Terminal Basin: March 23, 2016**

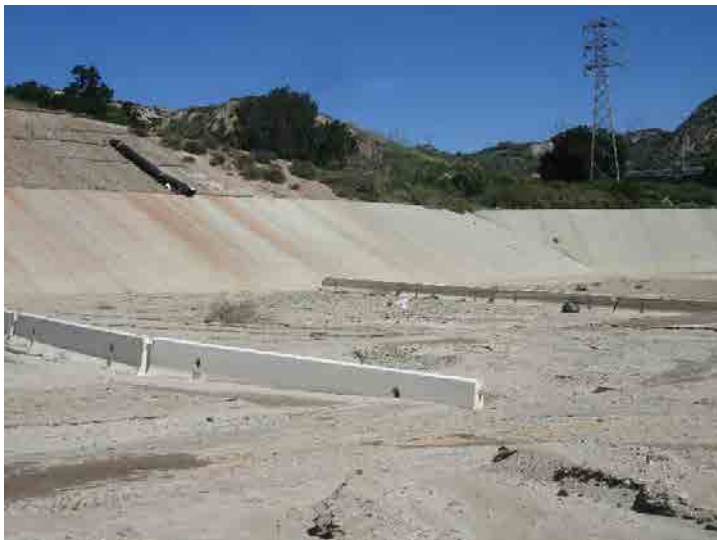
**Photo 255: Terminal Basin: March 23, 2016**

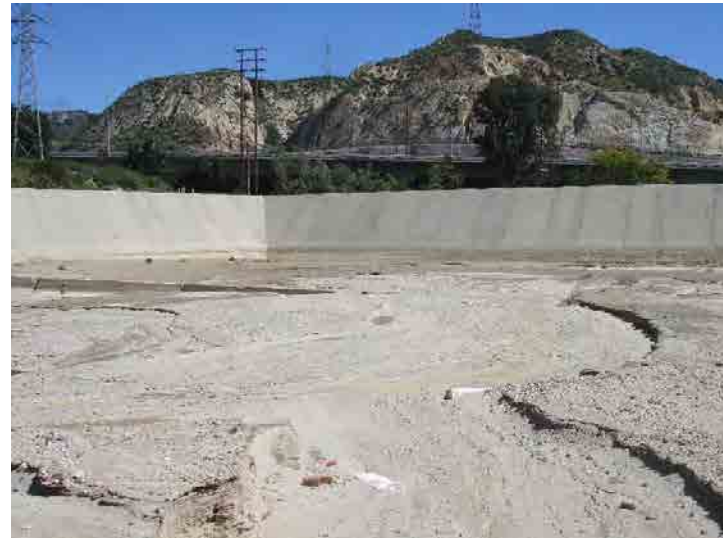
**Photo 256: Terminal Basin: March 23, 2016**

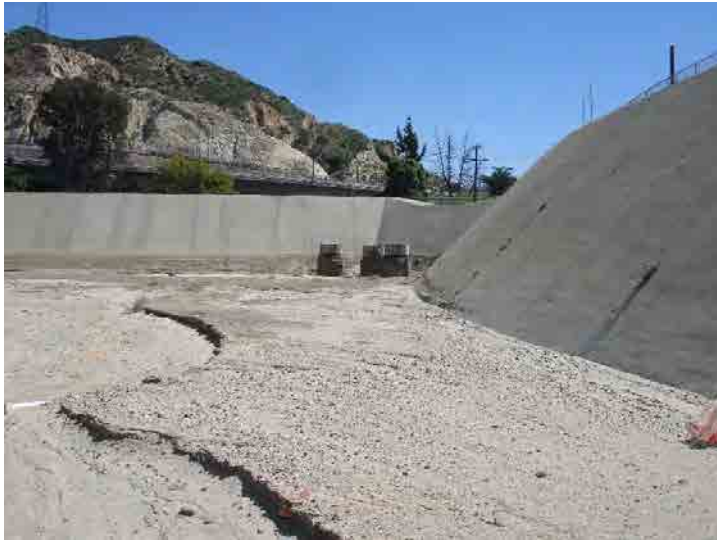
**Photo 257: Terminal Basin: March 23, 2016**

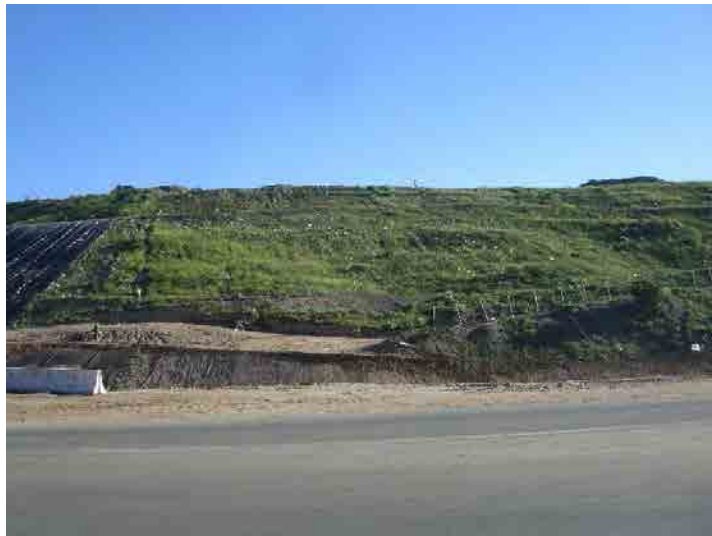
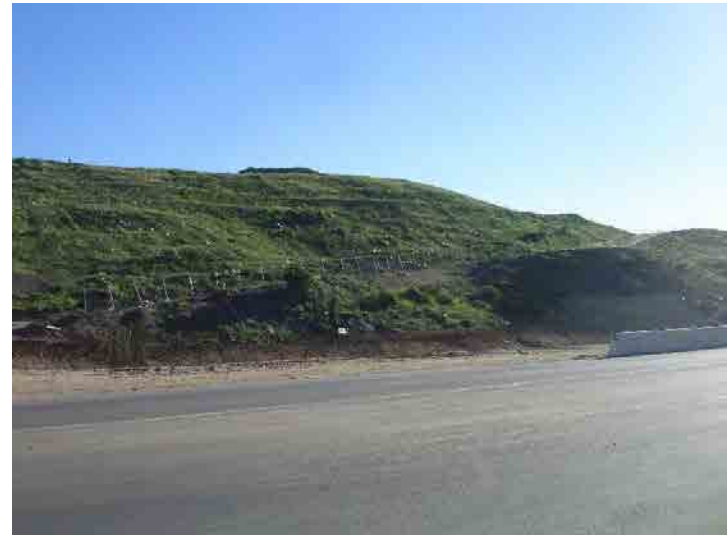
**Photo 298: City Cell CC3B Slope Litter: March 23, 2016**

**Photo 299: City Cell CC3B Slope Litter: March 23, 2016**

**Photo 300: City Cell CC3B Slope Litter: March 23, 2016**

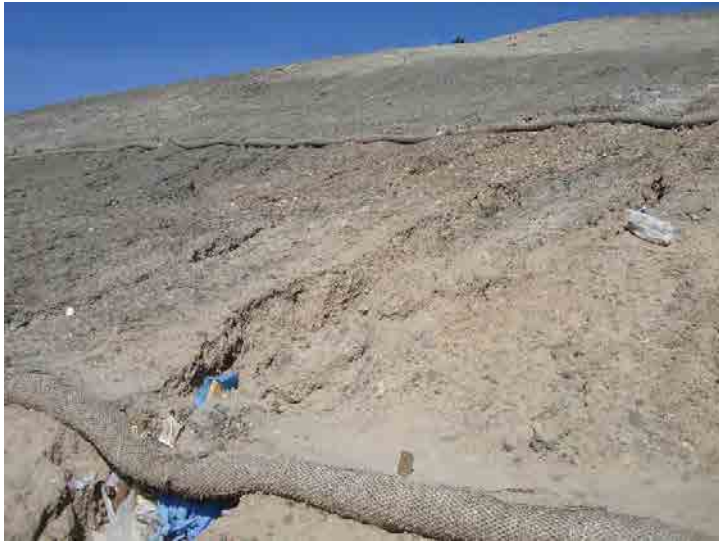
**Photo 348: County South Facing Slope, Inert Waste Exposed:  
February 24, 2016**

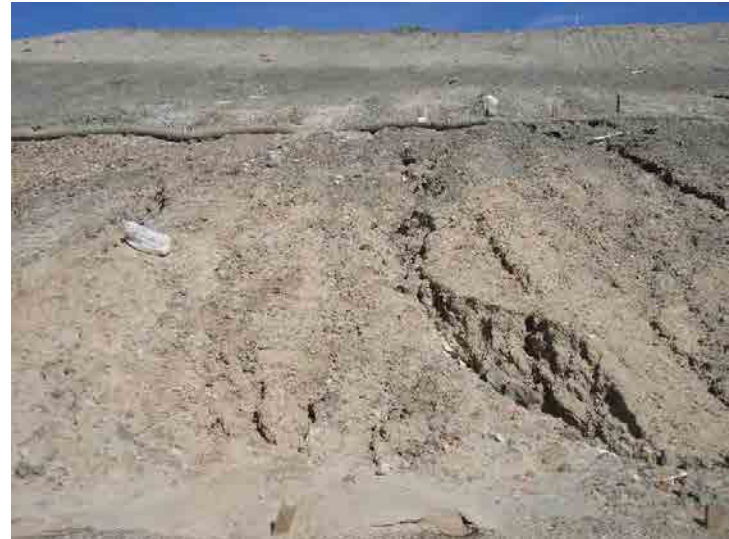
**Photo 349: County South Facing Slope, Inert Waste Exposed:  
February 24, 2016**

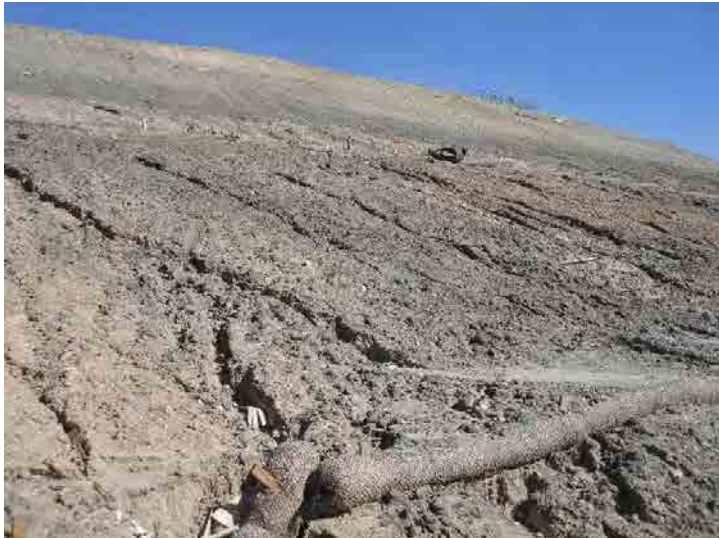
**Photo 350: County South Facing Slope, Inert Waste Exposed:  
February 24, 2016**

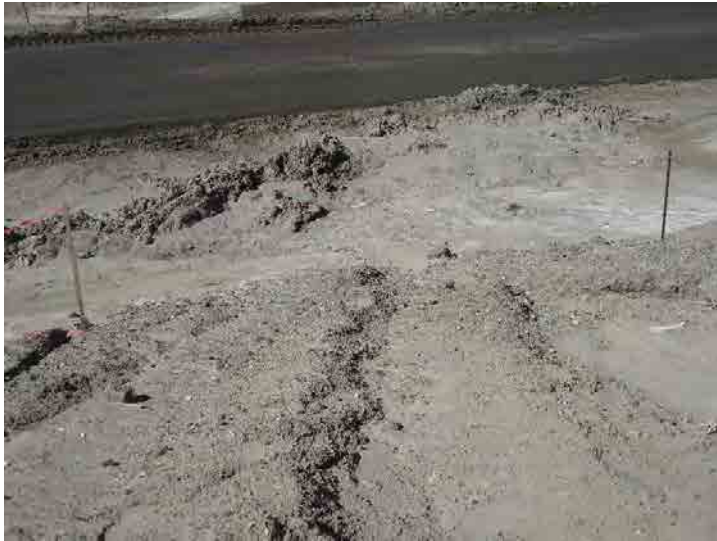
**Photo 352: Localized Condensate Odor: February 24, 2016**

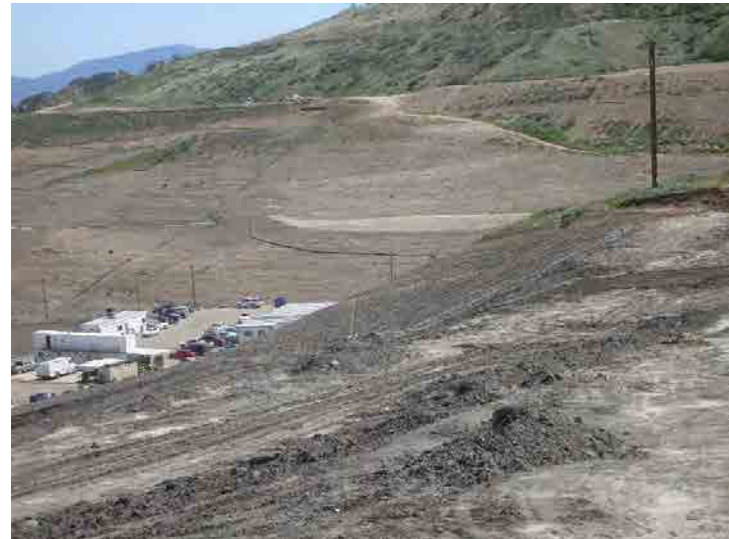
**Photo 367: Ponding on City Top Deck: March 9, 2016**

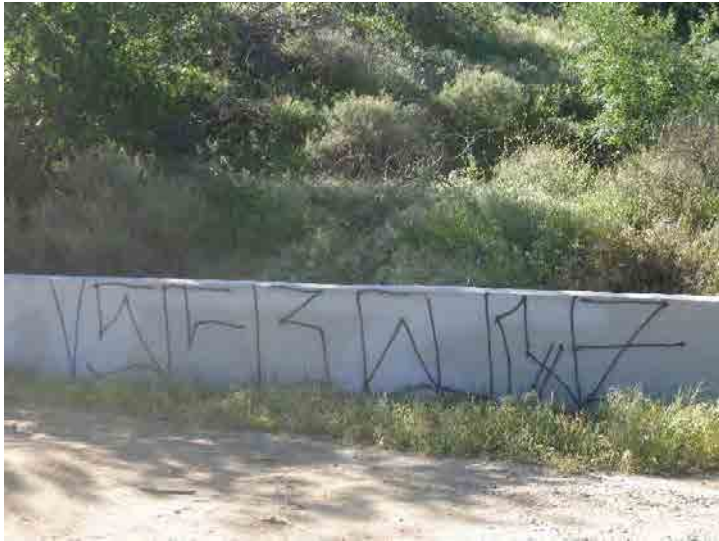
**Photo 532: Graffiti Frontage Wall on San Fernando Road: January 27, 2016**

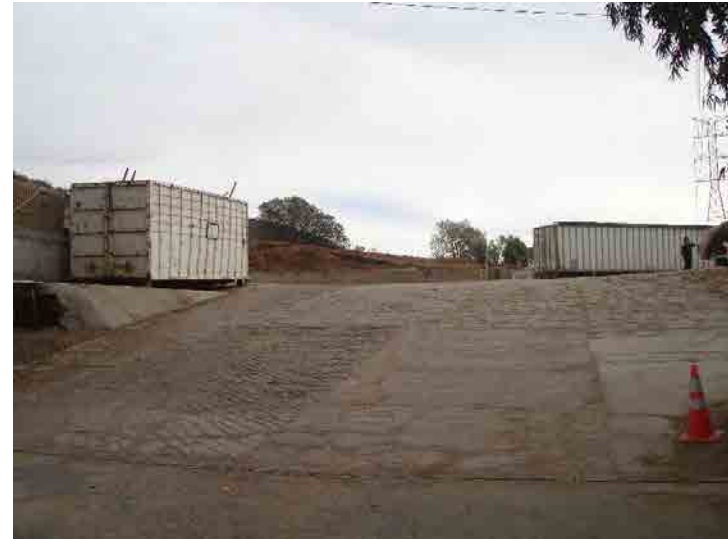
**Photo 565: Greenwaste Odor Source: January 27, 2016**

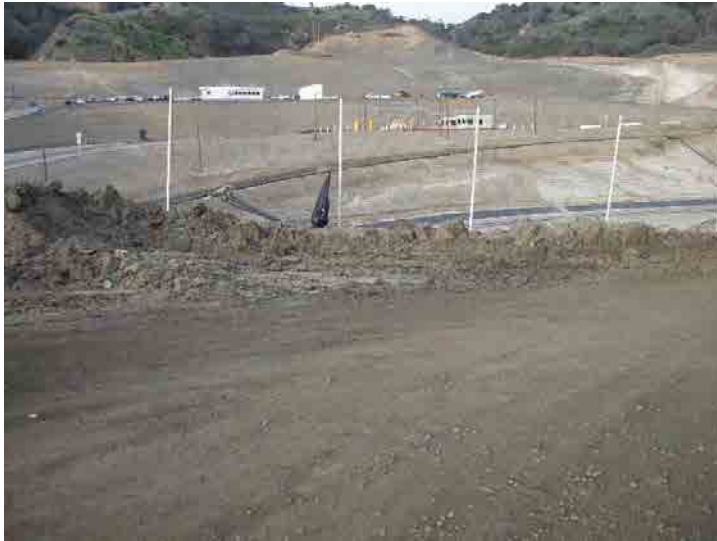
**Photo 576: Haul Road Liquids Odor Area: January 27, 2016**

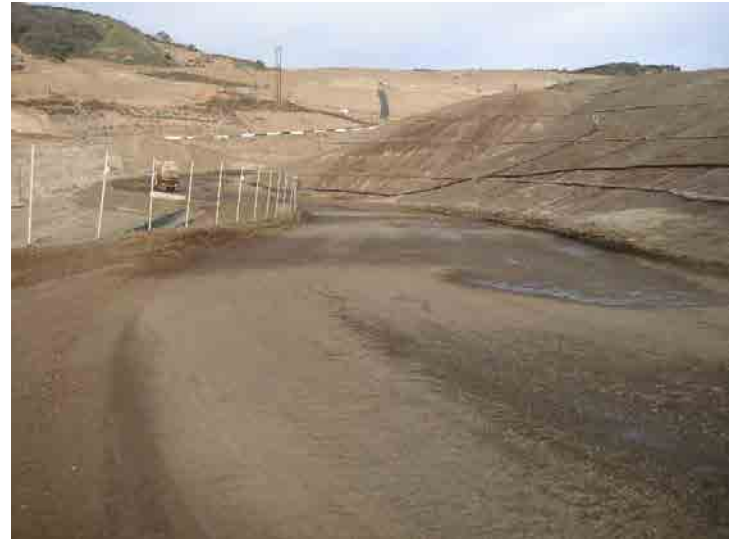
**Photo 577: Haul Road Liquids Odor Area: January 27, 2016**

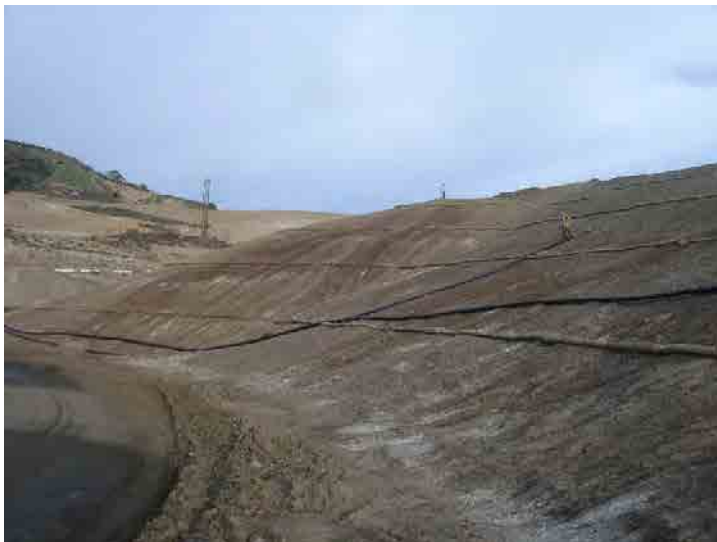
**Photo 578: Haul Road Liquids Odor Area: January 27, 2016**

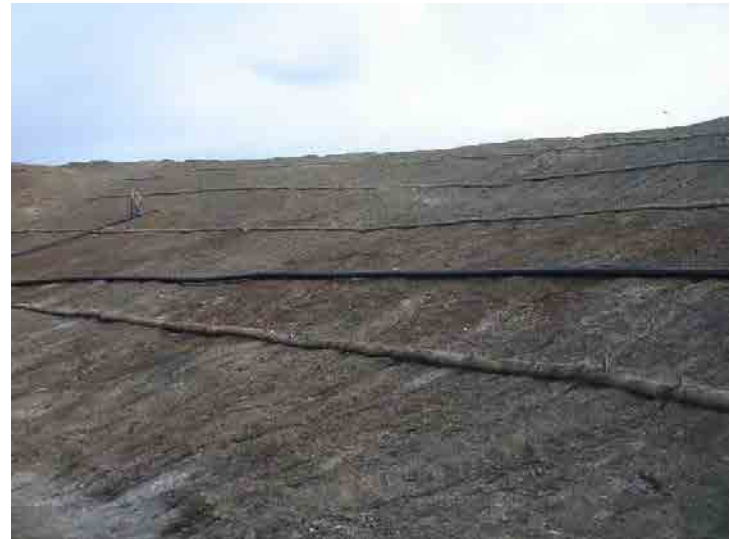
**Photo 579: Haul Road Liquids Odor Area: January 27, 2016**

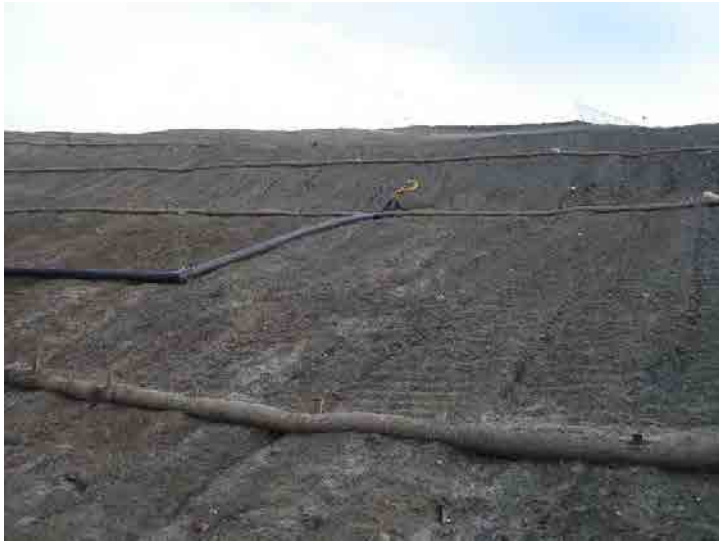
**Photo 580: Haul Road Liquids Odor Area: January 27, 2016**

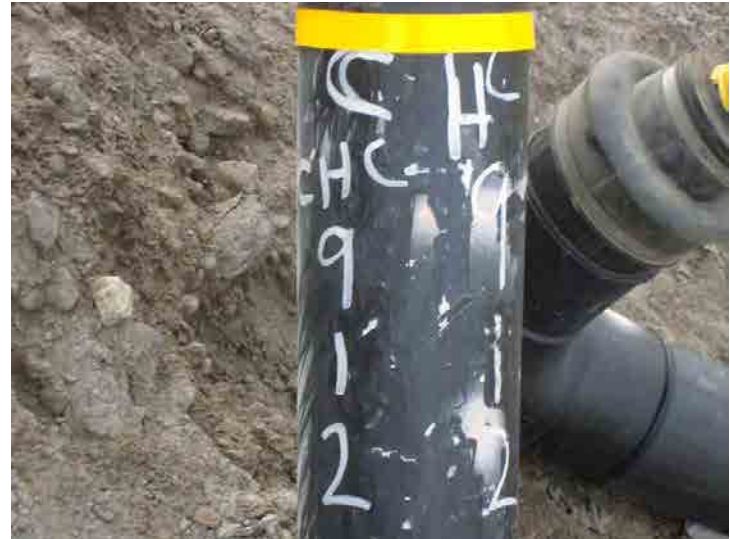
**Photo 581: Haul Road Liquids Odor Area: January 27, 2016**

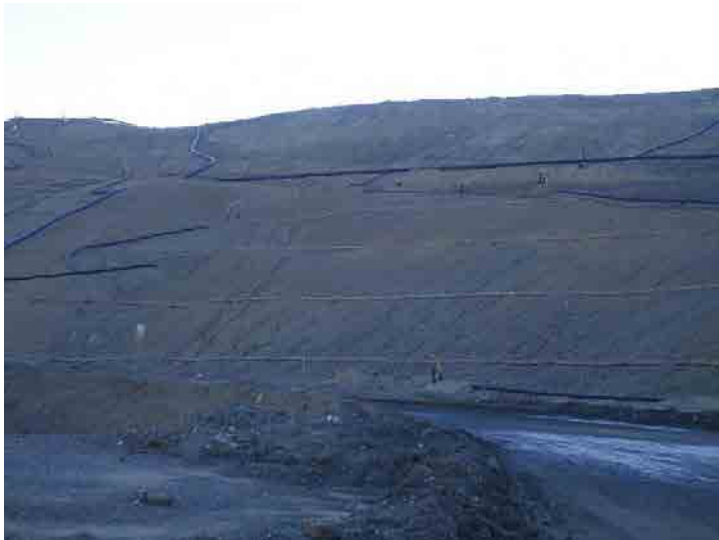
**Photo 582: Haul Road Liquids Odor Area: January 27, 2016**

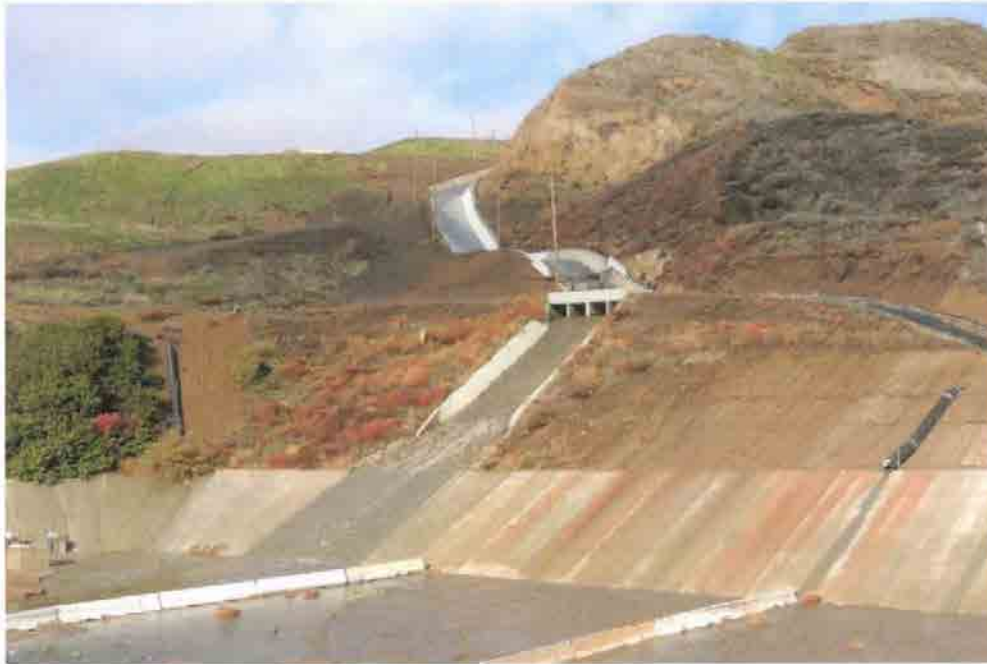
| <ul style="list-style-type: none"> <li>• tour the neighborhood to detect potential odors – None</li> <li>• it was the tail end of rainstorm, water still flowing down the main western ditch into the terminal basin, water is clear (Photo 1). A large amount of fines have accumulated in the basin (Photo 2). Source of the fines is runoff from cell CC3B under construction. The temporary lined diversion trench towards the remnants of the 96 inch-culvert draining into the basin failed (Photo 3) and muddy water flew into the basin. The K-rails (Photo 2) in the basin slowed down the muddy water leading to a limited build-out against the risers (Photo 4)</li> </ul> | |

Photo 1: Water flowing along western channel

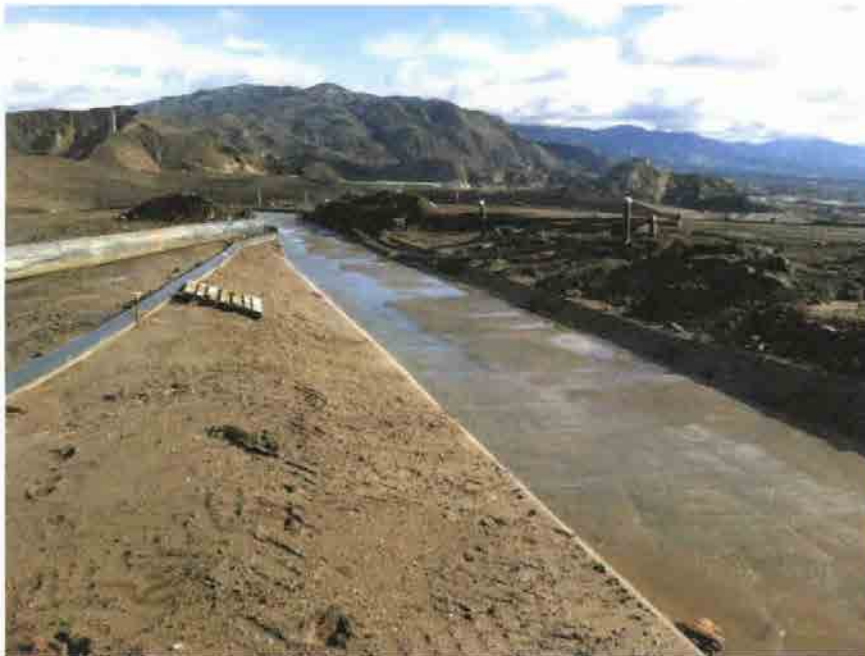
Photo 5: Drainage ditch out of Basin A cleaned and flowing
