**Sunshine Canyon Landfill  
Independent Monitor  
Quarterly Site Monitoring Status Report  
January 1, 2016 – March 31, 2016**

**City of Los Angeles Department of City Planning**

**County of Los Angeles Department of Regional Planning**

May 16, 2016

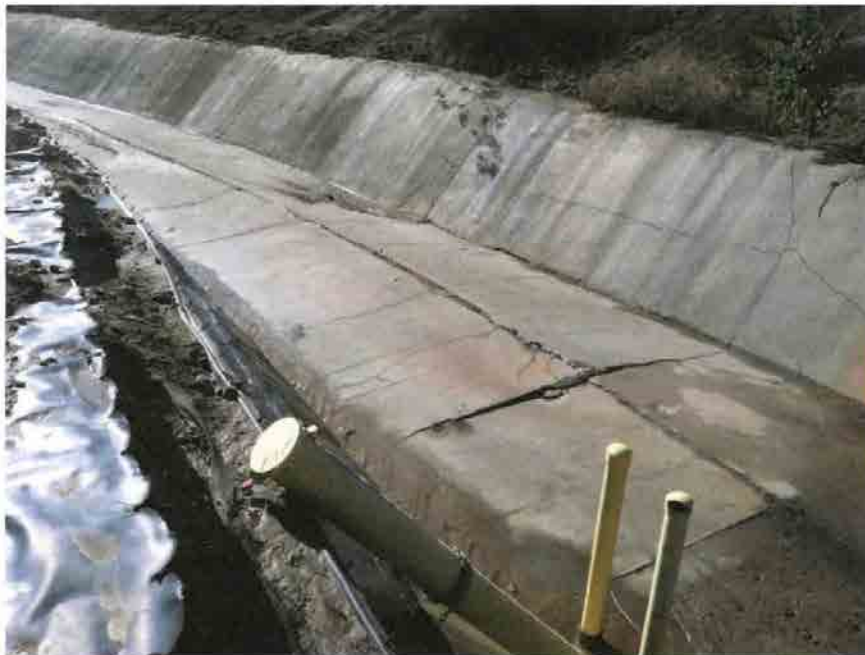
- Bottom slab held well (Photo 6)
  - Erosion on the cut slope above brought a fair amount of oil in the channel (Photo 7) that will have to be cleaned.

Photo 6: Channel between Basin A and Basin D

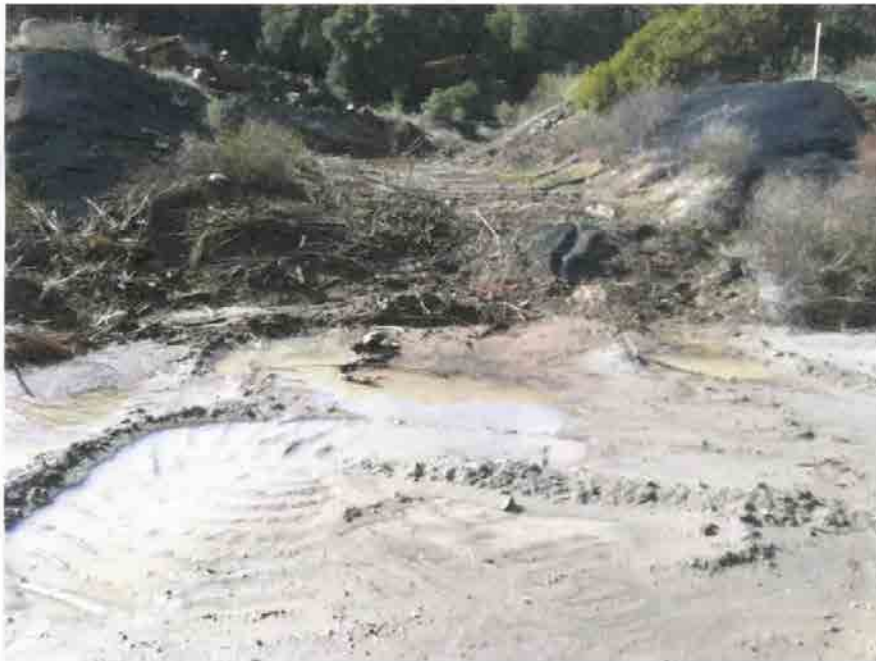
- The southern side drainage channel in the canyon at Basin D/boneyard noted in previous visit as blocked was opened (Photo 8) allowing drainage into Basin D

Photo 8: Cleared and opened southern side ditch at Basin D

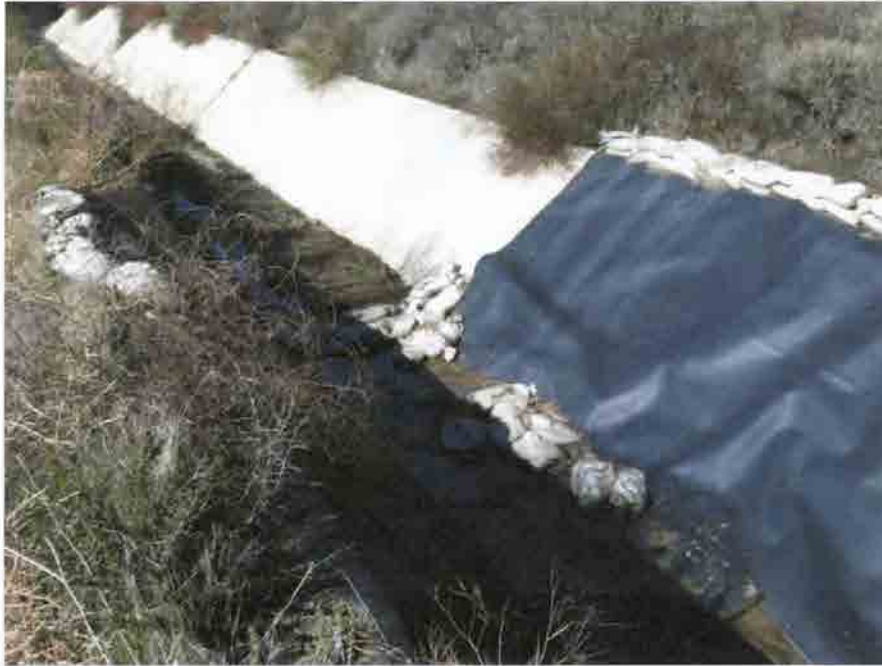
Photo 9: Geomembrane liner at beginning of lined portion between Basin D and Flare 9-10 access road

- Attach the geomembrane to the sides of the channel to reduce the risk of underflow (Photo 9).
    - fix the flap at entry to culvert to the shotcrete (Photo 10)

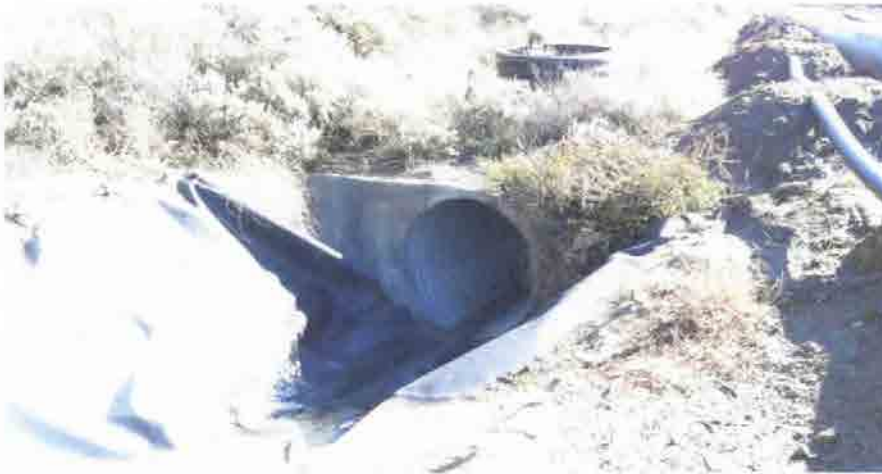
Photo 10: Geomembrane liner at entry to culvert near Flare 9-10 access road

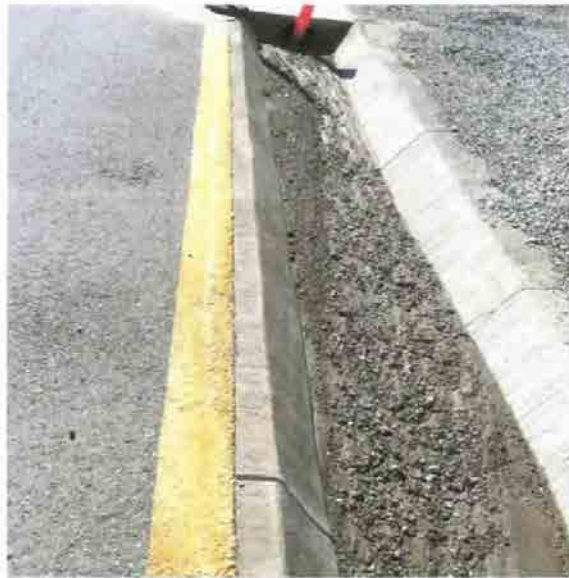
Photo 11: Drainage ditch along access road to Flares 9 and 10

- upper portion of channel draining the access road to the power generating station and Flares 9 and 10 should be cleaned prior to next storm (Photo 11)

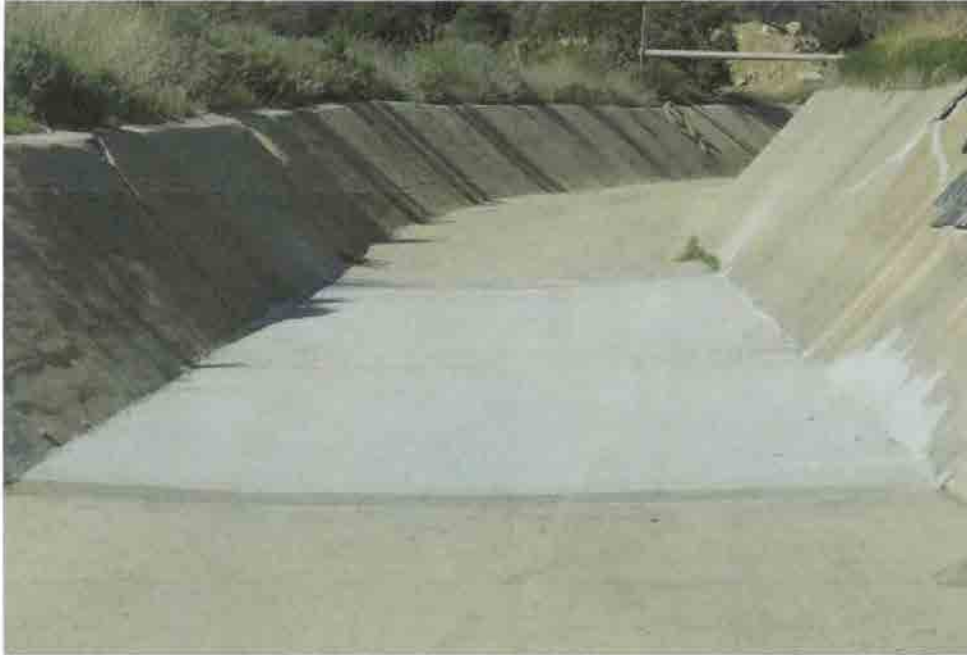
Photo 1: repaired bottom of channel between Basin A and Basin D

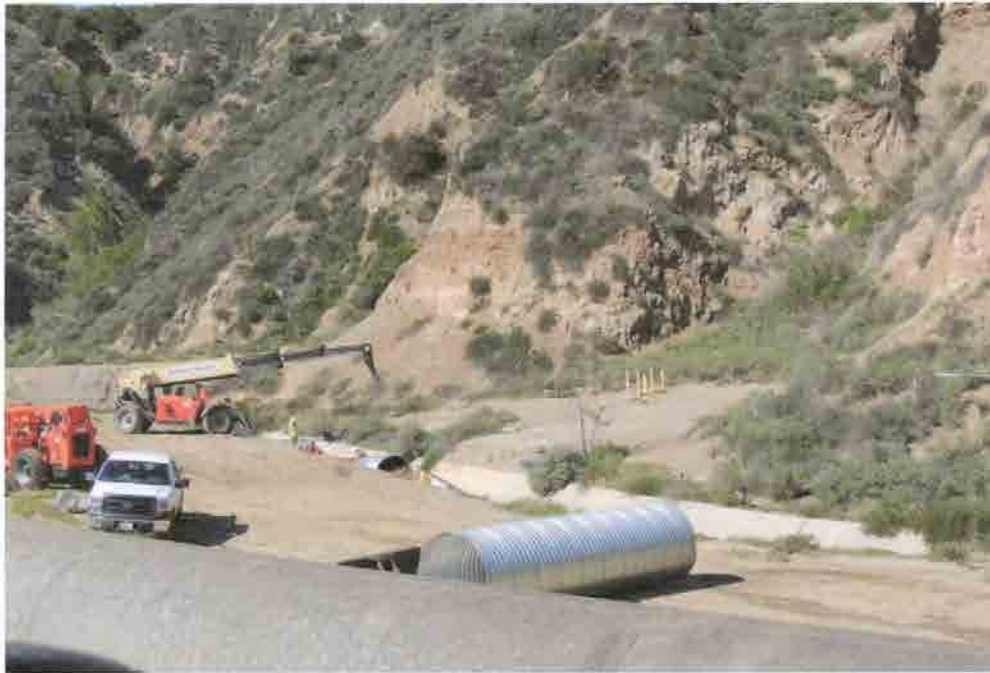
Photo 3: New CSP between Basin D and access road to Flare 9-10

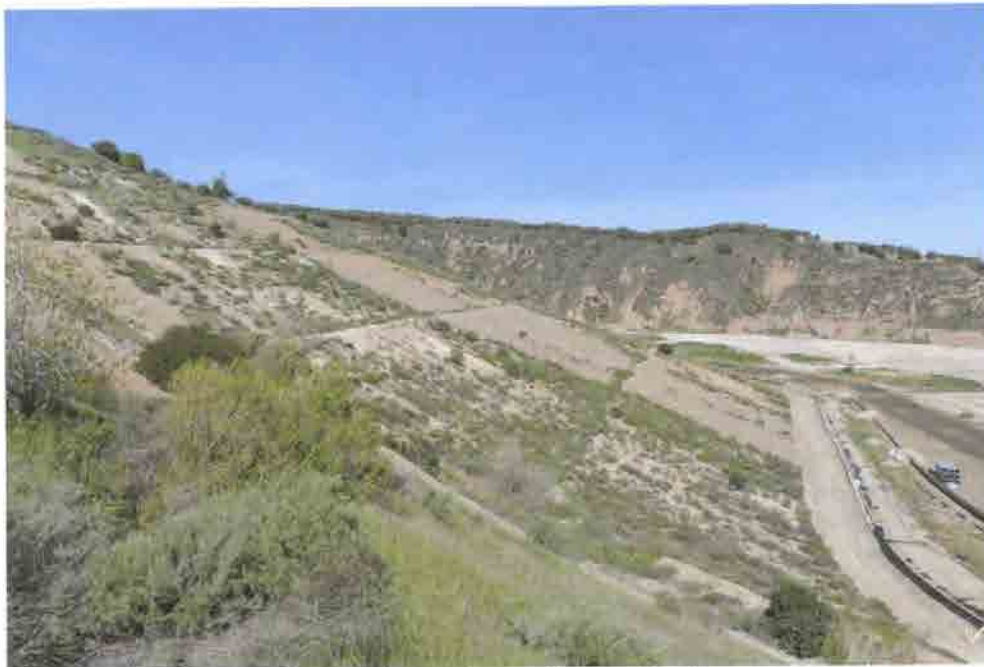
| <b>Coastal sage mitigation area</b> <ul style="list-style-type: none"> <li>the area includes 5 slopes and 4 benches (Photo 8)</li> <li>the benches are connected with concrete down chutes</li> <li>the benches are sloped back into the slope to create drainage ditches long the toe of the up-slope</li> <li>Erosion gullies are present on the bare areas and none on the vegetated areas. it was noted that the base geologic formation is different in the vegetated and non-vegetated areas which may contribute to the difference in behavior</li> <li>the down chute show some signs of distress <ul style="list-style-type: none"> <li>cracks where observed but with limited displacements(Photo 9) so the down chute is still functioning</li> <li>erosion along the edge on the downslopes(Photo 10)</li> </ul> </li> </ul> |

Photo 8: Overall view of coastal sage mitigation area

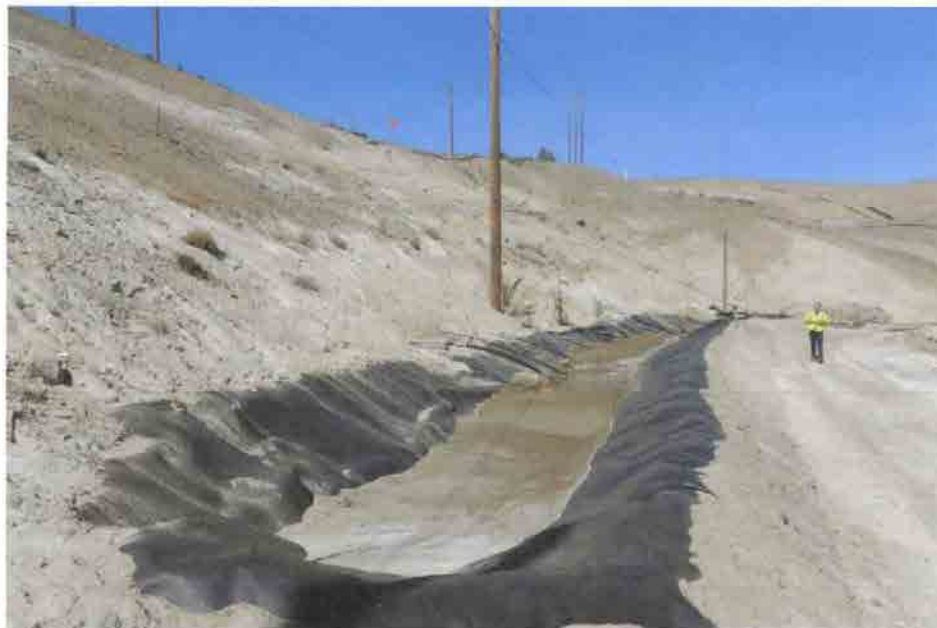
| <ul style="list-style-type: none"> <li>Flows from the seeps at the excavated face of future cell CCII are collected and properly managed (Photo 12).</li> </ul> |

Photo 12: Seep collection at toe of future Cell CCII
