**Sunshine Canyon Landfill  
Independent Monitor  
Quarterly Site Monitoring Status Report  
October 1, 2015 – December 31, 2015**

**City of Los Angeles Department of City Planning**

**County of Los Angeles Department of Regional Planning**

February 12, 2016

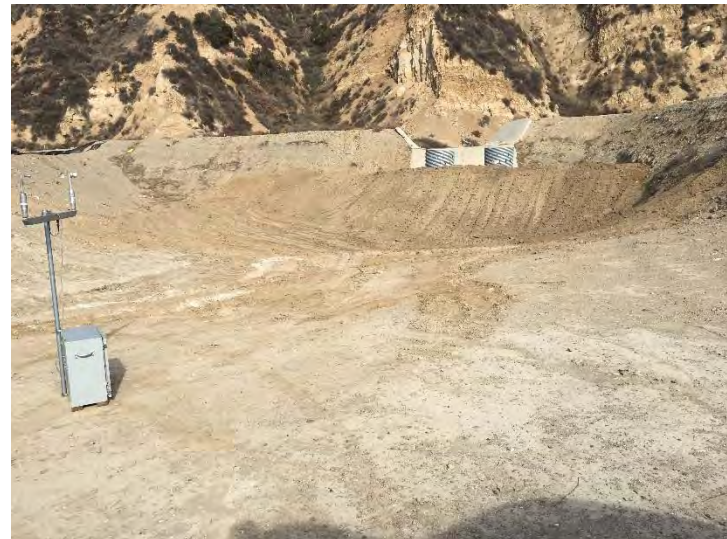
**Photo 83: Basin D: December 9, 2015**

**Photo 84: Basin D: December 9, 2015**

**Photo 85: Basin D: December 9, 2015**

**Photo 86: Basin D: December 9, 2015**

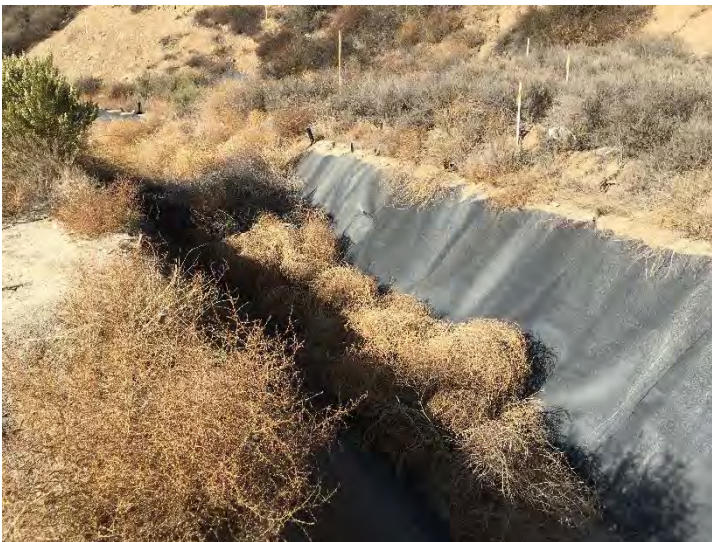
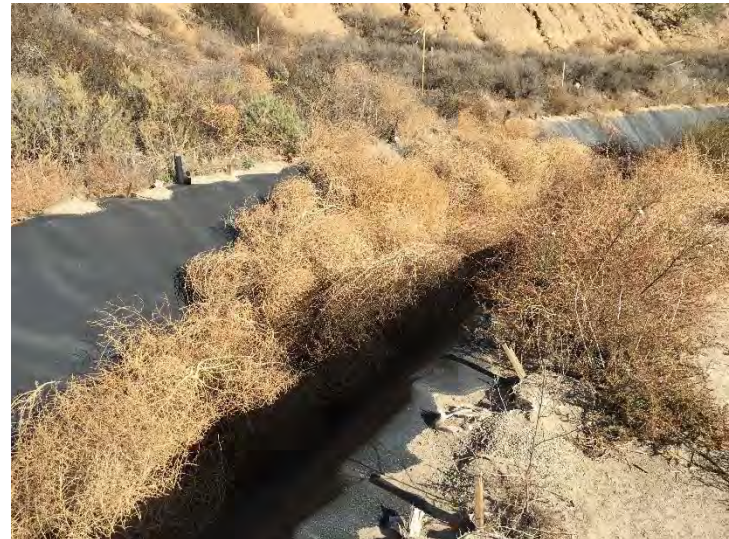
**Photo 87: Basin D Outlet Channel: October 14, 2015**

**Photo 88: Basin D Outlet Channel: October 14, 2015**

**Photo 89: Basin D Outlet Channel: October 14, 2015**

**Photo 90: Basin D Outlet Channel: October 14, 2015**

**Photo 91: Basin D Outlet Channel: October 14, 2015**

**Photo 92: Basin D Outlet Channel: October 28, 2015**

**Photo 93: Basin D Outlet Channel: October 28, 2015**

**Photo 94: Basin D Outlet Channel: October 28, 2015**

**Photo 95: Basin D Outlet Channel: November 16, 2015**

**Photo 96: Basin D Outlet Channel: November 16, 2015**

**Photo 97: Basin D Outlet Channel: November 16, 2015**

**Photo 98: Basin D Outlet Channel: December 9, 2015**

**Photo 99: Basin D Outlet Channel: December 9, 2015**

**Photo 100: Basin D Outlet Channel: December 9, 2015**

**Photo 101: Basin D Outlet Channel: December 9, 2015**

**Photo 102: Basin D Outlet Channel: December 9, 2015**

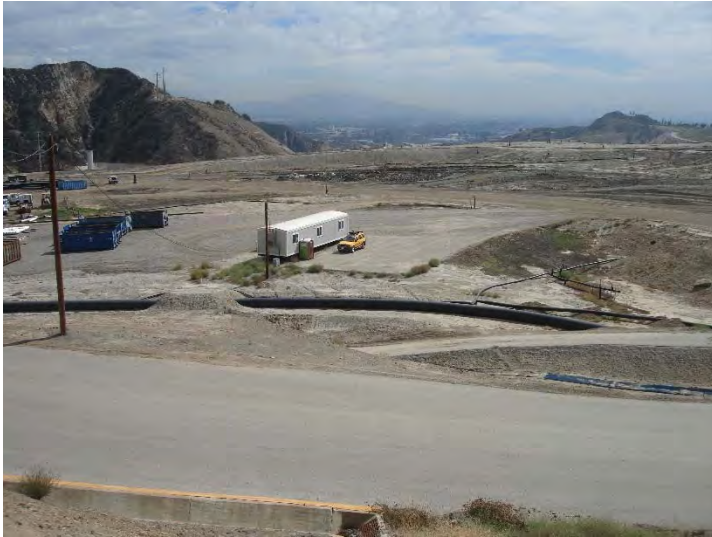
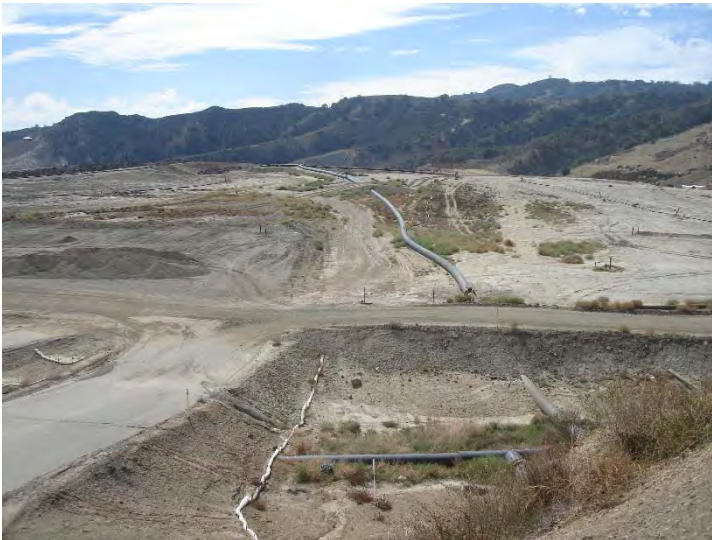
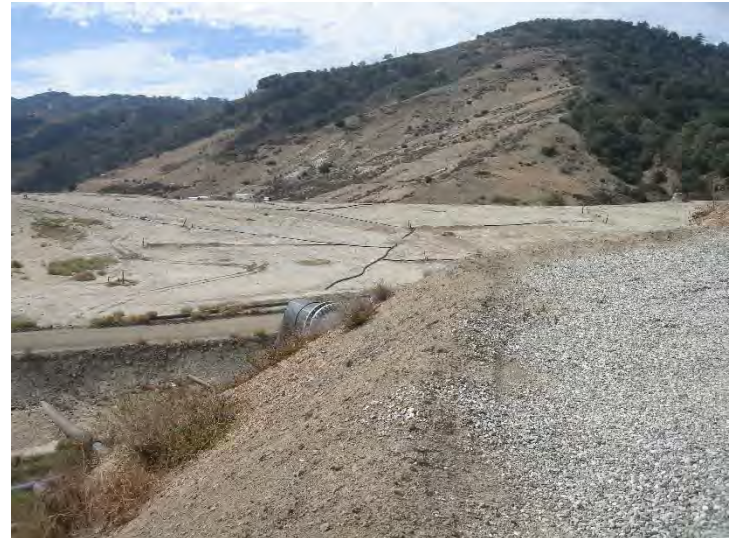
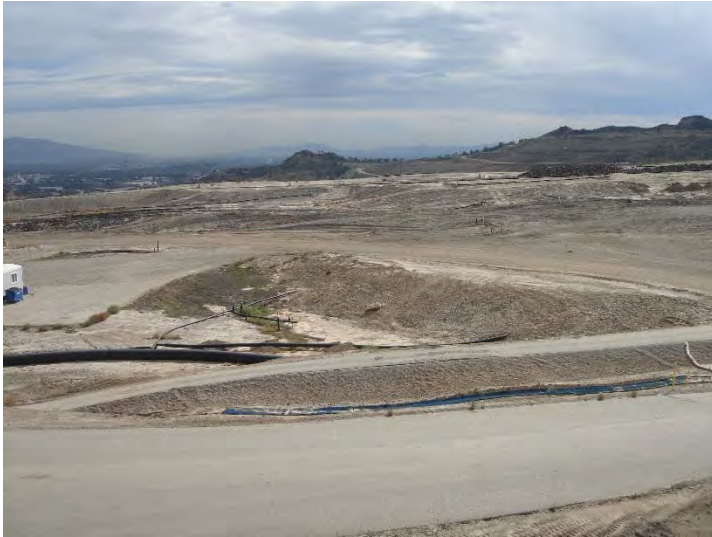
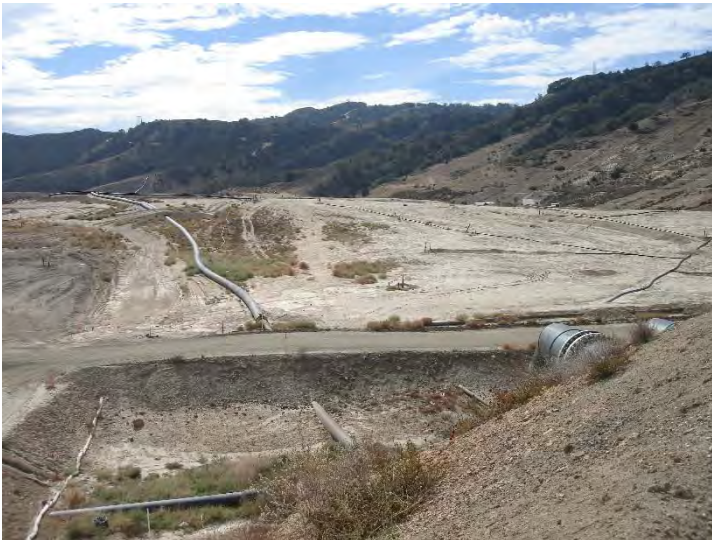
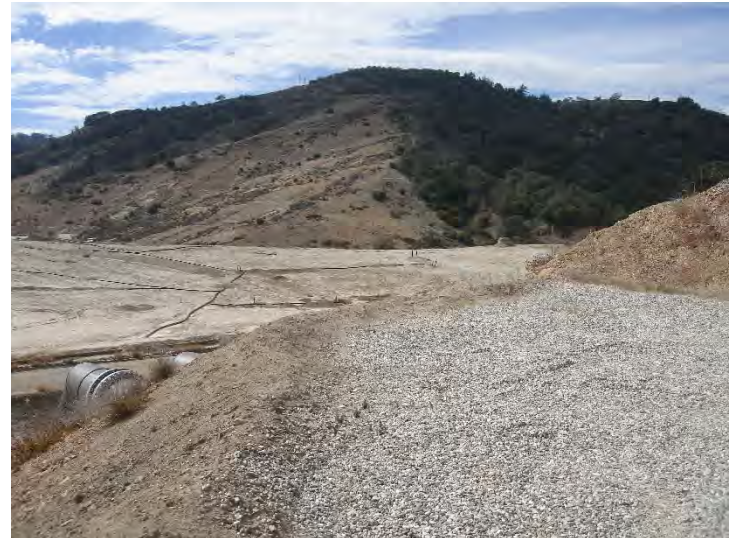
**Photo 108: County Top Deck: October 14, 2015**

**Photo 109: County Top Deck: October 14, 2015**

**Photo 110: County Top Deck: October 14, 2015**

**Photo 111: County Top Deck: October 14, 2015**

**Photo 112: County Top Deck: October 14, 2015**

**Photo 113: County Top Deck: October 14, 2015**

**Photo 114: County Top Deck: October 14, 2015**

**Photo 115: County Top Deck: October 28, 2015**

**Photo 116: County Top Deck: October 28, 2015**

**Photo 117: County Top Deck: October 28, 2015**

**Photo 118: County Top Deck: October 28, 2015**

**Photo 119: County Top Deck: October 28, 2015**

**Photo 120: County Top Deck: October 28, 2015**

**Photo 121: County Top Deck: October 28, 2015**

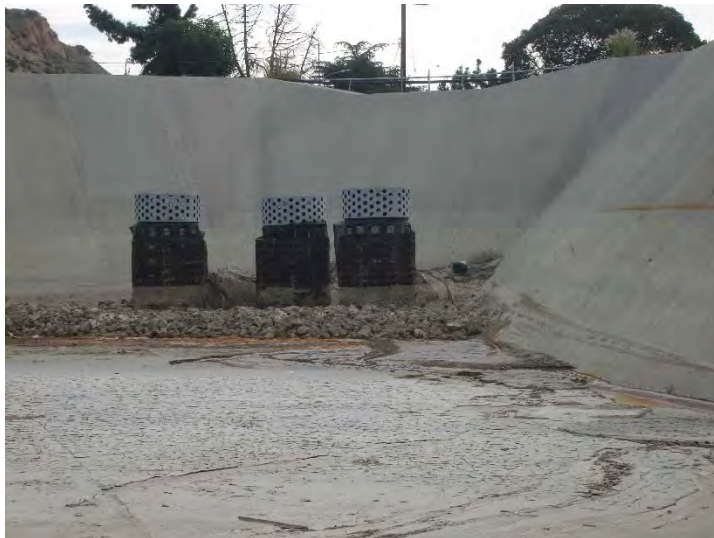
**Photo 162: Terminal Basin: October 28, 2015**

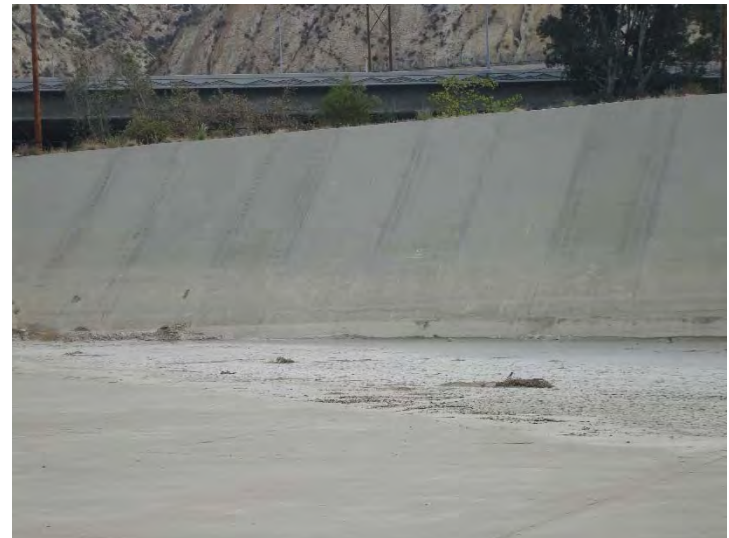
**Photo 163: Terminal Basin: October 28, 2015**

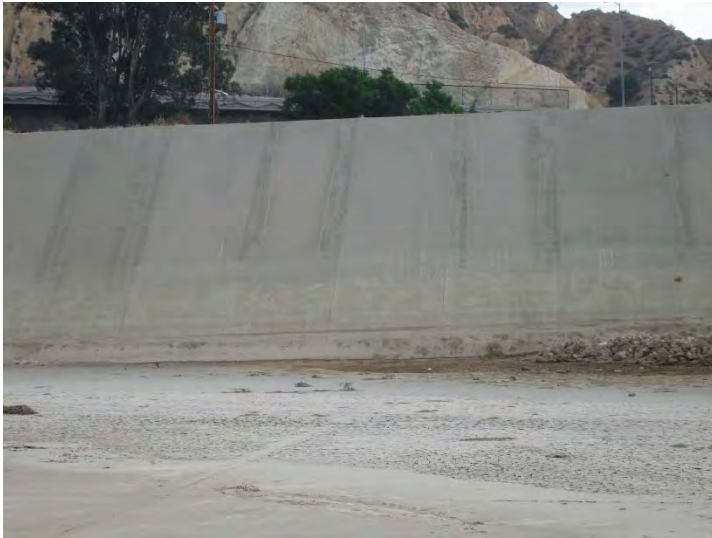
**Photo 164: Terminal Basin: October 28, 2015**

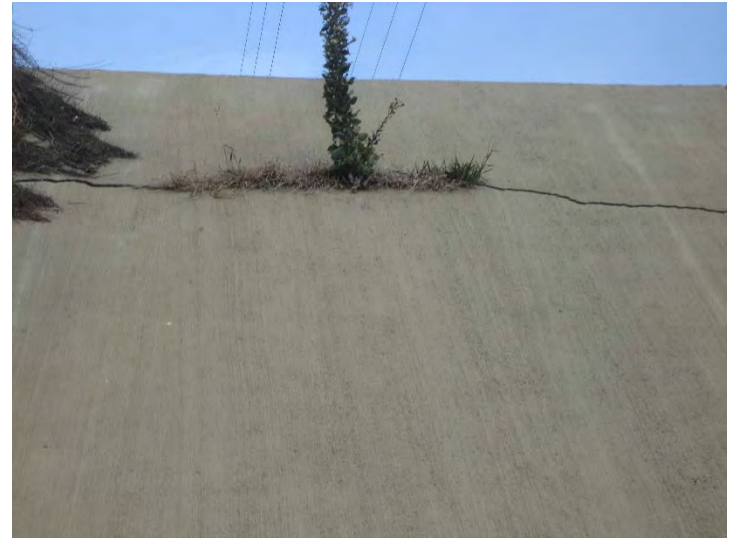
**Photo 165: Terminal Basin: October 28, 2015**

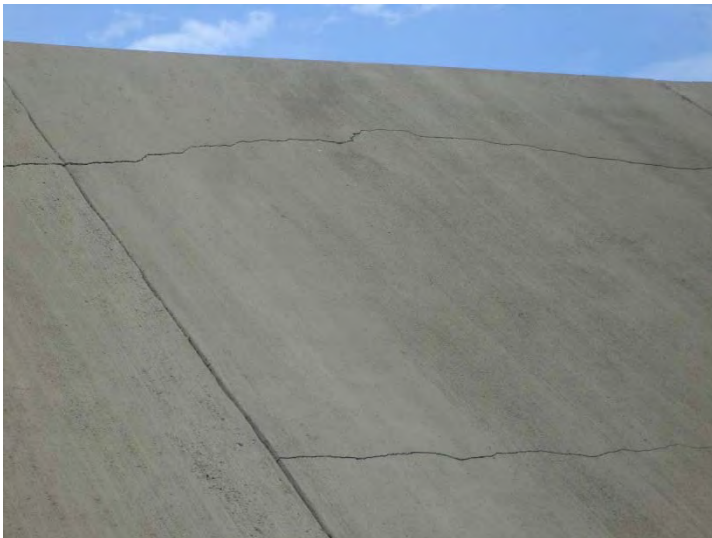
**Photo 166: Terminal Basin Exterior Wall: October 28, 2015**

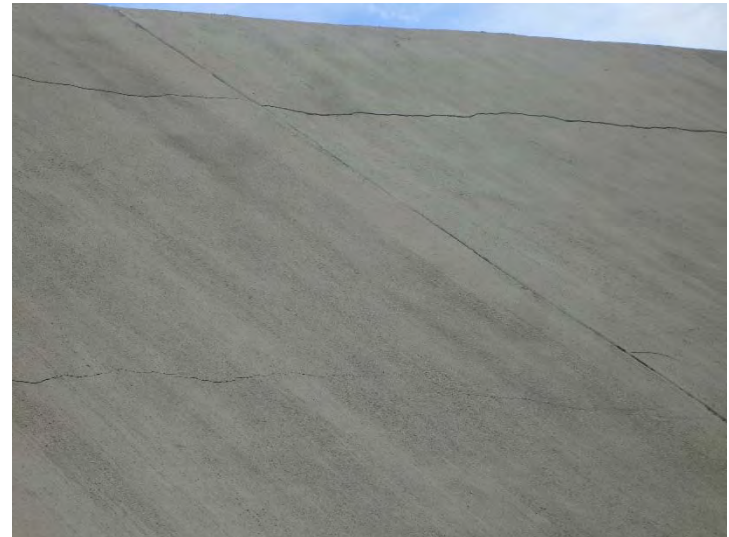
**Photo 167: Terminal Basin Exterior Wall: October 28, 2015**

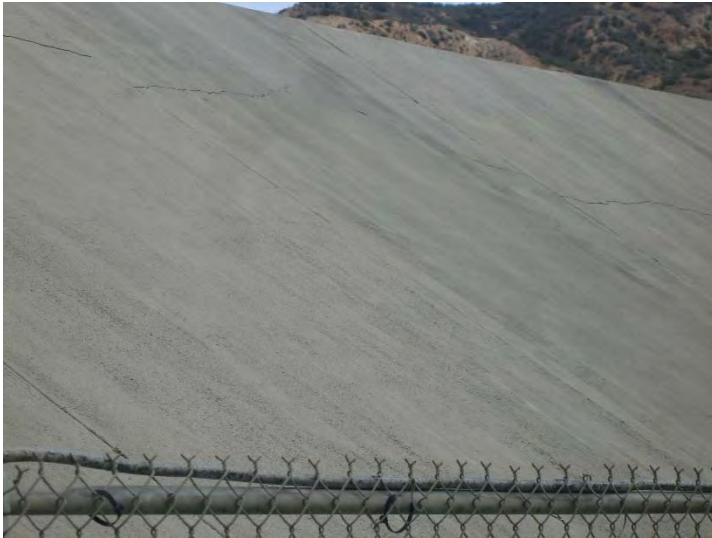
**Photo 168: Terminal Basin Exterior Wall: October 28, 2015**

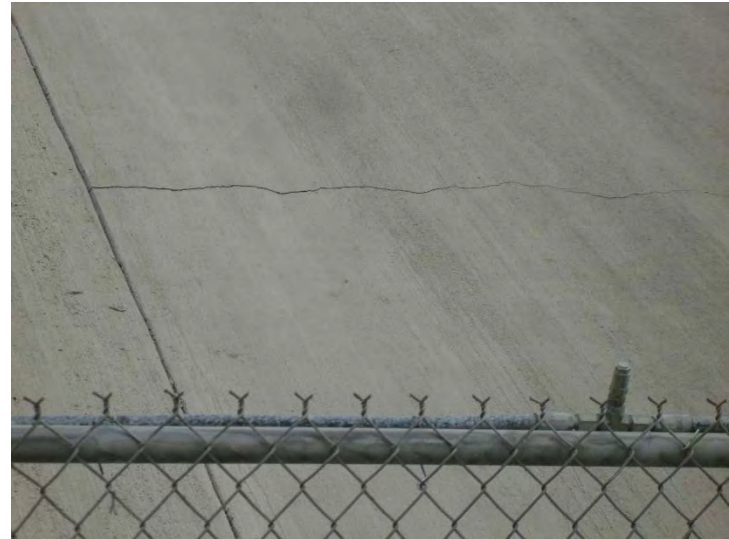
**Photo 169: Terminal Basin Exterior Wall: October 28, 2015**

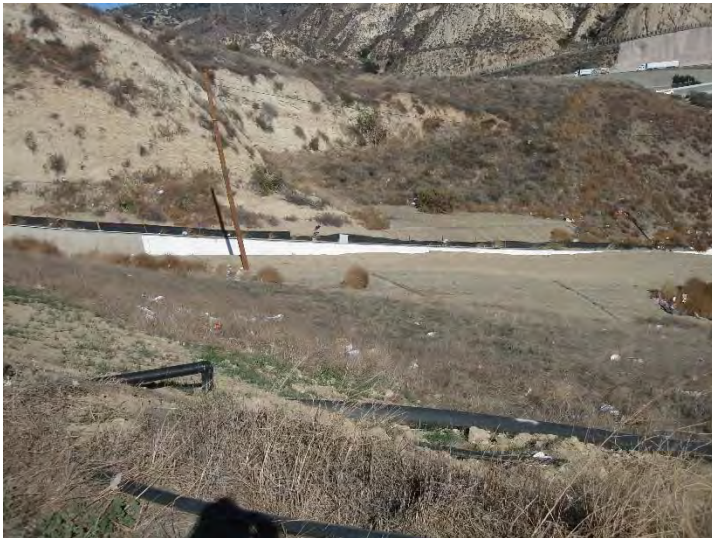
**Photo 170: Terminal Basin Exterior Wall: October 28, 2015**

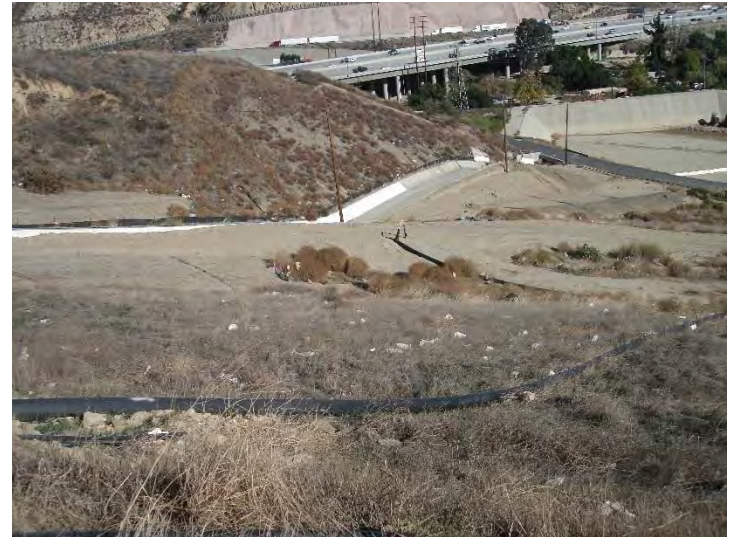
**Photo 171: Terminal Basin Area: November 16, 2015**

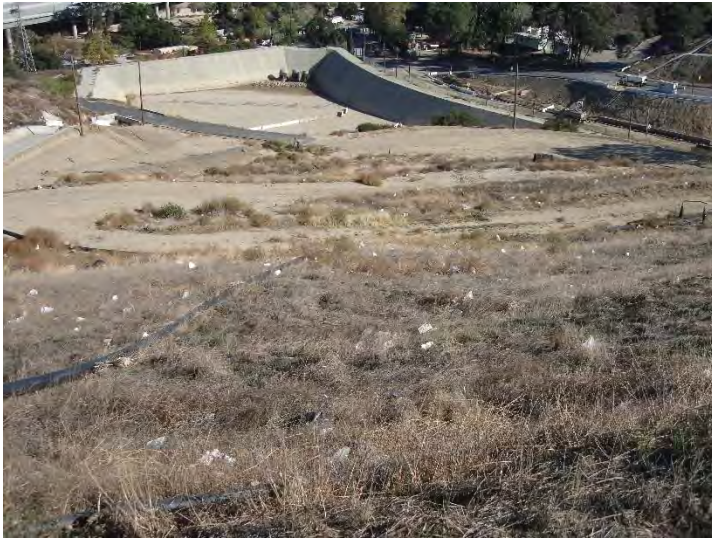
**Photo 172: Terminal Basin Area: November 16, 2015**

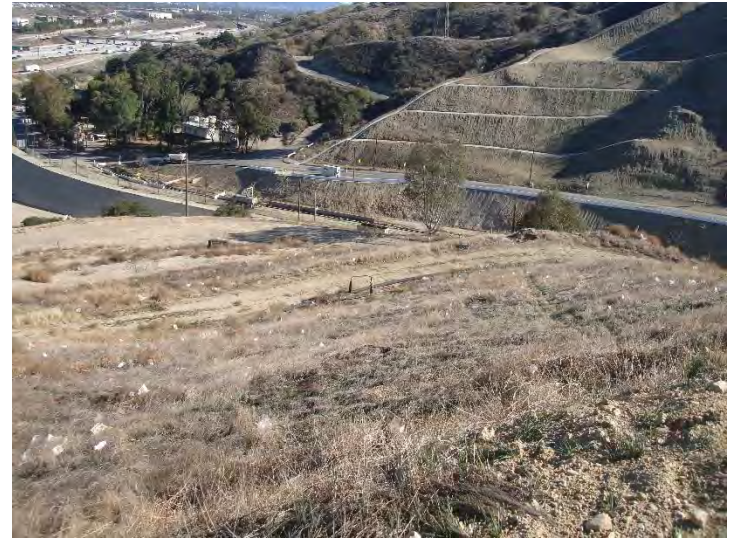
**Photo 173: Terminal Basin Area: November 16, 2015**

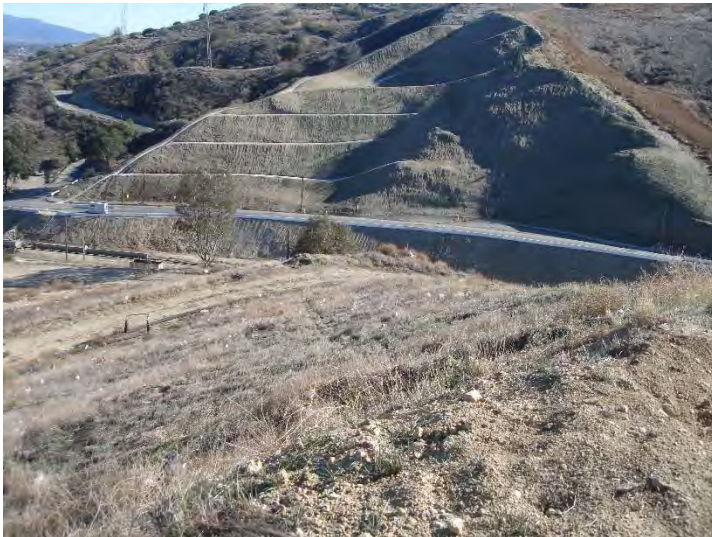
**Photo 174: Terminal Basin Area: November 16, 2015**

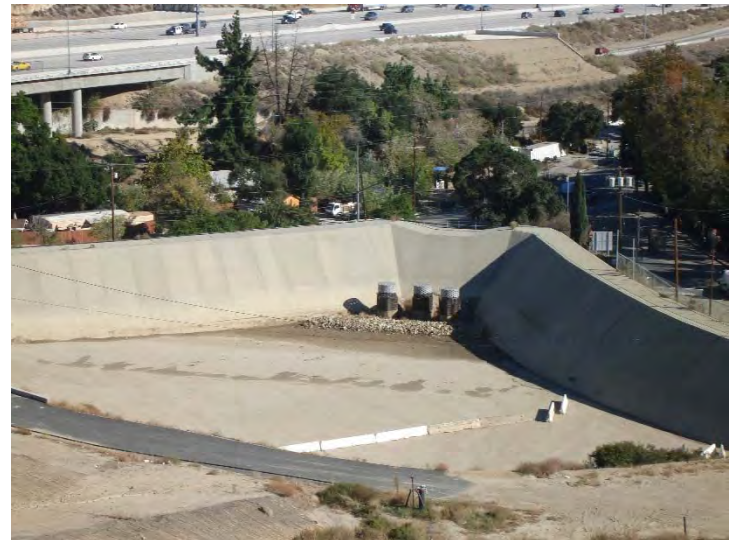
**Photo 175: Terminal Basin Area: November 16, 2015**

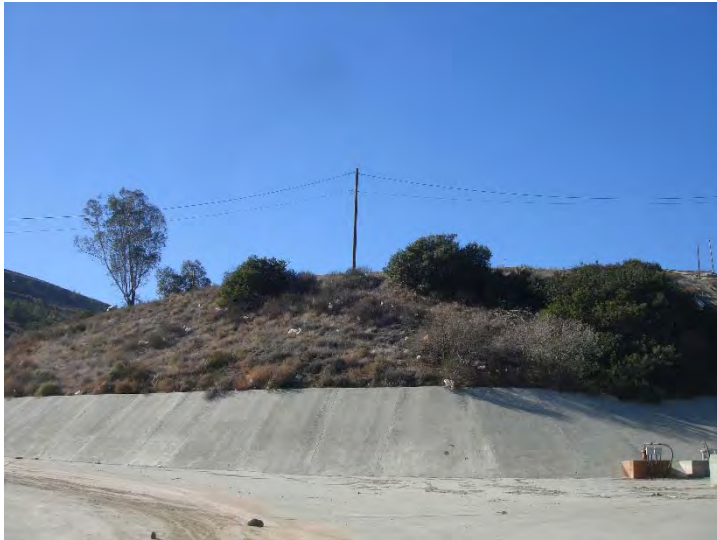
**Photo 176: Terminal Basin: November 16, 2015**

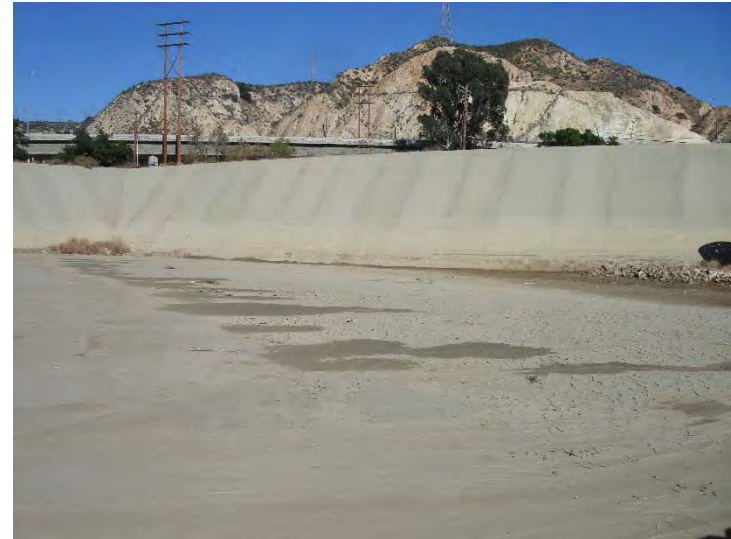
**Photo 177: Terminal Basin: November 16, 2015**

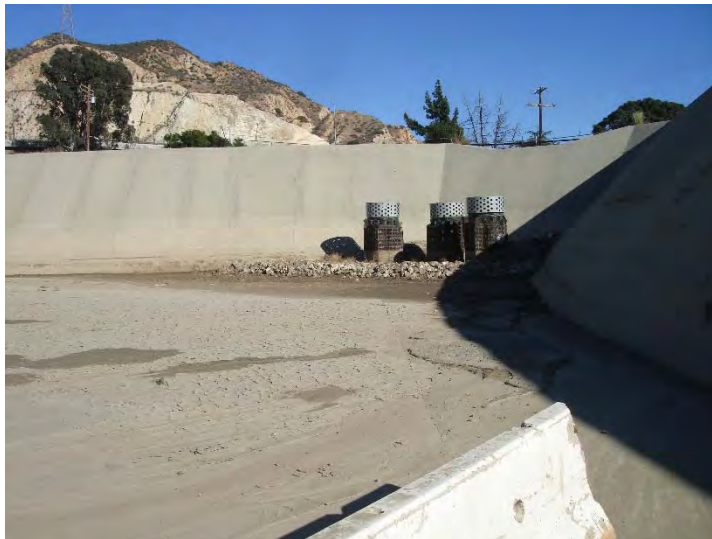
**Photo 178: Terminal Basin: November 16, 2015**

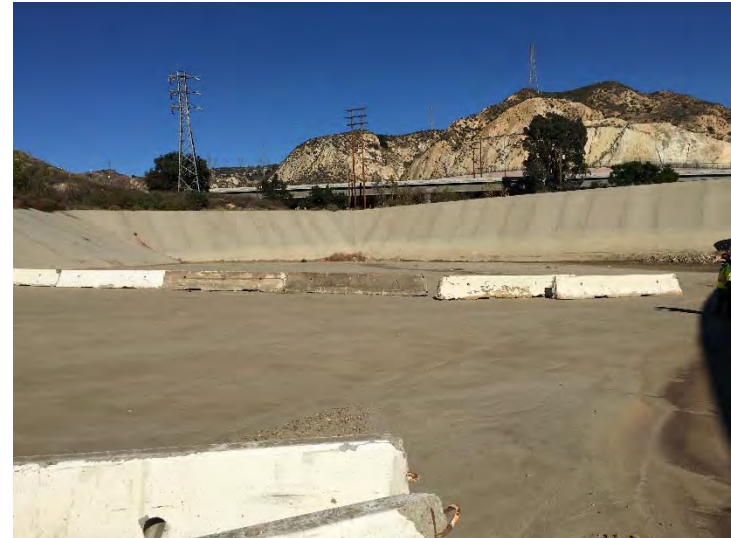
**Photo 179: Terminal Basin: November 16, 2015**

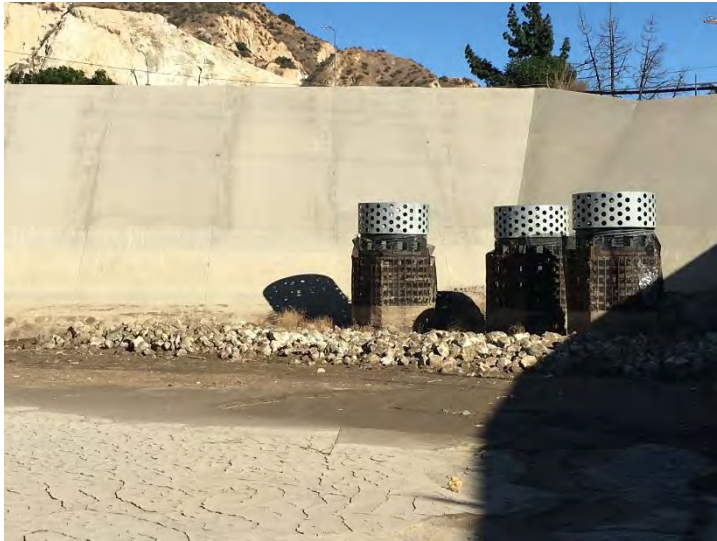
**Photo 180: Terminal Basin: November 16, 2015**

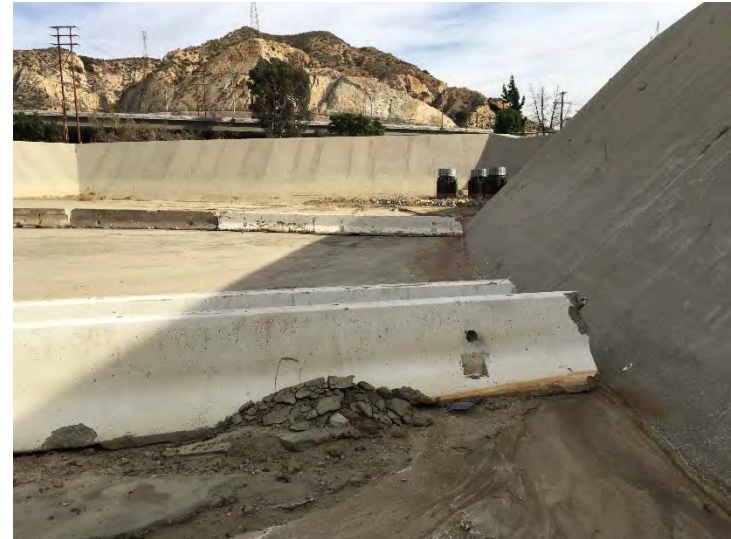
**Photo 181: Terminal Basin: November 16, 2015**

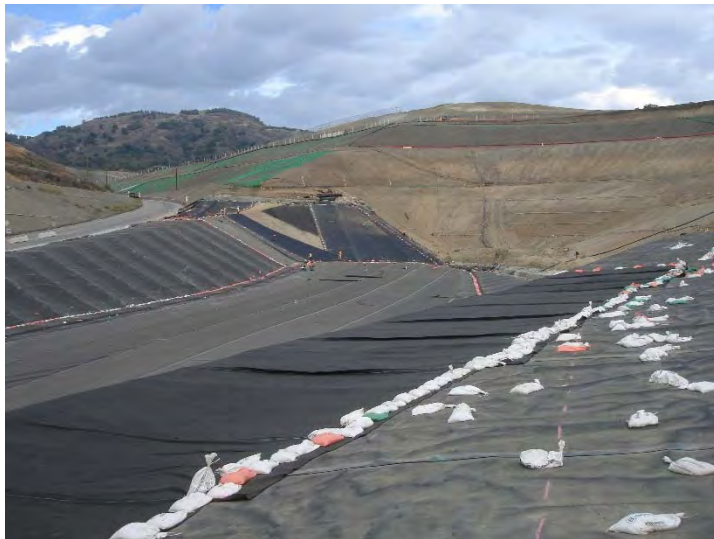
**Photo 182: Terminal Basin: December 9, 2015**

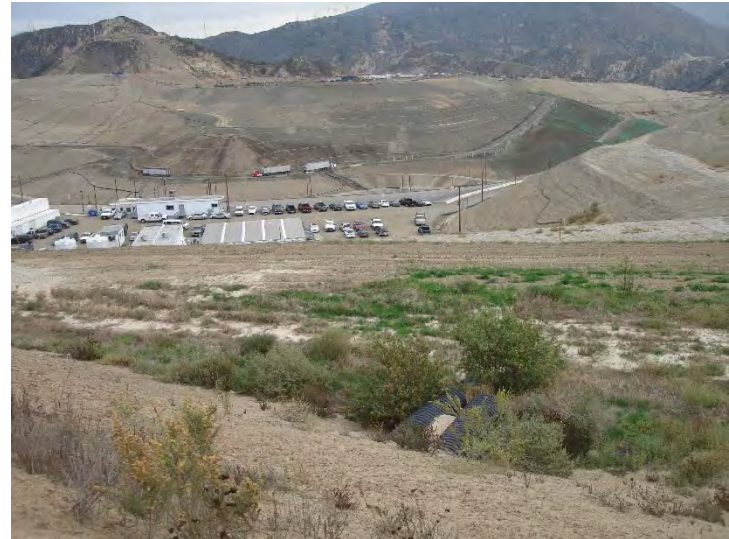
**Photo 254: City Slope Erosion Control: October 28, 2015**

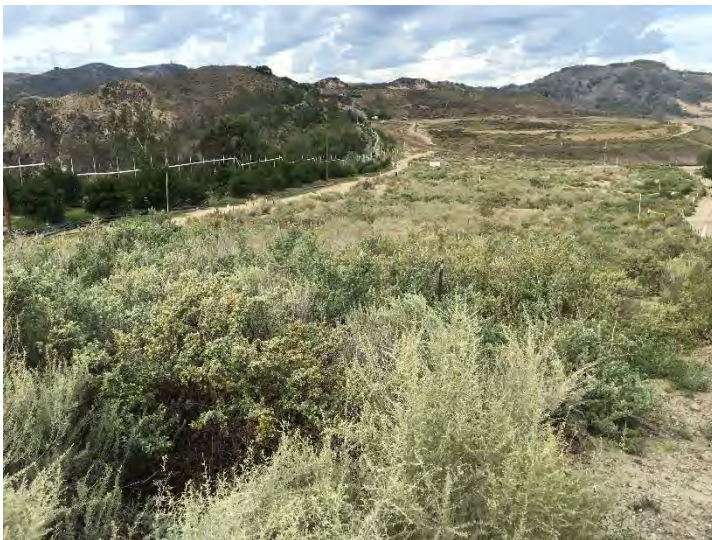
| Discipline | City Condition Reference # / Mitigation # | County Condition Reference # / Mitigation # | Responsible Agency | Further Review Needed-Comments |
|---|---|---|---|---|
| | M - 4.4.1 / 60 | | City Planning | <p>I-n: The monitors observed that the City Deck C sage mitigation was doing well. Removal of unwanted plants and thinning out of the salt bush was going to be scheduled. The oak mitigation trees on the City Deck C berm were doing well. The understory trees could be planted in over half of the berm. City Deck A and B had no sage mitigation or invasive plant removal activity.</p> <p>I-o: The monitors observed that the City Deck C sage mitigation had greened. Saltbush thinning and invasive plant removal was being performed by the contractor. There was no sage mitigation activity on City Decks A or B, or in the County sage mitigation area.</p> |

**Photo 276: City Sage Mitigation Deck C: October 14, 2015**

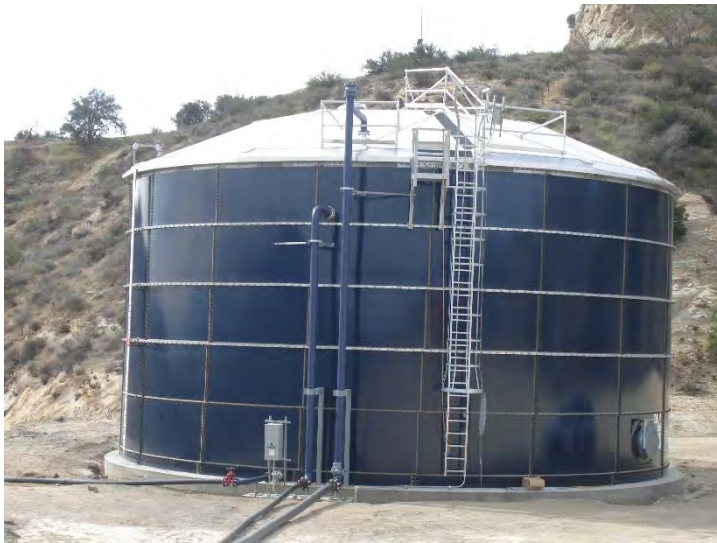
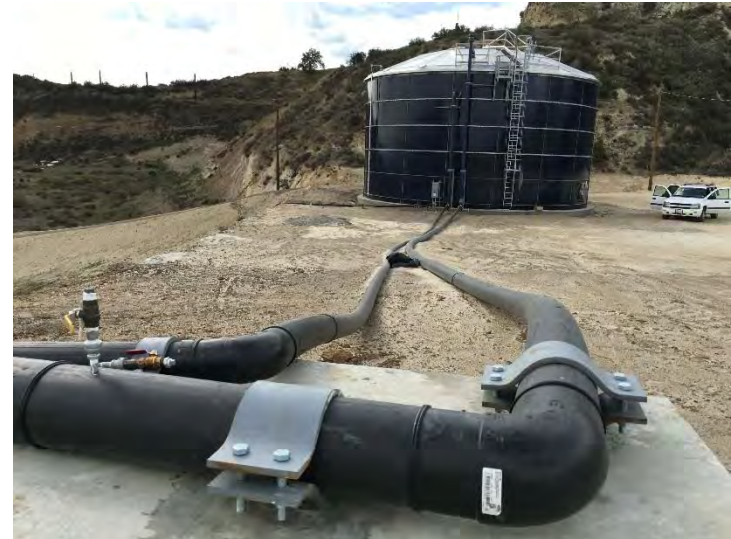
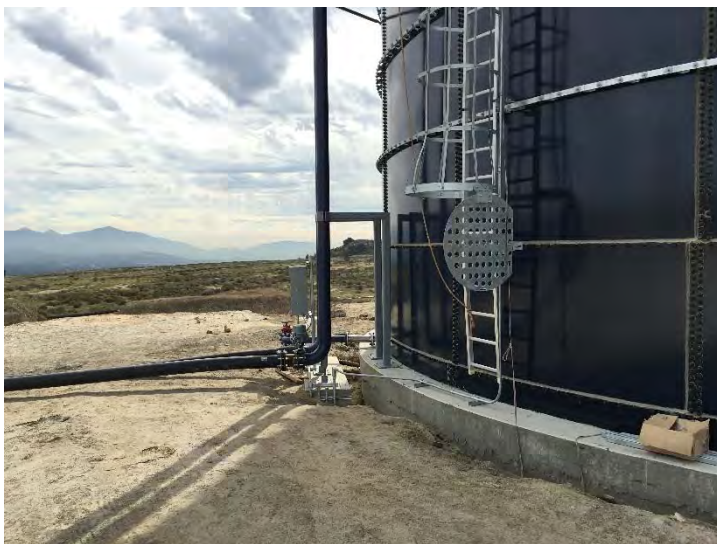
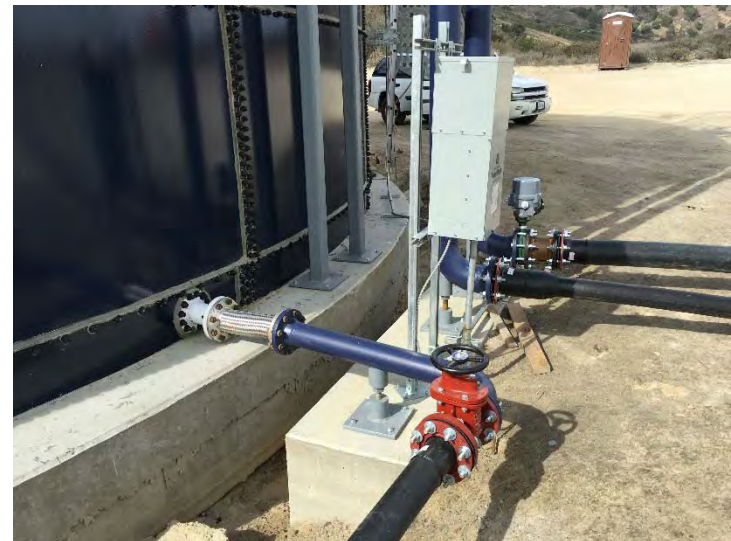
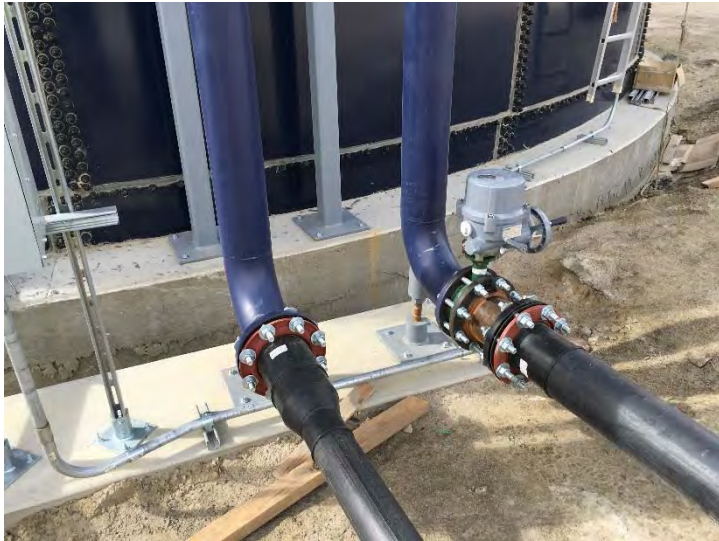
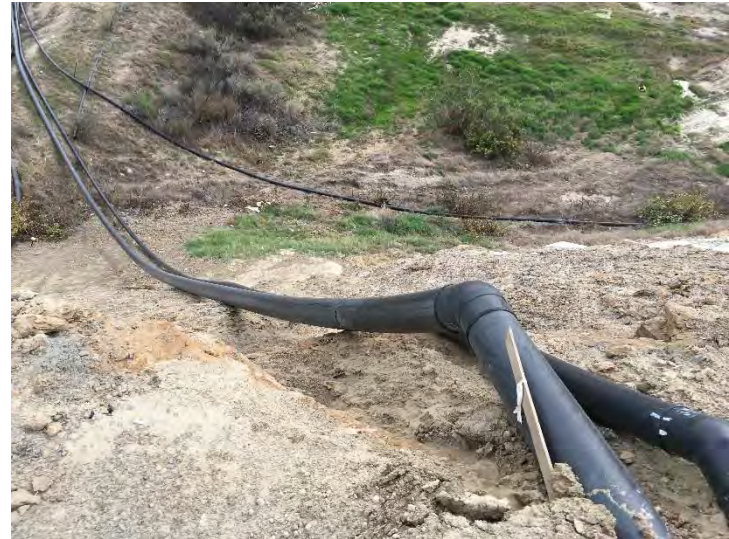
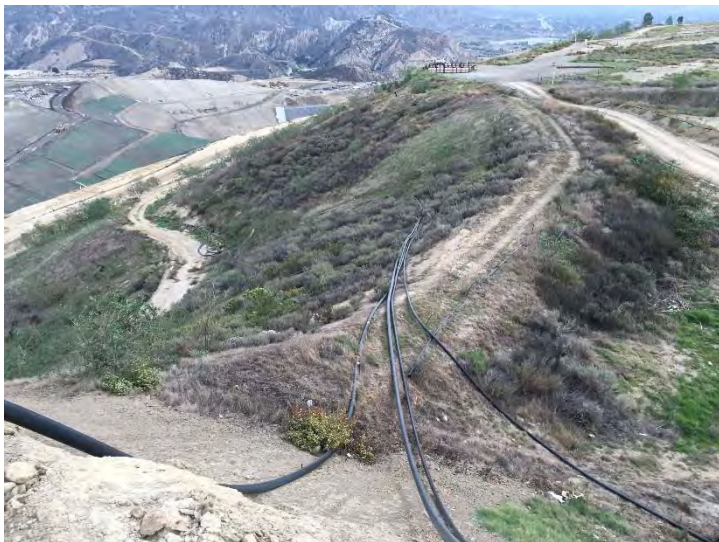
**Photo 300: New City South Water Tank Deck A: October 14, 2015**

- There was no sage mitigation activity on Decks A or B.
- The new water tank foundation has not been backfilled with soil. The soil on the deck adjacent to the tank is powder-like soil and should be treated with sealant.

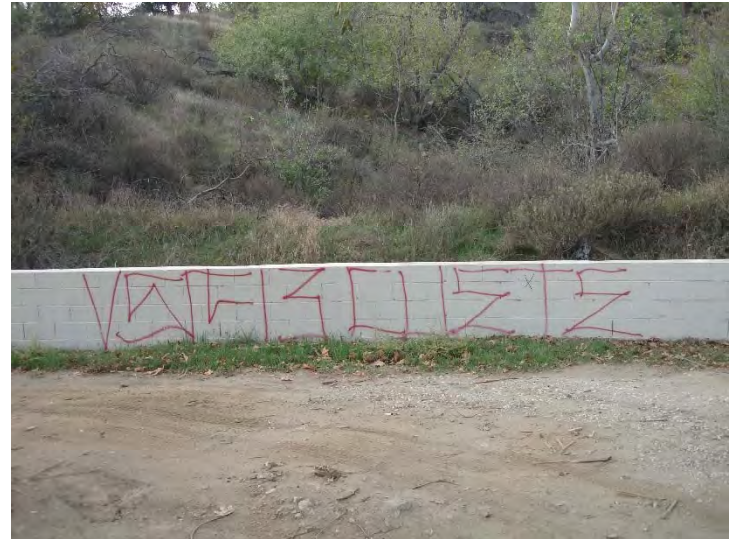
**Photo 326: Frontage Wall on San Fernando Road: October 28, 2015**

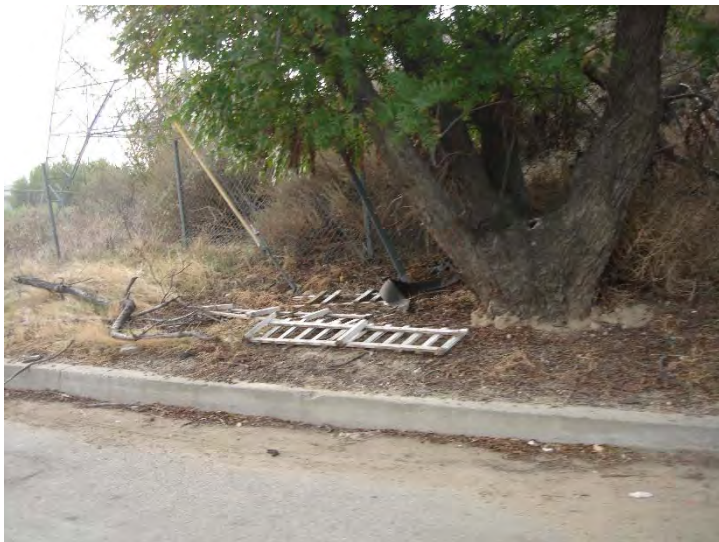
**Photo 342: Tree over Powerline: December 16, 2015**

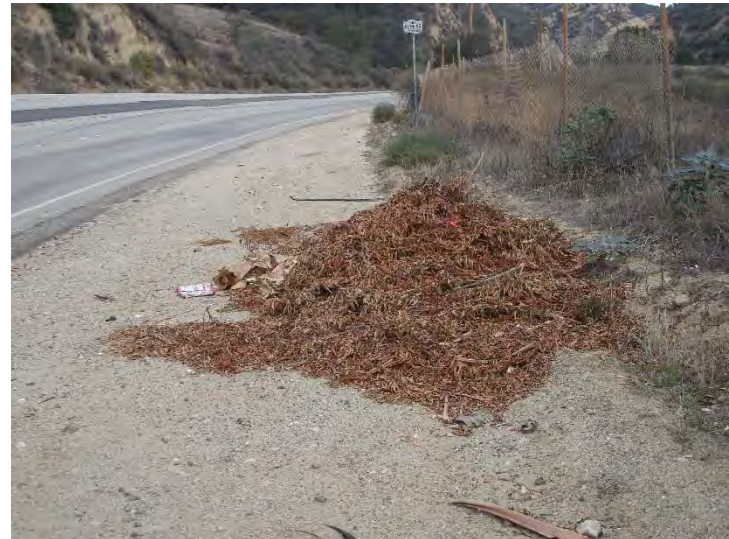
**Photo 359: Illegal Dumping: December 9, 2015**

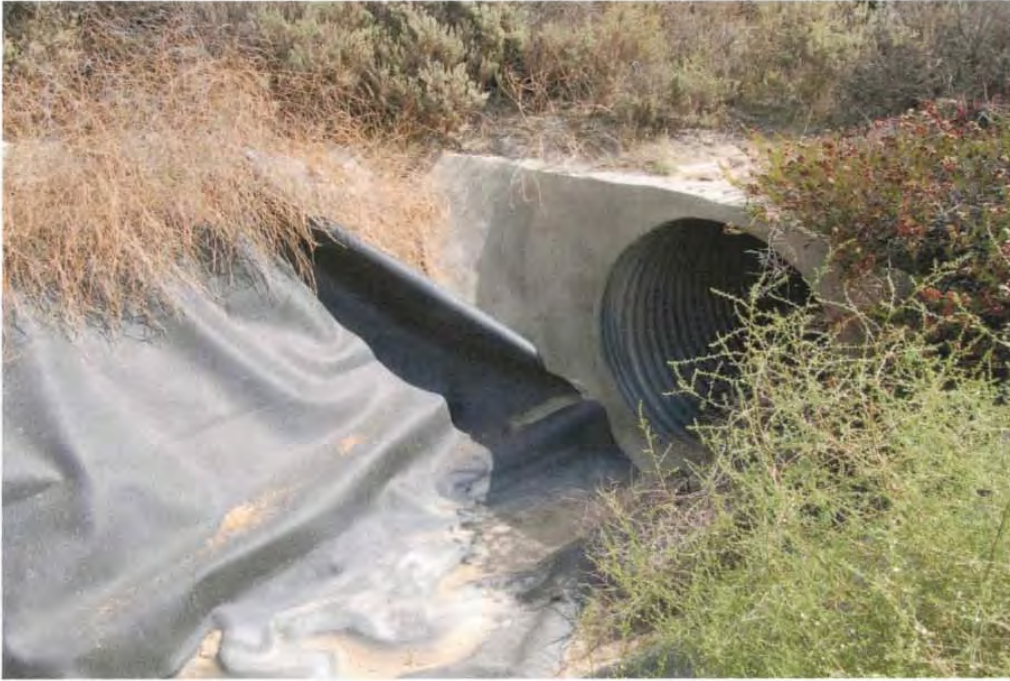
Photo 4: Geomembrane at Box Culver on Access Road

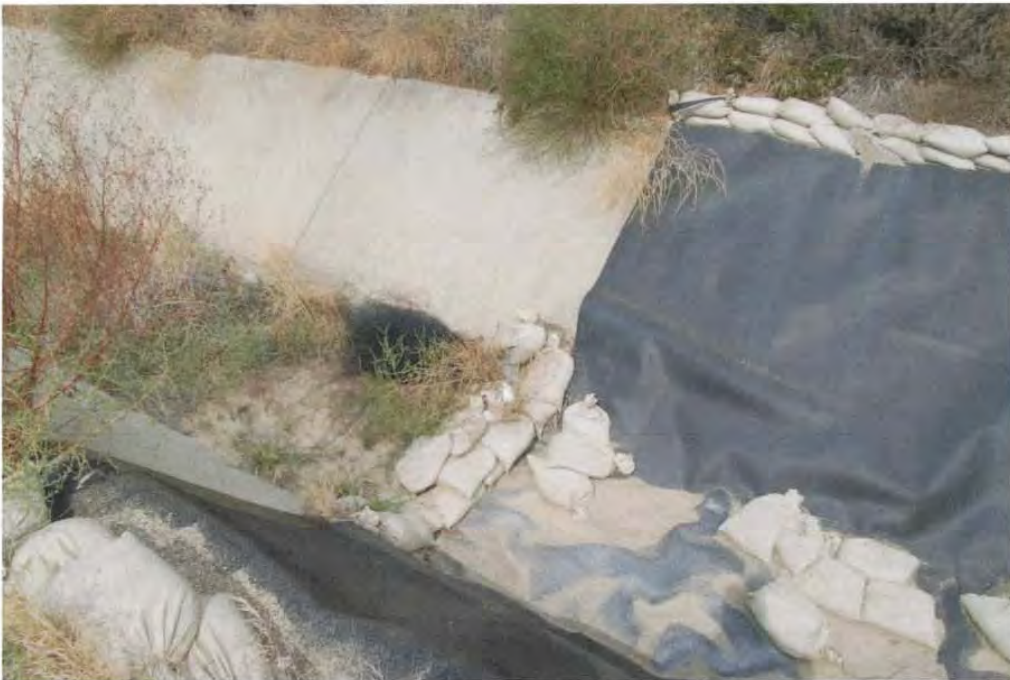
Photo 5: Geomembrane liner at entry to culvert near Flare 9-10 access road
