**Sunshine Canyon Landfill
Independent Monitor
Quarterly Site Monitoring Status Report
January 1, 2018 – March 31, 2018**

May 25, 2018

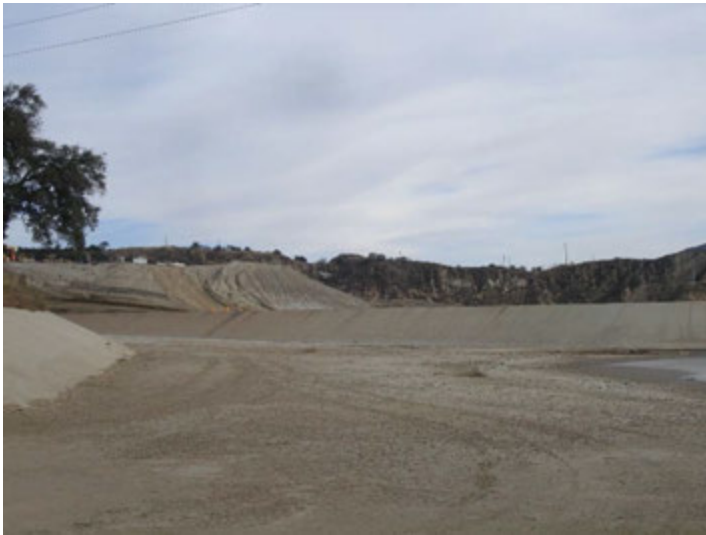
Photo 1: Basin A: January 30, 2018

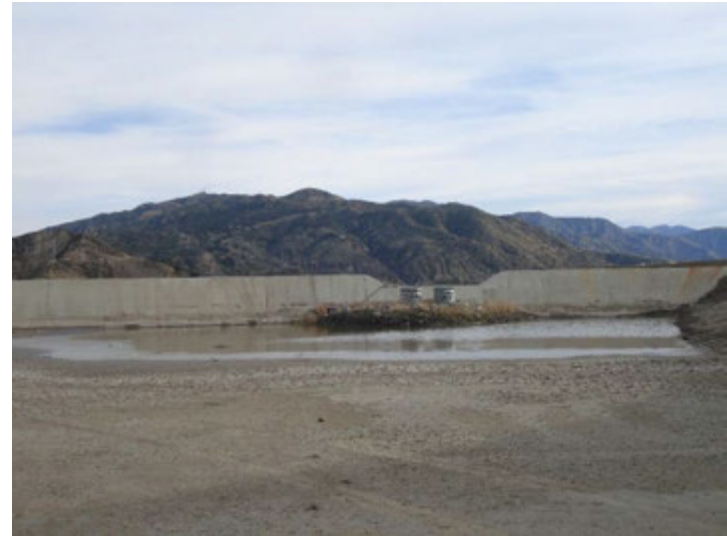
Photo 2: Basin A: January 30, 2018

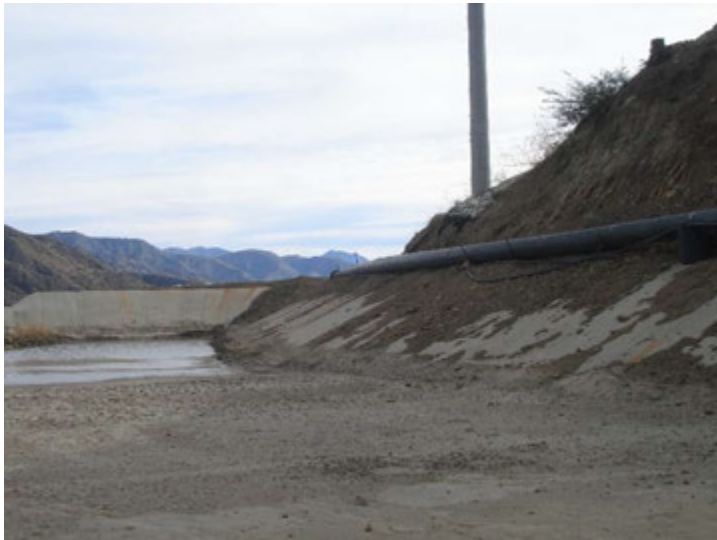
Photo 3: Basin A: January 30, 2018

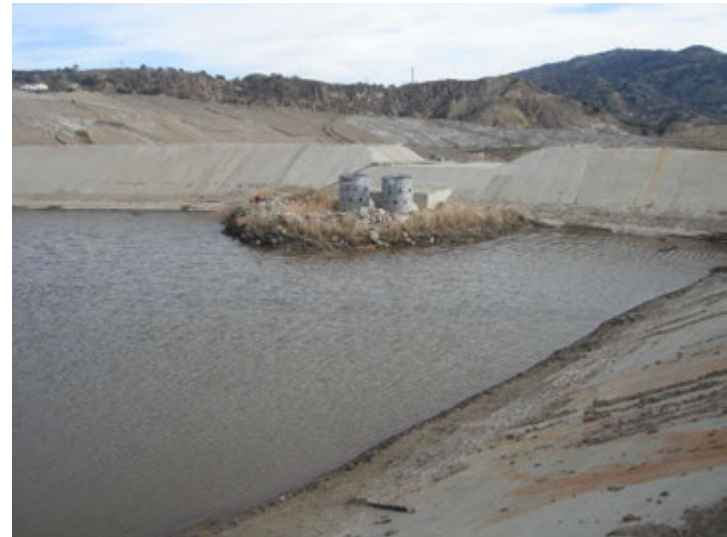
Photo 4: Basin A: January 30, 2018

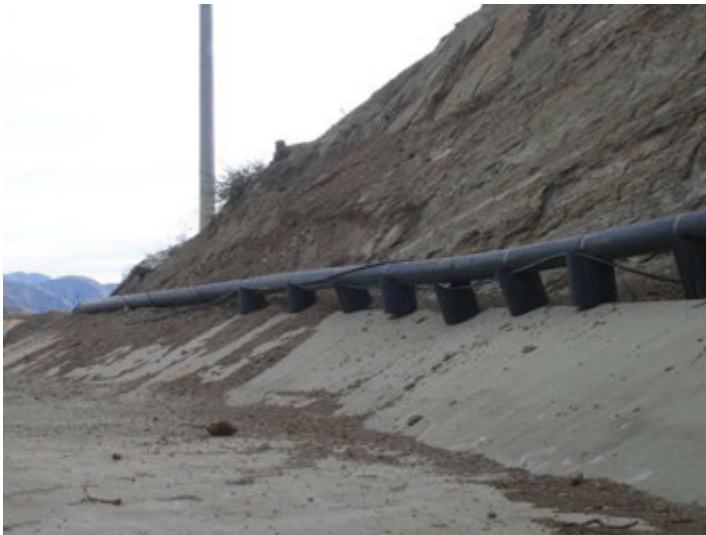
Photo 5: Basin A: January 30, 2018

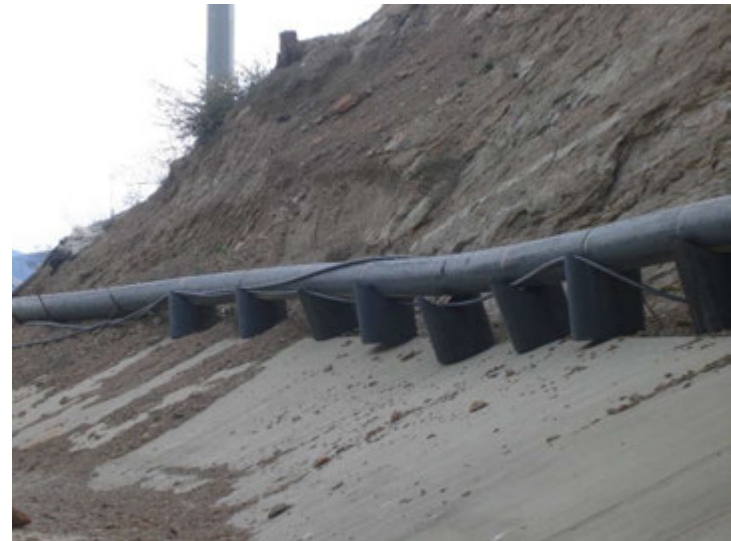
Photo 6: Basin A: January 30, 2018

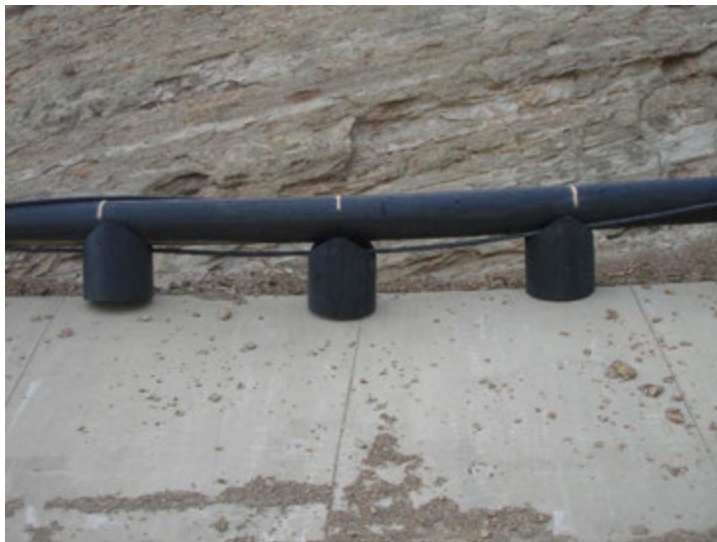
Photo 7: Basin A: January 30, 2018

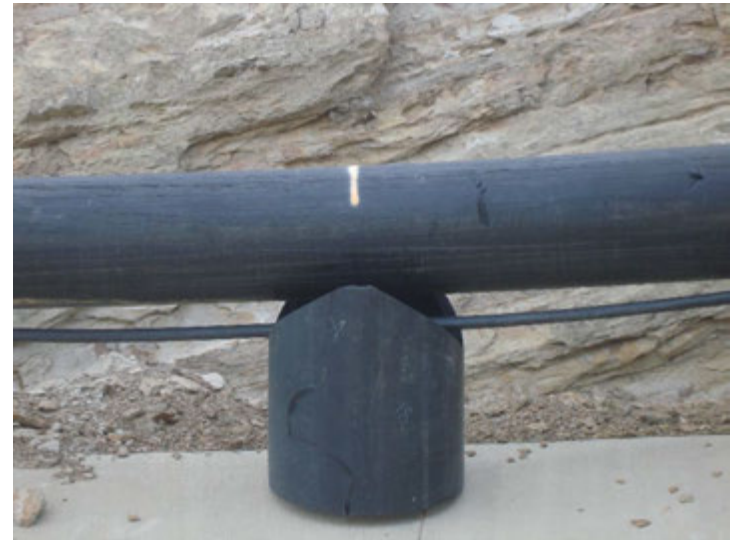
Photo 8: Basin A: January 30, 2018

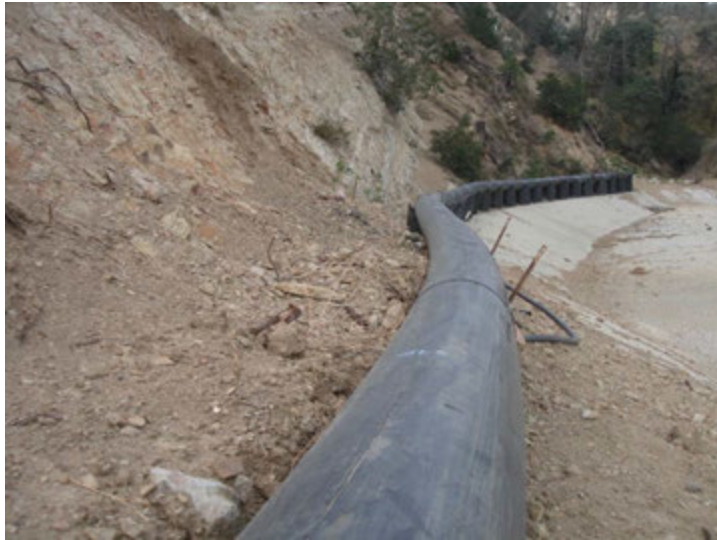
Photo 9: Basin A: January 30, 2018

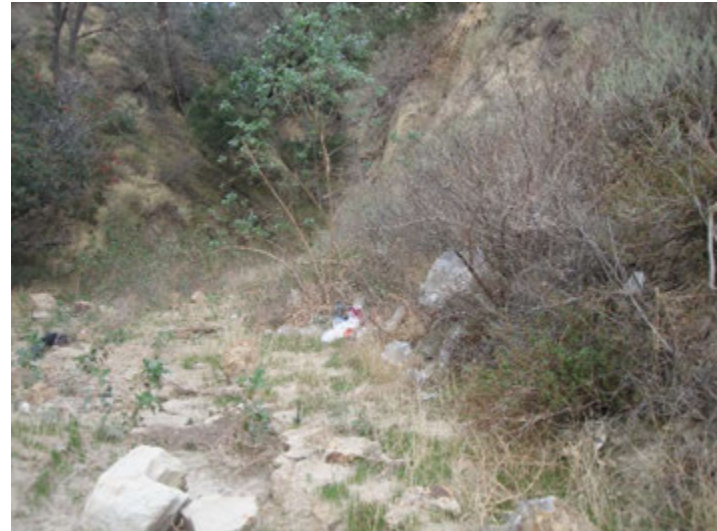
Photo 10: Basin A Back Native Hillside: January 30, 2018

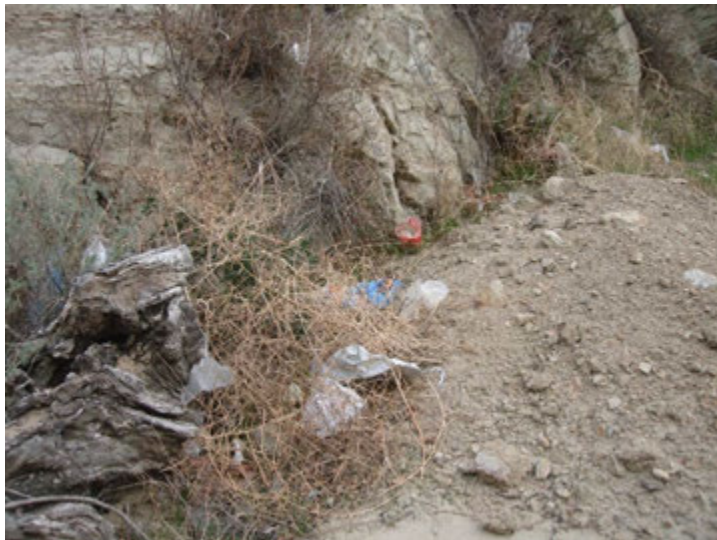
Photo 11: Basin A Back Native Hillside: January 30, 2018

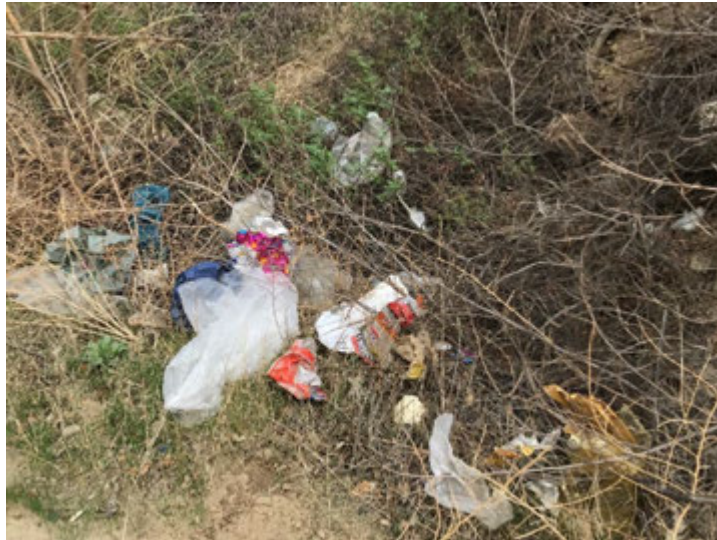
Photo 12: Basin A Back Native Hillside: January 30, 2018

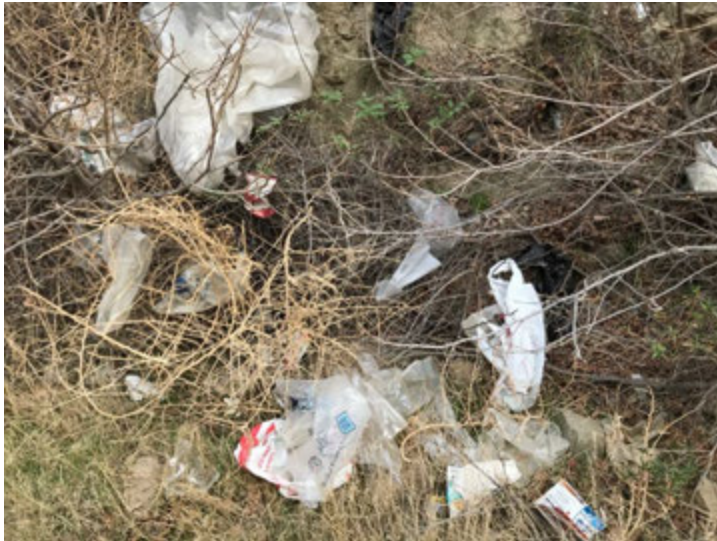
Photo 13: Basin A Back Native Hillside: January 30, 2018

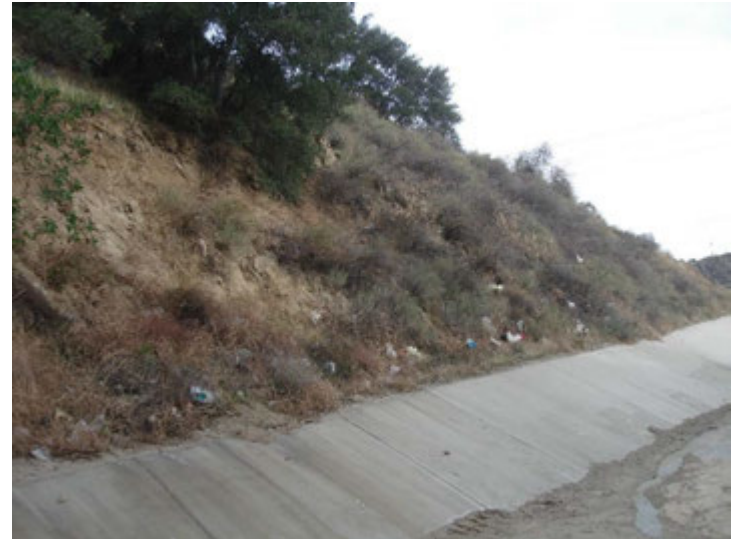
Photo 14: Basin A Side Native Hillside: January 30, 2018

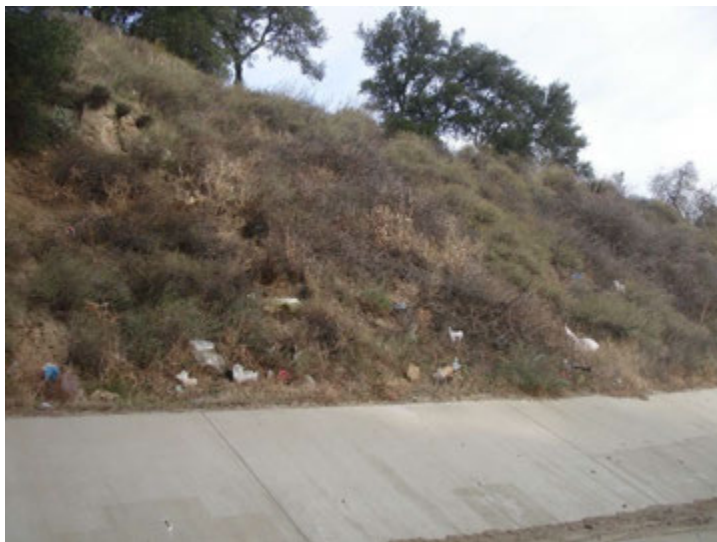
Photo 15: Basin A Side Native Hillside: January 30, 2018

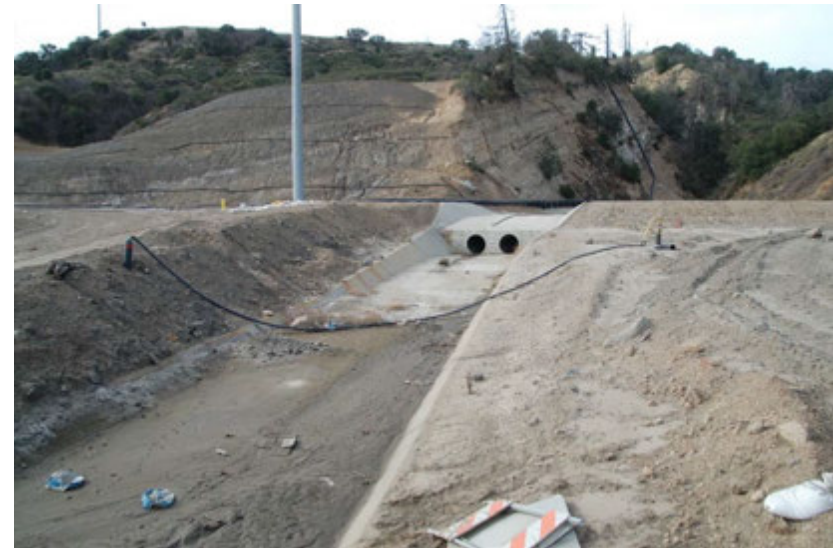
Photo 16: Basin A Outlet: January 30, 2018

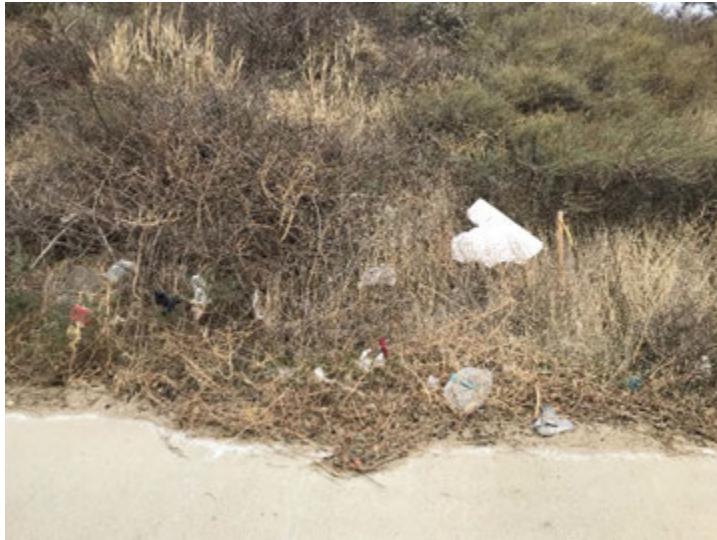
Photo 17: Basin A Side Native Hillside: January 30, 2018

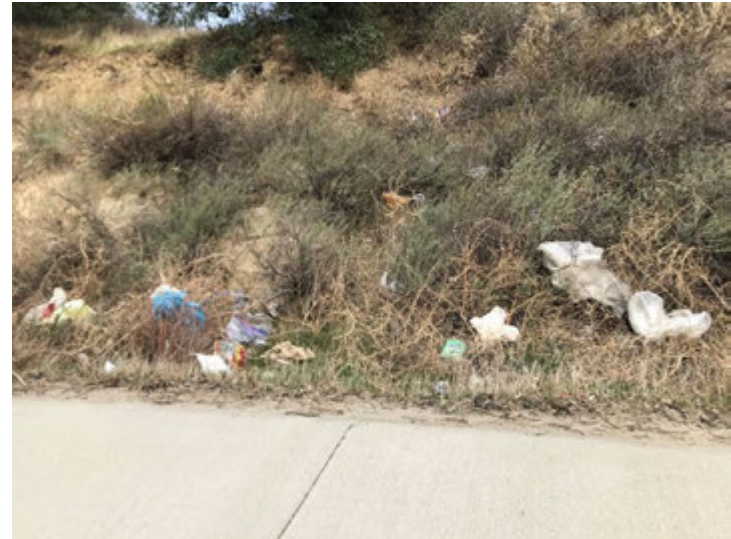
Photo 18: Basin A Side Native Hillside: January 30, 2018

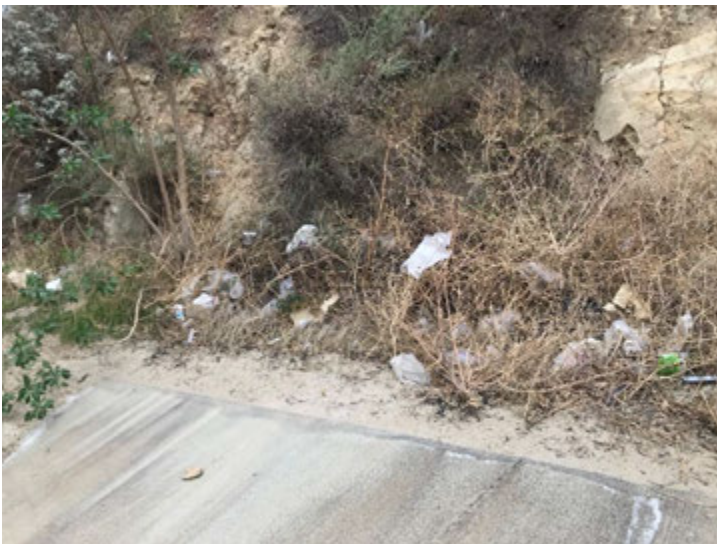
Photo 19: Basin A Side Native Hillside: January 30, 2018

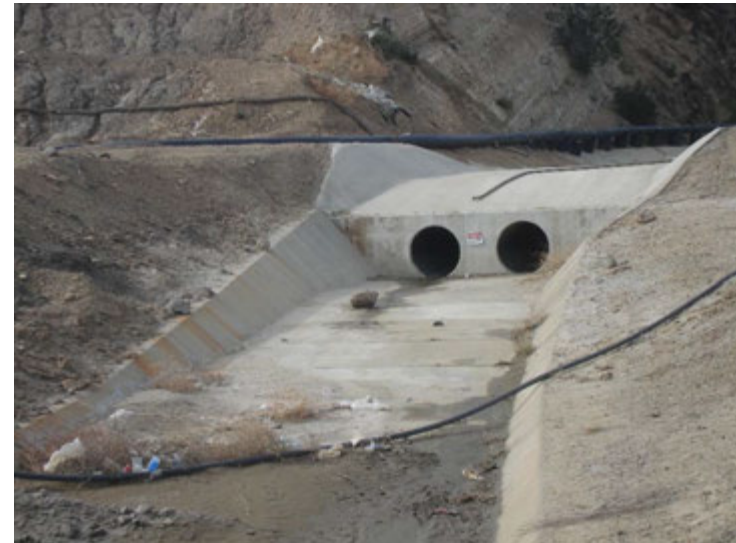
Photo 20: Basin A Outlet: January 30, 2018

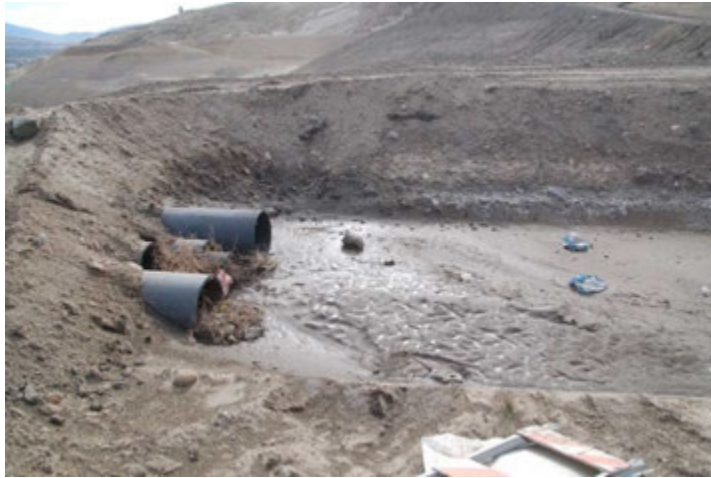
Photo 21: Basin A Outlet Channel: January 30, 2018

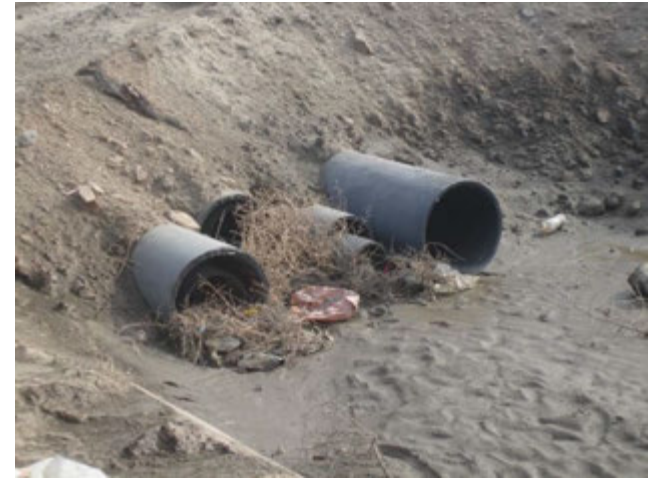
Photo 22: Basin A Outlet Channel: January 30, 2018

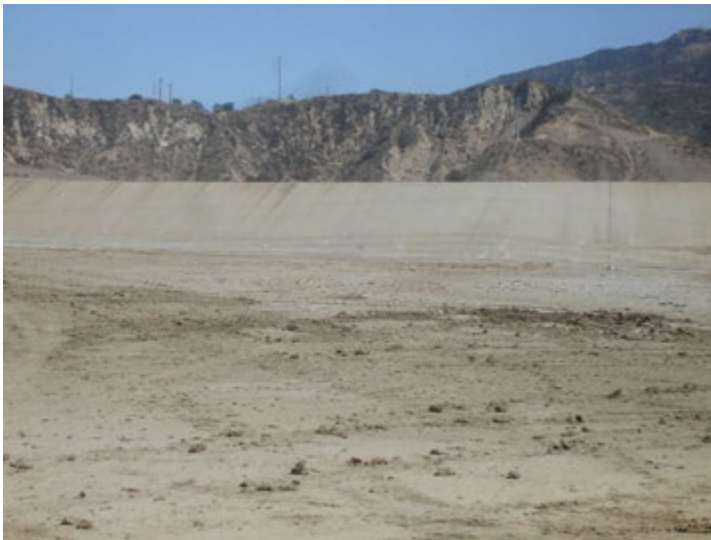
Photo 23: Basin A: February 20, 2018

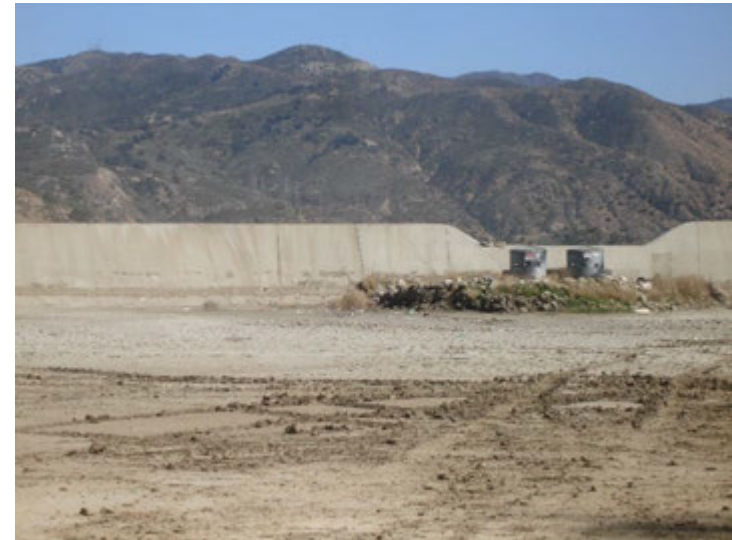
Photo 24: Basin A: February 20, 2018

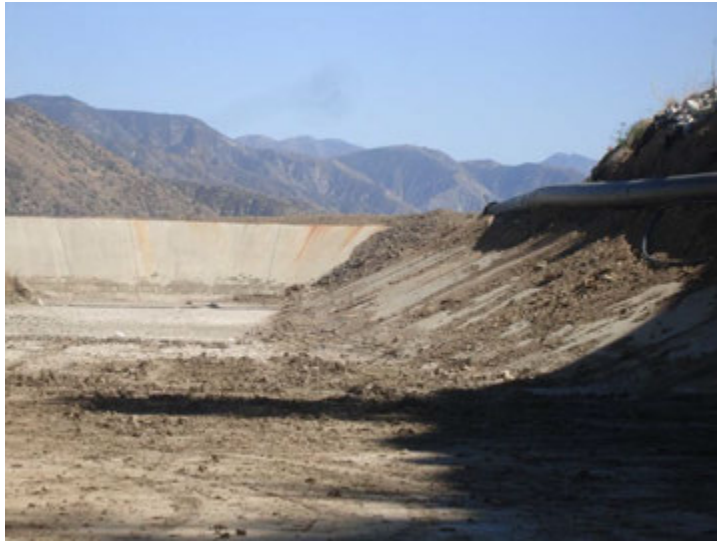
Photo 25: Basin A: February 20, 2018

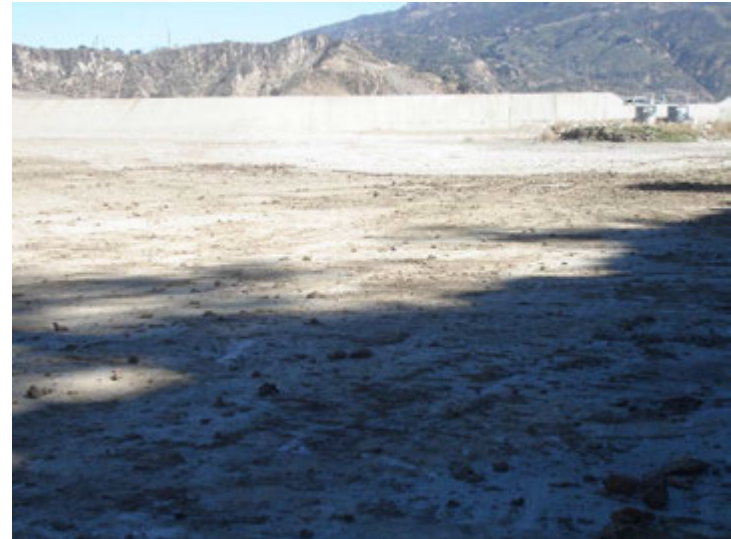
Photo 26: Basin A: February 20, 2018

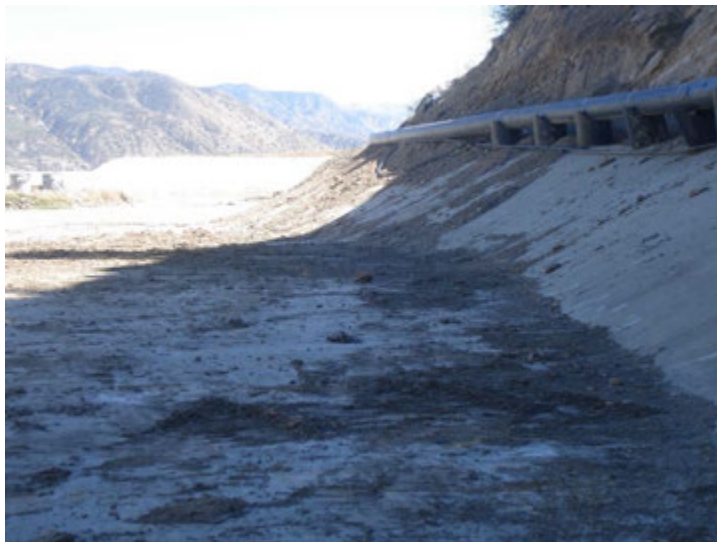
Photo 27: Basin A: February 20, 2018

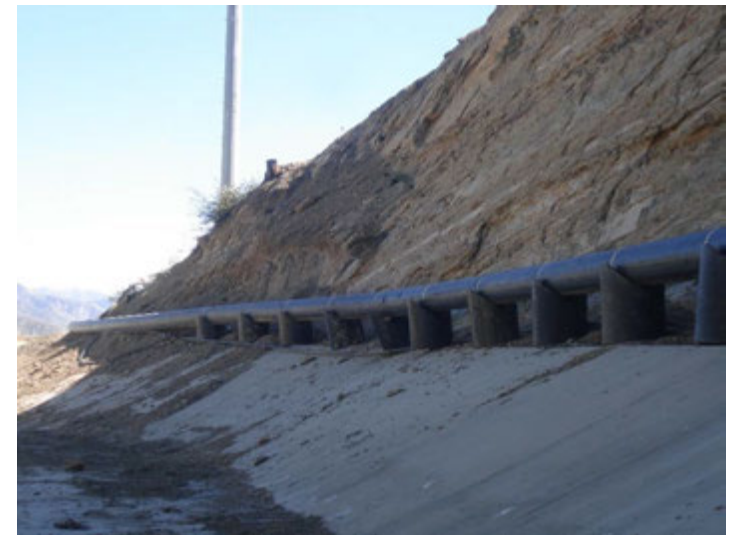
Photo 28: Basin A: February 20, 2018

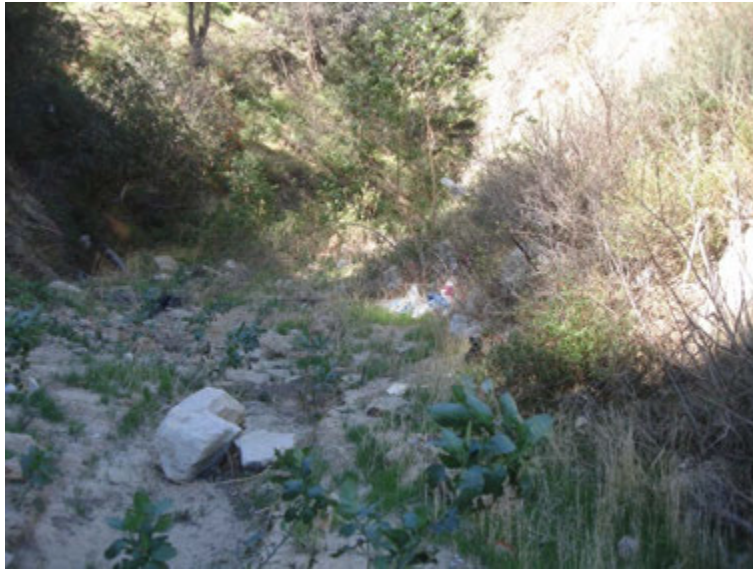
Photo 29: Basin A Back Native Hillside: February 20, 2018

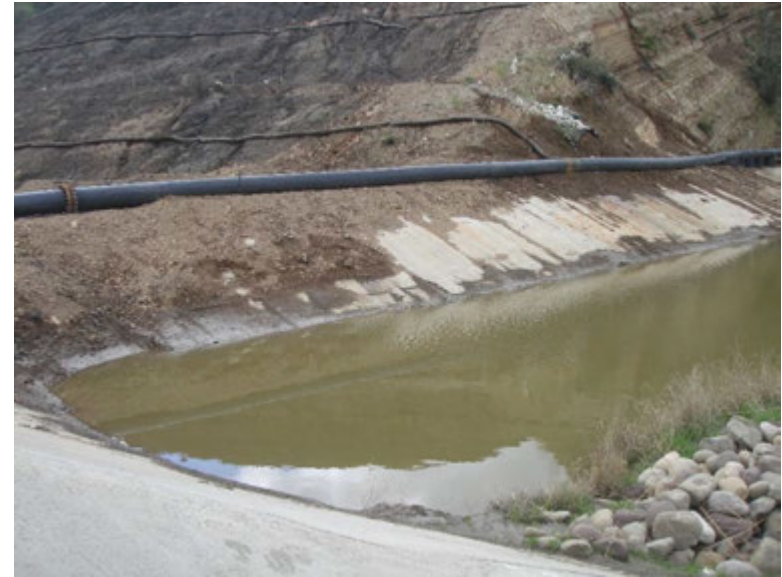
Photo 30: Basin A: March 14, 2018

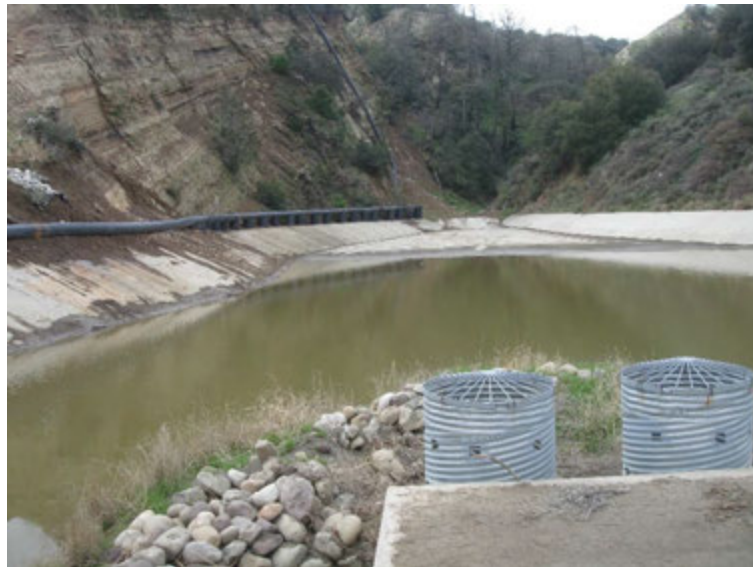
Photo 31: Basin A: March 14, 2018

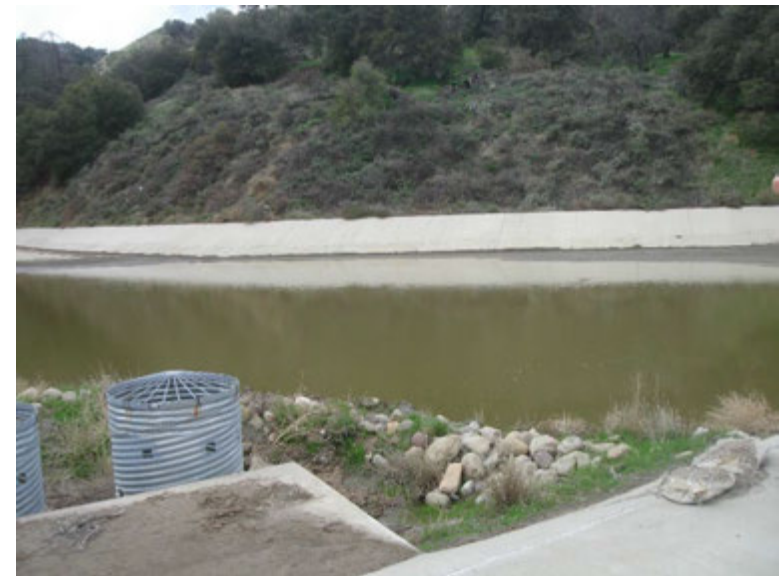
Photo 32: Basin A: March 14, 2018

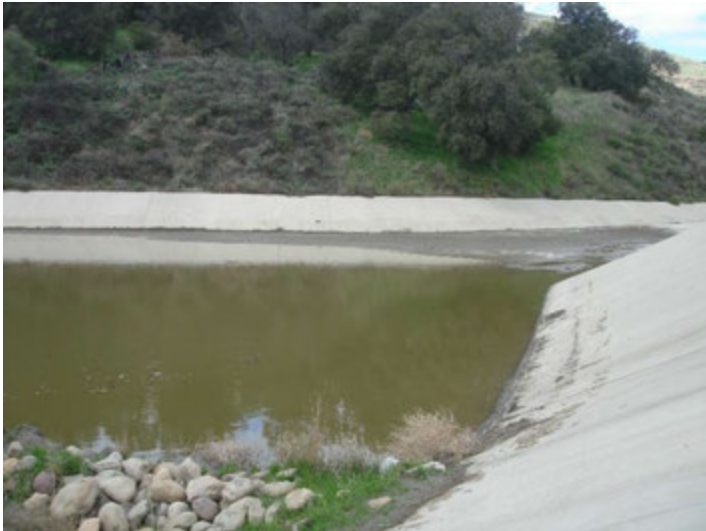
Photo 33: Basin A: March 14, 2018

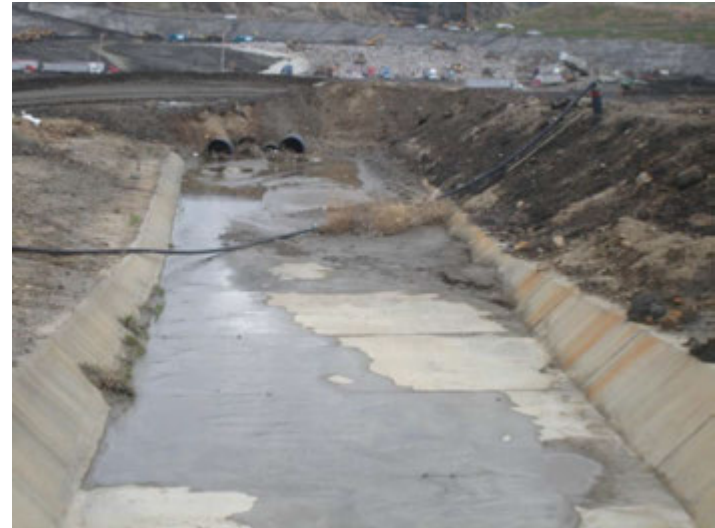
Photo 34: Basin A Outlet Channel: March 14, 2018

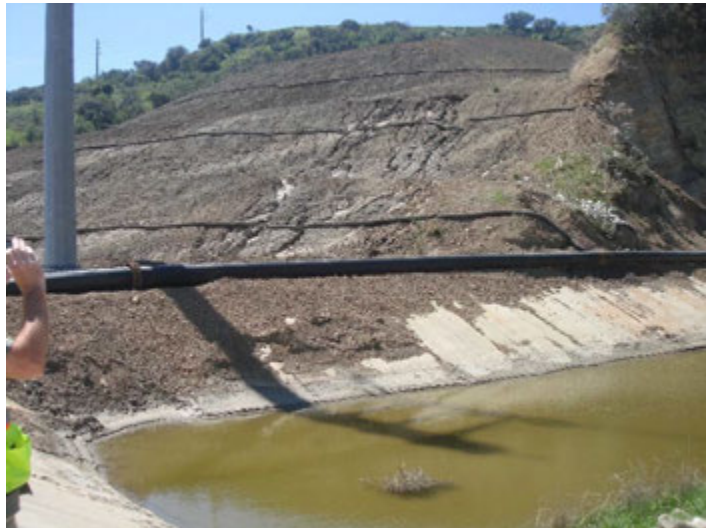
Photo 35: Basin A: March 29, 2018

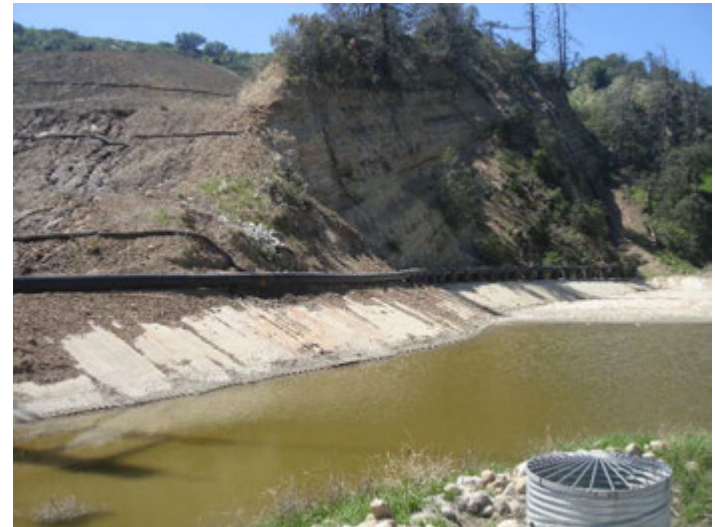
Photo 36: Basin A: March 29, 2018

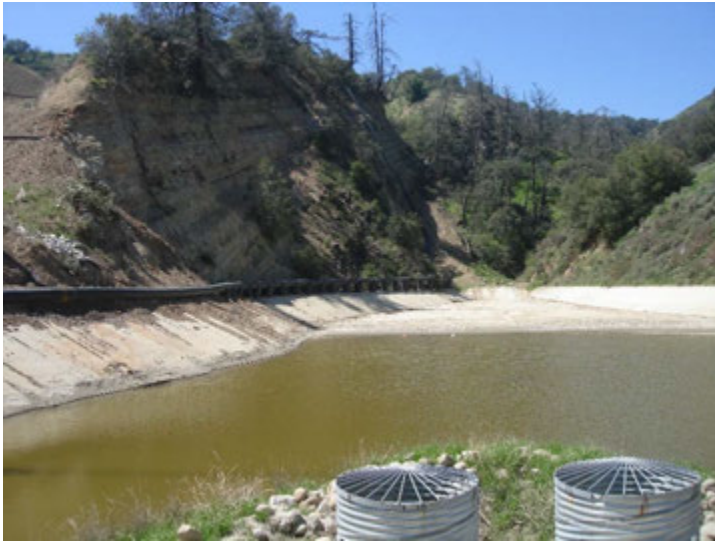
Photo 37: Basin A: March 29, 2018

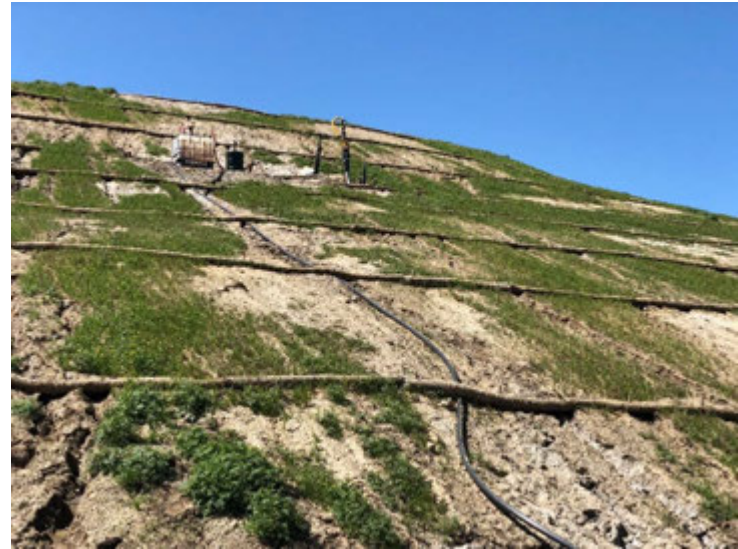
Photo 229: CC3A East Slope Localized Liquids Odors: March 29, 2018

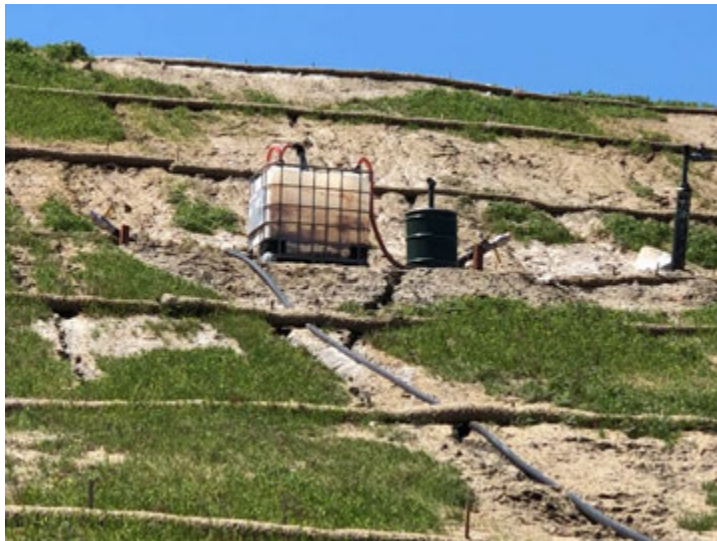
Photo 230: CC3A East Slope Localized Liquids Odors: March 29, 2018

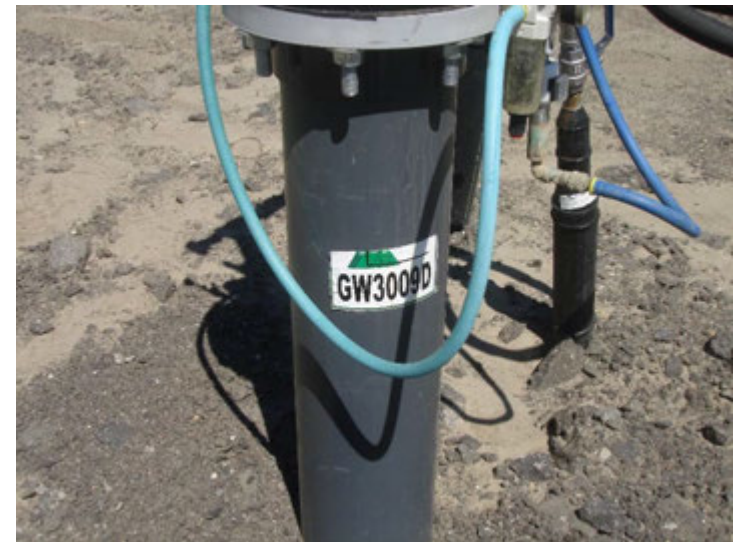
Photo 231: CC3A East Slope Localized Liquids Odors: March 29, 2018

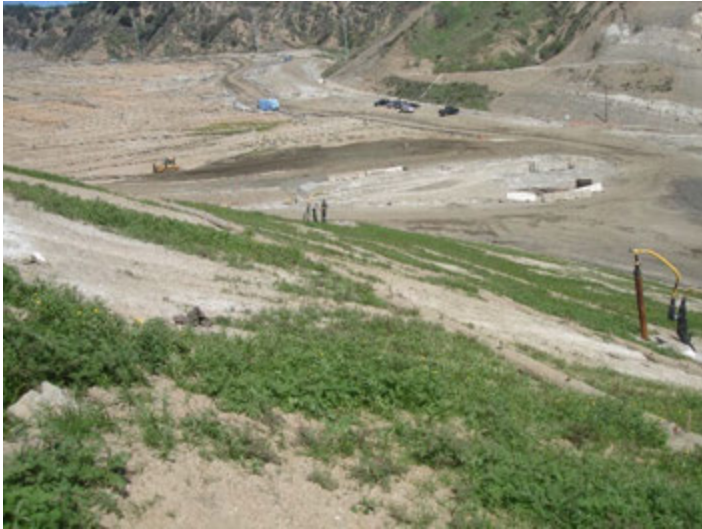
Photo 232: CC3A East Slope Localized Liquids Odors: March 29, 2018

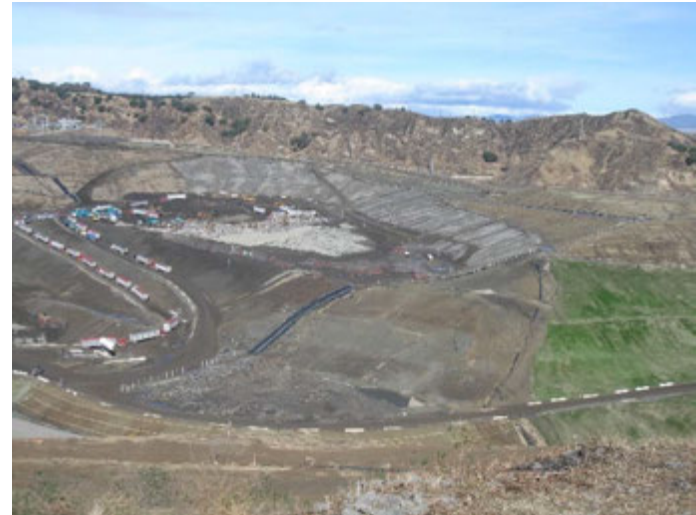
Photo 243: Closure Turf & Posi-Shell: January 10, 2018

<p>I-d: There was a significant amount of slope erosion at the western and eastern edges of the Closure Turf and soil interface. The Closure Turf had no apparent impact. The sand on the Turf was washed away in some areas and observed in the terminal basin. The hydroseeded slopes above the Closure Turf had significant erosions rills. The Posi-Shell covered areas had erosion rills where uncontrolled slope drainage occurred.</p> <p>I-e: The Closure Turf had no apparent problems from the rain events. Erosion that was observed on the western and eastern edges of soil slopes on the prior monitoring was repaired. The Posi-Shell covered areas that were impacted from erosion during prior rain events were being repaired. There were a minimal amount of areas not repaired.</p>
		Surface Water - 2.03 Surface Water - 2.12	County DPW EPD/ LARWQCB SCL-LEA	I-a through I-e: See M - 4.3.1/ 37, 38 above.
	M - 4.3.1 / 39		City Planning/LARWQCB Cal Recycle	I-a through I-e: See M - 4.3.1/ 37, 38 above.

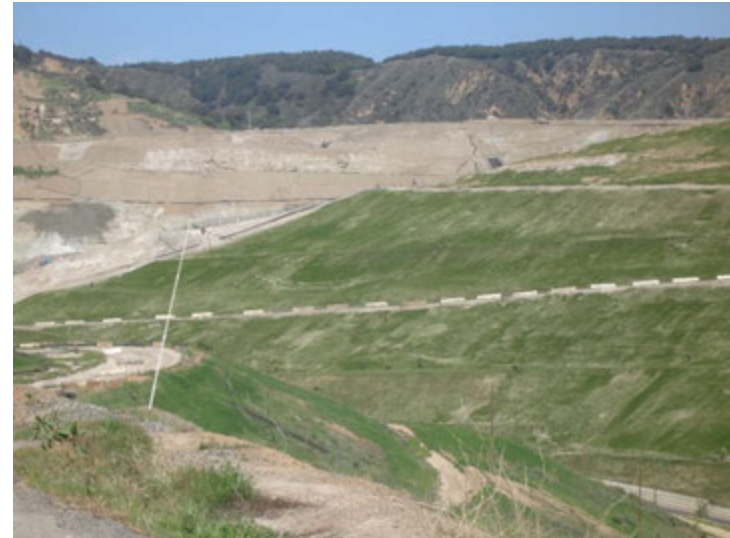
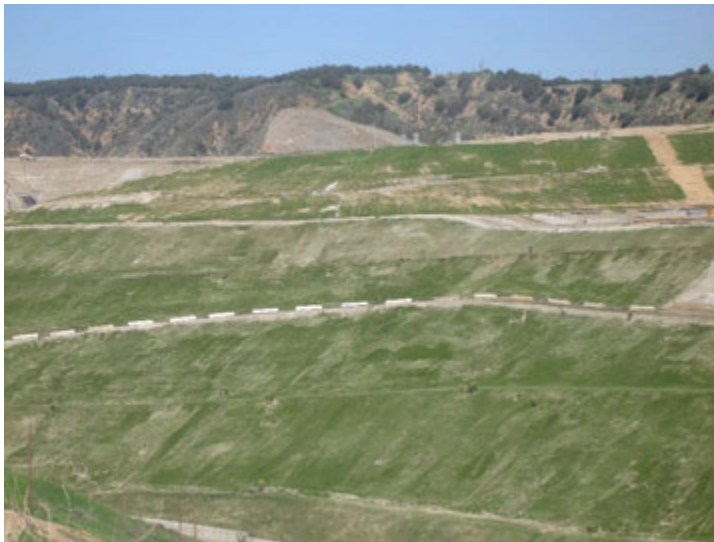
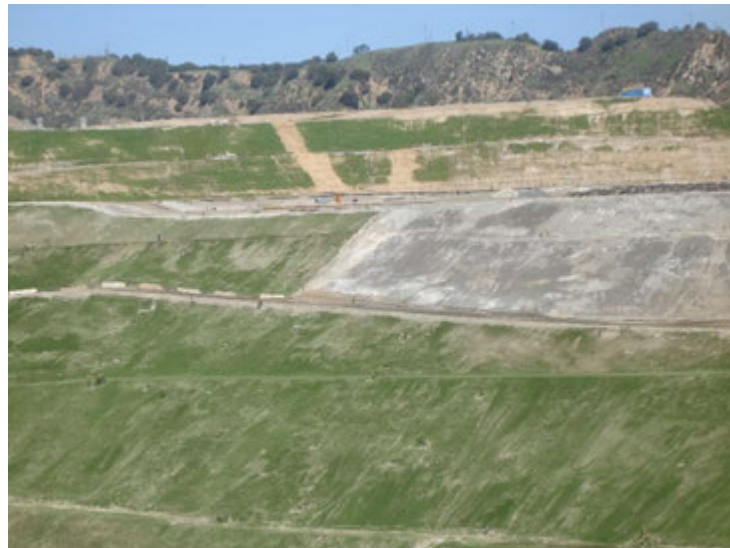
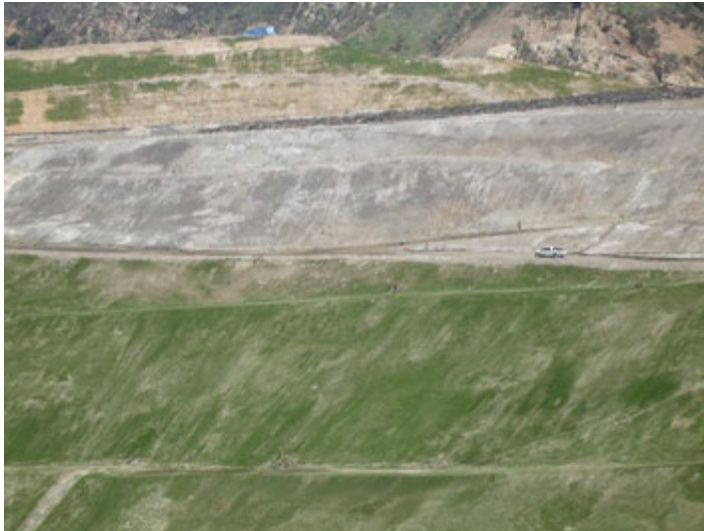
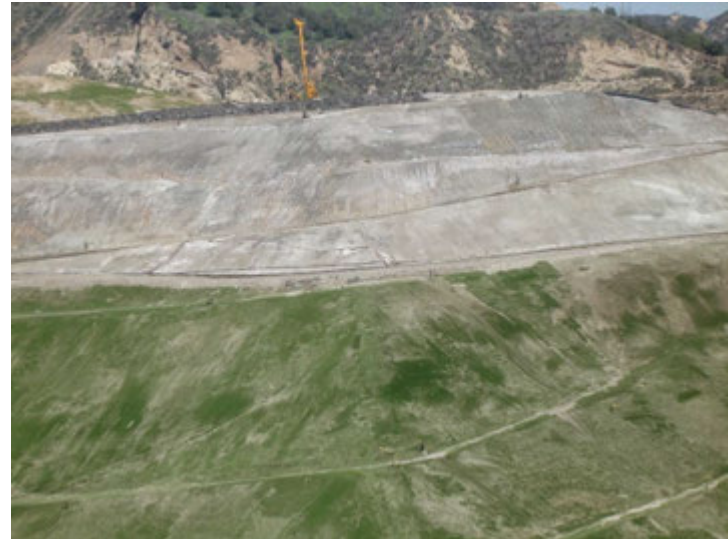
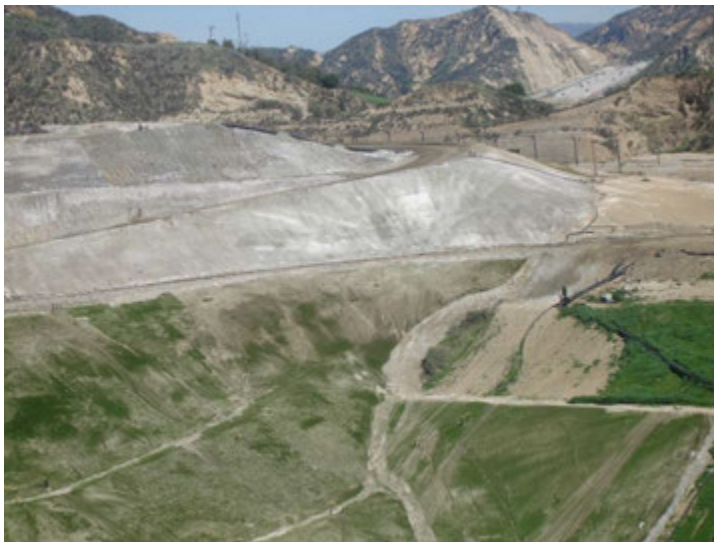
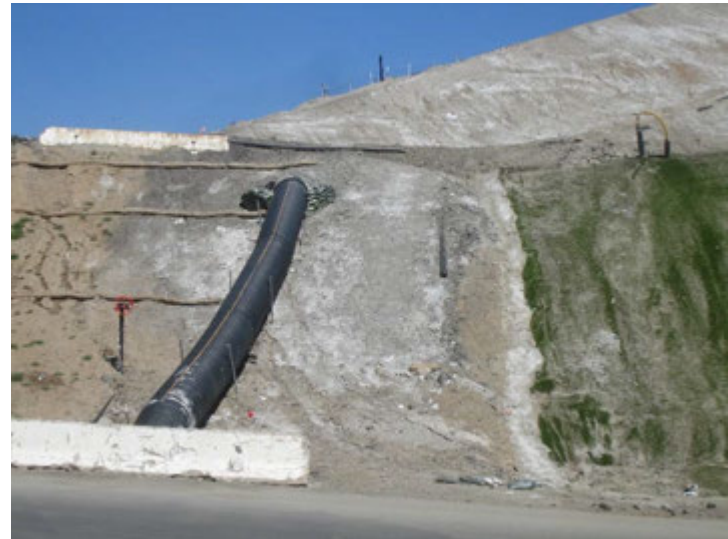
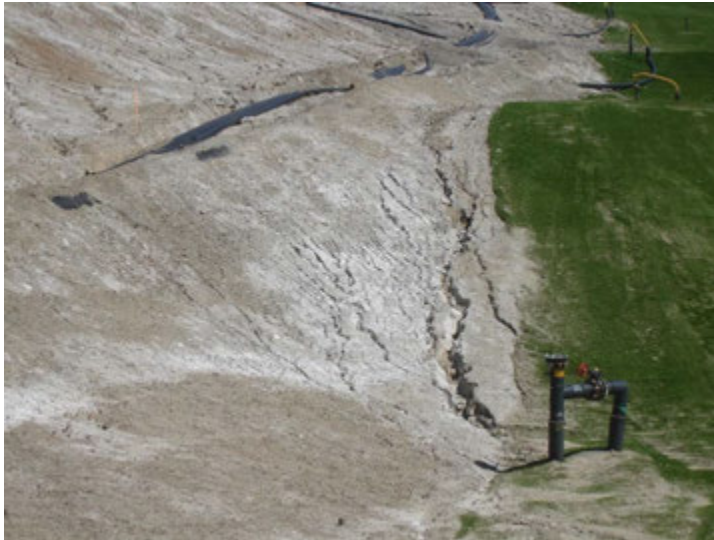
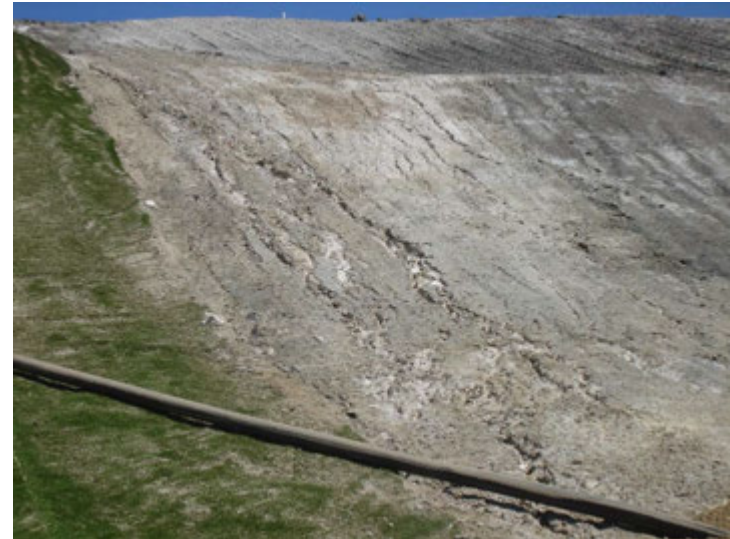
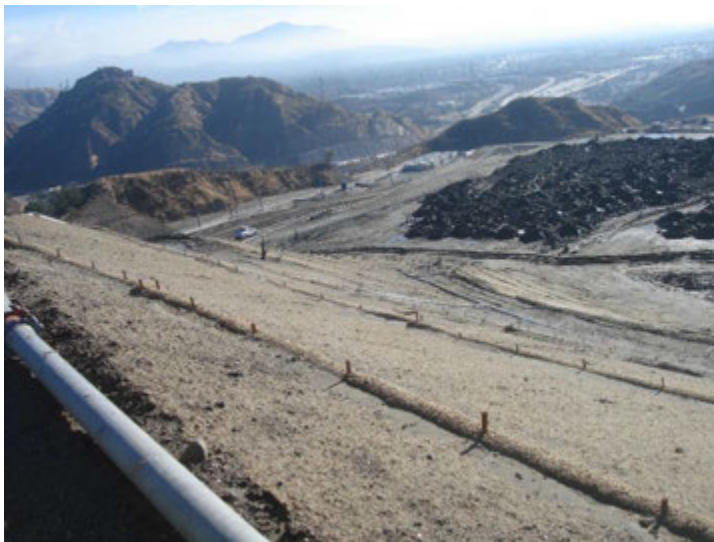
Discipline	City Condition Reference # / Mitigation #	County Condition Reference # / Mitigation #	Responsible Agency	Further Review Needed – Comments
Hydrologist	M - 4.3.1/ 37, 38		City Planning/ LARWQCB CalRecycle SCL-LEA PW-BOE	<p>I-a through I-e: Surface drainage systems were in place to intercept or divert rainwater away from prior landfill cells and current filling operations. Most of these were temporary systems in active areas, and most conveyance V-ditches were unlined. The effectiveness of the erosion control measures being used on the site need to be evaluated and modified for future use. Significant erosion occurred in the landfill area from uncontrolled drainage and ineffective straw wattles. Ponding occurred in numerous areas after every rain event.</p> <p>I-a: The heavy rain events cause slope erosion and exposed trash on the CC-3A slope next to the western edge of the Closure Turf and on the western slopes of CC-4 Part 2. Slope erosion was observed in some other areas of CC-4 Parts 1 and 2, CC-3A, and CC-3B.</p> <p>I-b: Erosion rills where trash was exposed were repaired. The top deck erosion and drainage gullies of CC-3B were repaired. There were significant erosion rills on the eastern vegetated slopes of CC-3B and CC-3A and the County top deck and bowl. The straw wattles were not buried when installed and water flowed under them, creating rills.</p> <p>I-c: Erosion rills were observed on the slopes above and into the CC-3B basin. There were no lined slope drainage downcomers in this area. Slopes with erosion rills at the back of Cells CC-4 Parts 1 and 2 were sprayed with Posi-Shell to control erosion. HDPE lined downcomer channels were installed on the CC-3A slopes in two areas. The CC-3A dirt slope where it meets the Closure Turf had deep erosion rills due to there being no lined downcomer channel.</p>

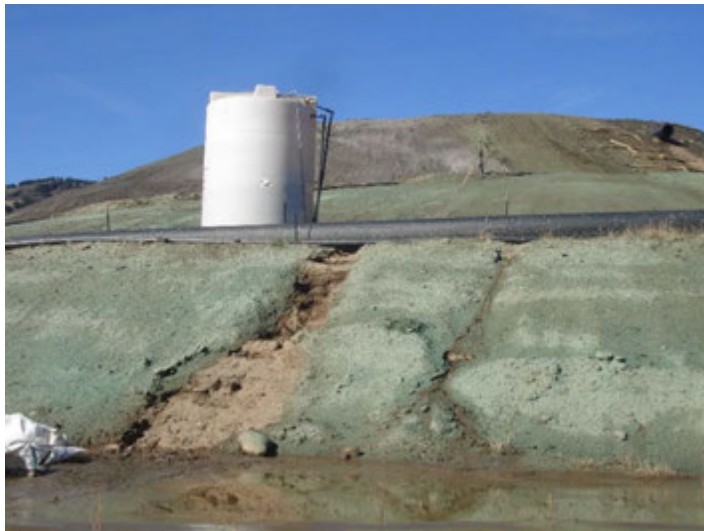
Photo 341: CC3B Slope Drainage Failure: January 10, 2018

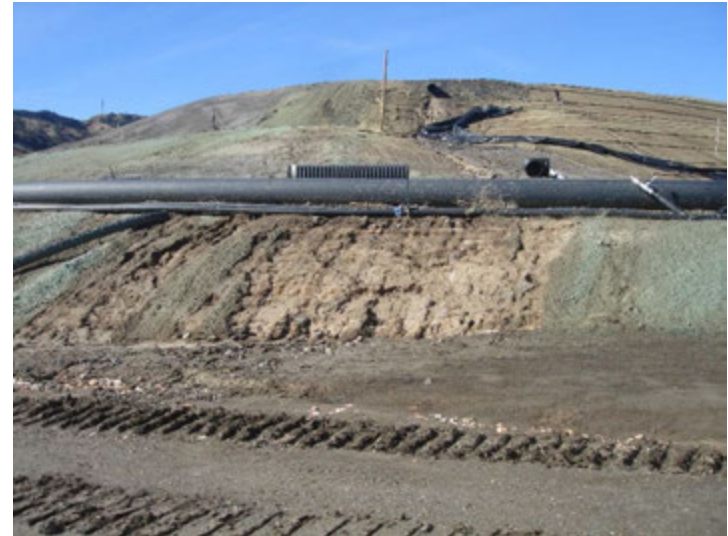
Photo 343: CC3B Slope Drainage Erosion: January 10, 2018

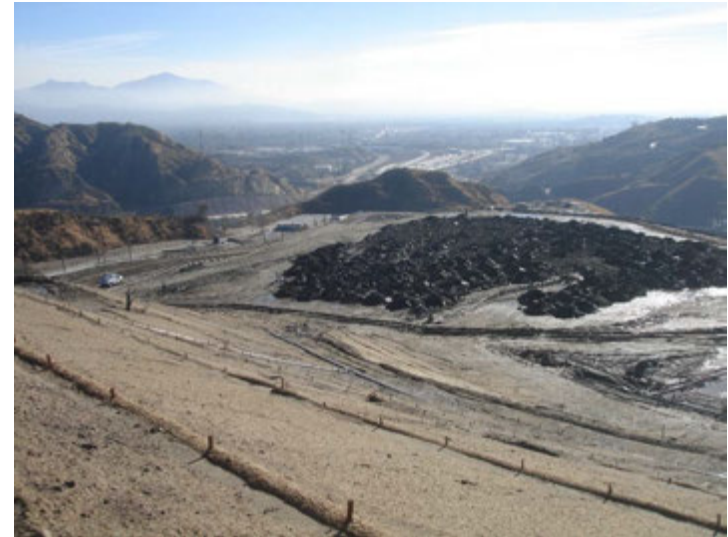
Photo 342: CC3B Slope Drainage Erosion: January 10, 2018

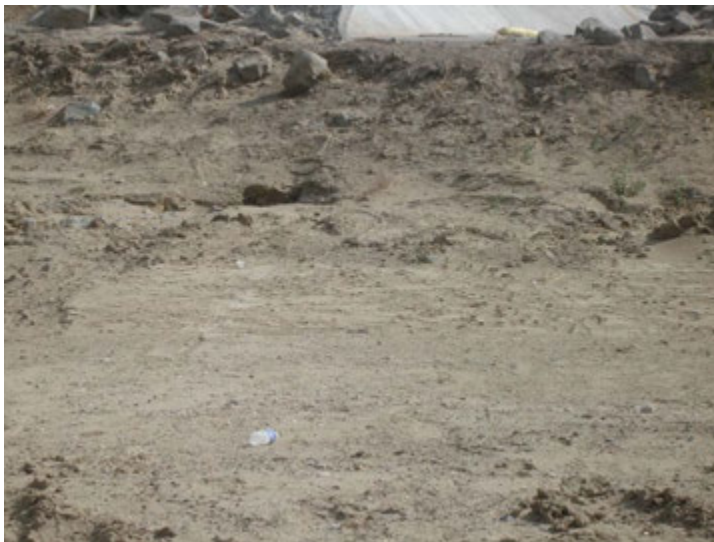
Photo 358: Basin CC3B Plugged Low Flow-Outlet: January 30, 2018
