**Sunshine Canyon Landfill
Independent Monitor
Quarterly Site Monitoring Status Report
January 1, 2018 – March 31, 2018**

May 25, 2018

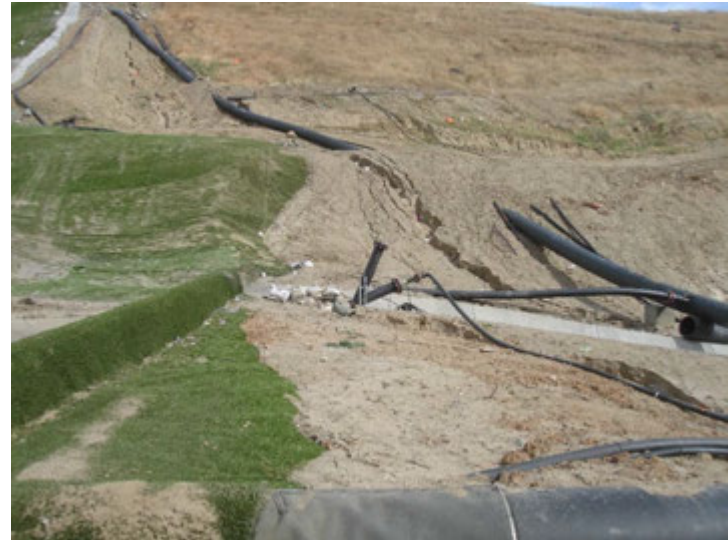
Photo 359: Basin CC3B Plugged Low Flow-Outlet: January 30, 2018

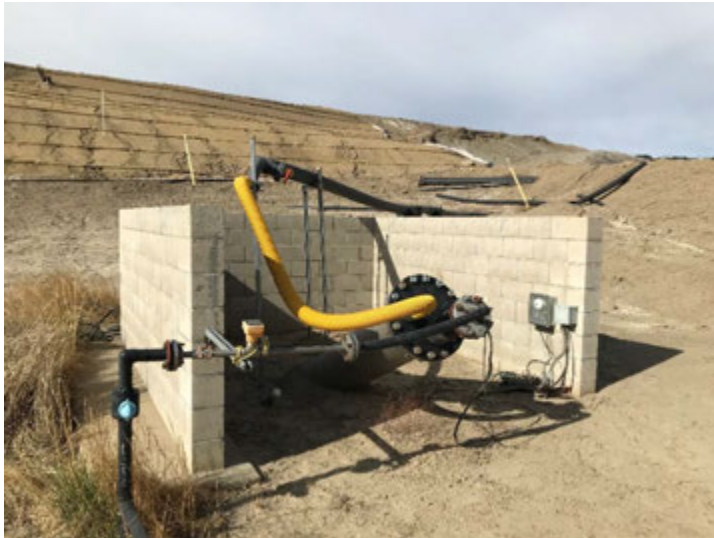
**Photo 406: Idle Liquids Handling at Old City North Top Deck:
January 30, 2018**

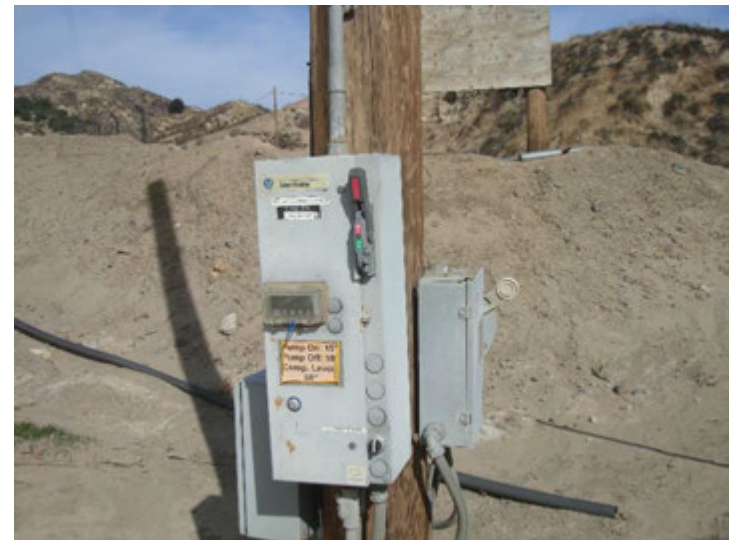
**Photo 407: Idle Liquids Handling at Old City North Top Deck:
January 30, 2018**

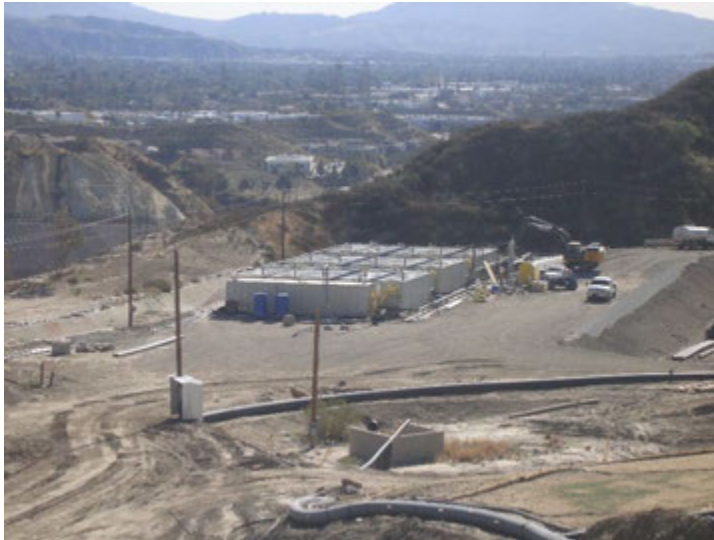
**Photo 408: Idle Liquids Handling at Old City North Top Deck:
January 30, 2018**

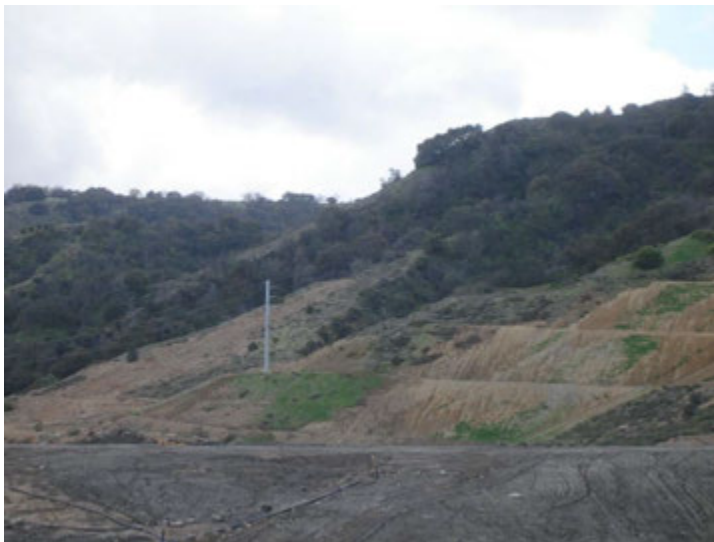
Photo 438: County Sage Mitigation Area Slope: March 14, 2018

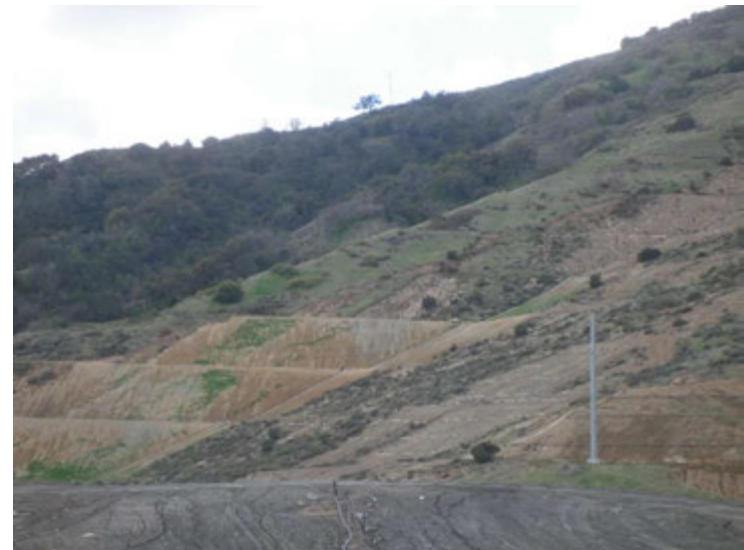
Photo 439: County Sage Mitigation Area Slope: March 14, 2018

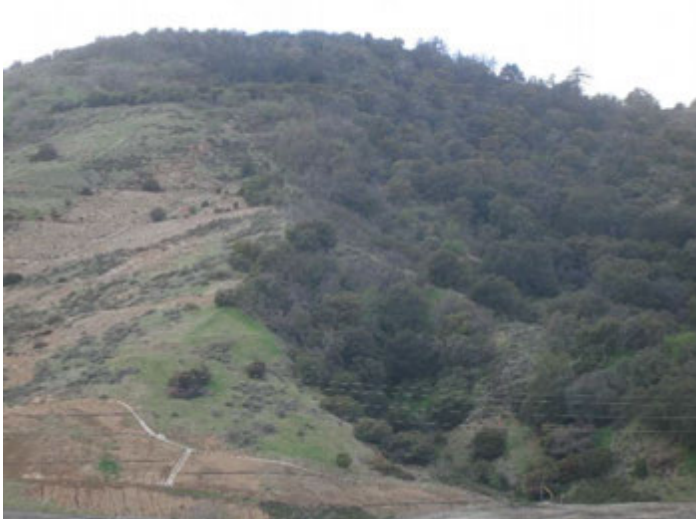
Photo 440: County Sage Mitigation Area Slope: March 14, 2018

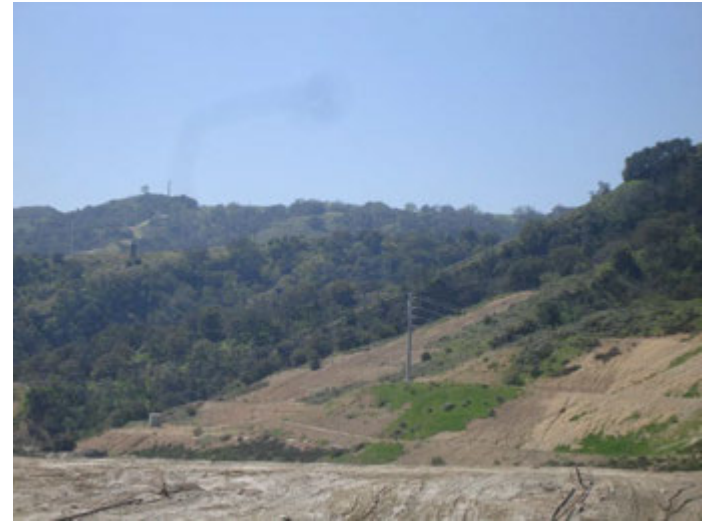
Photo 441: County Sage Mitigation Area Slope: March 14, 2018

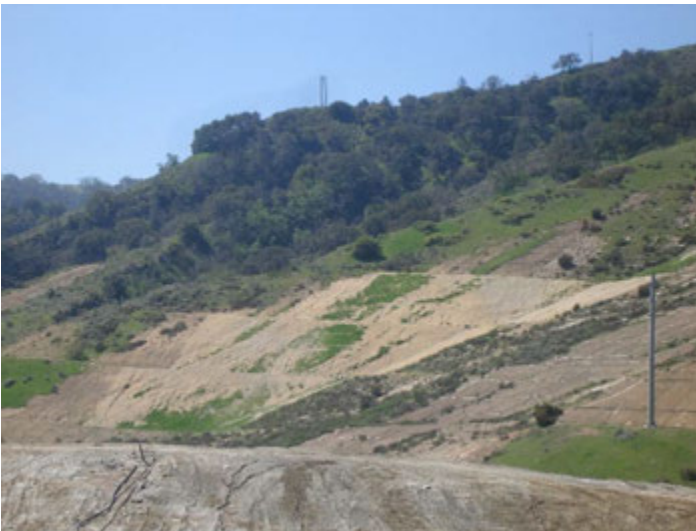
Photo 442: County Sage Mitigation Area Slope: March 29, 2018

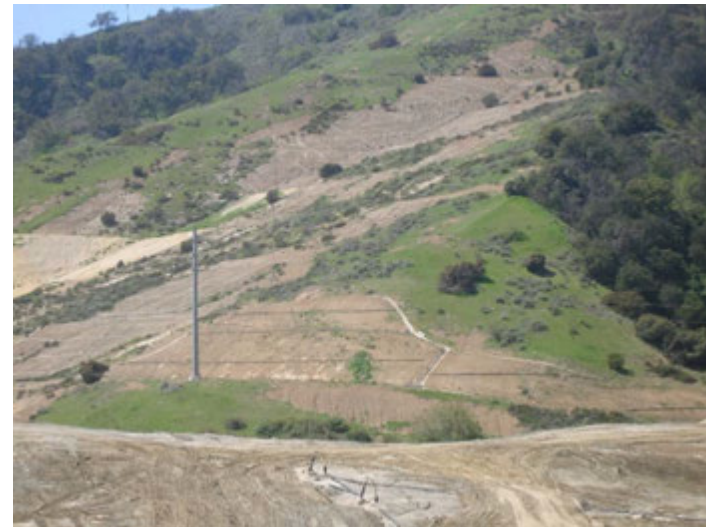
Photo 443: County Sage Mitigation Area Slope: March 29, 2018

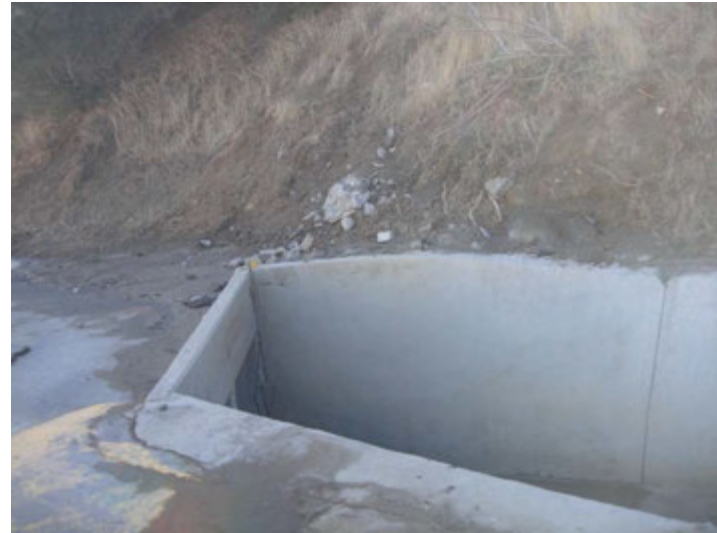
Photo 445: Westside Drainage Channel: January 10, 2018

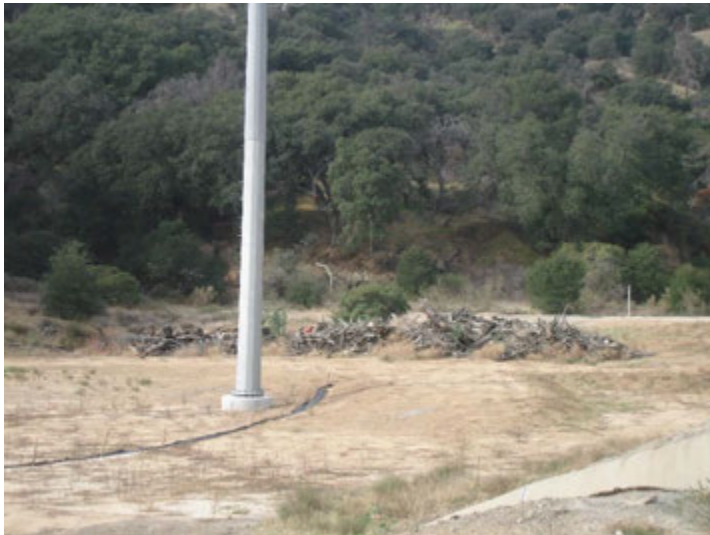
Photo 446: Westside Drainage Channel: January 10, 2018

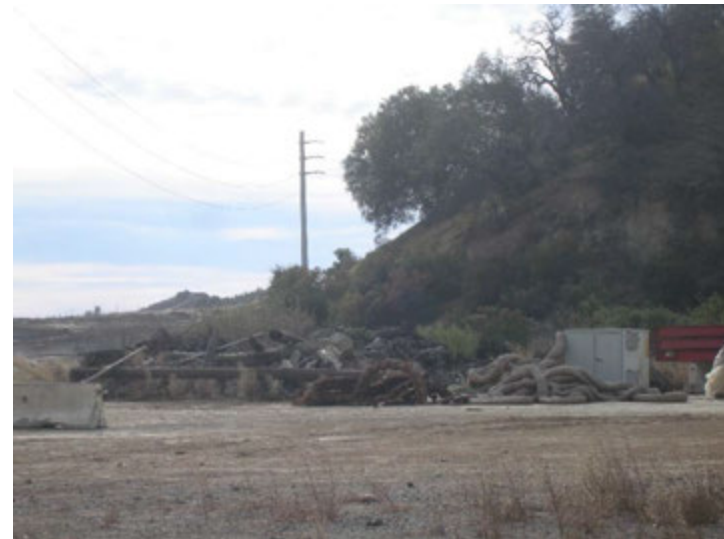
Photo 447: Waste Material near Basin D Storage Area: January 30, 2018

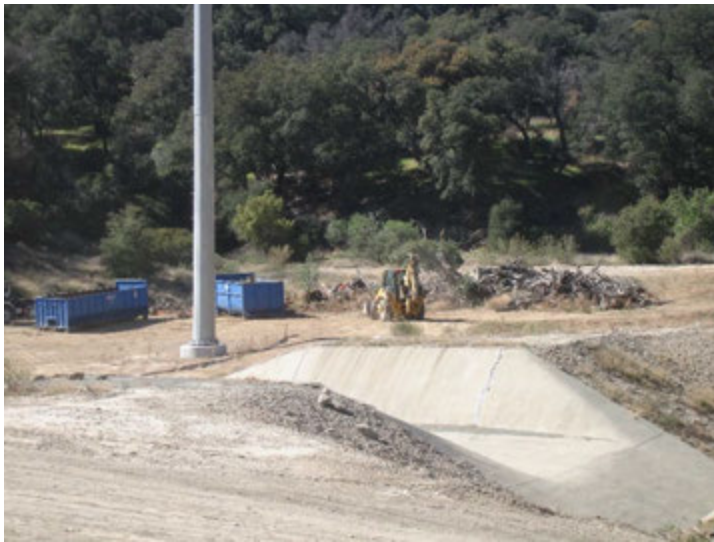
Photo 448: Waste Material in Basin D Storage Area: January 30, 2018

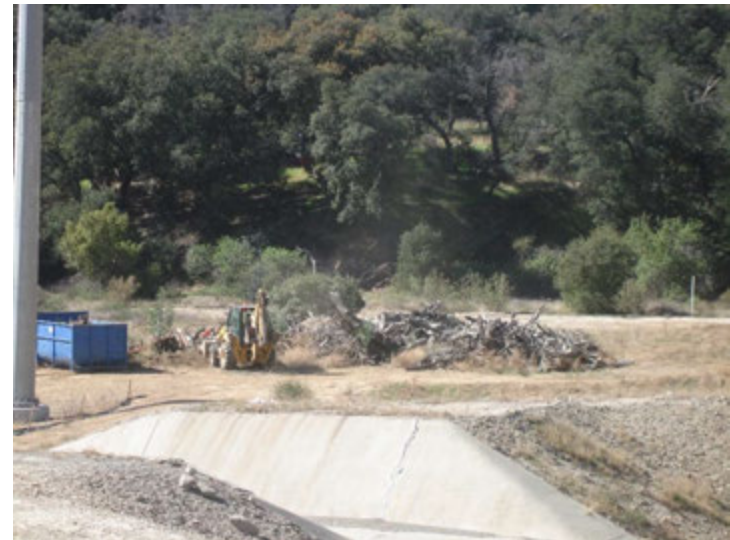
Photo 449: Waste Material in Basin D Storage Area: February 20, 2018

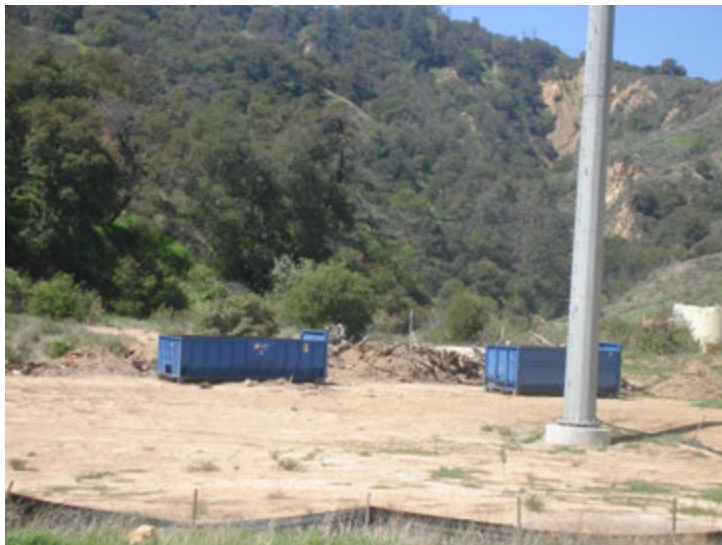
Photo 450: Waste Material in Basin D Storage Area: February 20, 2018

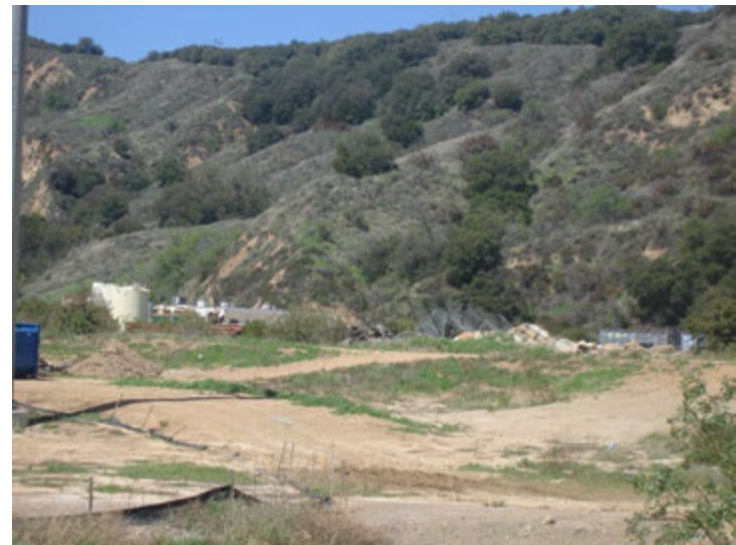
Photo 451: Basin D Deck Wood Waste Stockpile: March 29, 2018

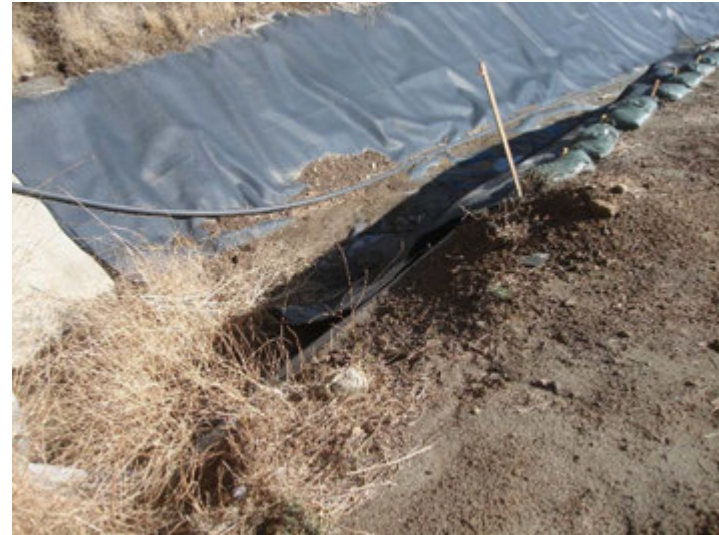
Photo 453: Basin D Outlet Channel: January 10, 2018

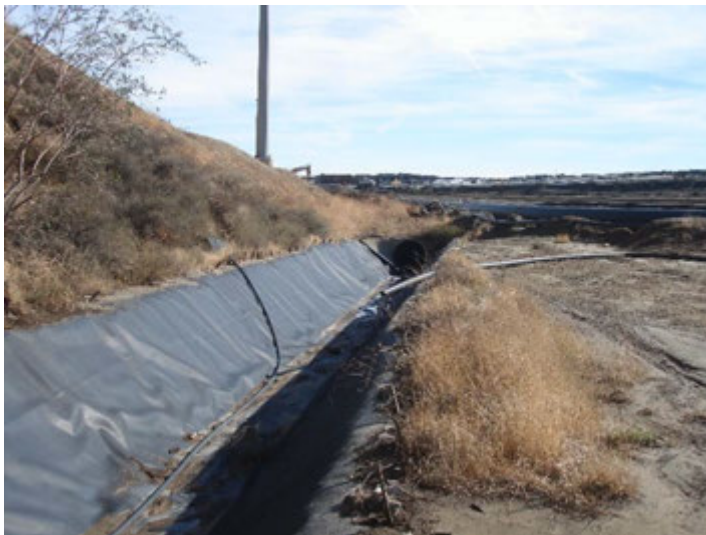
Photo 454: Basin D Outlet Channel: January 10, 2018

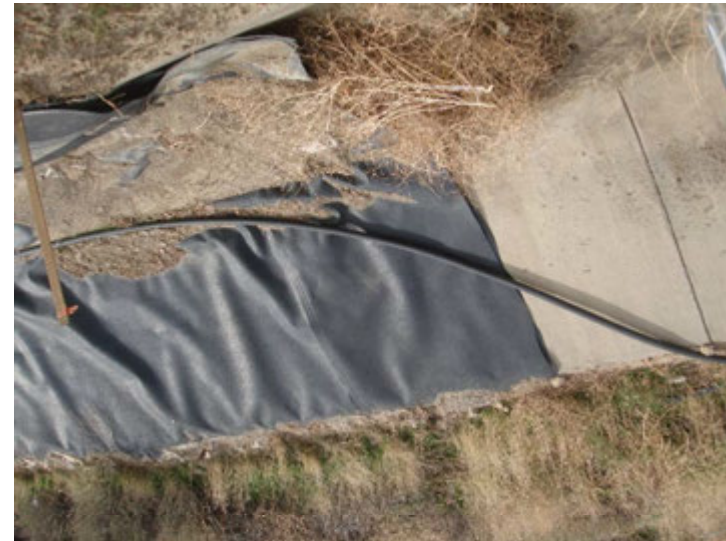
Photo 455: Basin D Outlet Channel: January 10, 2018

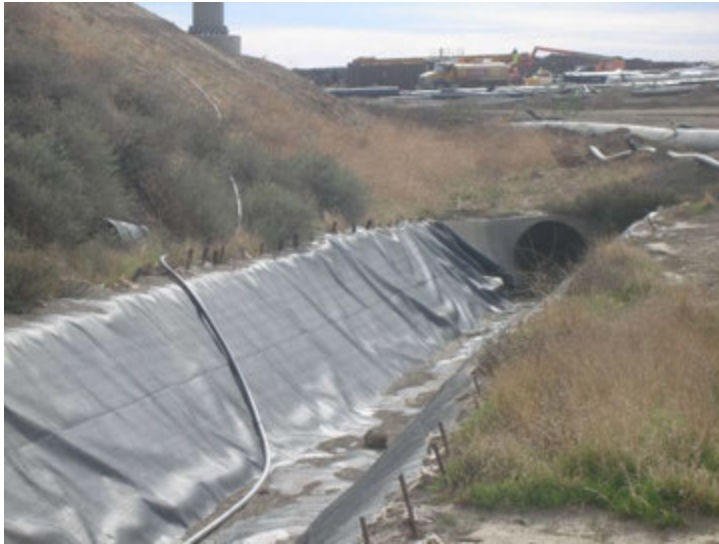
Photo 456: Basin D Outlet Channel: January 30, 2018

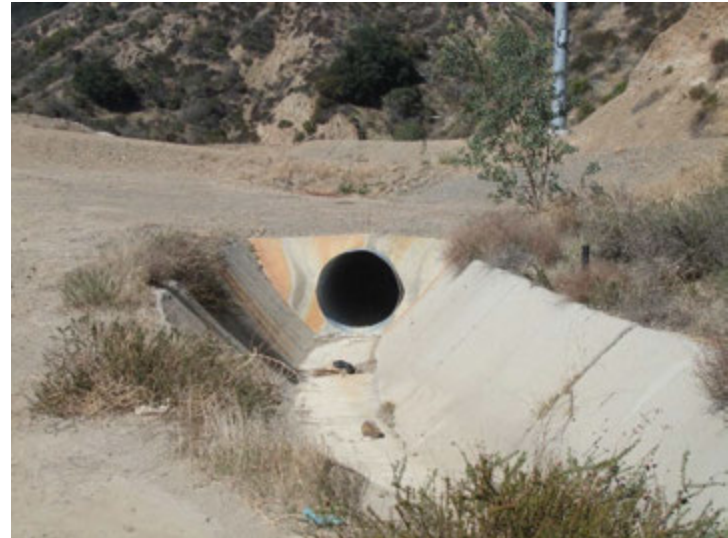
Photo 457: Basin D Outlet Channel: January 30, 2018

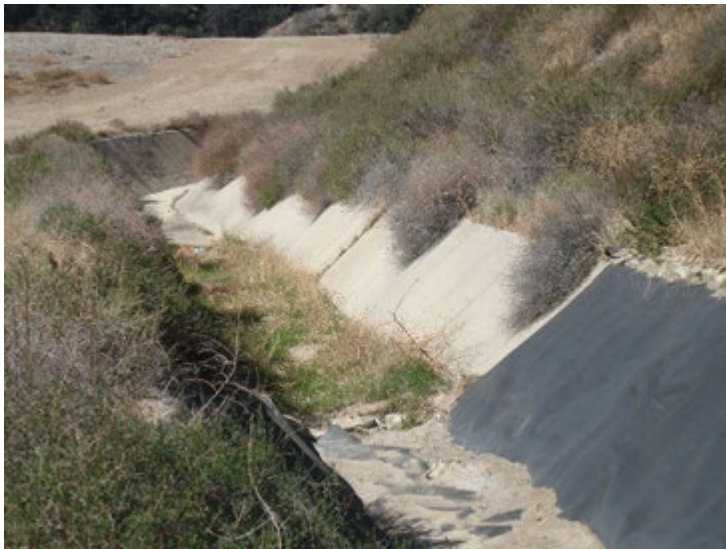
Photo 458: Basin D Outlet Channel: February 20, 2018

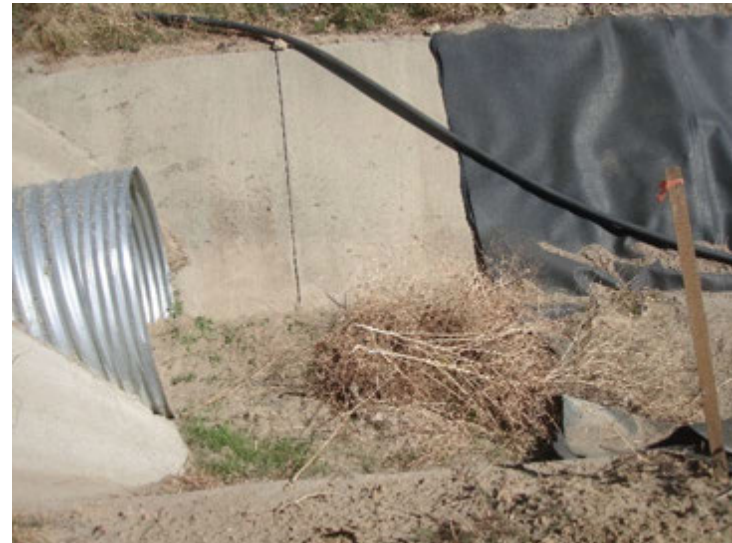
Photo 459: Basin D Outlet Channel: February 20, 2018

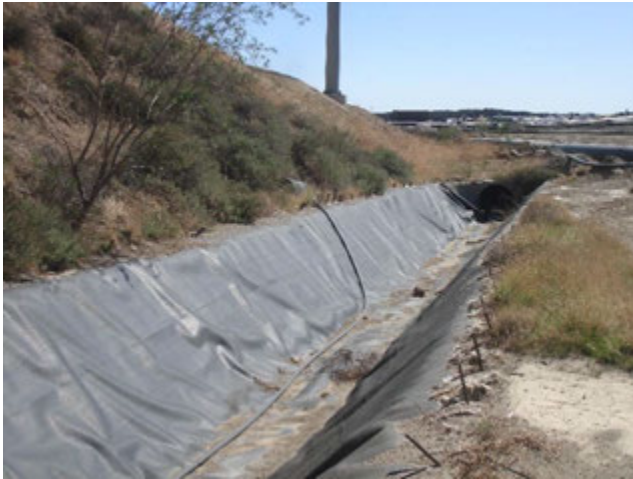
Photo 460: Basin D Outlet Channel: February 20, 2018

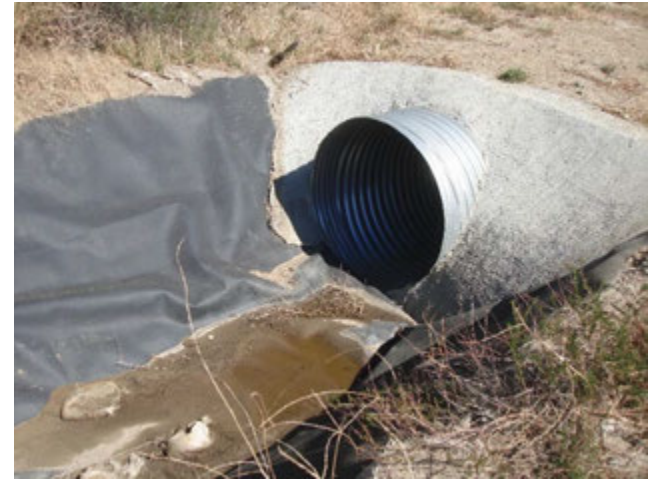
Photo 461: Basin D Outlet Channel: February 20, 2018

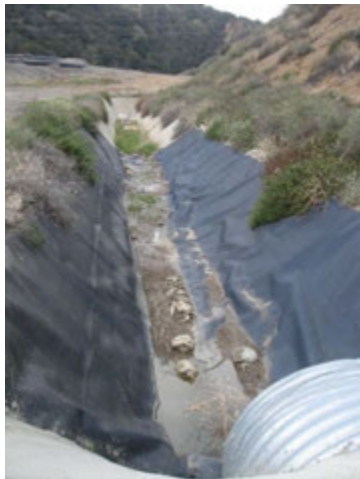
Photo 462: Basin D Outlet Channel: February 20, 2018

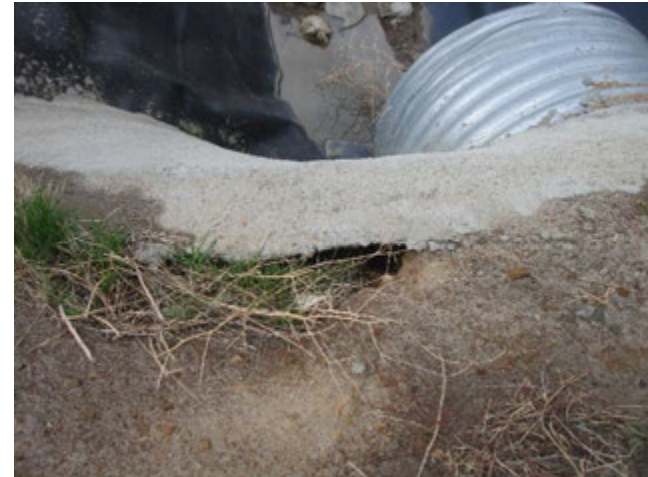
Photo 463: Basin D Outlet Channel: March 14, 2018

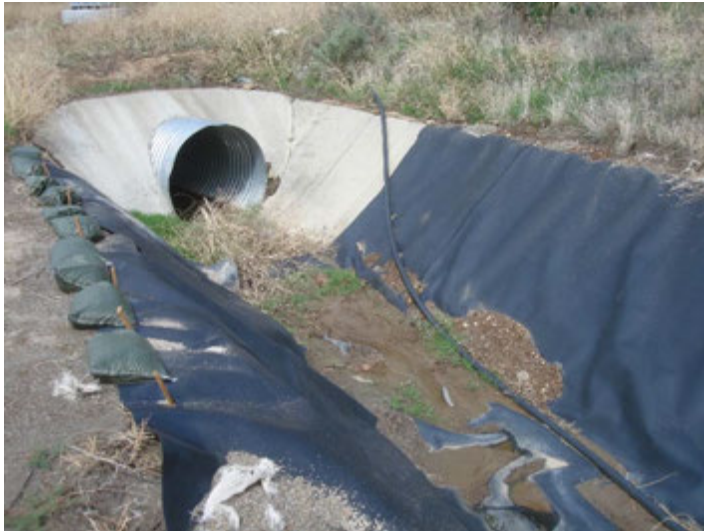
Photo 464: Basin D Outlet Channel: March 14, 2018

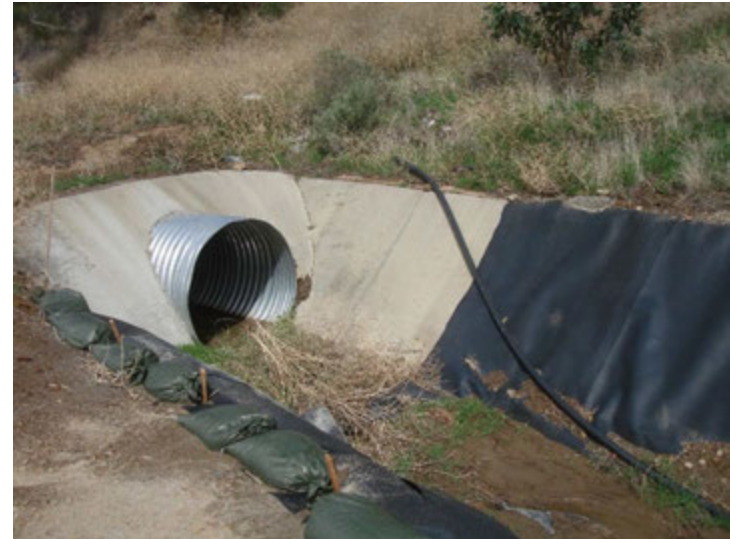
Photo 465: Basin D Outlet Channel: March 14, 2018

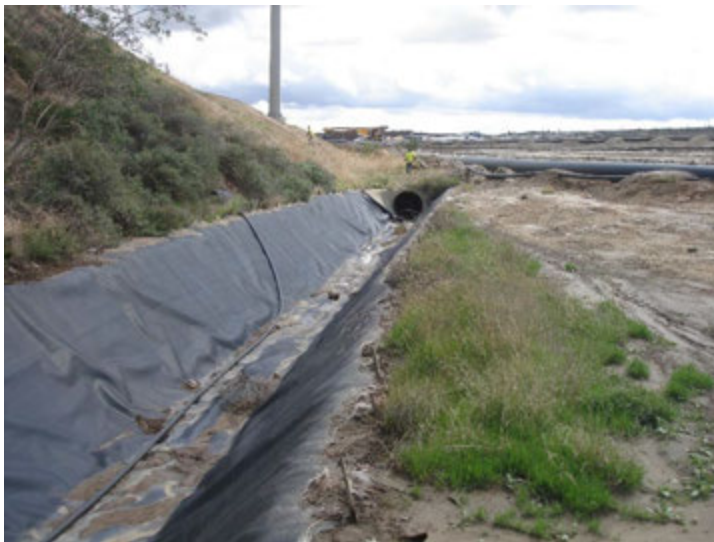
Photo 466: Basin D Outlet Channel: March 14, 2018

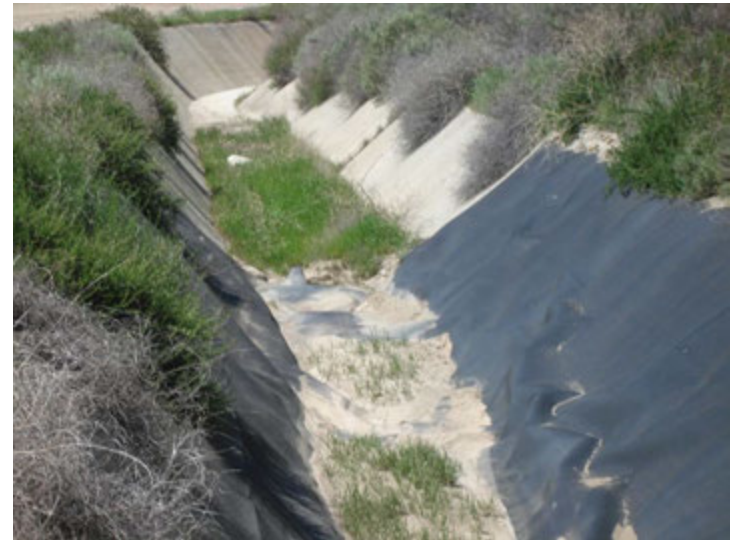
Photo 467: Basin D Outlet Channel: March 14, 2018

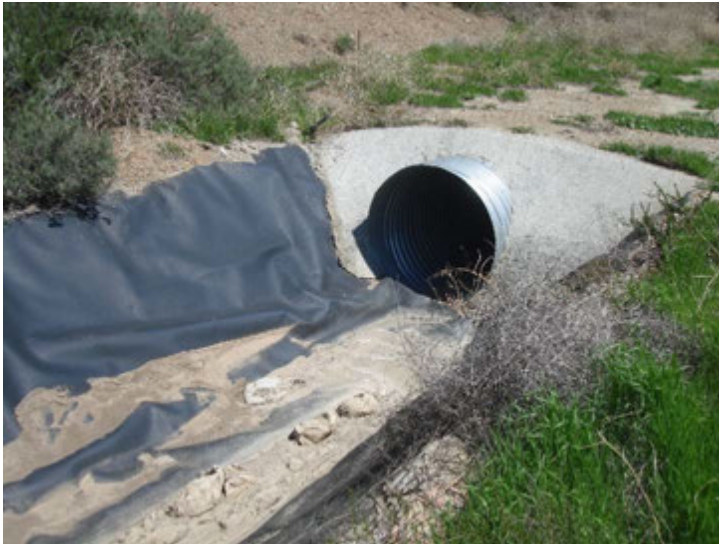
Photo 468: Basin D Outlet Channel: March 29, 2018

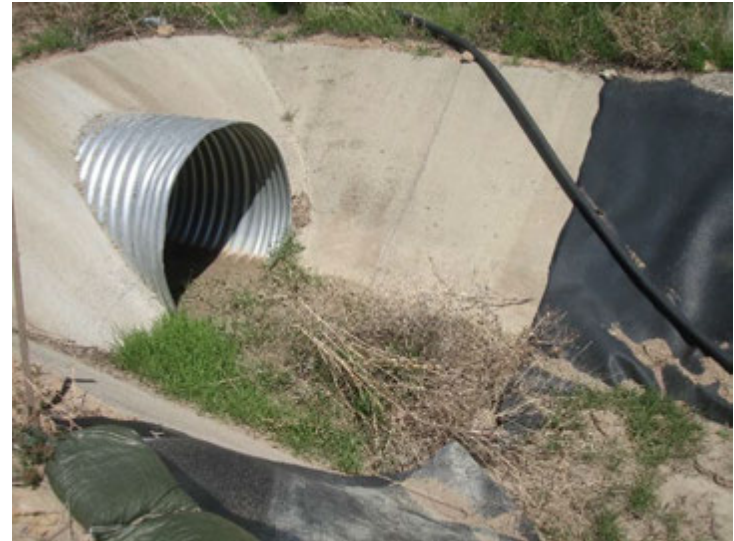
Photo 469: Basin D Outlet Channel: March 29, 2018

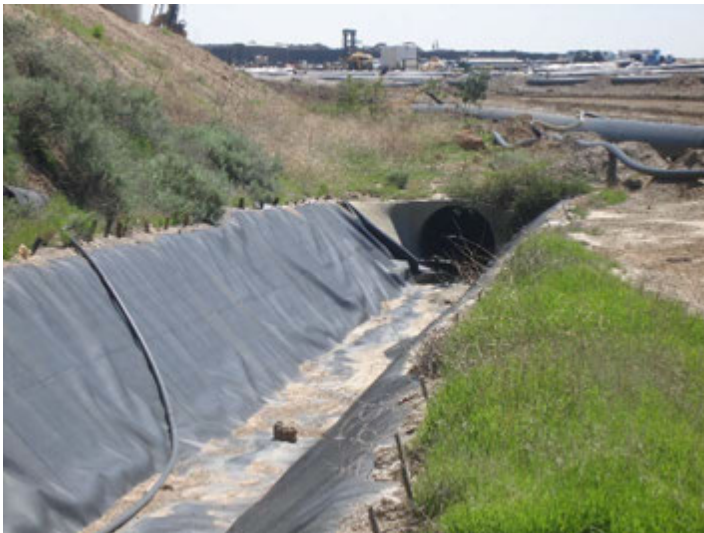
Photo 470: Basin D Outlet Channel: March 29, 2018

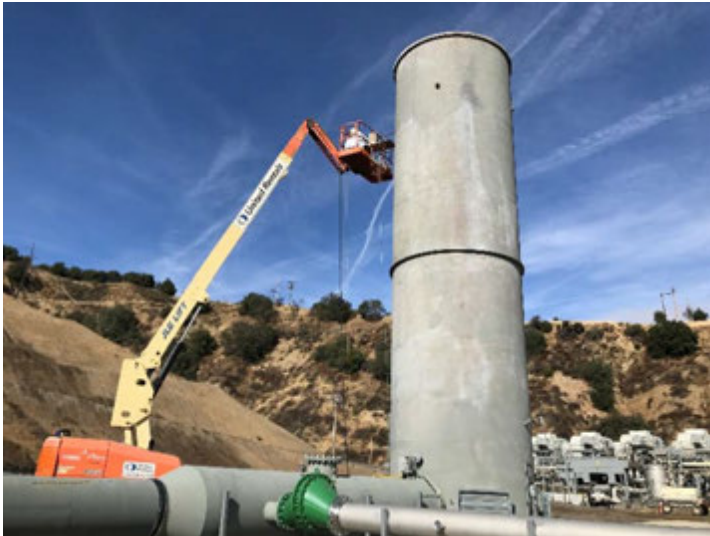
Photo 472: Flare 11 Emissions Test: January 10, 2018

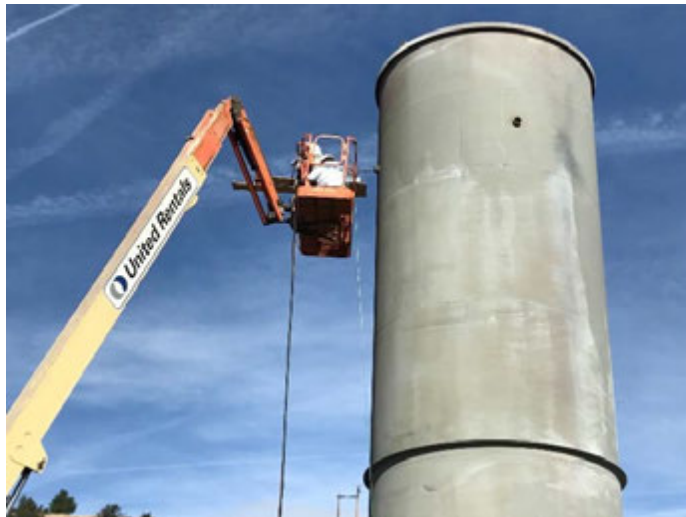
Photo 473: Flare 11 Emissions Test: January 10, 2018

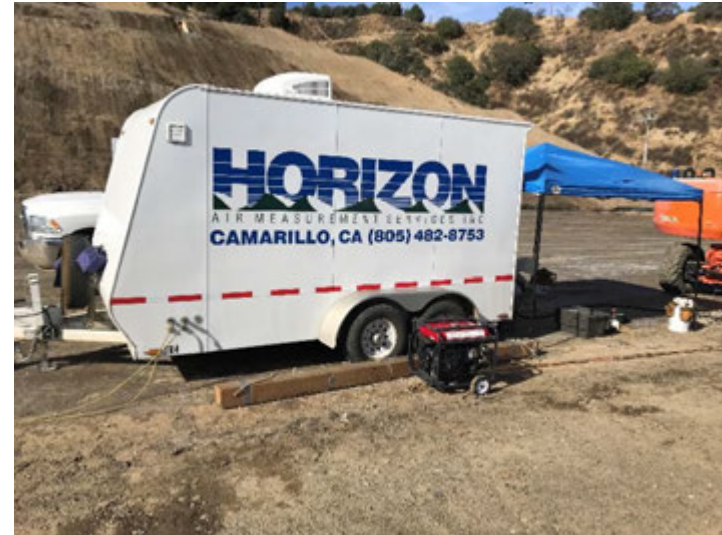
Photo 475: Flare 11 Emissions Test: January 10, 2018

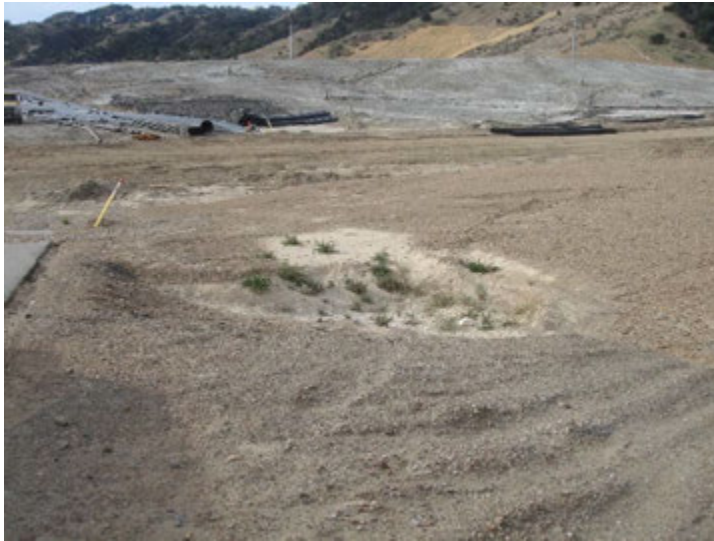
Photo 476: Plugged Drain at Flare 9-11 Access Road: January 30, 2018

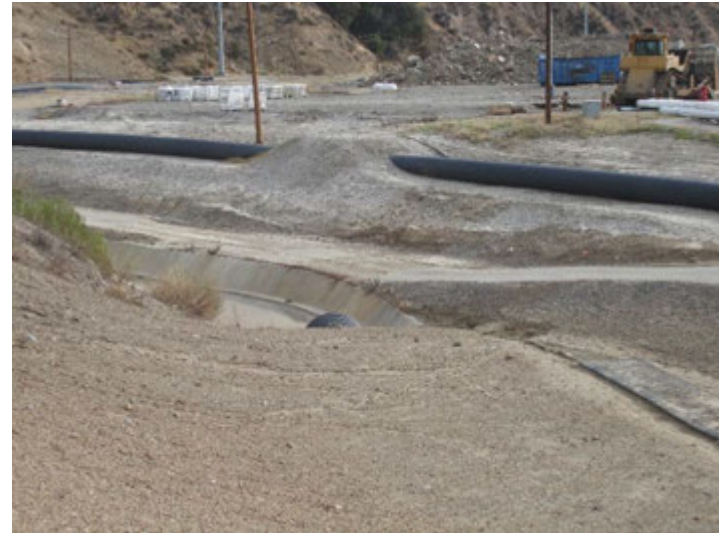
Photo 477: Plugged Drain at Flare 9-11 Access Road: January 30, 2018

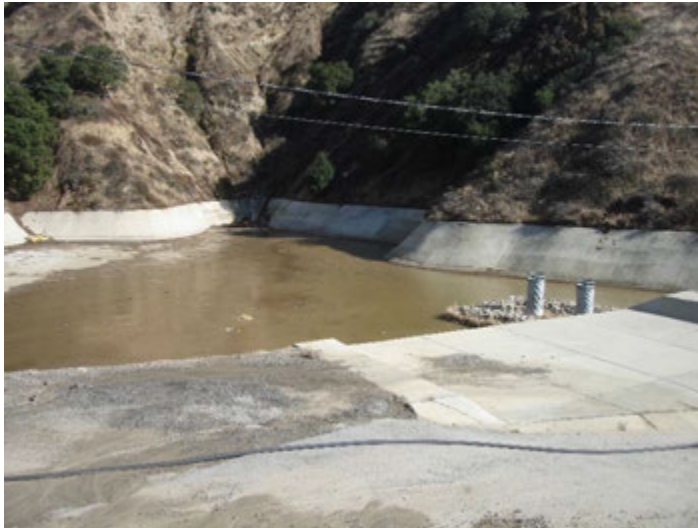
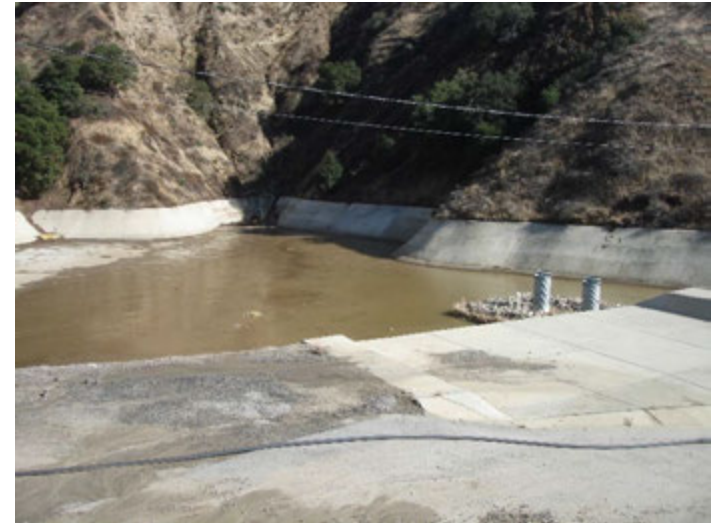
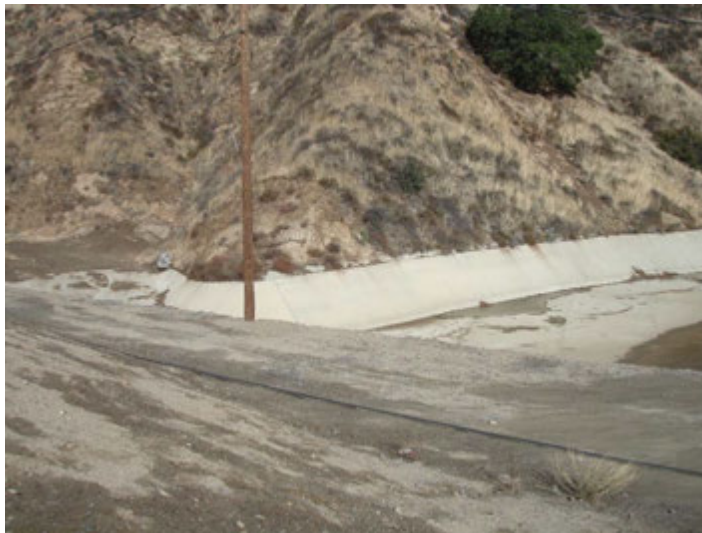
Photo 564: Basin B: January 10, 2018

Monitor: James Aidukas	Page: 1 of 2
Discipline: Project Manager	Date: 1/10/18
Site Conditions: Clear, 45-65°F, 0-10 MPH winds	
SITE LOG	
<p>Republic General Manager - Chris Coyle</p> <p>Drove the Granada Hills and adjacent Sylmar neighborhood areas from 6:30 to 7:30 a.m. and there were no landfill odors detected. Met with Mike Lindsay (UltraSystems) signed in, had a brief meeting with Joshua Mills, and proceeded to monitor the site and observed the following:</p> <ul style="list-style-type: none"> • Drove San Fernando Road north and Sierra Highway and did not observe any illegal dumping or windblown litter. • The terminal basin outlet channel had a significant amount of sediment that was discharged during yesterday's rain. The cause of the discharge was not evident. <p>Met with Gladys Gallardo (LACDPW) and she joined us during the monitoring.</p> <ul style="list-style-type: none"> • There was water ponding on the closure turf. The lower portion of the green grass cover of the turf slid down along the edge of the main access road, exposing the HDPE liner. The western area where it meets with the soil slope of CC-3A had washout areas and exposed trash. • Slope erosion and exposed waste was seen on the slopes of CC-4 Part 2. Standing water in the lined drainage channel was scheduled to be pumped into trucks and sewered. • Significant slope erosion was seen in some areas of CC-4A Parts 1 and 2, CC-3A and CC-3B. • A slope HDPE drainage channel was washed away on the eastern slope of CC-3B. • There was a strong odor coming from the top deck of CC-3A. This could be coming from the soil amendment for the revegetation activity. • Ponding of rainwater was seen on the Old City North top deck near the leachate and condensate tank farm. • Rainwater ponding was seen on the top deck of CC-3B. • CC-4A Part 1 was accepting waste with three tippers operating. CC-4A Part 2 was not active. • The eastern slopes of CC-3A and the County inactive decks and slopes being revegetated had deep erosion rills. The straw wattles were not effective in controlling the runoff. Ponding was seen in these areas. • The Posi-Shell appeared to hold up to the rain event. There were only minor areas that needed to be repaired. • The effectiveness of the erosion control measures being used on the whole site need to be evaluated. The areas that had erosion exposing trash need immediate remedial attention. • The eastside drainage channel had an area north of Basin B where the concrete channel wall was spalling. The channel had significant sediment behind the gabions. • Basin B had sediment and standing water.

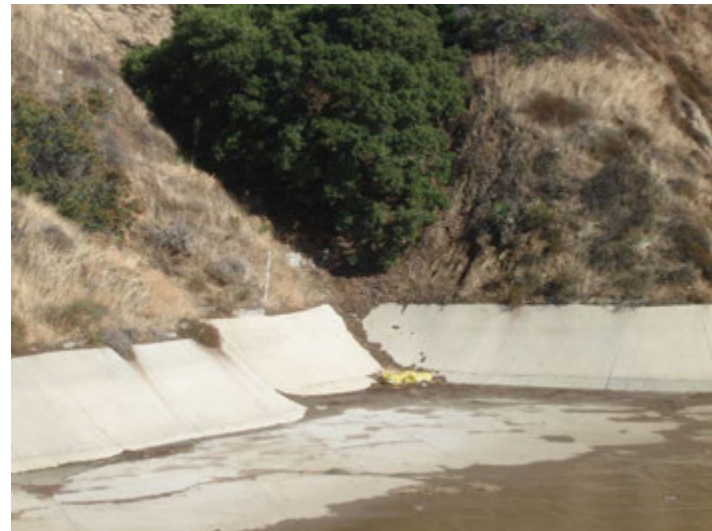
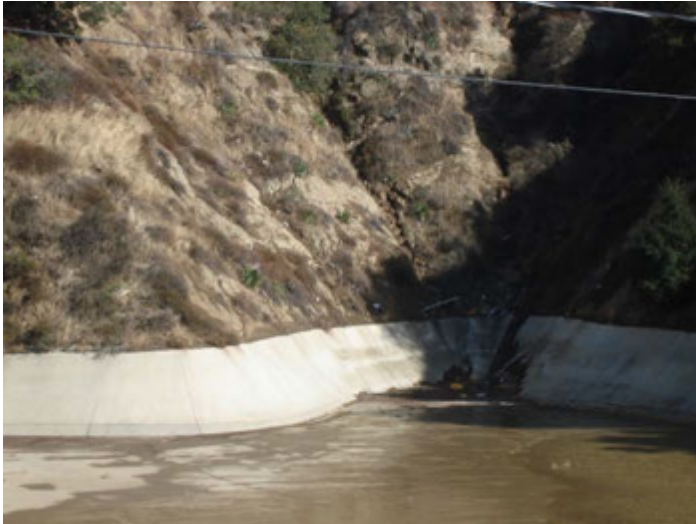
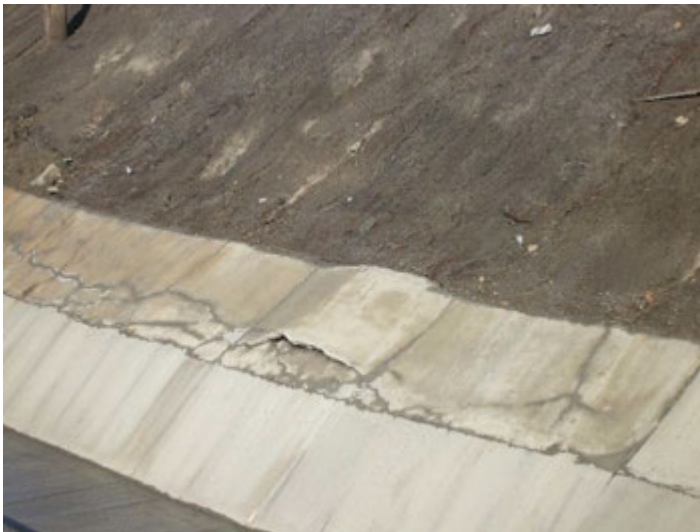
Photo 567: Basin B Native Hillside: January 10, 2018

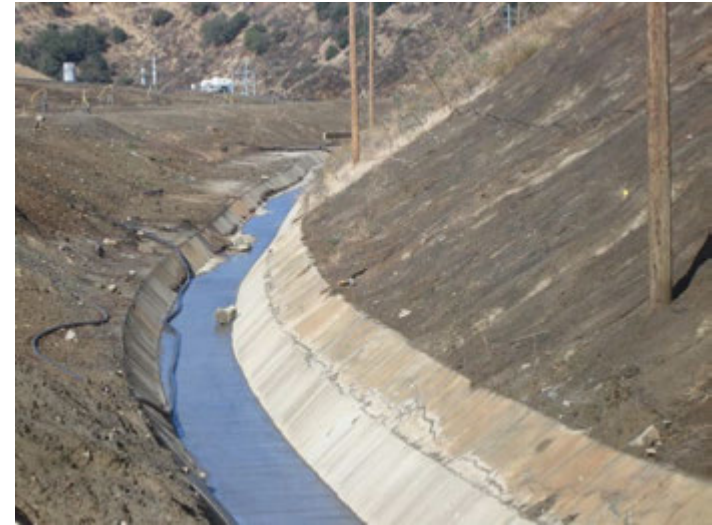
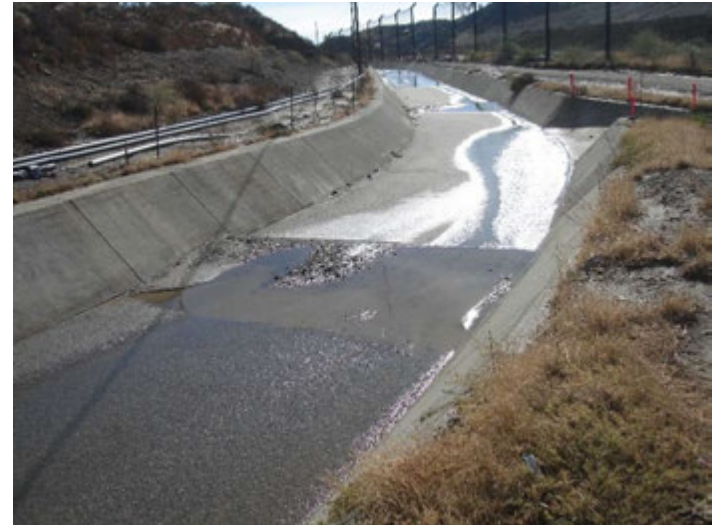
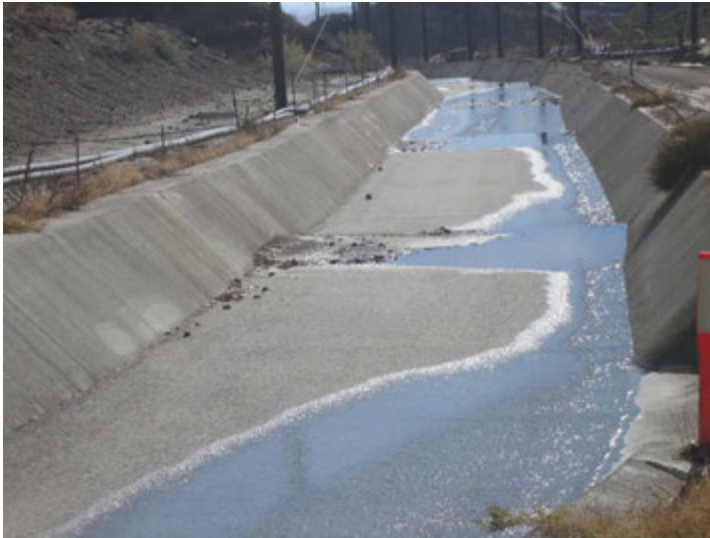
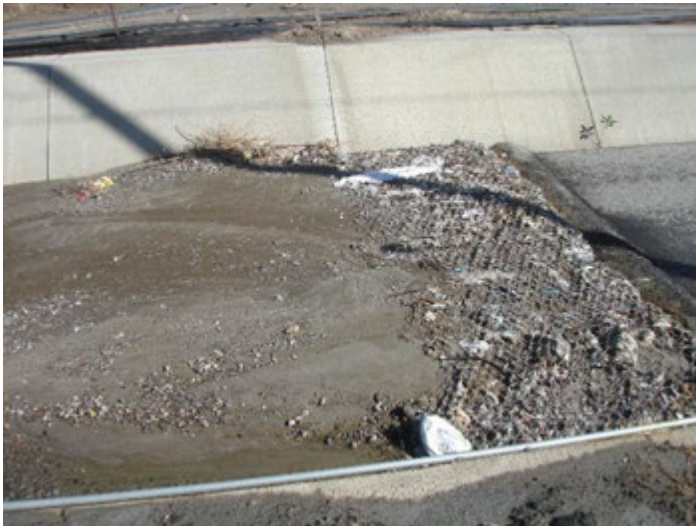
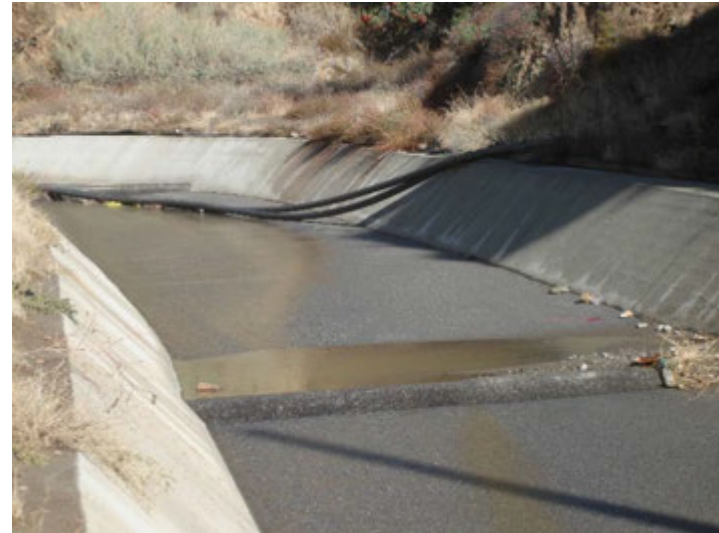
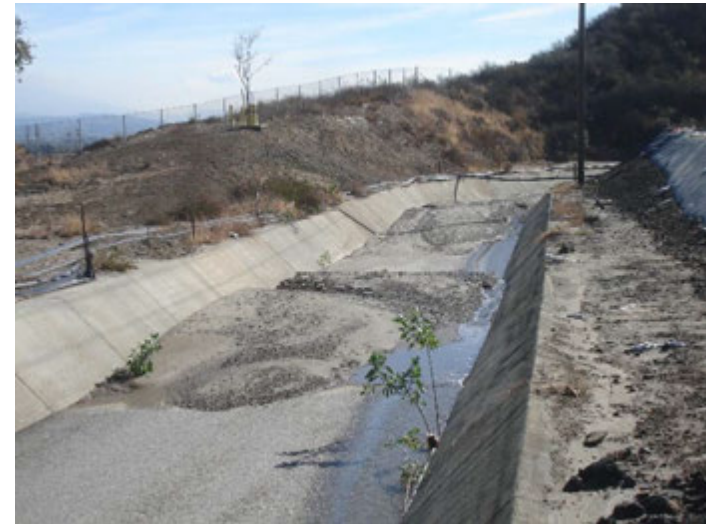
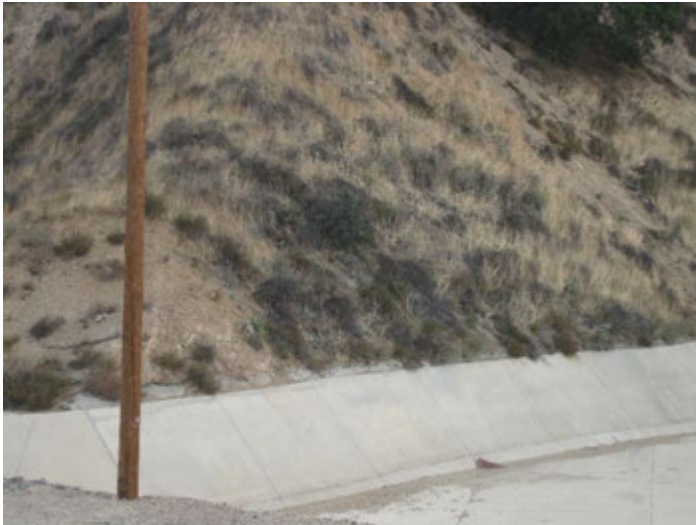
Photo 571: Eastside Drainage Channel: January 10, 2018
