**Sunshine Canyon Landfill
Independent Monitor
Quarterly Site Monitoring Status Report
January 1, 2018 – March 31, 2018**

May 25, 2018

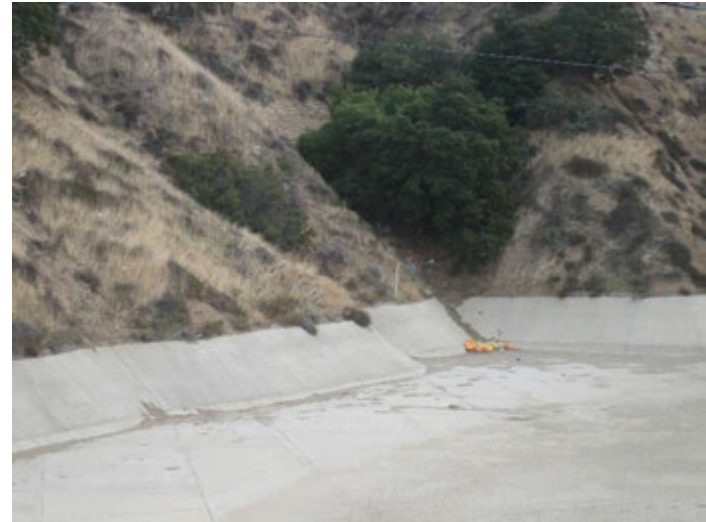
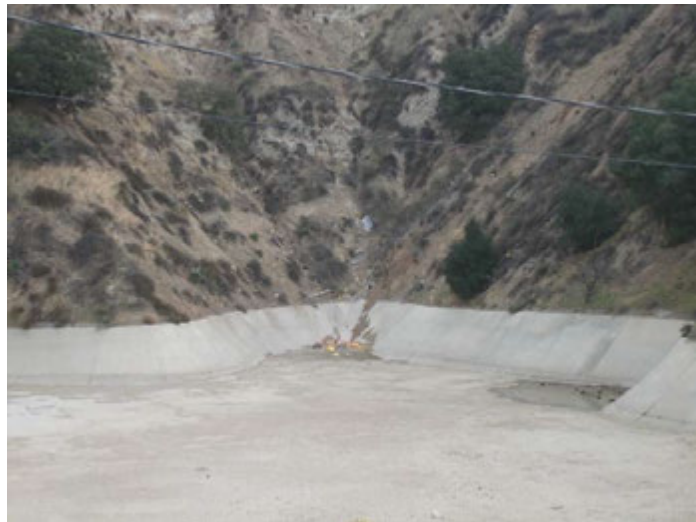
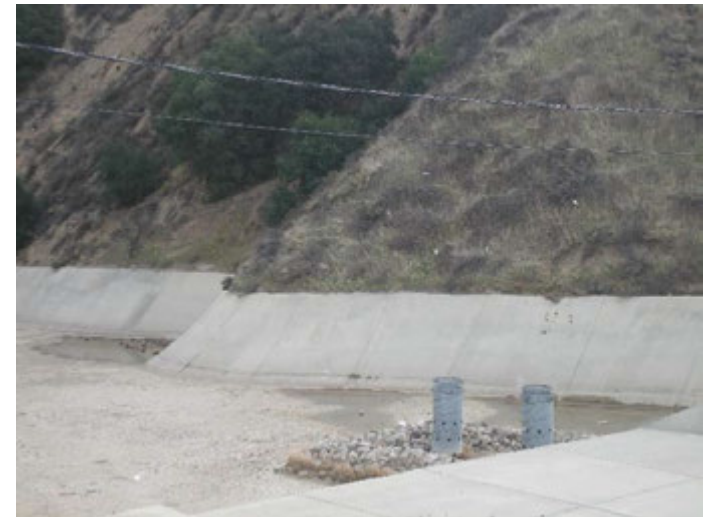
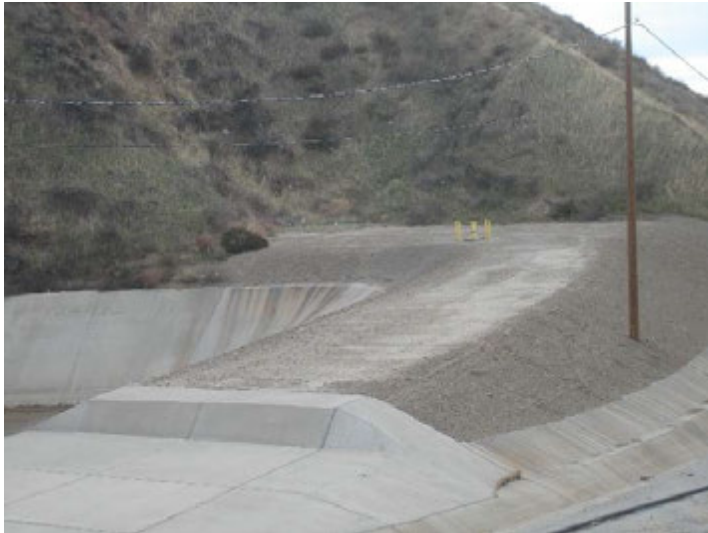
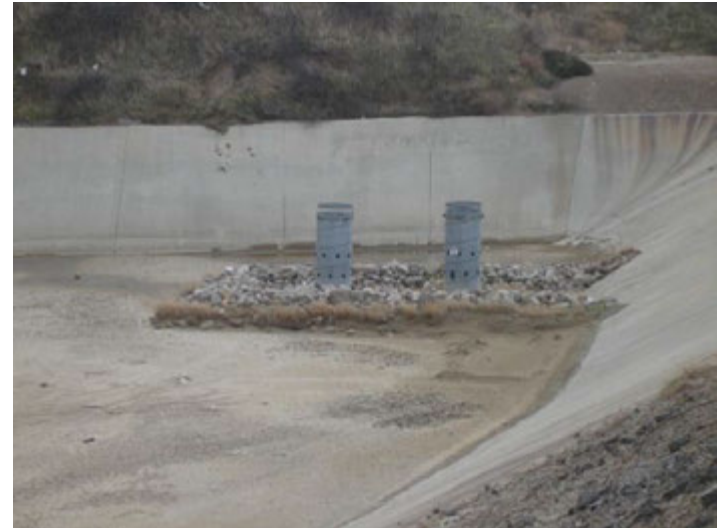
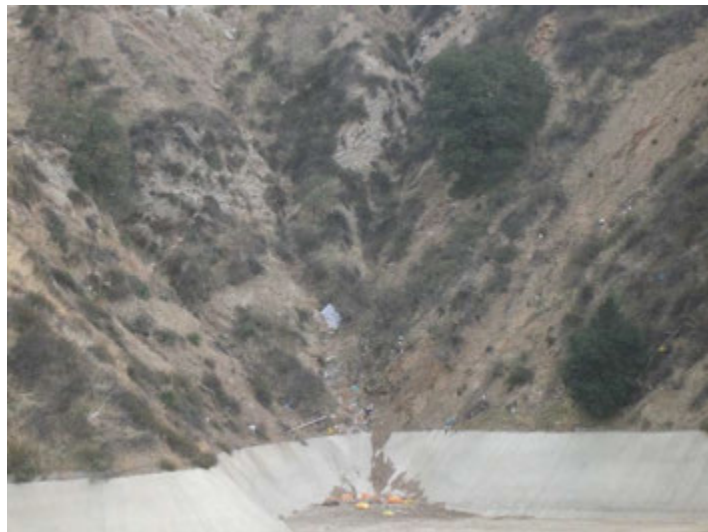
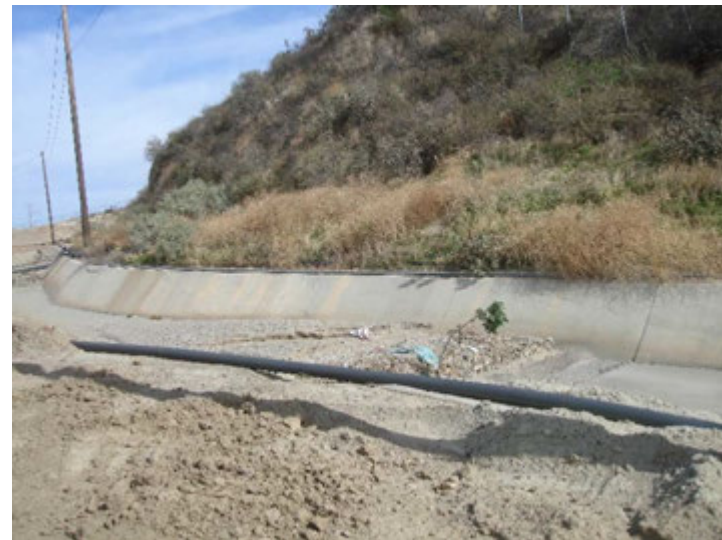
Photo 577: Basin B: January 30, 2018

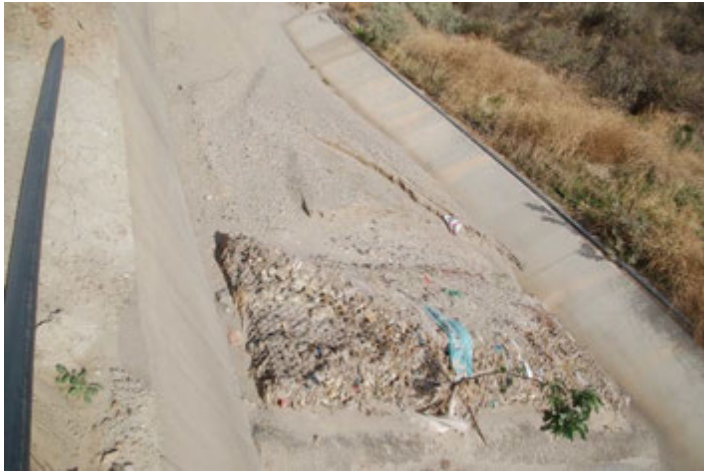
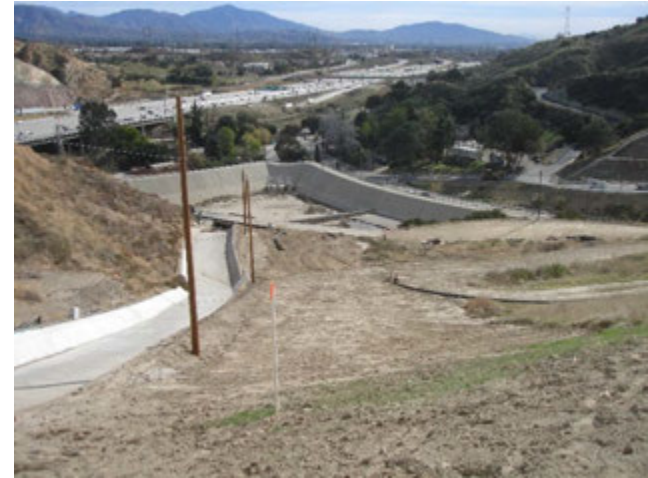
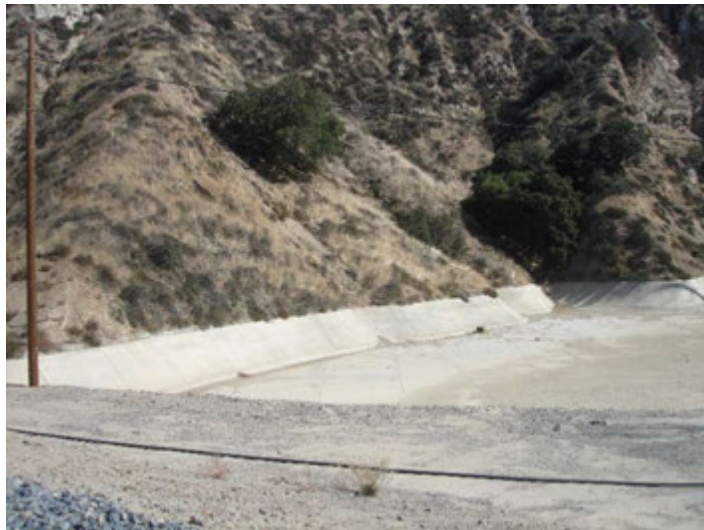
Photo 584: Eastside Drainage Channel: January 30, 2018

Monitor: James Aidukas	Page: 1 of 2
Discipline: Project Manager	Date: 1/30/18
Site Conditions: Clear, 45-65°F, 0-10 MPH winds	
SITE LOG	
<p>Republic General Manager - Chris Coyle</p> <p>Drove the Granada Hills neighborhood areas from 6:45 to 7:30 a.m. and there were no landfill odors detected. Met with Mike Lindsay (UltraSystems) and Tarik Hadj-Hamou (SLR), signed in, had a brief meeting with Ricky Dhupar, and proceeded to monitor the site and observed the following:</p> <ul style="list-style-type: none"> • Erosion rills on slopes in Cells CC-3A, CC-3B southern side, CC-4A Parts 1 and 2, and the Old City south were in the process of being repaired. All areas where trash was previously exposed have been repaired. • There were no liquids odors detected on the CC-3A access road adjacent to the closure turf where a previous landfill liquids spill occurred. • There was an area of the slope closure turf that appears to have slid or sunk. • The City South landfill soil stockpile area south of the office parking lot has one area that has further subsidence. This area needs to be monitored by Republic. • The Old City north deck liquids handling tank farm was operating with liquids being trucked away. Connection to the sewer was not yet completed. The rest of this deck was graded and rain impacts repaired. • The CC-3B top deck erosion and drainage gullies were repaired. • There were significant erosion rills on the eastern vegetated slopes of CC-3B and CC-3A. The straw wattles were not buried when installed and water flowed under them, creating rills. • Basin B was cleared of litter with minimal sediment and standing water. The native hillsides had windblown litter. • Wet weather road base and landfill drainage rock was stockpiled on the County top deck along with drainage piping and gas collection piping and materials. • The drainage channel along the paved access road to the Flares 9, 10, and 11 site had the outlet plugged. • Basin D outlet channel liner leading edge was lifting and had tumbleweed and sediment under the liner. • The deck above Basin D still had stockpiles of tree trunks and branches, wood waste and other debris. • The portion of the County sage area that was covered with jute netting and hydroseeded held up to the rains with no erosion seen, and were greening up with vegetation. • Basin A had sediment and standing water at the outlet risers. There was windblown litter in the back and side native vegetation areas. The gas collection piping to Flare 3 was sliding off its supports and becoming unstable due to the cut hillside sloughing soil. • Cells CC-4A Part 1 and 2 were accepting waste. • The eastside drainage channel had significant sediment and litter behind channel gabions.

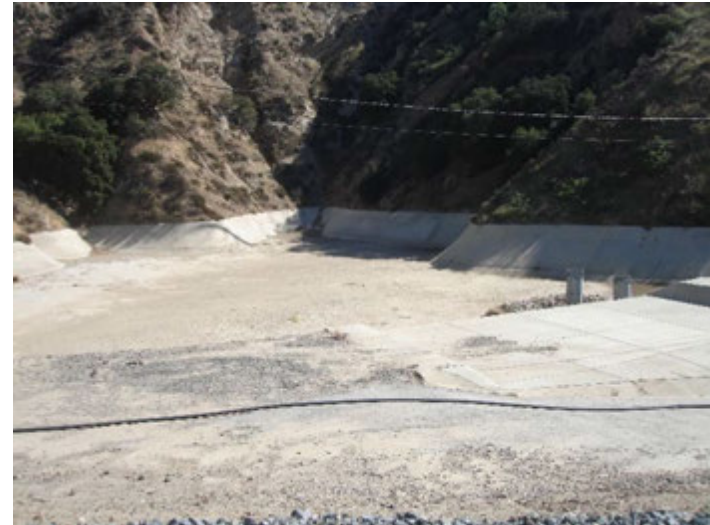
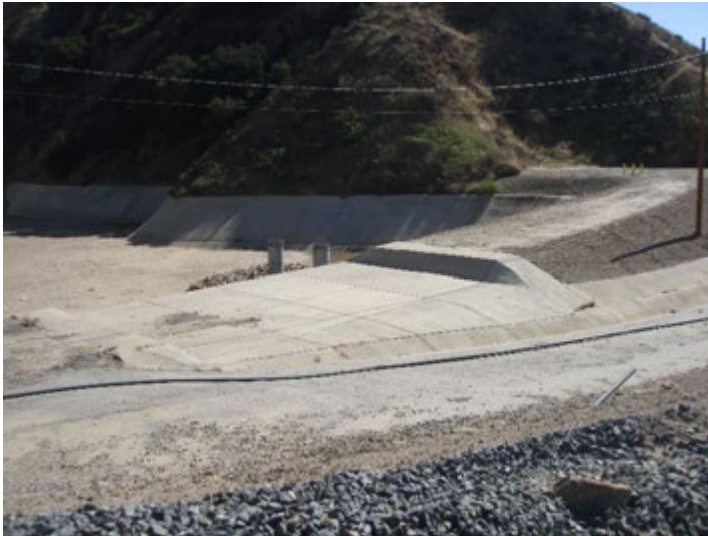
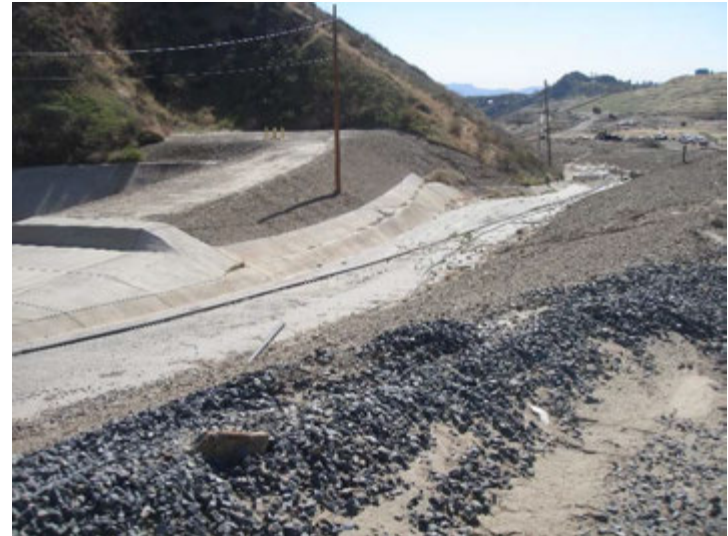
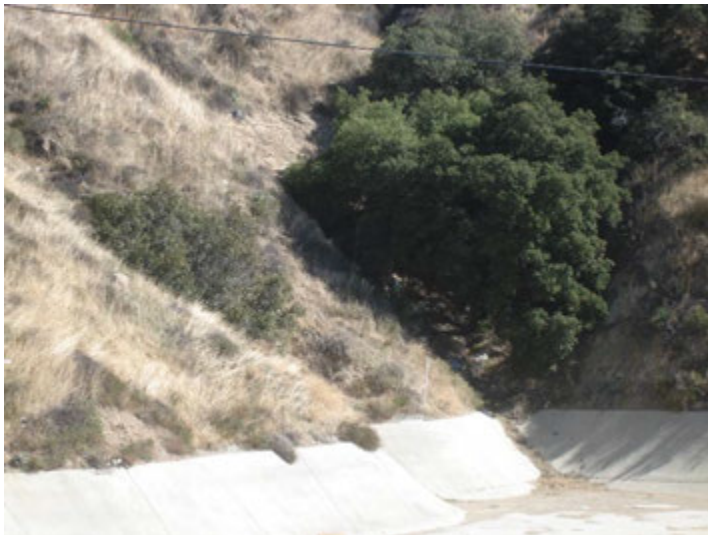
Photo 587: Basin B: February 20, 2018

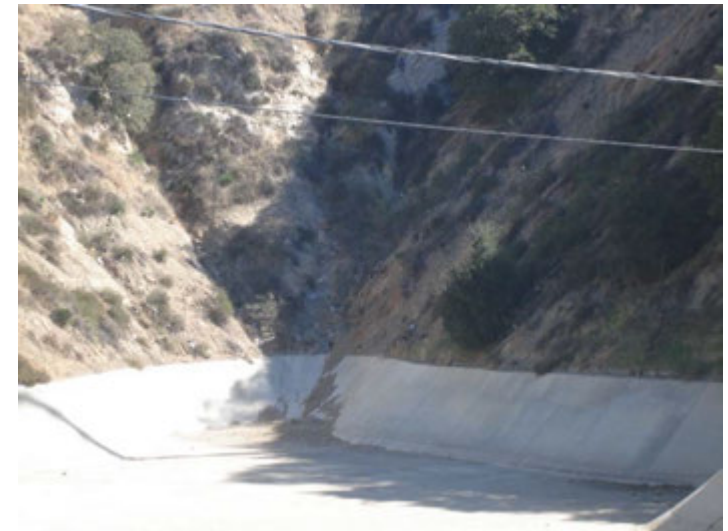
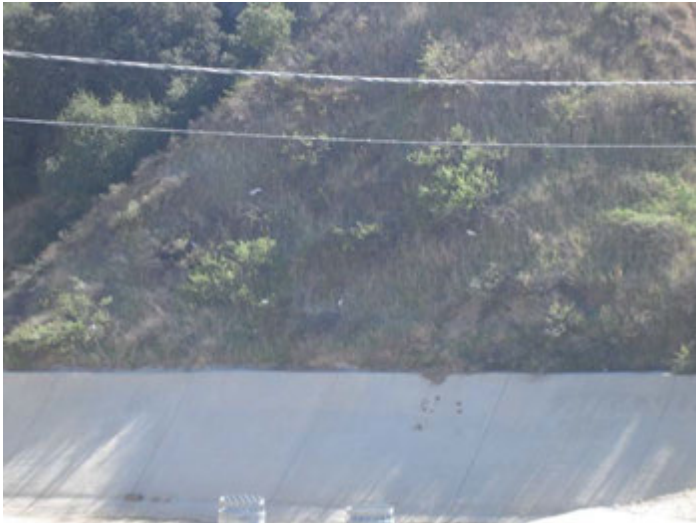
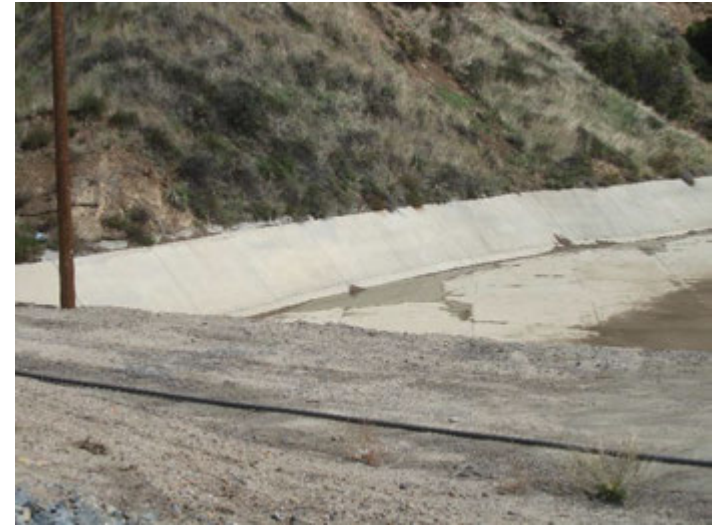
Photo 591: Basin B Native Hillside Litter: February 20, 2018

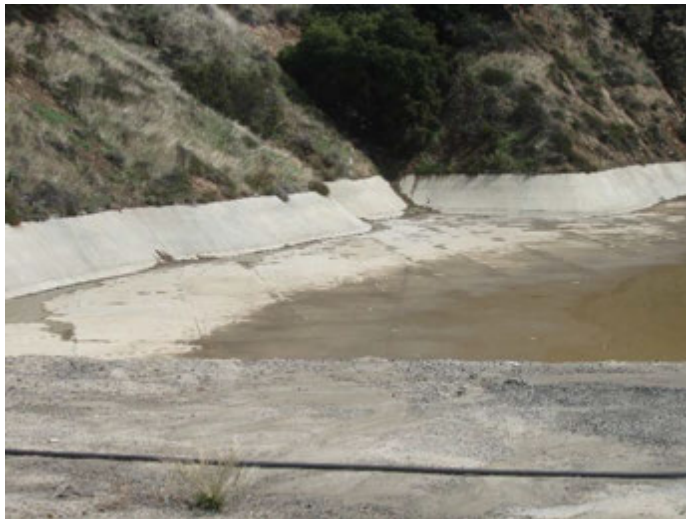
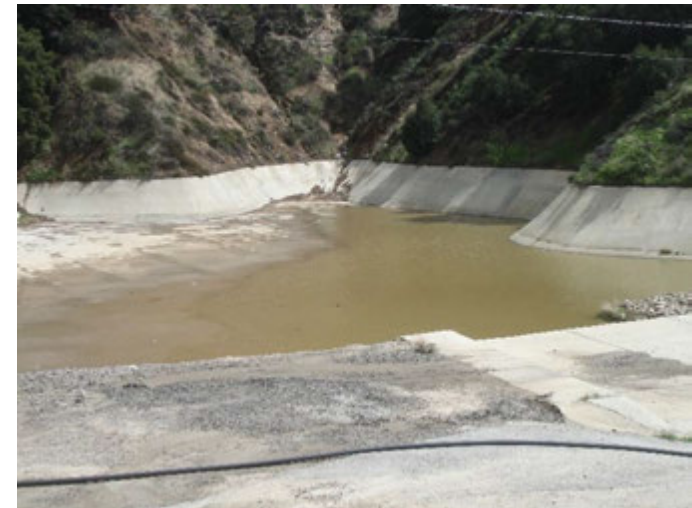
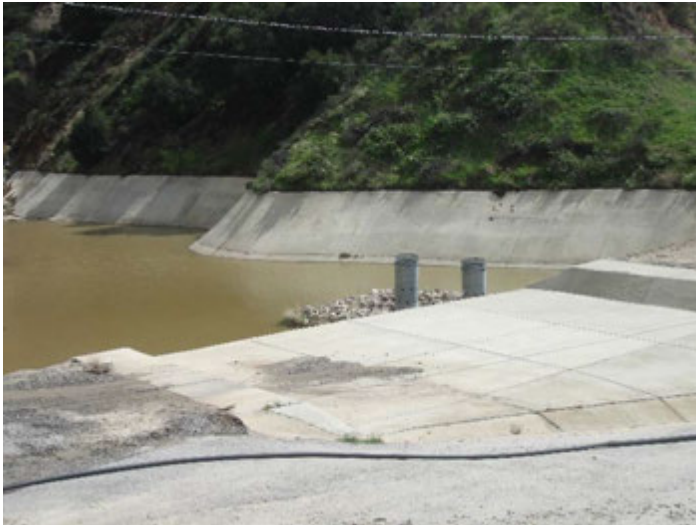
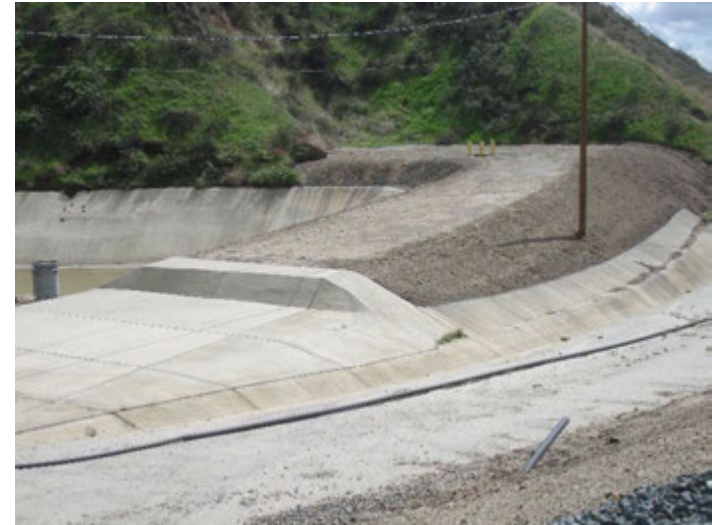
Photo 594: Basin B: March 14, 2018

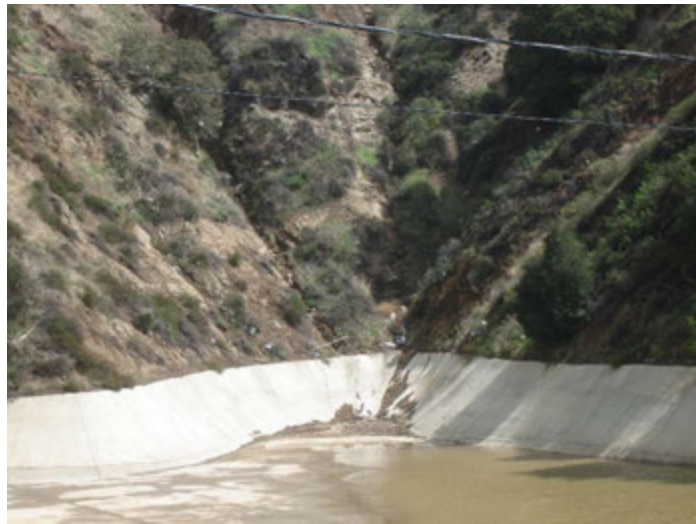
Photo 599: Basin B Native Hillside Litter: March 14, 2018

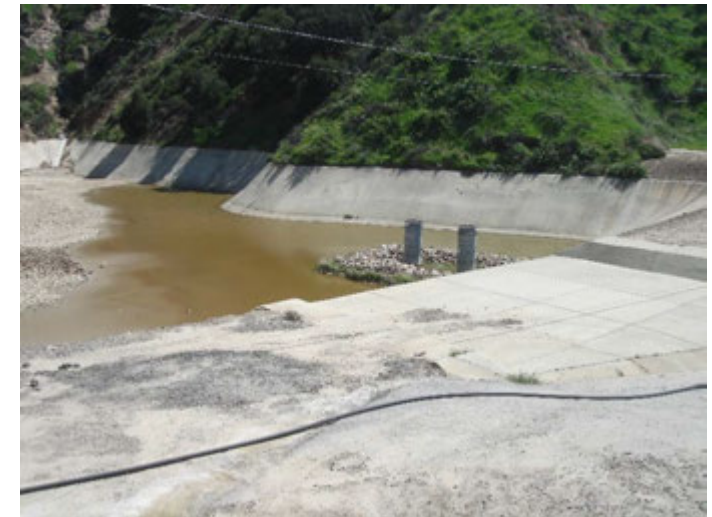
Photo 604: Basin B Back Hillside Litter: March 29, 2018

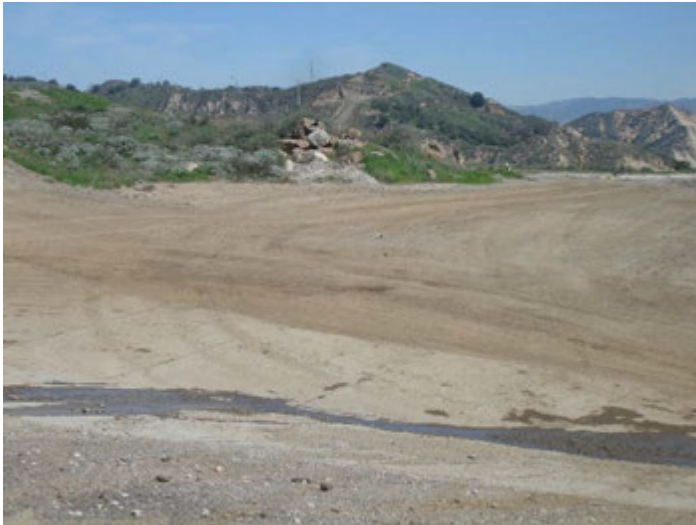
Photo 605: Basin B Sage Mitigation Area: March 29, 2018

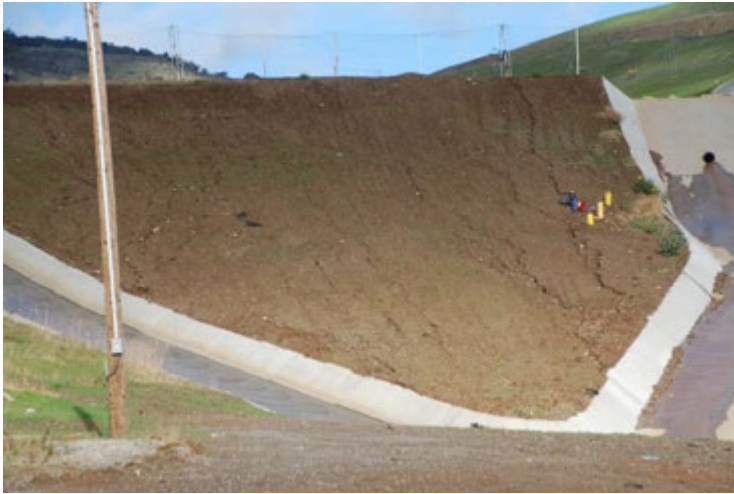
Photo 629: Terminal Basin Inlet: March 14, 2018

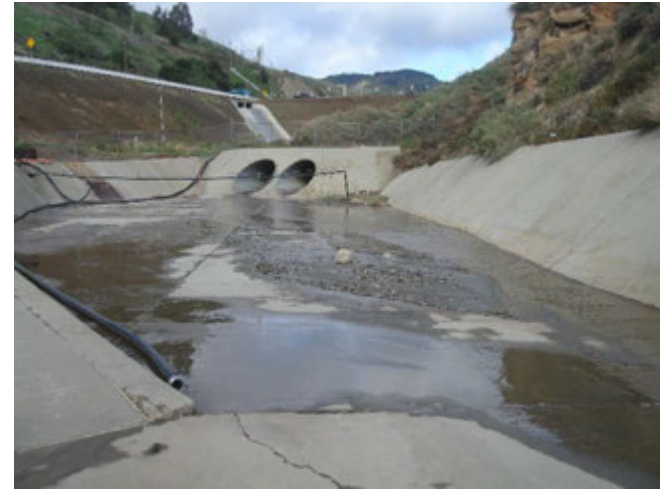
Photo 630: Terminal Basin Inlet: March 14, 2018

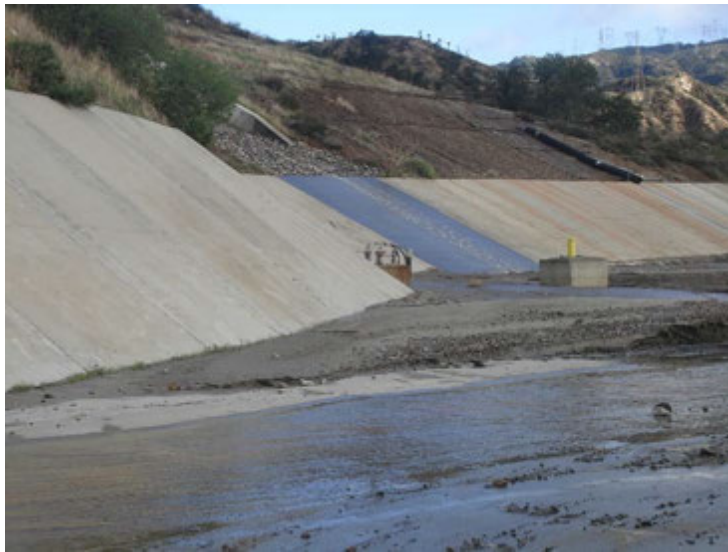
Photo 631: Terminal Basin Inlet: March 14, 2018

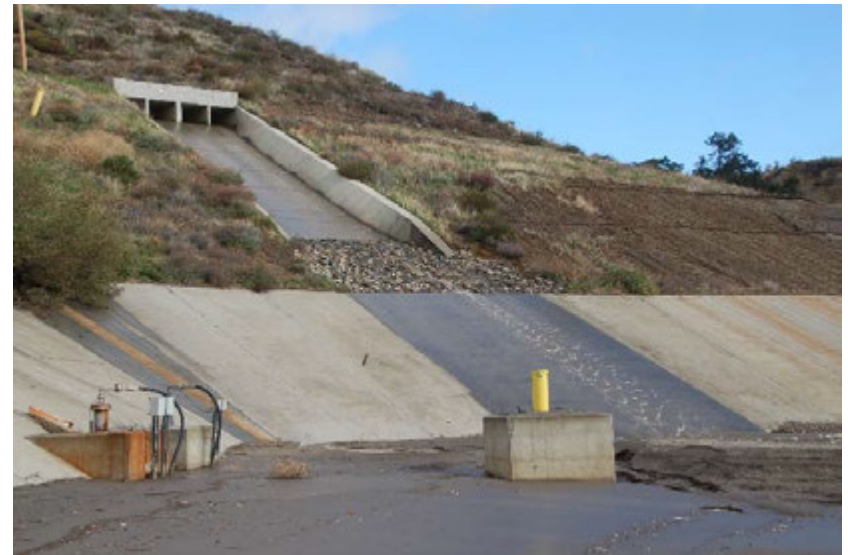
Photo 632: Terminal Basin Inlet: March 14, 2018

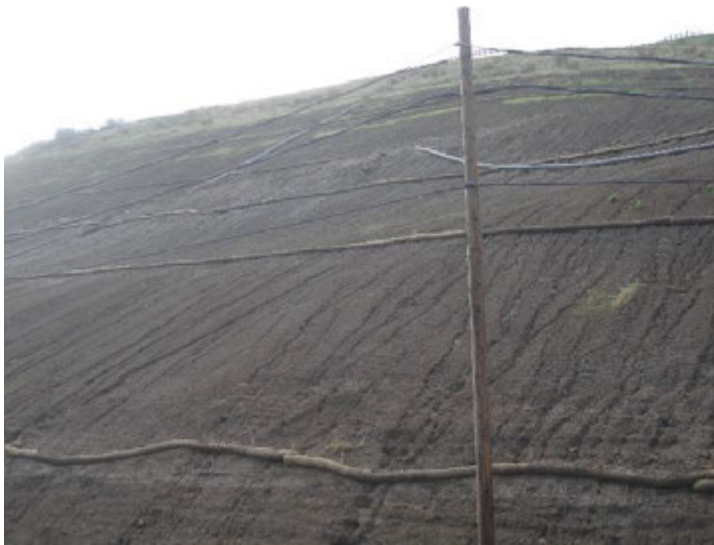
Photo 633: Old City South Soil Stockpile: March 14, 2018

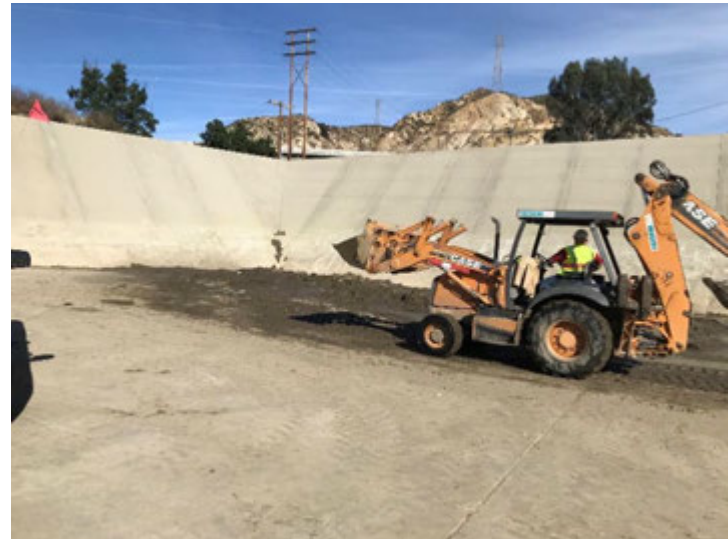
Photo 651: Terminal Basin: January 10, 2018

- CC-3B basin had standing water. The low-flow drain was plugged.
- The terminal basin has one skimmer riser support break and caused an uncontrolled release of sediment during yesterday's rain event. The risers were being repaired and reinforced.

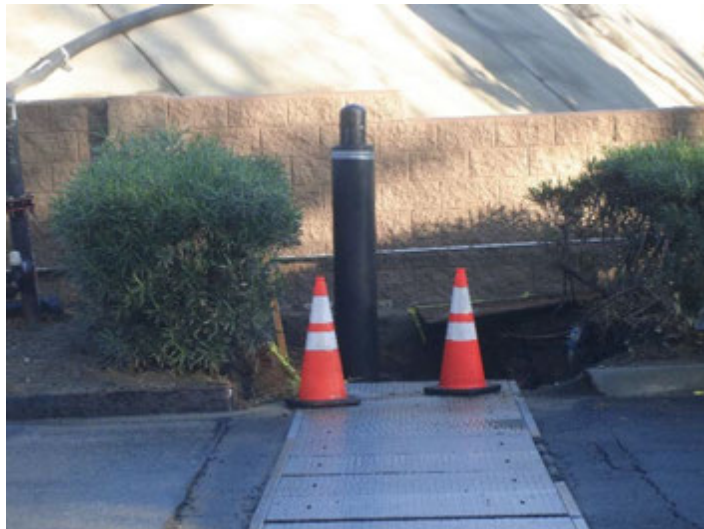
Photo 654: Terminal Basin Outlet: January 10, 2018

1. Repair buckling concrete at sediment basin B drainage channel.
2. Eliminate ponding water at tank farm.
3. Eliminate ponding water at Cell CC-4 Part 2.
4. Repair erosion ruts at Cell CC-4 Part 1 and Part 2.
5. Repair erosion ruts above Flare 1.
6. Eliminate ponding water at sediment basin B.
7. Eliminate fine sediment at terminal basin outlet channel.

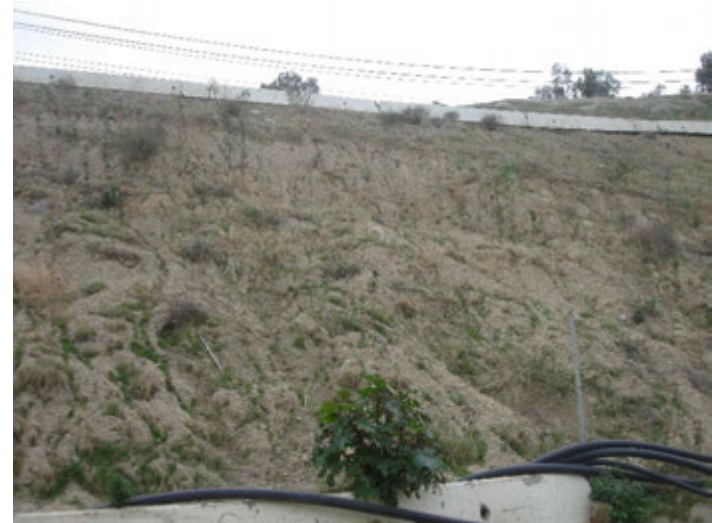
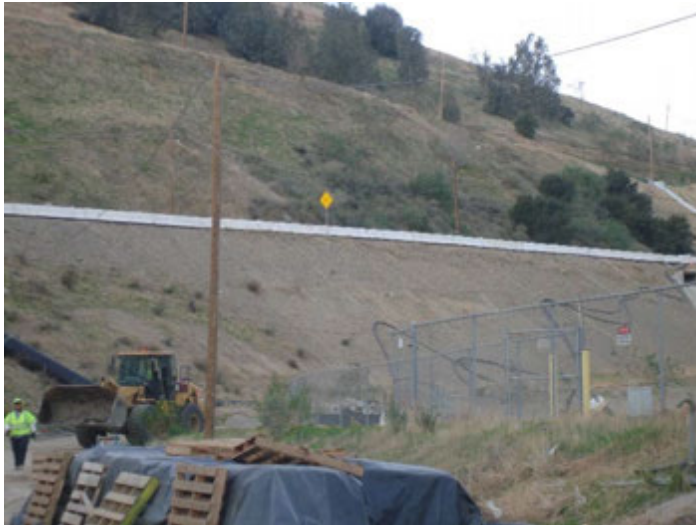
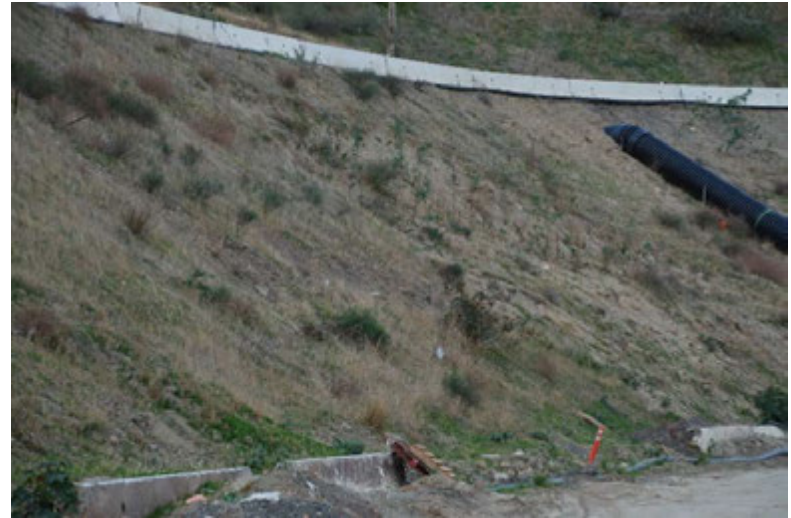
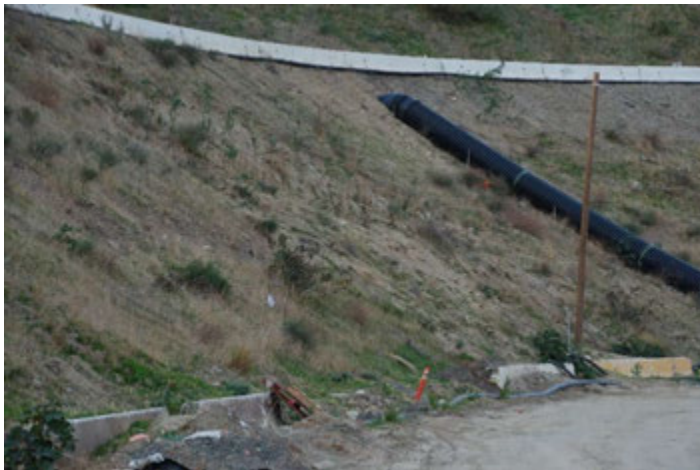
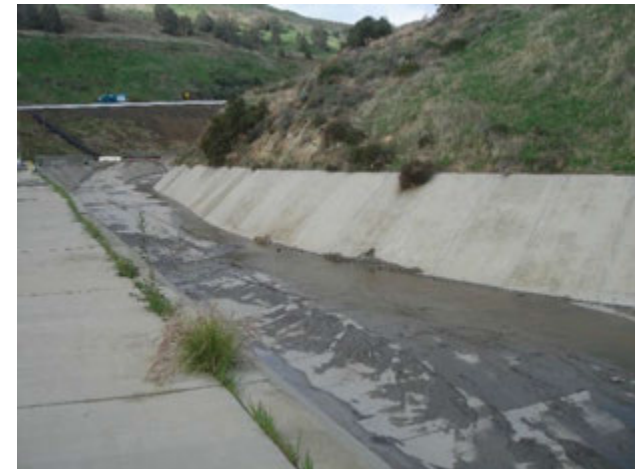
Photo 667: Access Road near Terminal Basin: January 30, 2018

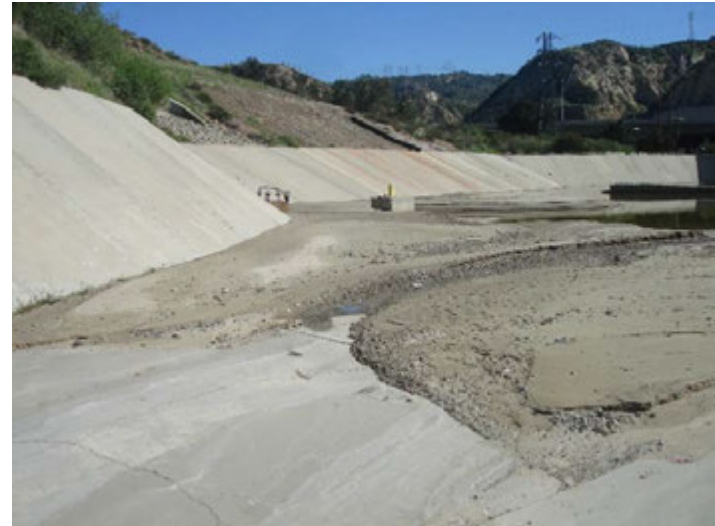
Photo 725: Access Road Settlement: March 14, 2018

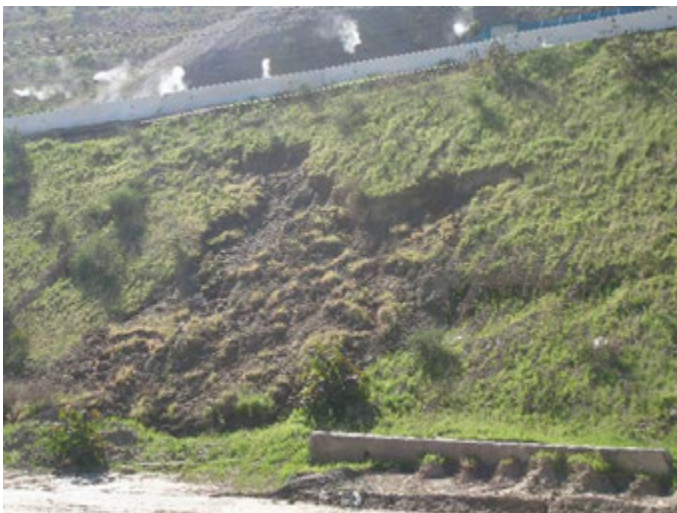
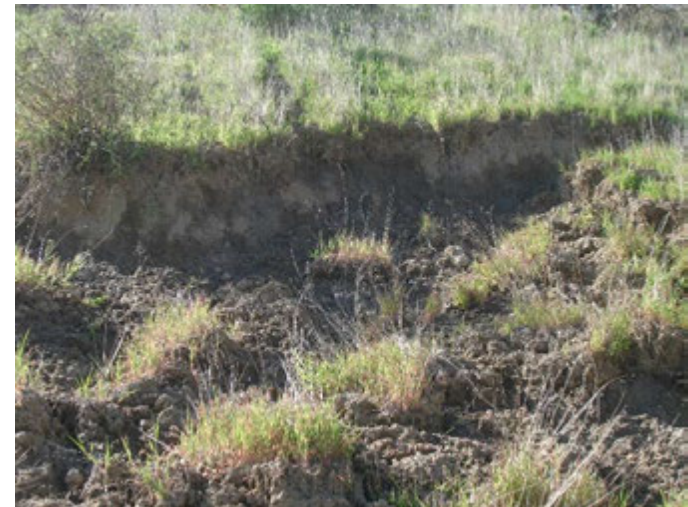
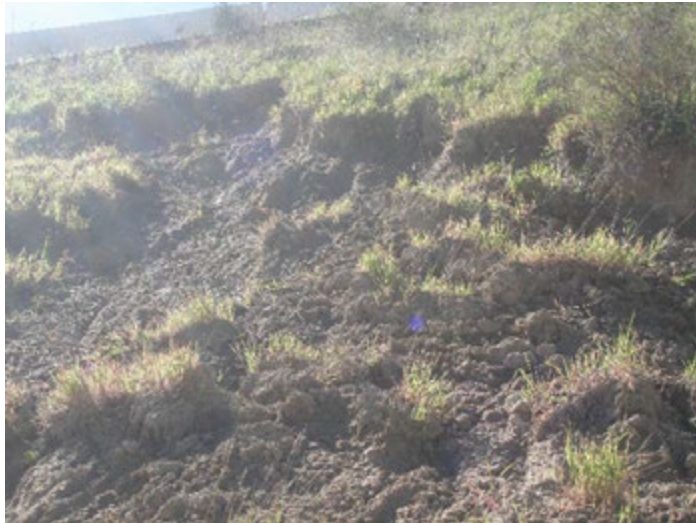
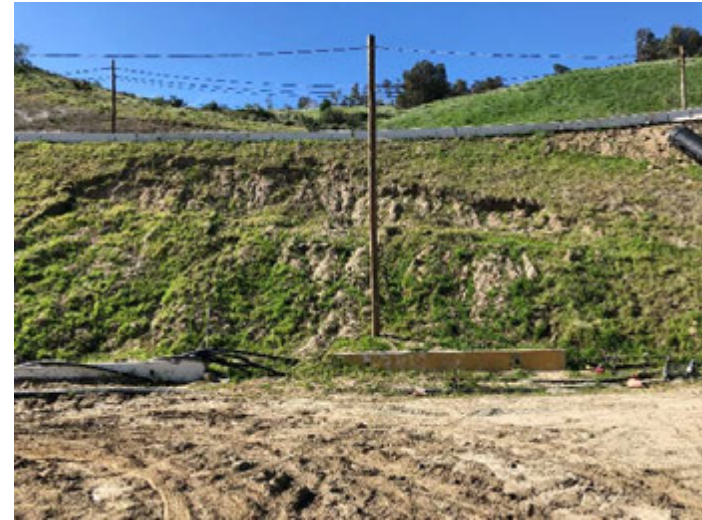
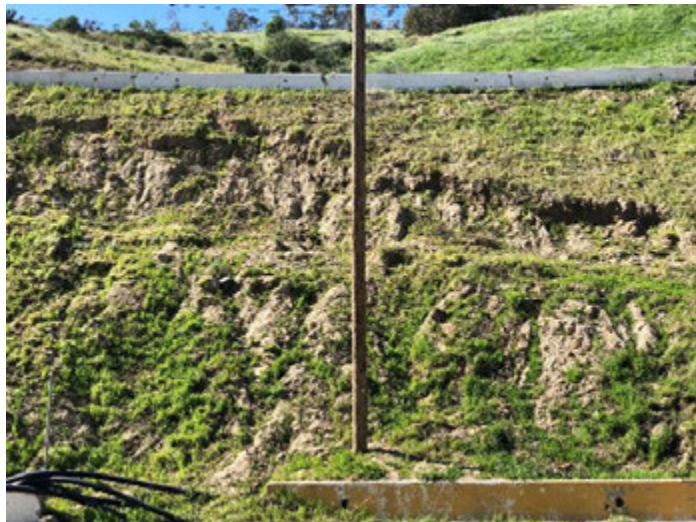
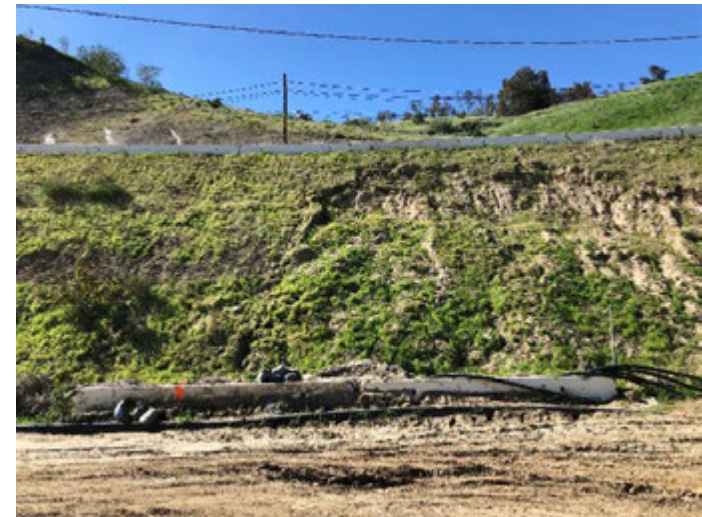
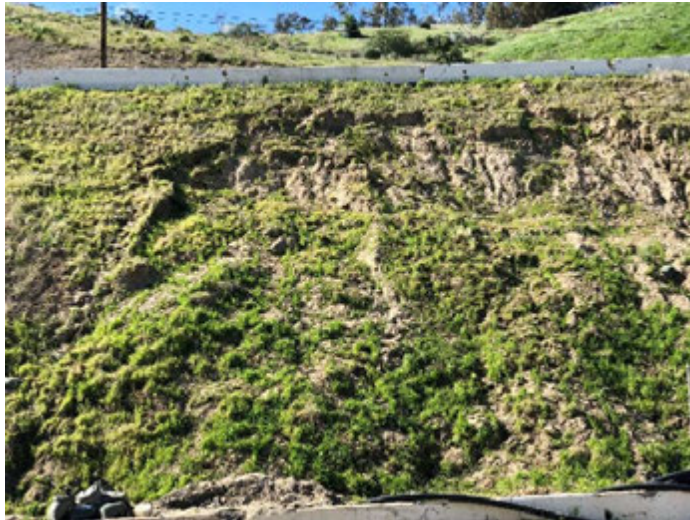
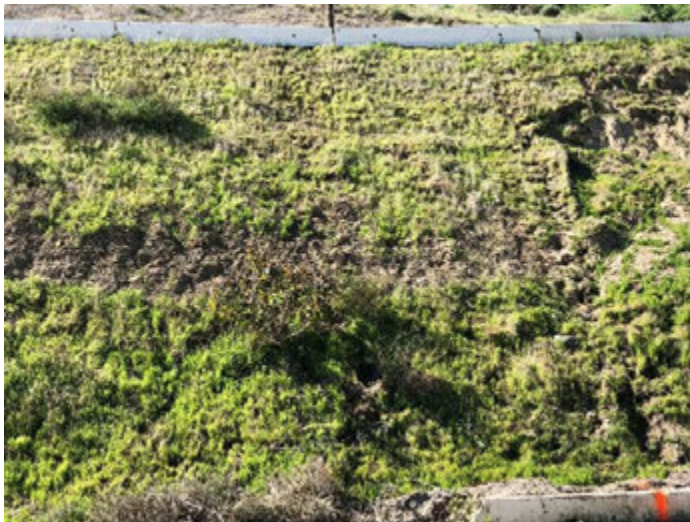
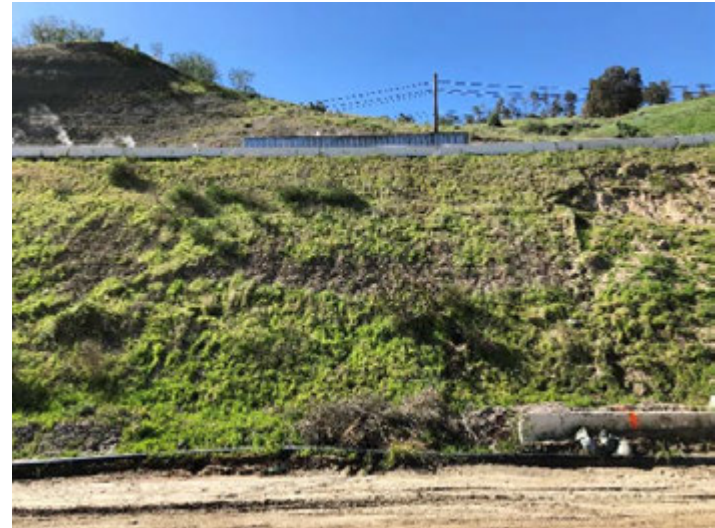
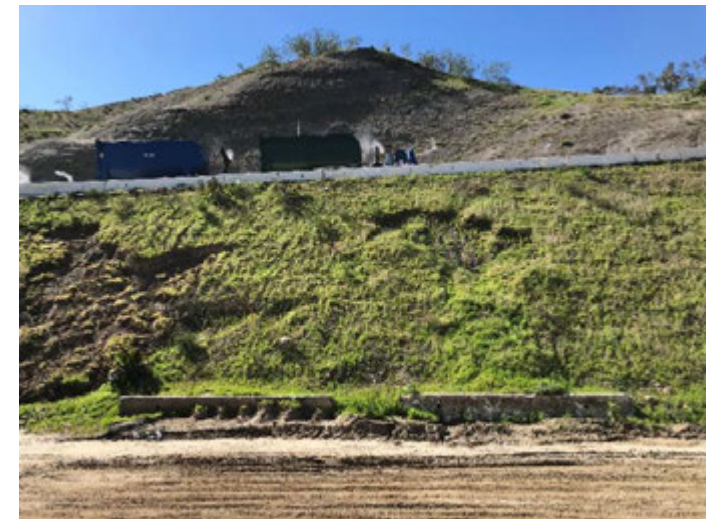
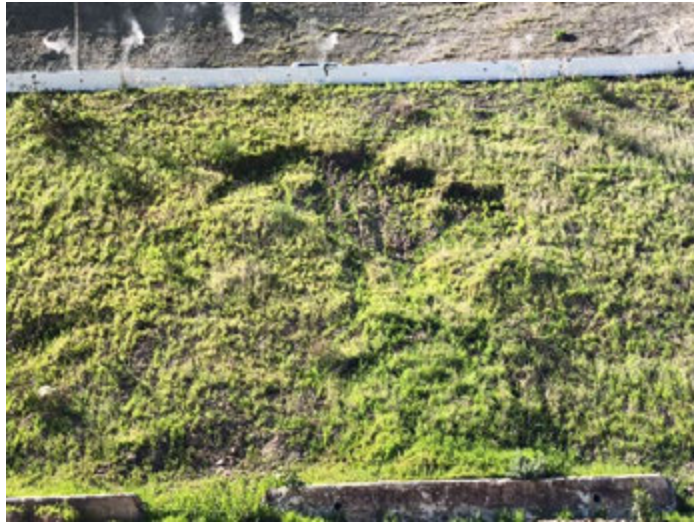
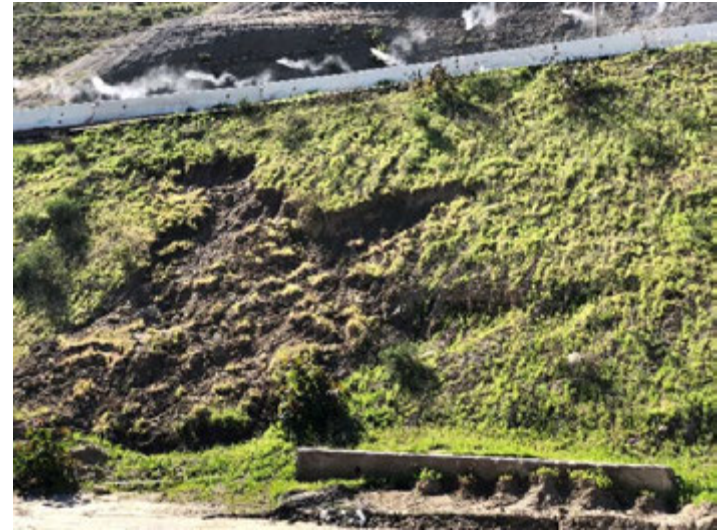
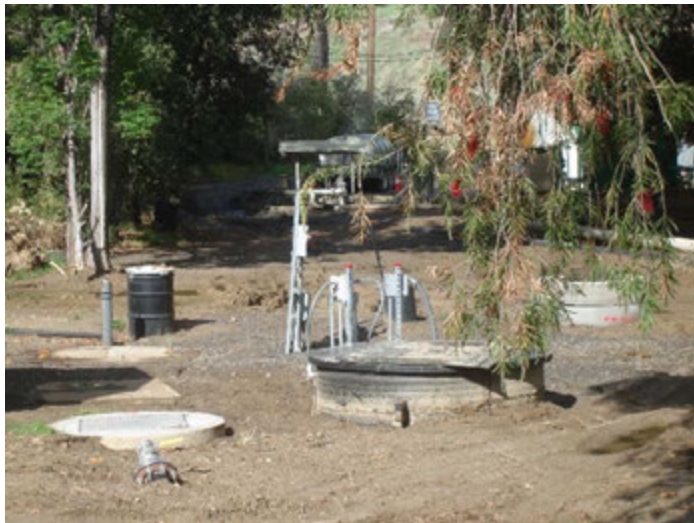
**Photo 758: Access Road Slope near Terminal Basin Entrance:
March 29, 2018**

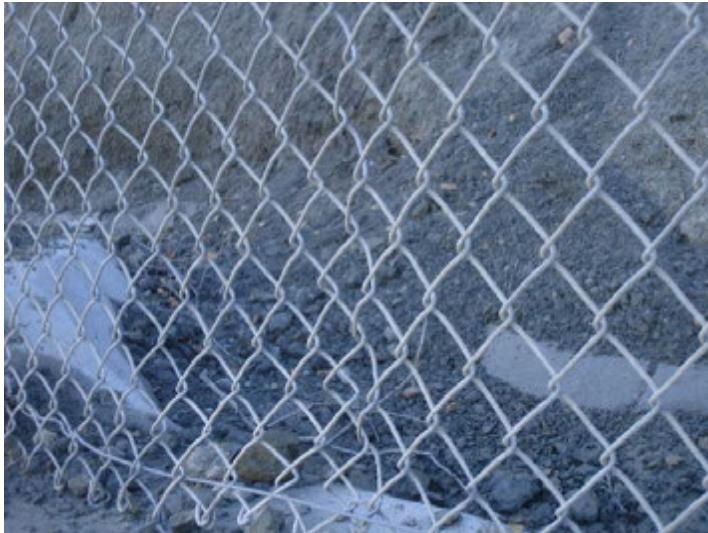
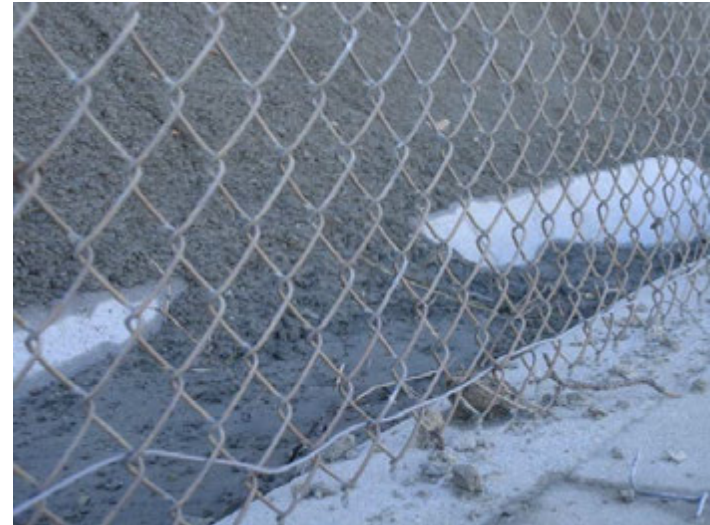
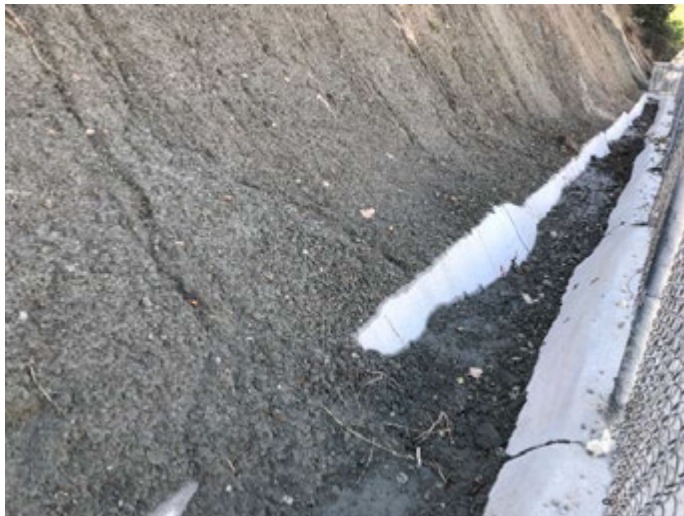
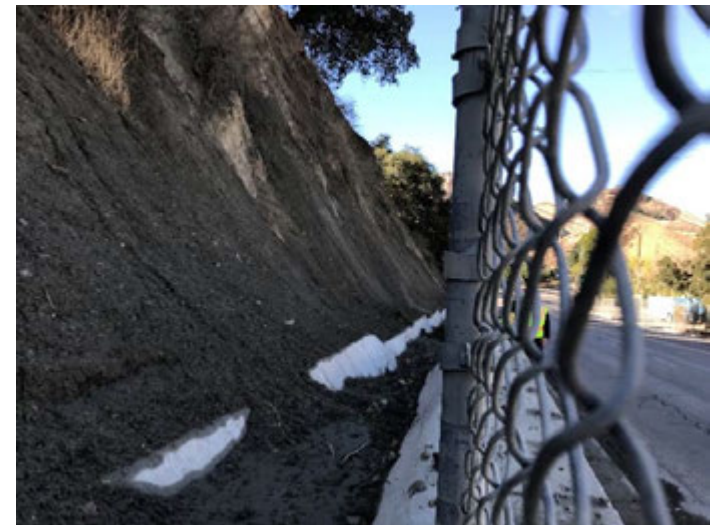
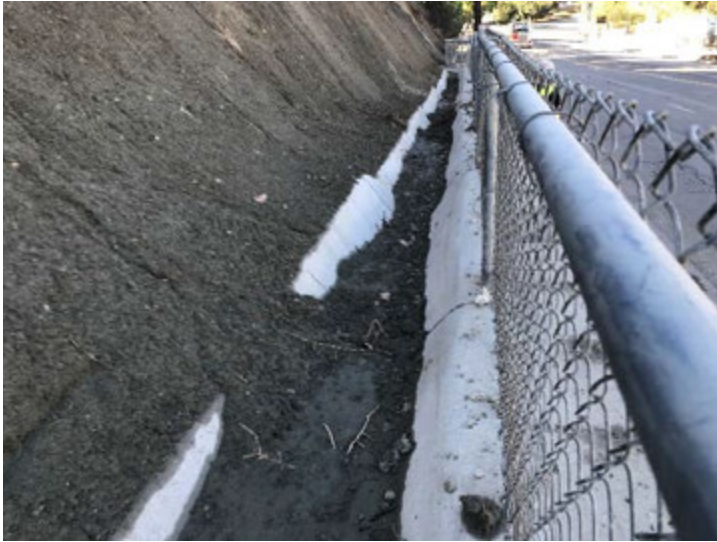
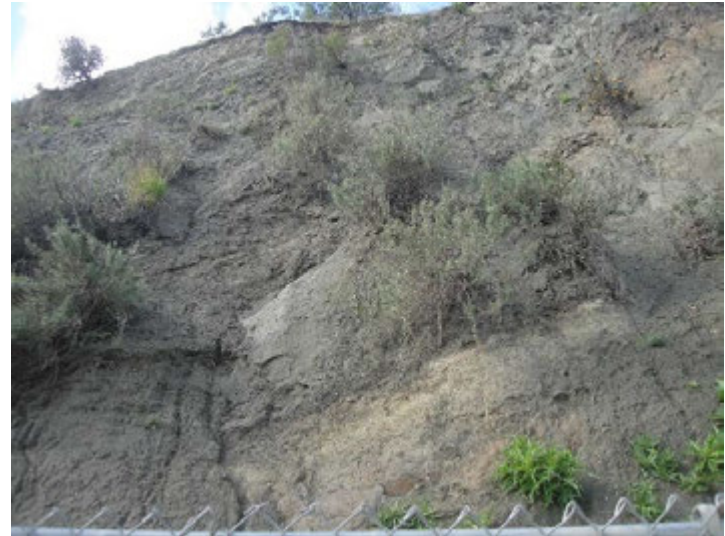
**Photo 772: Frontage Retaining Wall Slope on San Fernando Road:
January 10, 2018**
