**Sunshine Canyon Landfill
Independent Monitor
Quarterly Site Monitoring Status Report
January 1, 2018 – March 31, 2018**

May 25, 2018

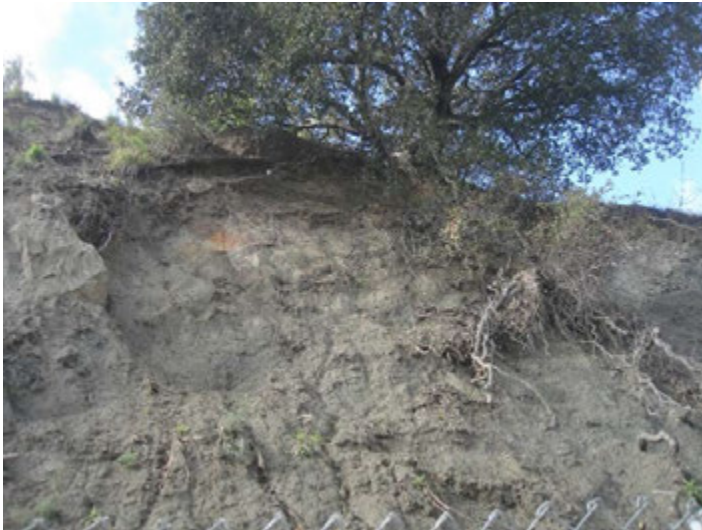
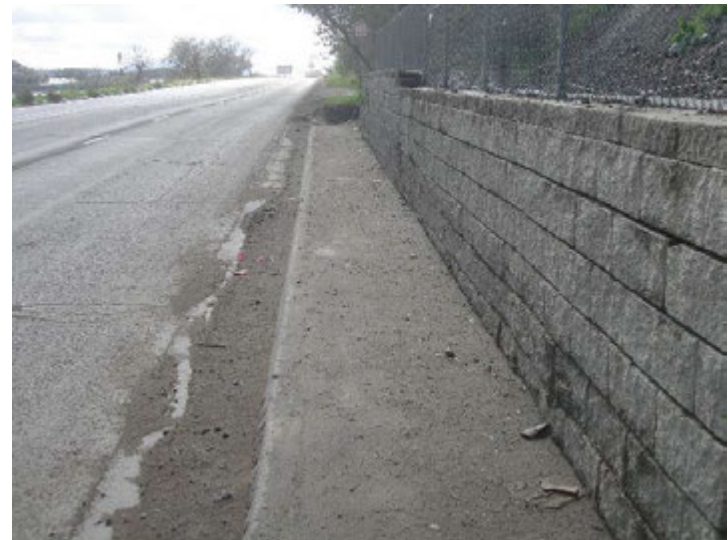
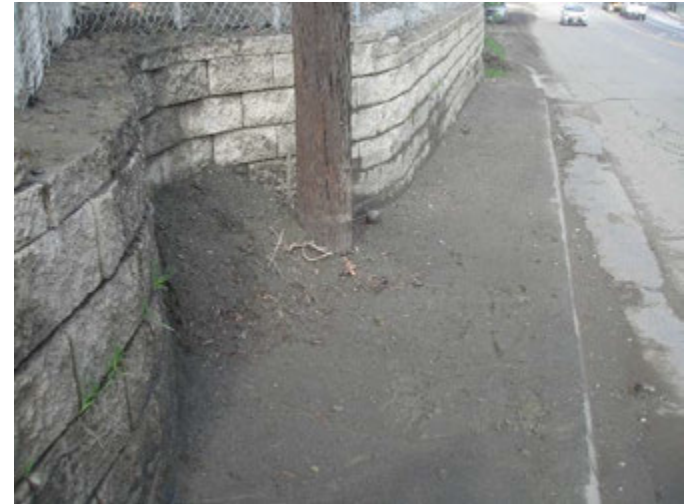
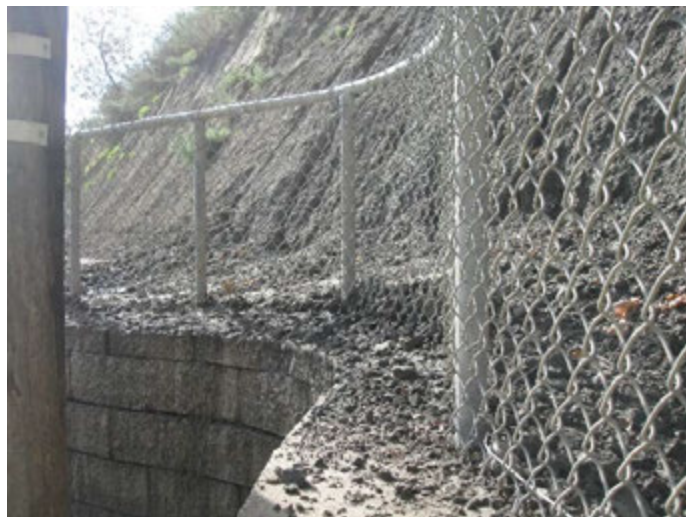
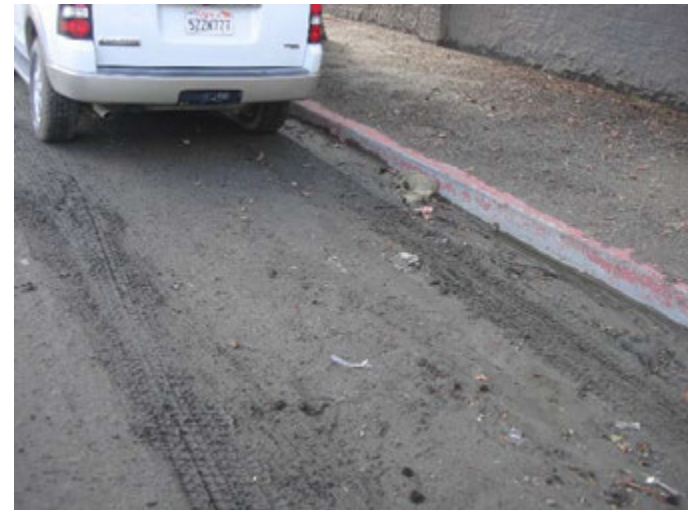
**Photo 778: Frontage Retaining Wall Slope on San Fernando Road:
March 14, 2018**

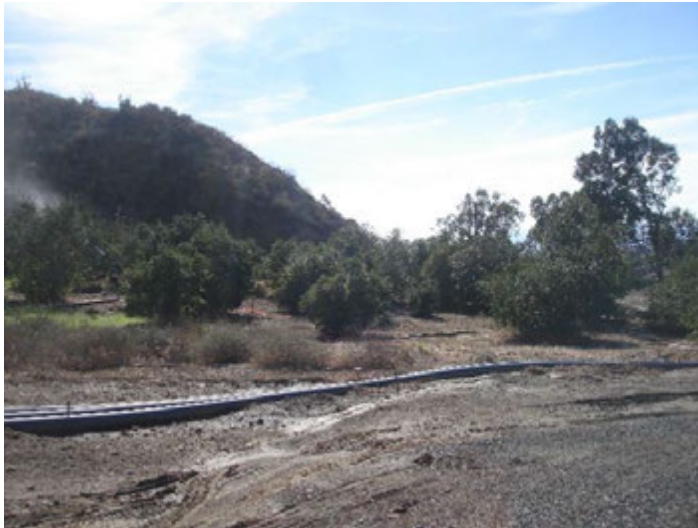
**Photo 788: Acceleration Lane on San Fernando Road: March 14,
2018**

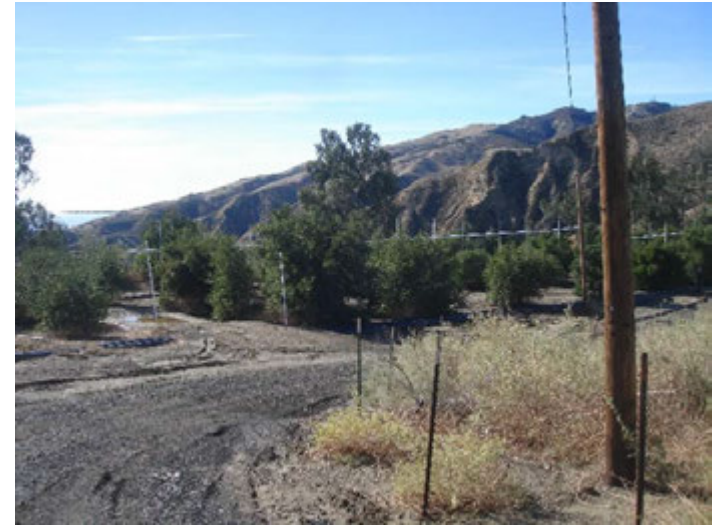
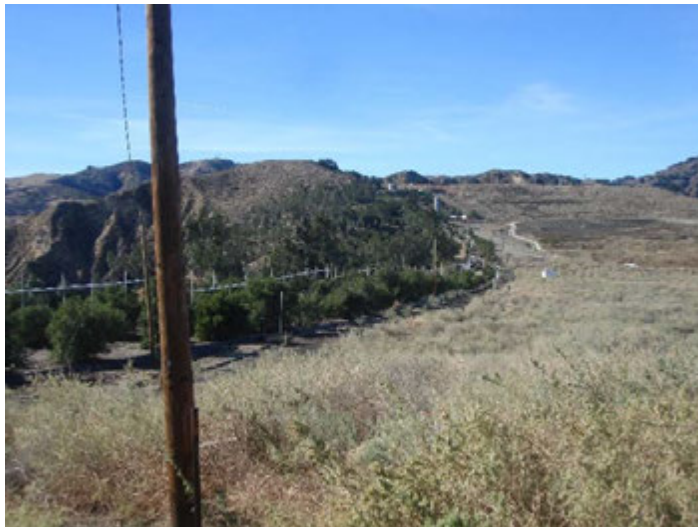
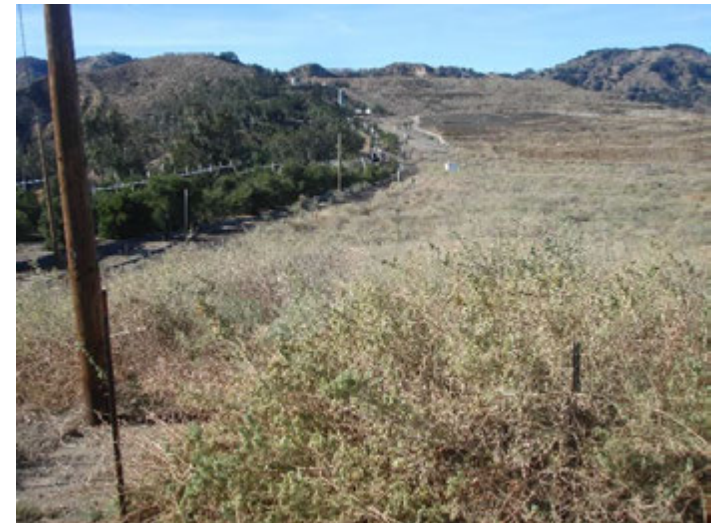
Photo 789: PM 10 Berm Area: January 10, 2018

- Deck C sage mitigation was greening up due to the cooler weather and moisture. No maintenance work appears to have been done.
- The PM-10 berm Oak Trees were doing well, greening up, and growing.

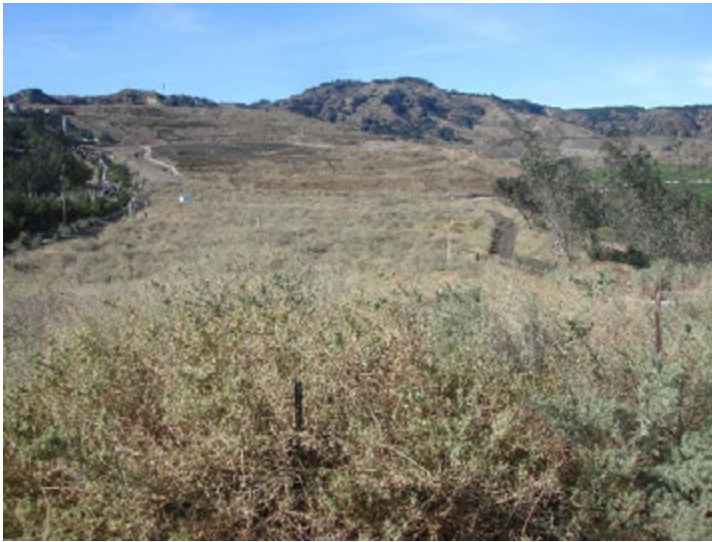
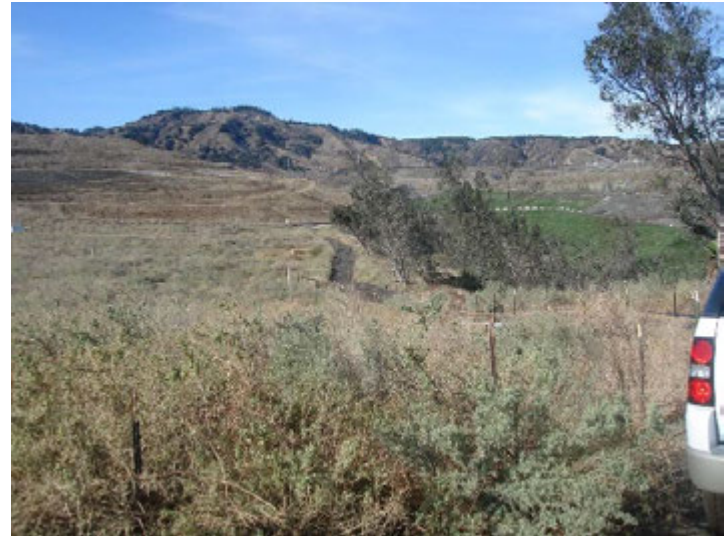
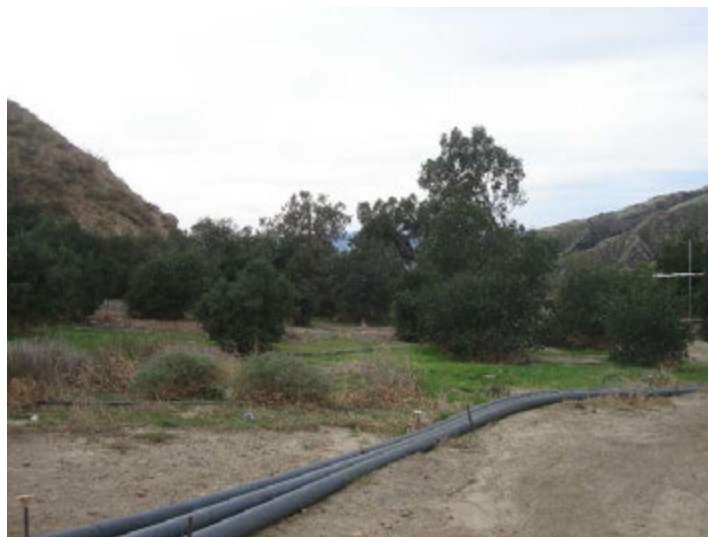
Photo 792: Deck C Sage Mitigation Area: January 10, 2018

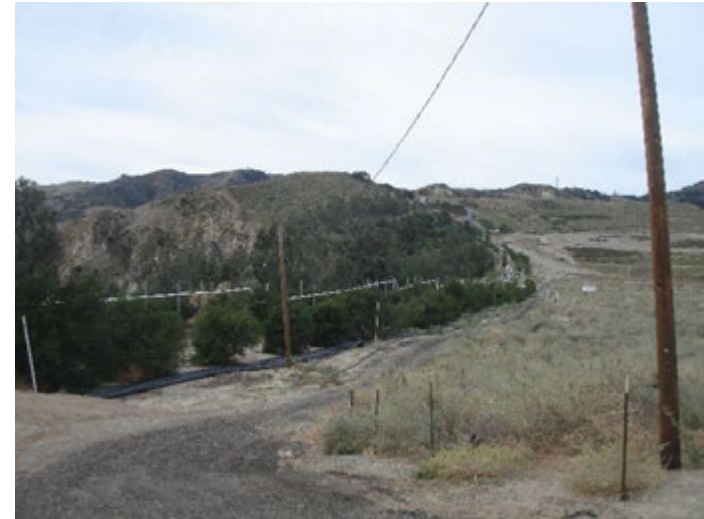
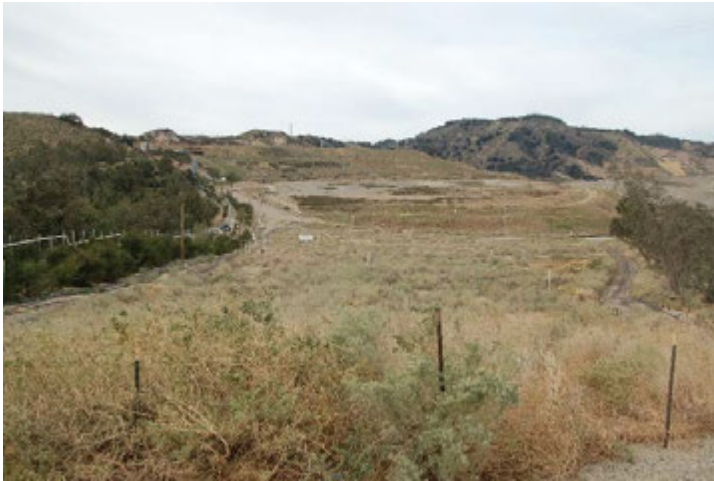
Photo 795: PM 10 Berm Area: January 30, 2018

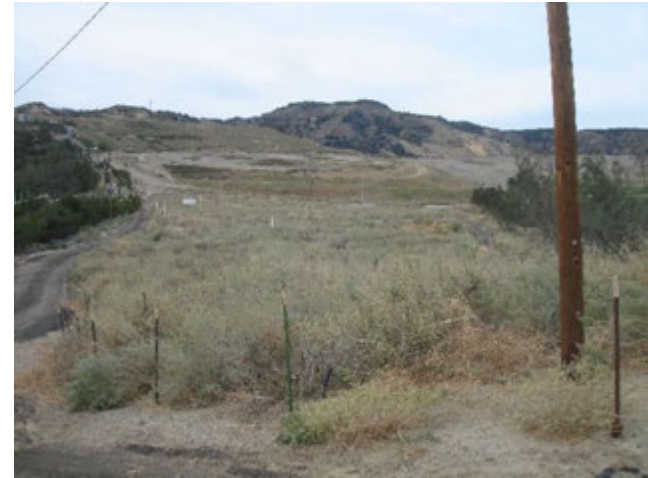
Photo 797: Deck C Sage Mitigation Area: January 30, 2018

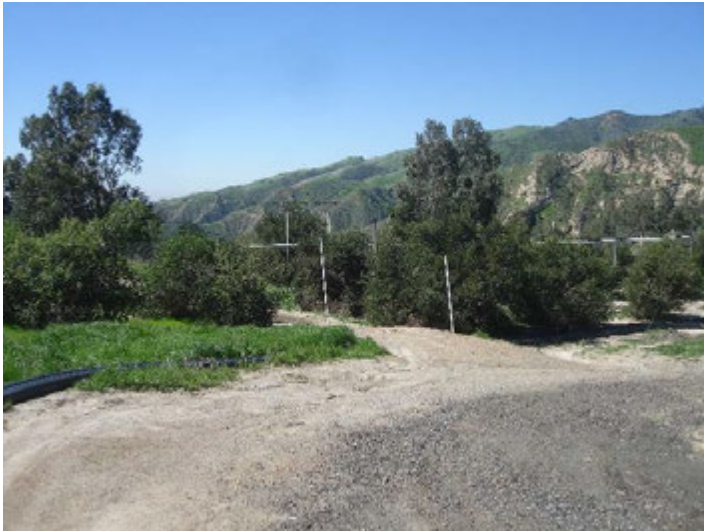
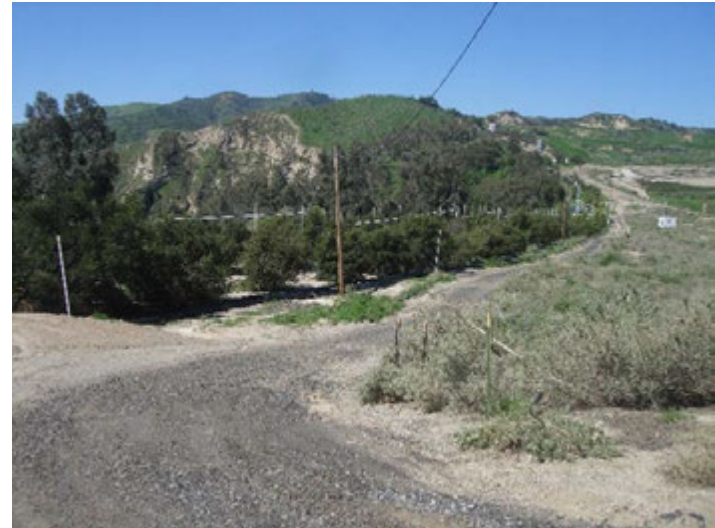
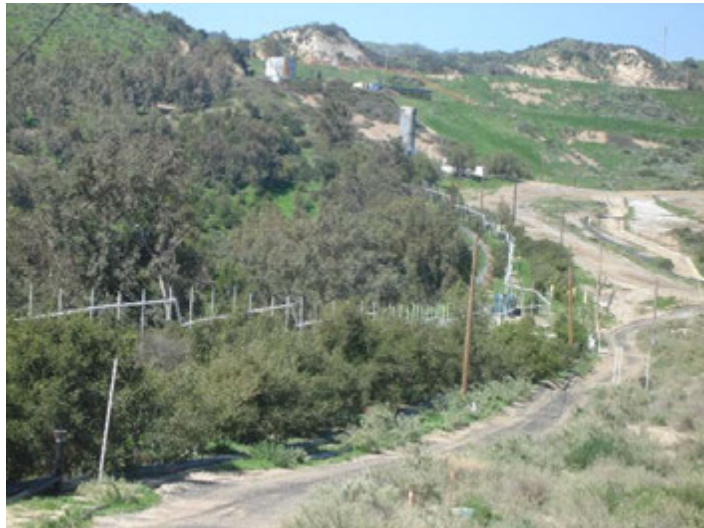
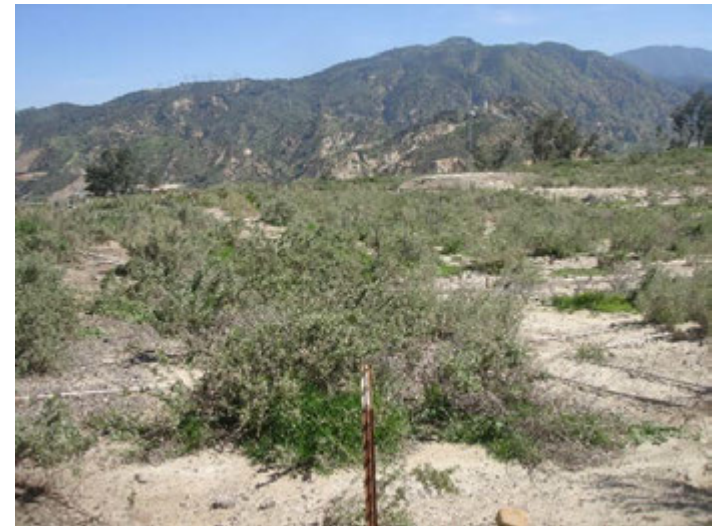
Photo 804: Deck C PM 10 Berm Area: March 29, 2018

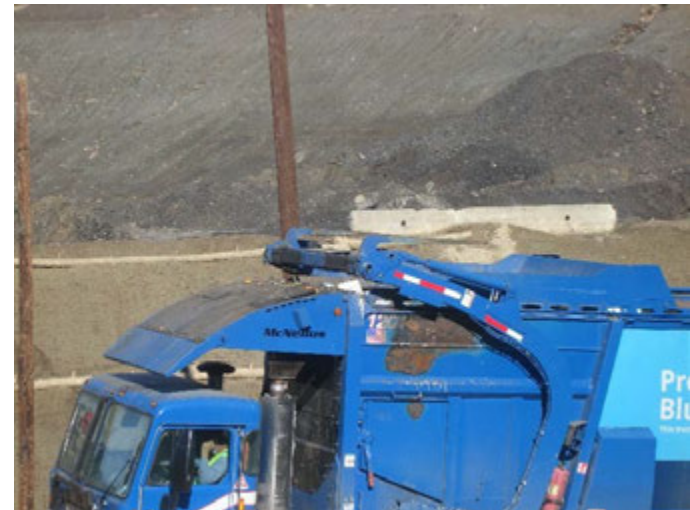
Photo 831: Slope Above Flare 1 Pad: January 10, 2018

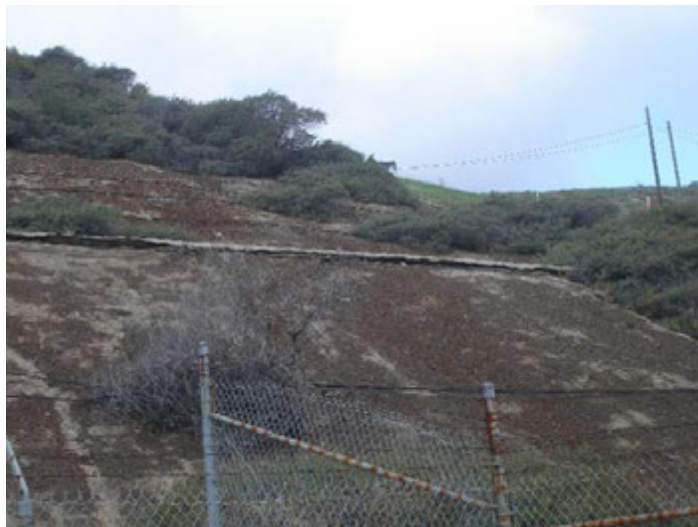
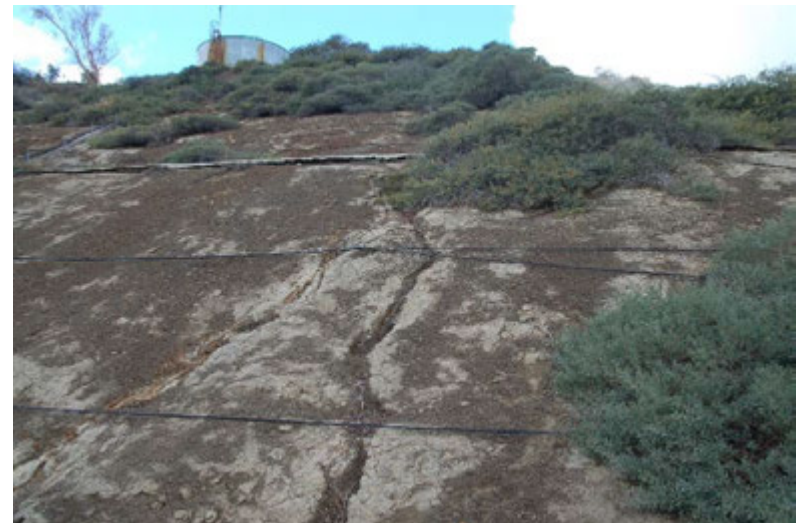
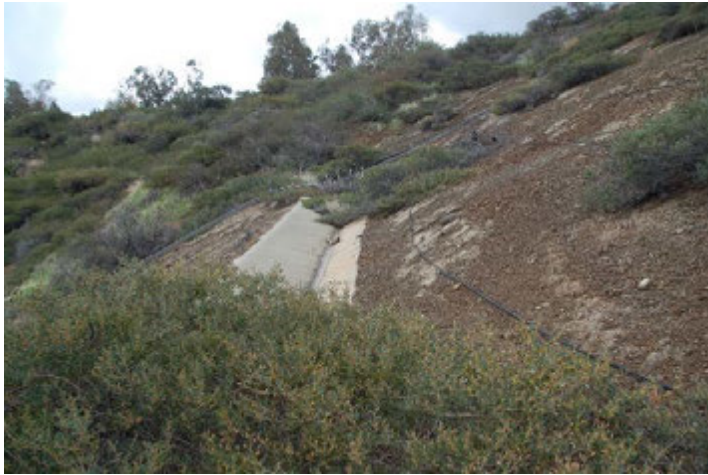
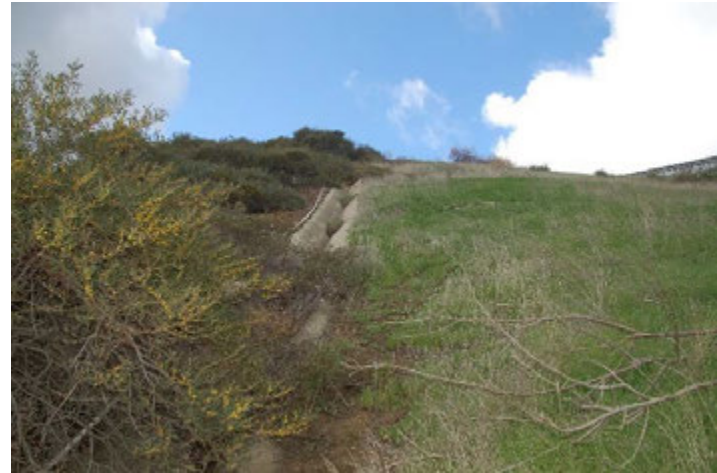
Photo 834: Flare 1 Hillside V-Ditch: March 14, 2018

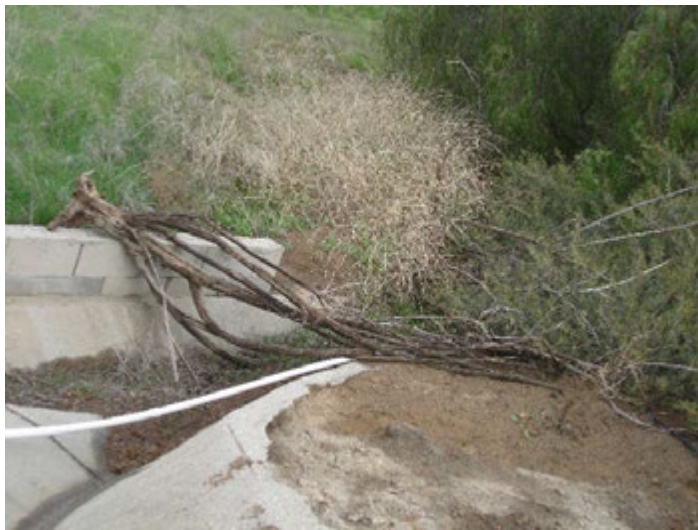
Photo 839: Flare 1 Hillside V-Ditch: March 14, 2018

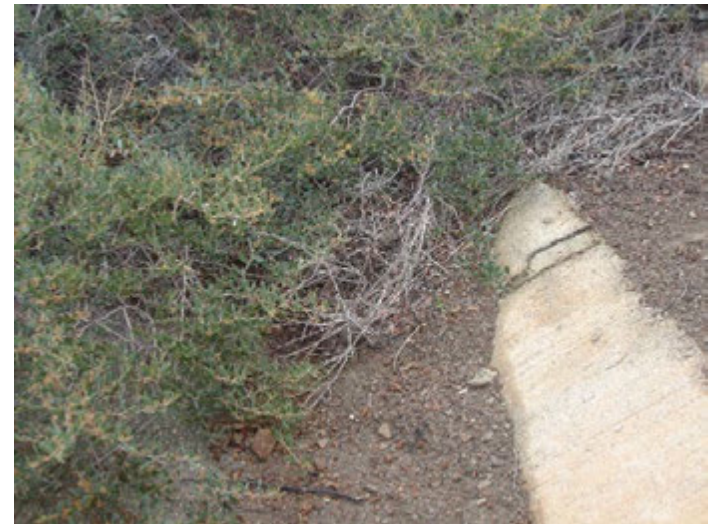
Photo 840: Flare 1 Hillside V-Ditch: March 14, 2018

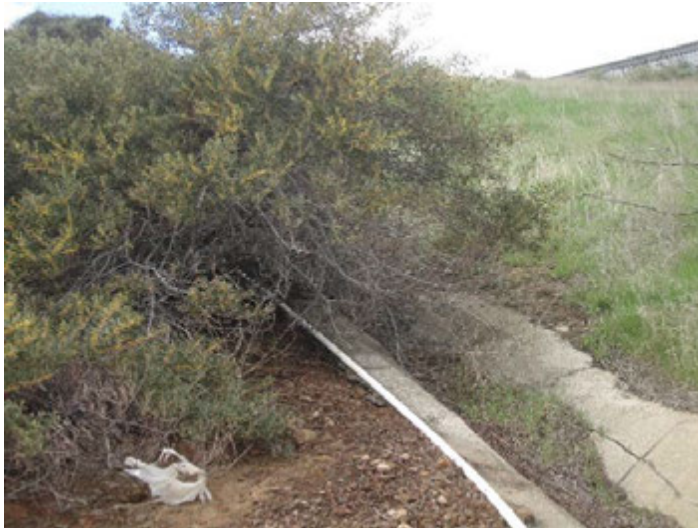
Photo 841: Flare 1 Hillside V-Ditch: March 14, 2018

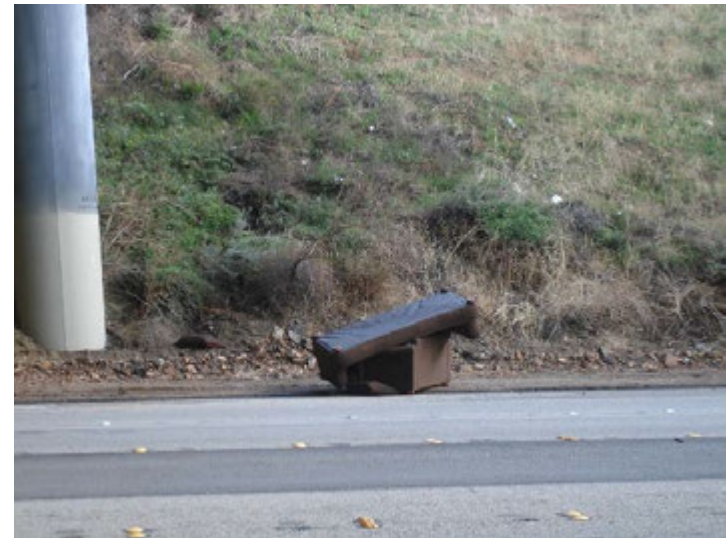
**Photo 842: Illegal Dumping at Sierra Highway near I-14 Overpass:
March 14, 2018**

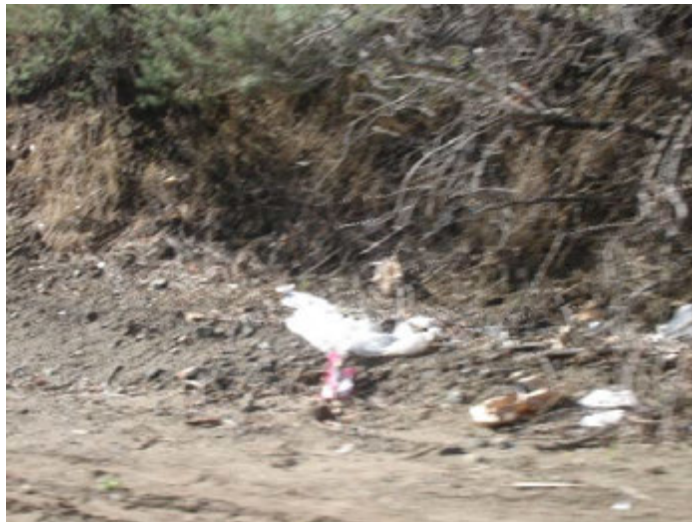
**Photo 843: Illegal Dumping at Sierra Highway near I-14 Overpass:
March 14, 2018**

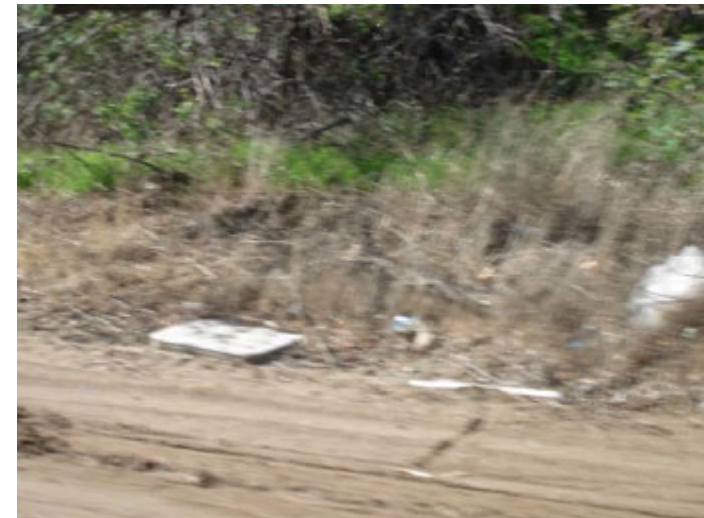
**Photo 844: Illegal Dumping at Sierra Highway near I-14 Overpass:
March 14, 2018**

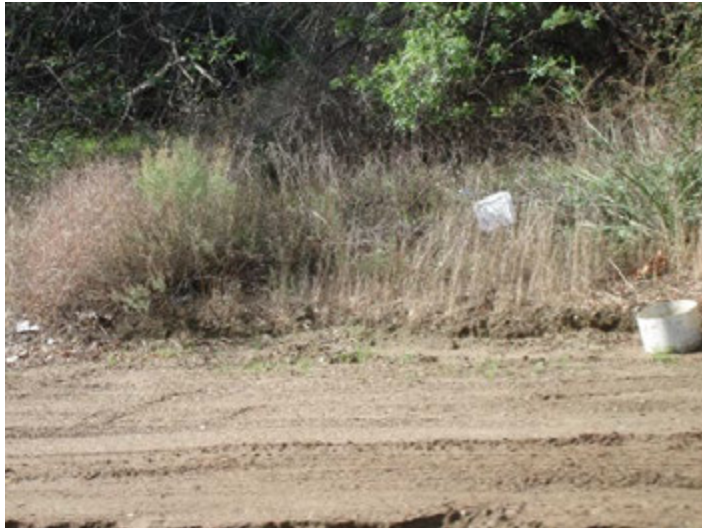
**Photo 845: Illegal Dumping at Sierra Highway near I-14 Overpass:
March 14, 2018**

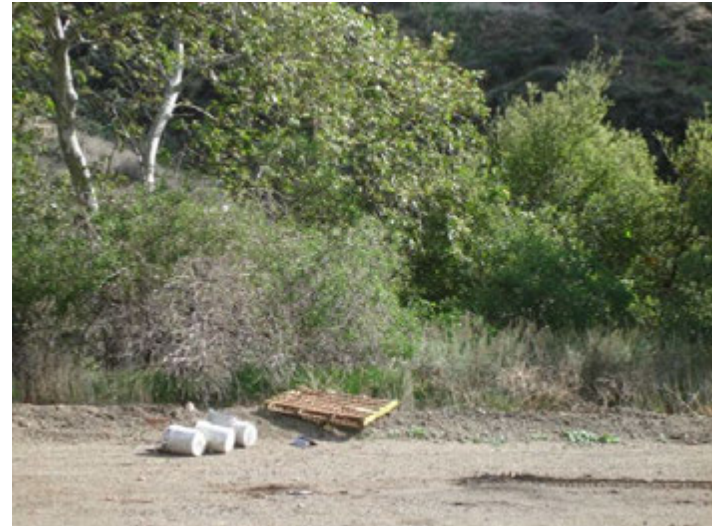
**Photo 846: Illegal Dumping at Sierra Highway near I-14 Overpass:
March 14, 2018**

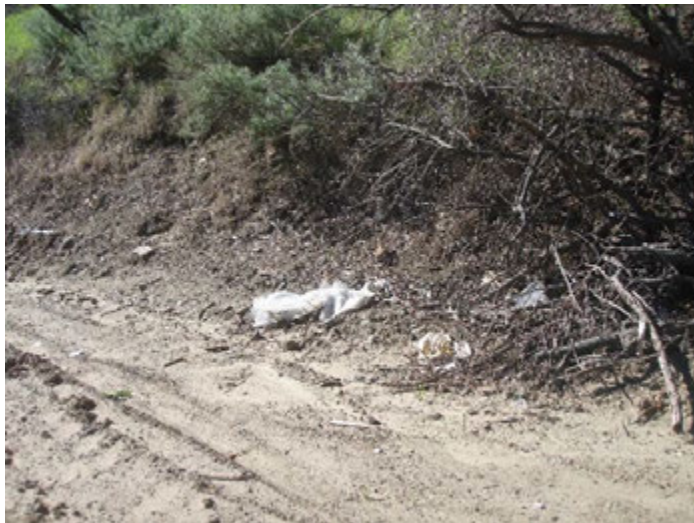
**Photo 847: Illegal Dumping at Sierra Highway near I-14 Overpass:
March 29, 2018**

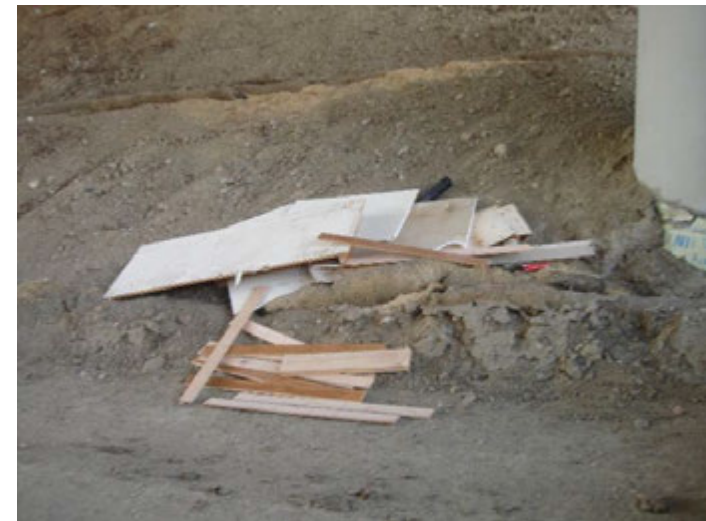
**Photo 848: Illegal Dumping at Sierra Highway near I-14 Overpass:
March 29, 2018**

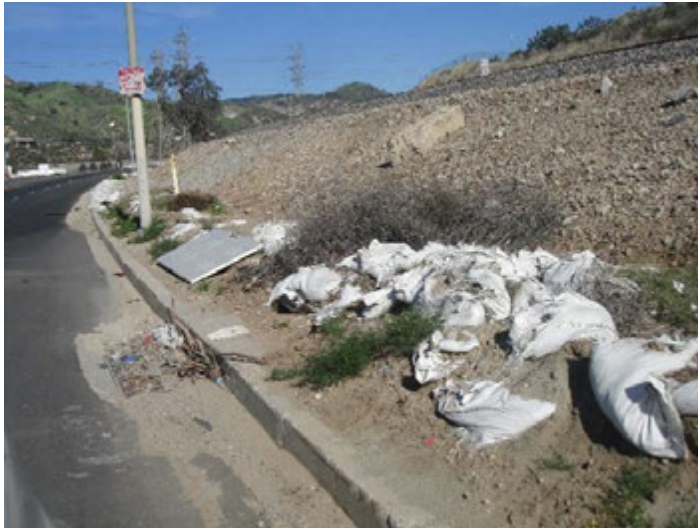
**Photo 849: Illegal Dumping at Sierra Highway near I-14 Overpass:
March 29, 2018**

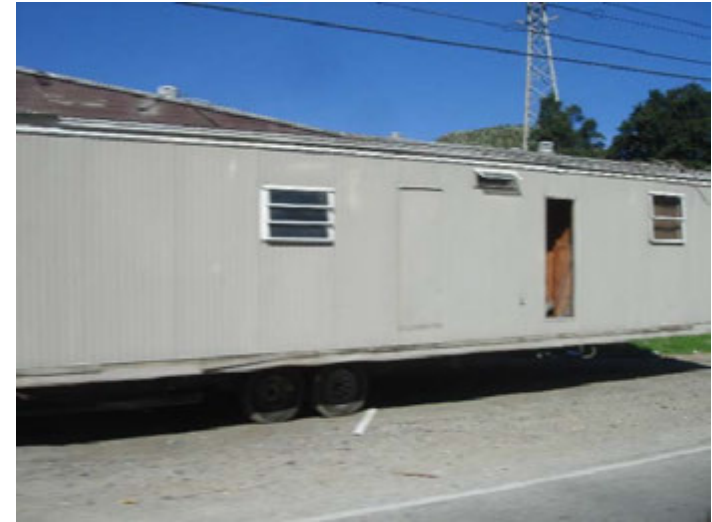
Photo 850: Abandoned Trailer North of Entrance: March 29, 2018

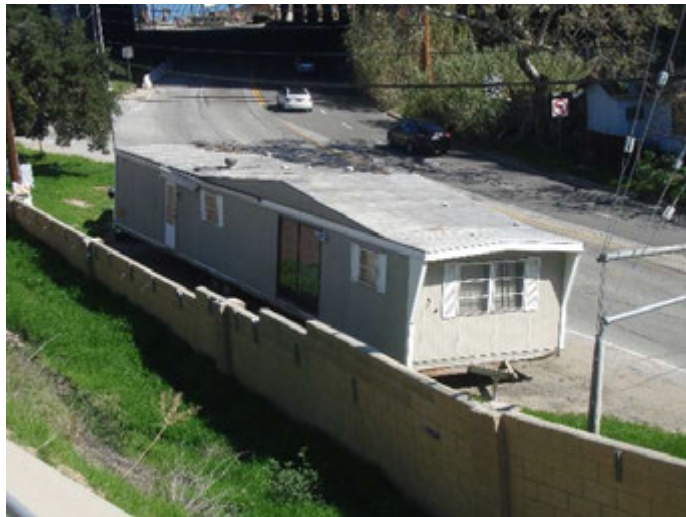
Photo 851: Abandoned Trailer North of Entrance: March 29, 2018

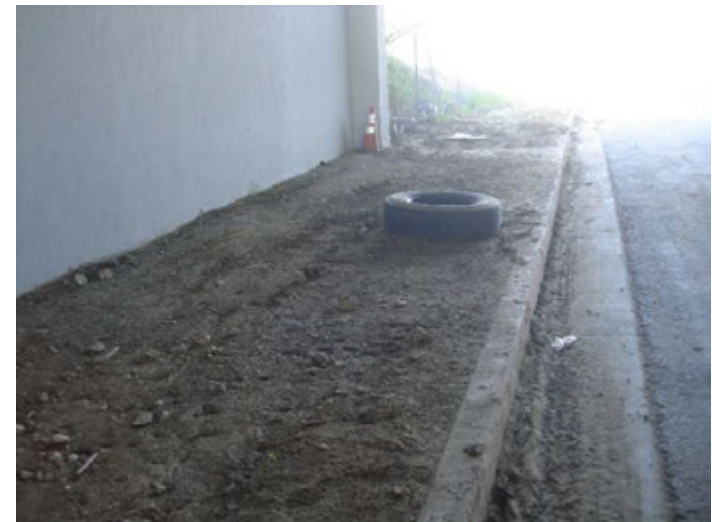
**Photo 852: Illegal Dumping San Fernando Road at I-5 Overpass:
March 29, 2018**

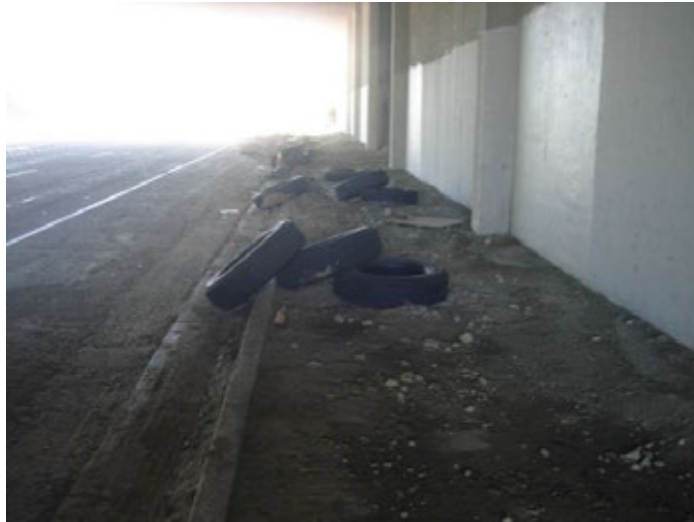
**Photo 853: Illegal Dumping San Fernando Road at I-5 Overpass:
March 29, 2018**

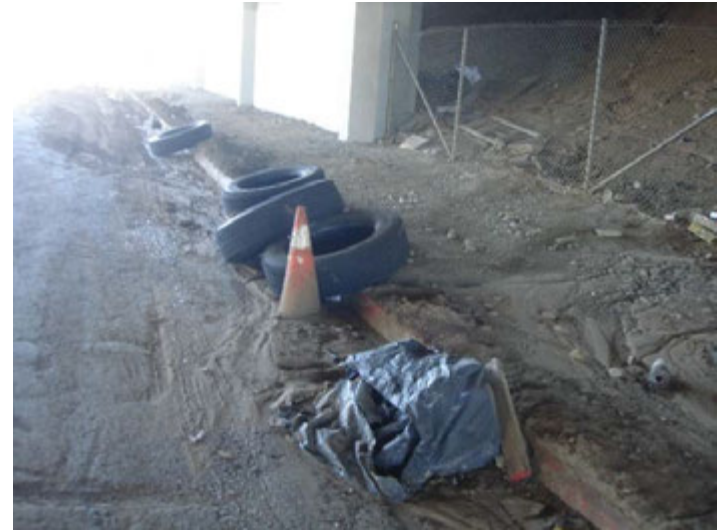
**Photo 854: Illegal Dumping San Fernando Road at I-5 Overpass:
March 29, 2018**

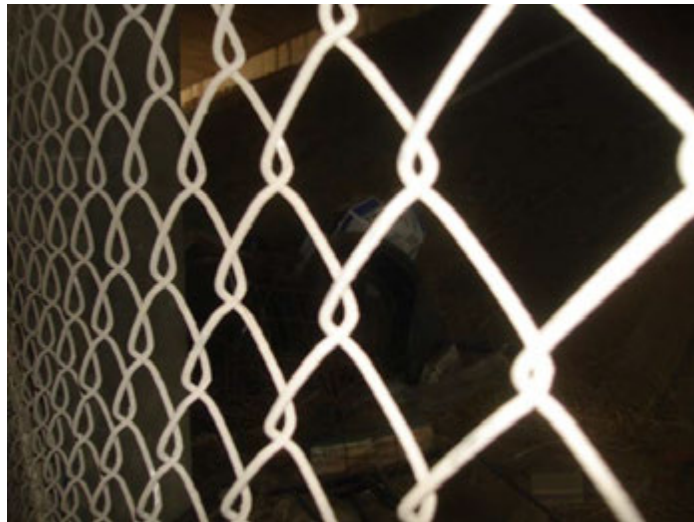
**Photo 855: Illegal Dumping San Fernando Road at I-5 Overpass:
March 29, 2018**

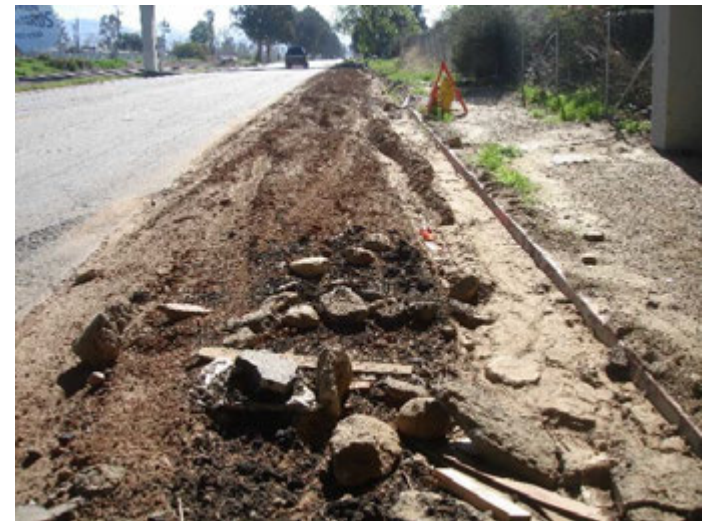
**Photo 856: Illegal Dumping San Fernando Road at I-5 Overpass:
March 29, 2018**

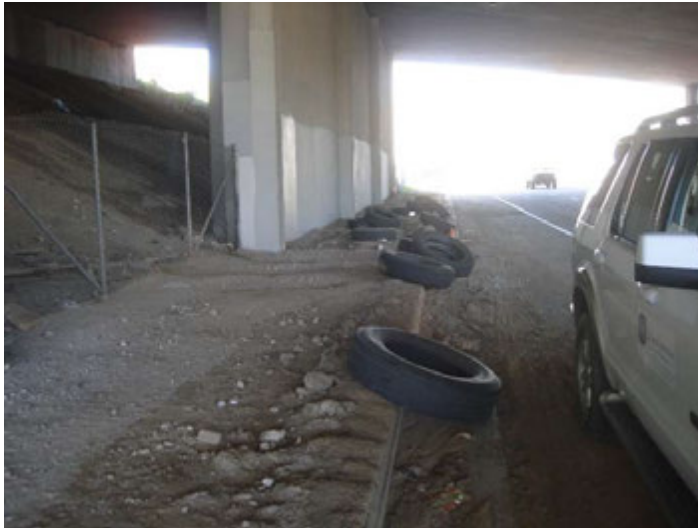
**Photo 857: Illegal Dumping San Fernando Road at I-5 Overpass:
March 29, 2018**

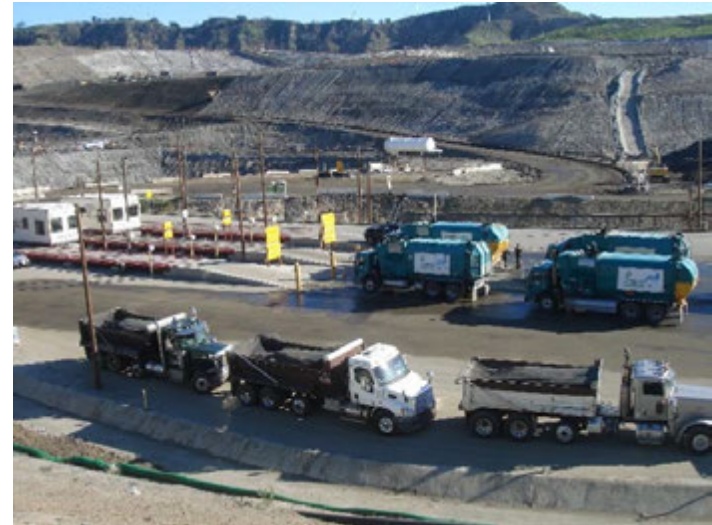
Photo 858: Trucks Staging at Scales: March 29, 2018

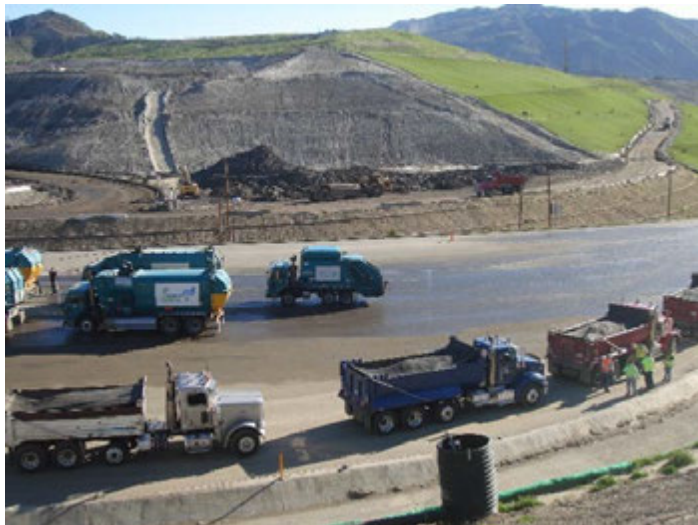
Photo 859: Trucks Staging at Scales: March 29, 2018

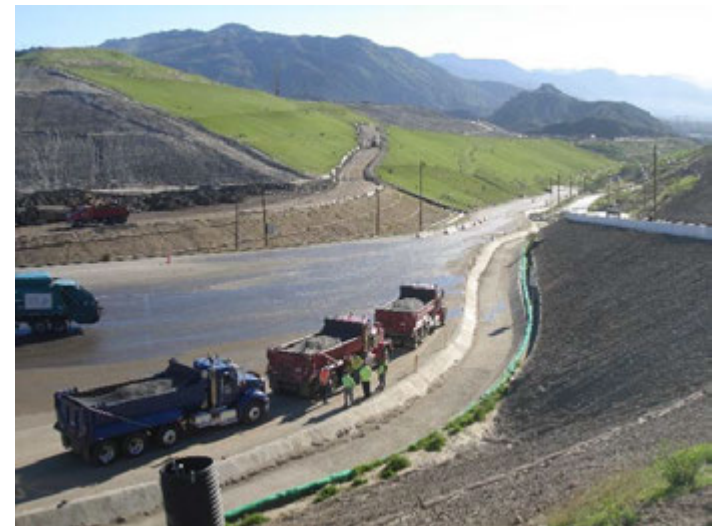
Photo 860: Trucks Staging at Scales: March 29, 2018

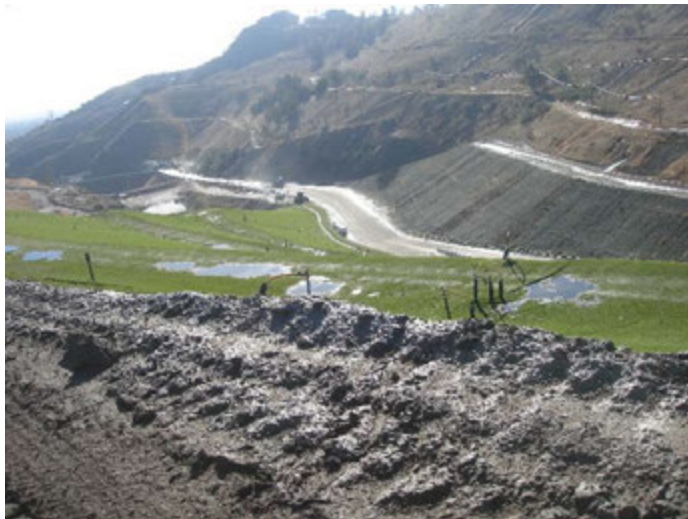
Photo 861: Site Water Pounding: January 10, 2018

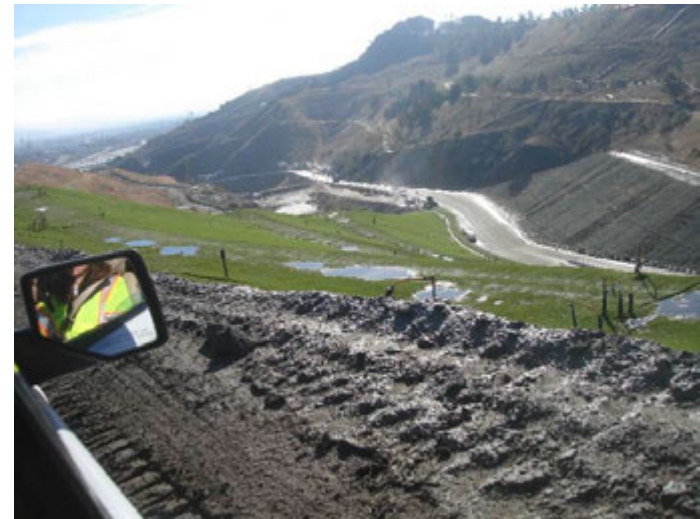
Photo 862: Site Water Pounding: January 10, 2018

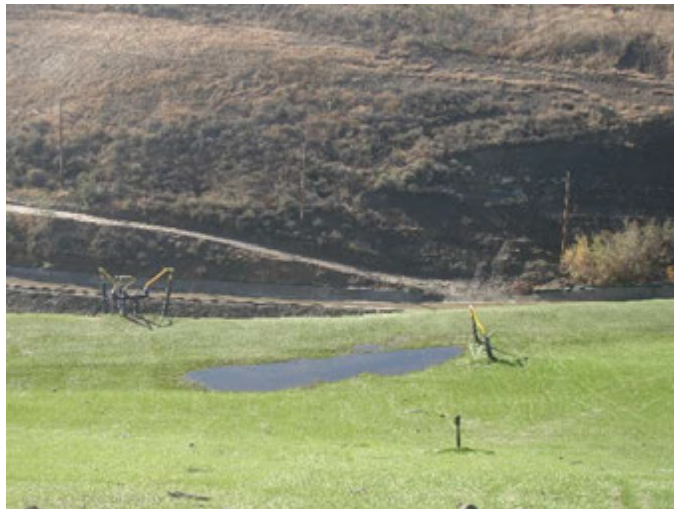
Photo 863: Site Water Pounding: January 10, 2018

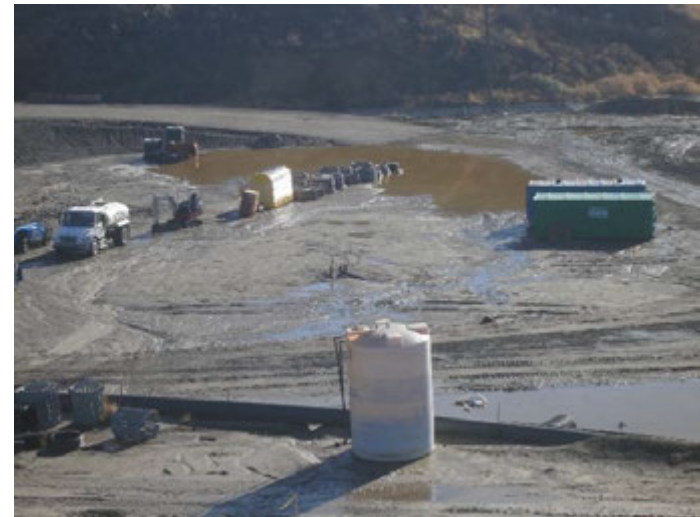
Photo 864: Site Water Pounding: January 10, 2018

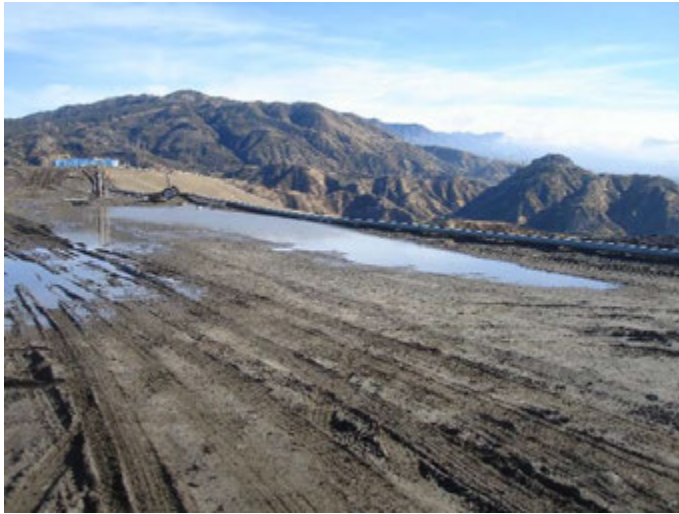
Photo 865: Site Water Pounding: January 10, 2018

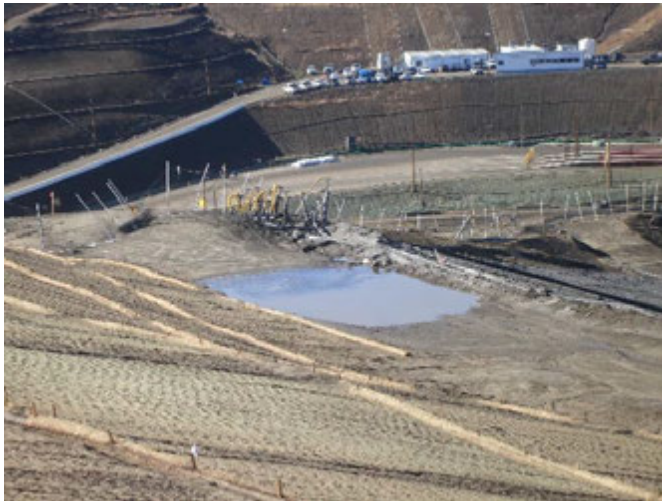
Photo 867: Site Water Pounding: January 10, 2018

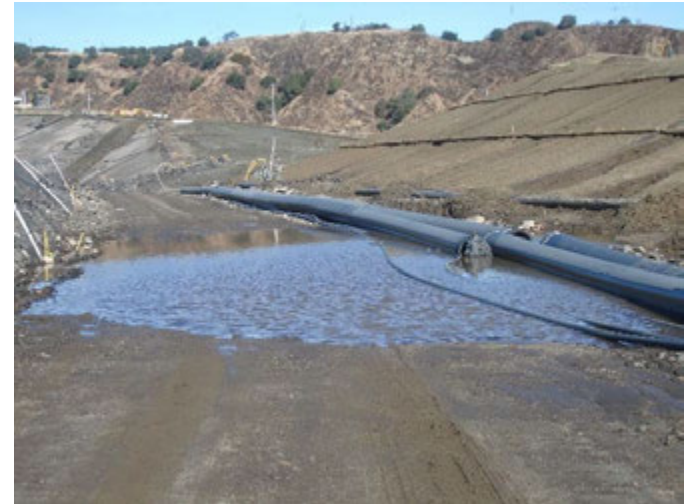
Photo 866: Site Water Pounding: January 10, 2018

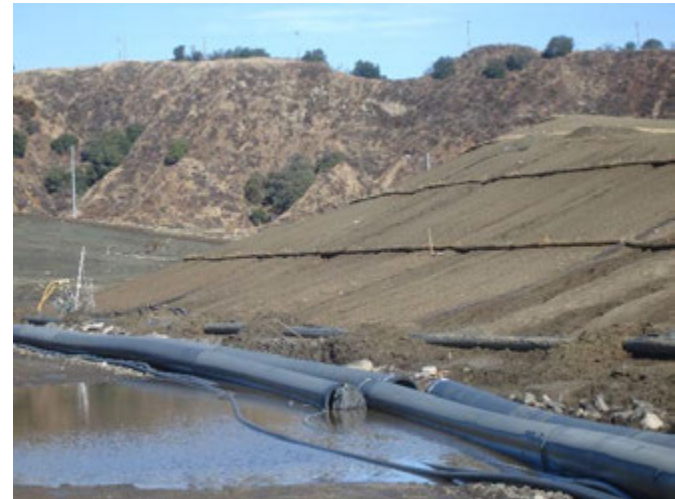
Photo 868: Site Water Pounding: January 10, 2018

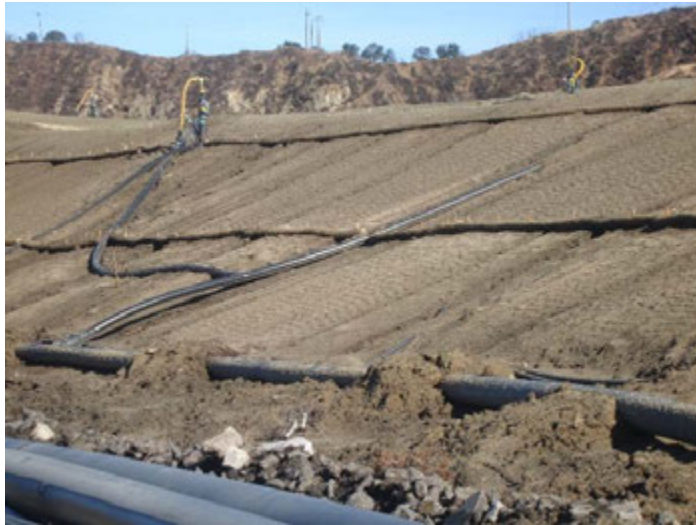
Photo 869: Site Water Pounding: January 10, 2018

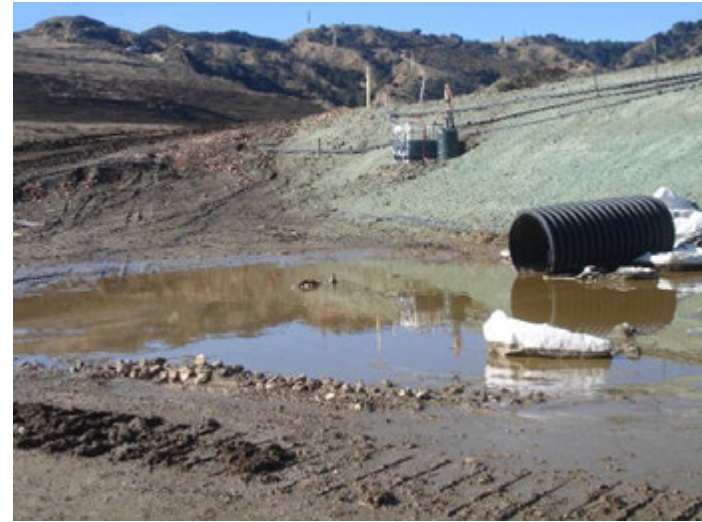
Photo 870: Site Water Pounding: January 10, 2018

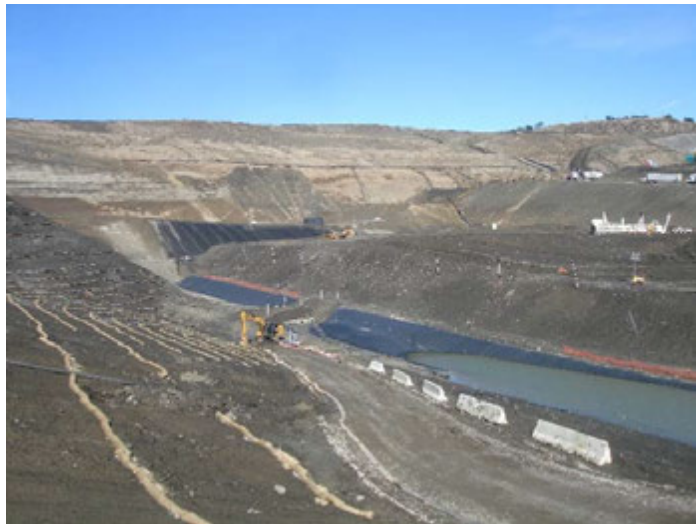
Photo 871: Site Water Pounding: January 10, 2018

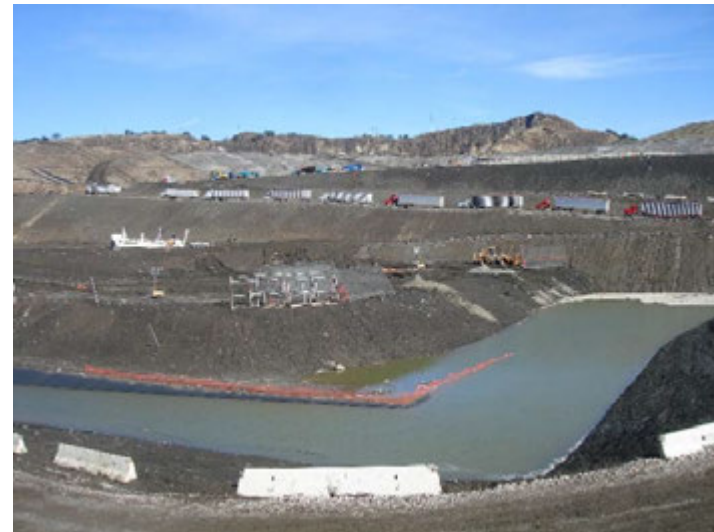
Photo 872: Site Water Pounding: January 10, 2018

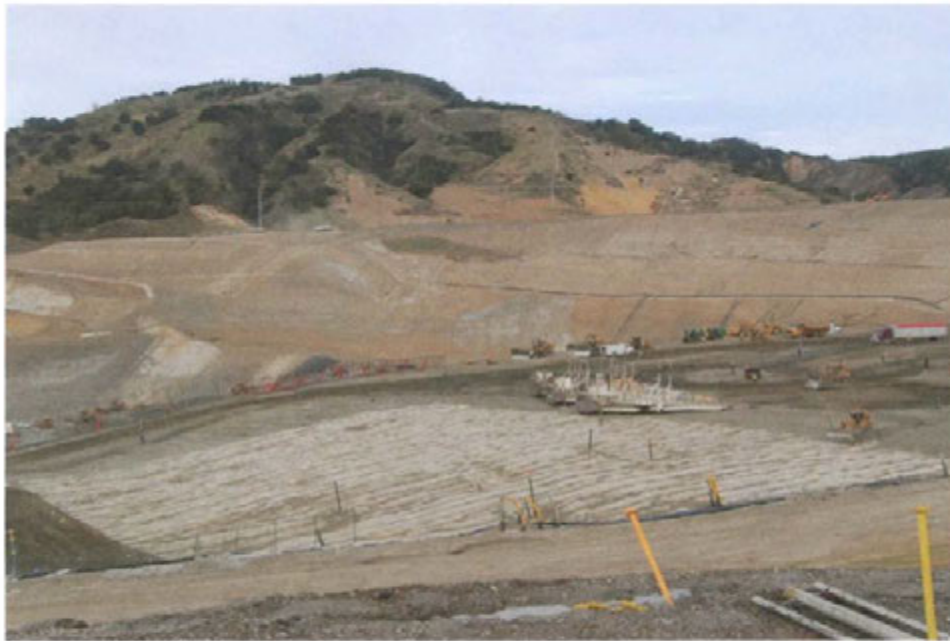
Photo 1: ADC Cell CC4 Phase 1

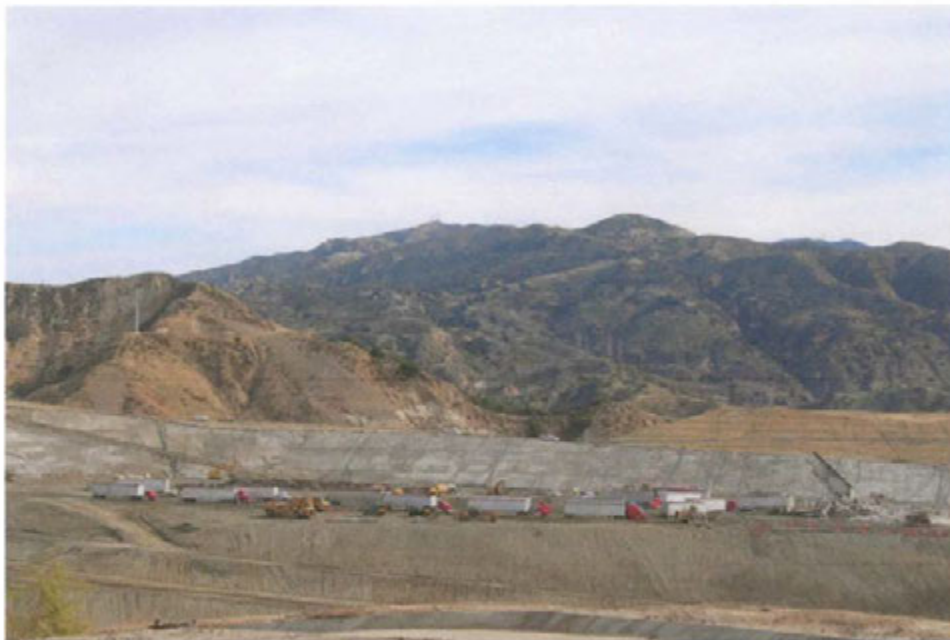
Photo 2: Waste Disposal in Cell CC4 Phase 1
