**Sunshine Canyon Landfill
Independent Monitor
Quarterly Site Monitoring Status Report
January 1, 2018 – March 31, 2018**

May 25, 2018

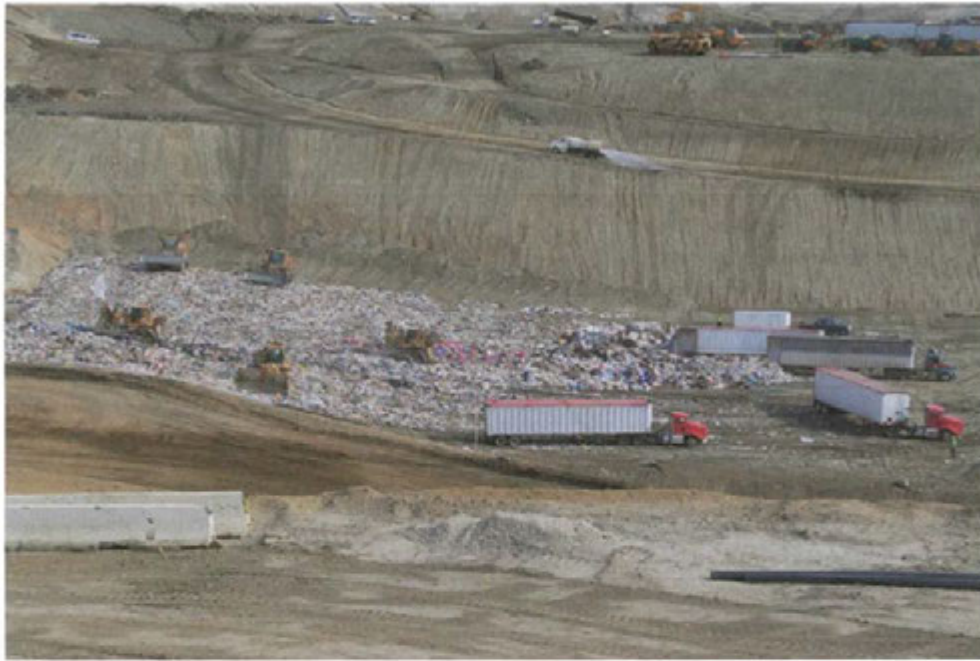
Photo 3: Waste Disposal in Cell CC4 Phase 2

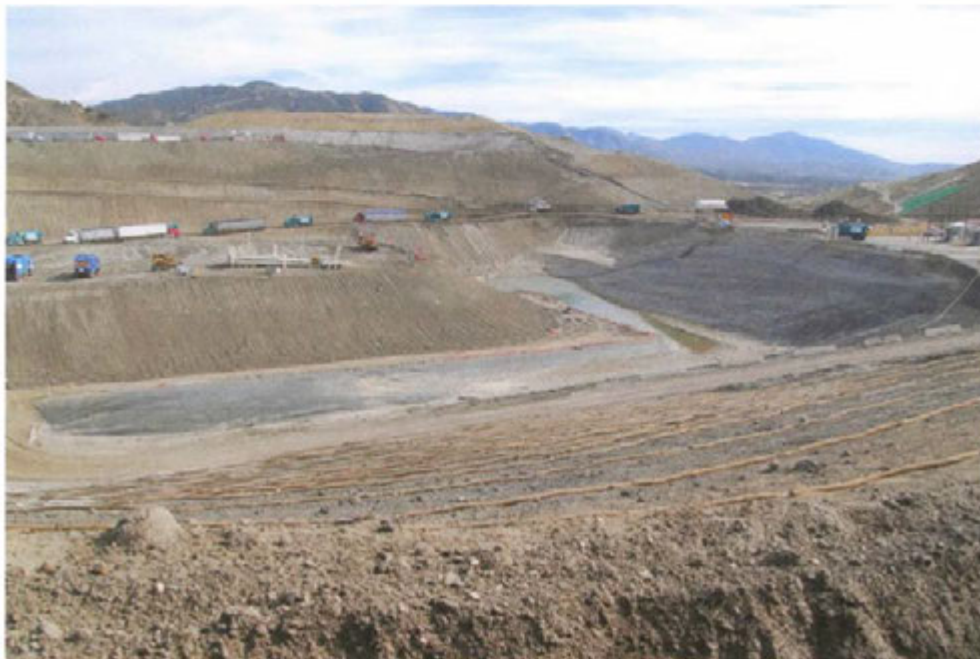
7:00 Met with UltraSystems team members Jim Aidukas and Mike Lindsay, prepare tour of landfill, 8:20: Sign-up in main office.	
8:10 – 12:00 Site inspection	
<ul style="list-style-type: none"> • Placement of waste in Cell CC4 Phase 1 and Phase 2 • Erosion protection system • Drainage systems (Basins, channels) • Access Roads • Closure Turf on slopes of Cell CC3 • Landfill for geotechnical and hydrological issues 	
Waste Placement in Cell CC4	
<ul style="list-style-type: none"> • Waste Placement in Cell CC4 Phase 1 <ul style="list-style-type: none"> – large area of Enviro™Cover system in place (Photo 1) – Cell was accepting waste (Photo 2) – 3 Tilters were in use • Waste Placement in Cell CC4 Phase 2 <ul style="list-style-type: none"> – cell was accepting waste (Photo 3) – No tilters in use – the collection channel/pond around Cell CC4 Phase 2 is full of water that has been impacted by waste (photo 4)

Photo 4: Water Channel Collection and Pond at Cell CC4 Phase 2

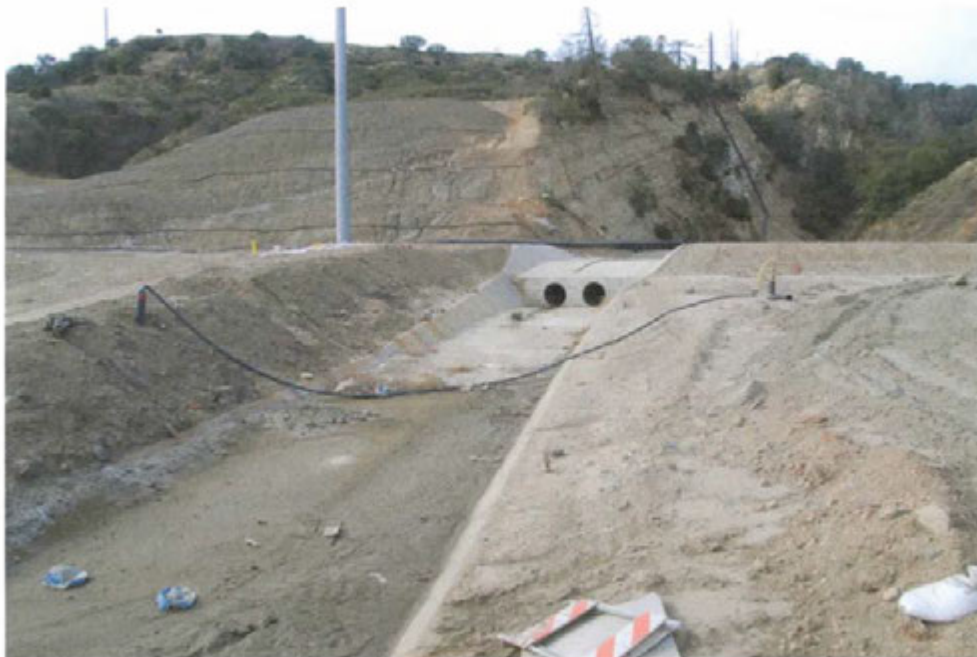
<p>was pushing again the pipe (photo 7) further increasing the risk of the header falling into the basin with and associated risk of rupture.</p> <ul style="list-style-type: none"> – the outlets from Basin A observed to be blocked by tumbleweeds on December 12, 2017 have been cleared (Photo 8) – The downstream channel is still used as access road with pipes under earth fill (Photo 9). The capacity of pipes to accept design flow should be checked and flow capacity restored if needed as the accumulation of wet sediments near the pipe intakes indicate clearly that flow is reduced. <ul style="list-style-type: none"> • Basin B <ul style="list-style-type: none"> – Some sediments have accumulated near the outlet (photo 10), but the amount is not significant enough to affect the performance of the basin. • Basin D <ul style="list-style-type: none"> – Clean • Channel between Basin D and access road to Flare 9 and 10. <ul style="list-style-type: none"> – Geomembrane installed in the channel noted in previous visit to be in state of disrepair has been repaired. New sandbags and stakes have been installed (Photo 11). There is still a risk of water flowing between the membrane and the concrete and could create problems in the future – Most of the tumbleweeds and soil in channel noted on December 12, 2017 have been removed • Terminal Basin (Photo 12) <ul style="list-style-type: none"> – all sediments between the skimmers and the mid-basin gabion wall have been removed – removal operations were ongoing for sediment upstream of mid-basin gabion wall – The three skimmers are installed

Photo 8: Cleaned up Drain Pipes of Basin A

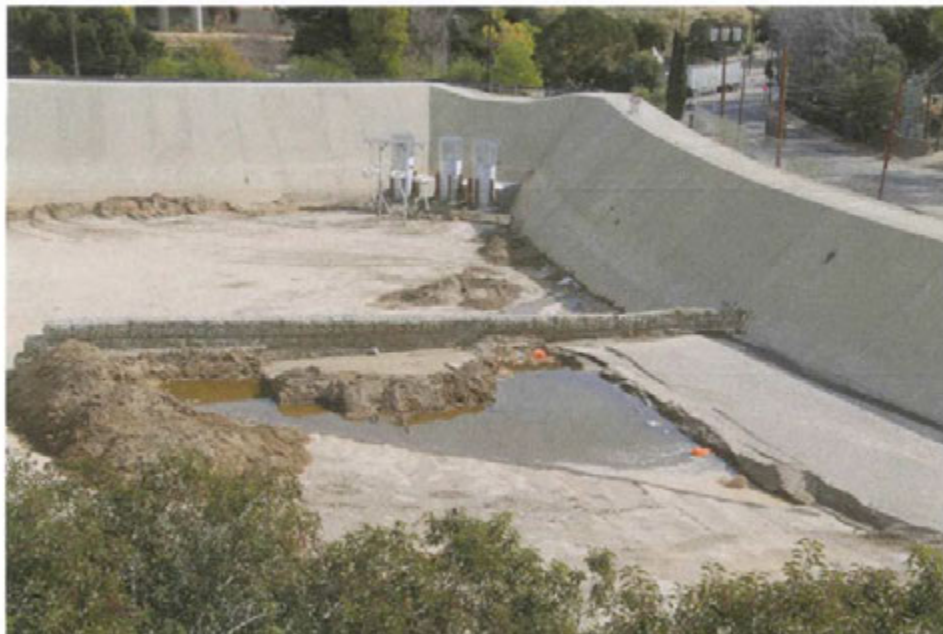
Photo 12: Condition at Terminal Basin

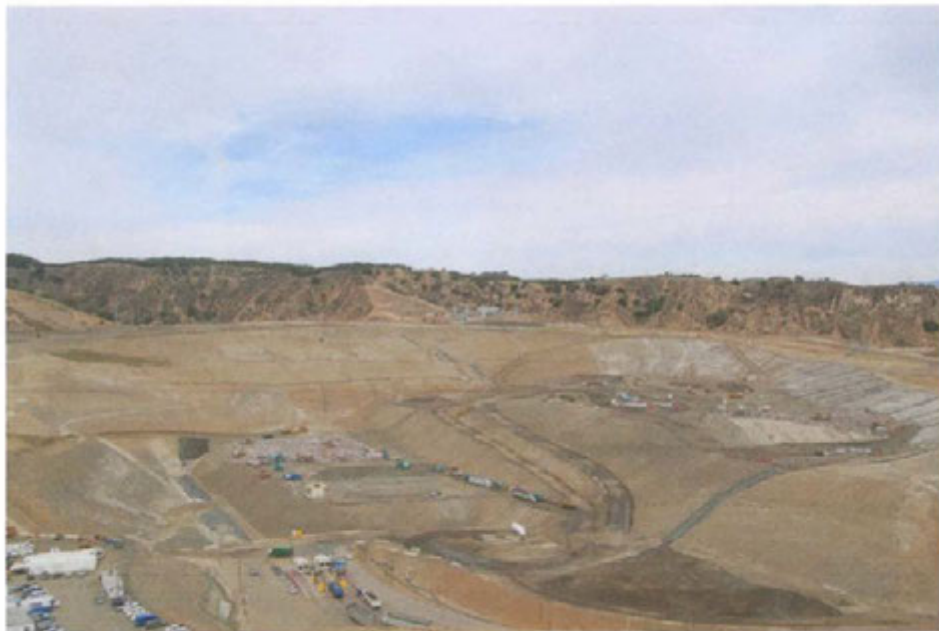
- Photo 14 shows an overview of Cell CC4 Phase 1 (on the right) and Phase 2 (on the left). Drainage from the slopes between Phase 1 and Phase 2 may flow over part of Phase 1, likewise water flowing from the back on Phase 2 may enter in contact with the waste. This impacted water which will end-up in the collection trench/pond around Phase 2 will have to be treated.
- Should the landfill be hit by a large storm this could result in large volumes of water to treat. Republic should task his consultant into looking at possibilities to install diversion berms or ditches along the roads and at toe of slopes to direct clean stormwater away from the waste face.

Photo 14: Overview of Cell CC4 and Watershed areas Onto Phase 2

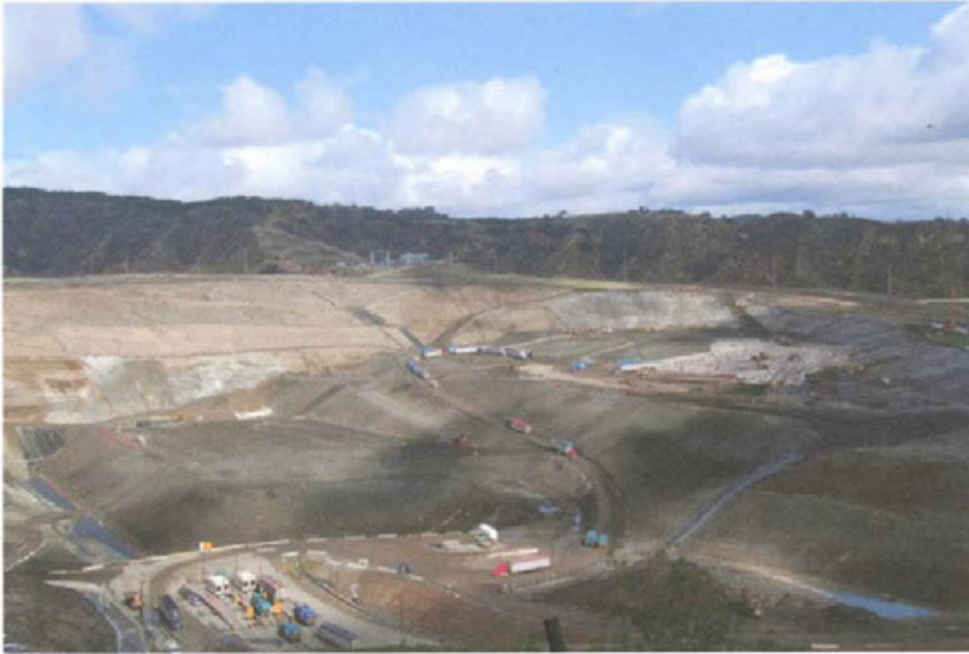
Photo 1 : Waste placement at Cell CC4

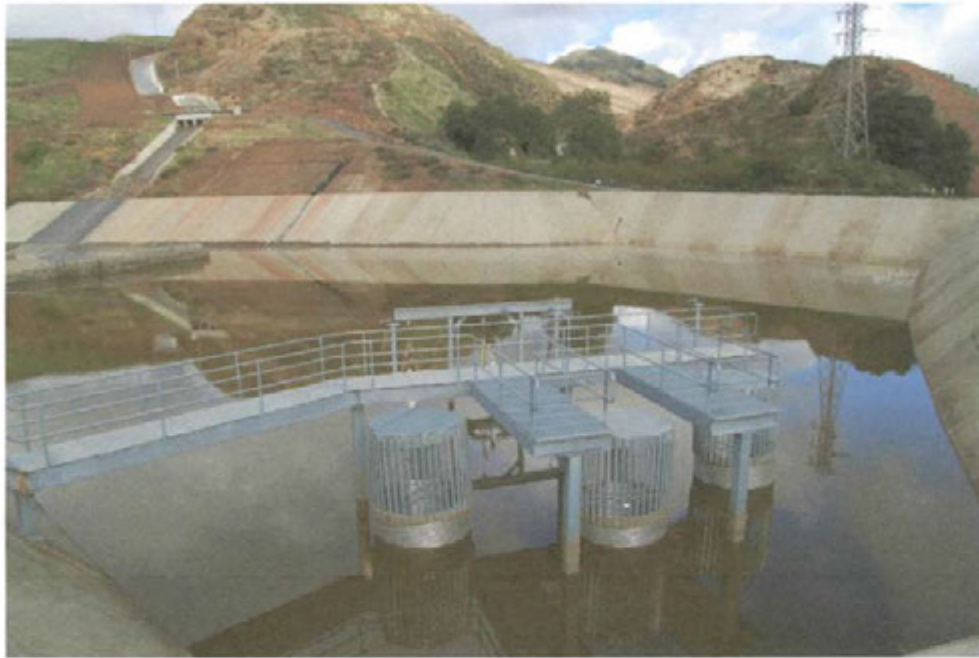
Drainage System	
<ul style="list-style-type: none"> • Terminal Basin <ul style="list-style-type: none"> – site visit followed a rain event, therefore there were sediments in the basin accumulated against the separators gabion walls (Photo 4) – Water was approximately 1 ft. below the top of the drain towers (Photo 5) – We observed that some of the sediment was coarse sand probably from the hydro turf (Photo 6). If large amounts of sand end-up in the basin after each storm, it may be prudent

Photo 5: Water Accumulation in Terminal Basin

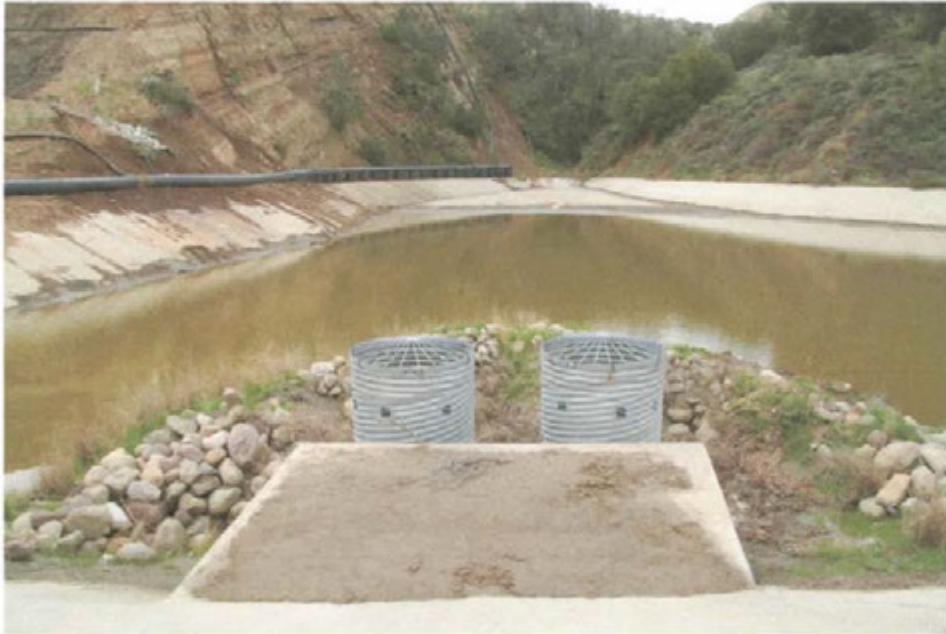
- The three skimmers are raised
- Basin A
 - Water and sediments have accumulated in basin following recent storm. The volume in the basin does not reduce the overall capacity significantly and is deemed not detrimental to its performance (Photo 7)

Photo 7: Stormwater Accumulation in Basin A

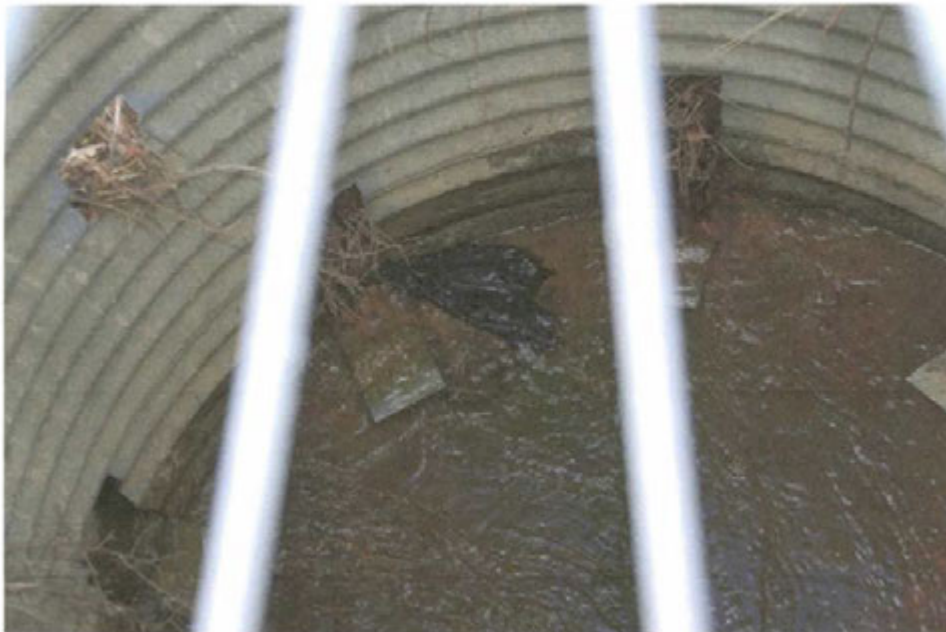
- Although the rock pile around the risers appears to be totally clogged with fine sediments, impeded water flow, there was a low flow through the weep holes of the two risers (Photo 8)

Photo 8: Stormwater Draining through Weepholes in Risers in Basin A

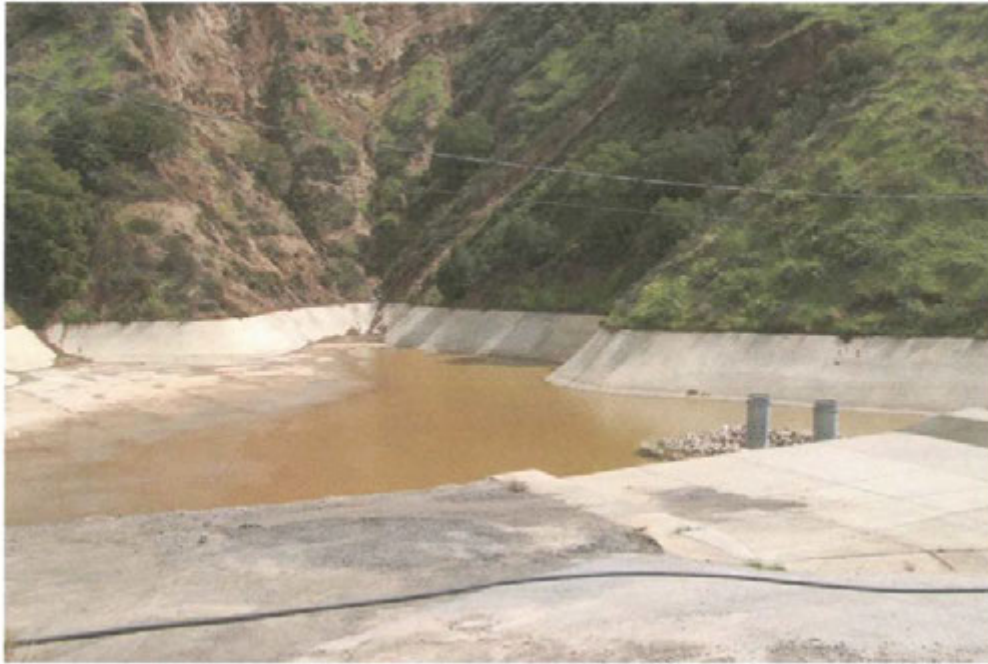
- Basin B
 - Water has accumulated near the outlet (photo 11), but is flowing through weepholes in the riser as seen in the concrete channel downstream from the basin (photo 12),

Photo 11: Water accumulated in Basin B

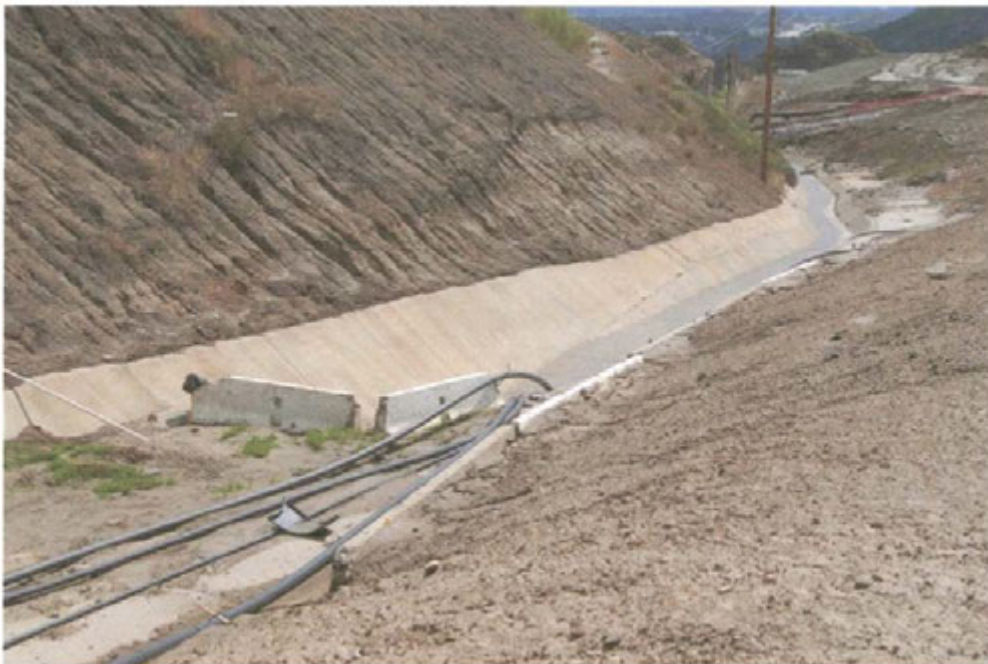
Photo 12: Water draining out of basin B in concrete channel
