**Sunshine Canyon Landfill  
Independent Monitor  
Quarterly Site Monitoring Status Report  
January 1, 2019 – March 31, 2019**

April 29, 2019

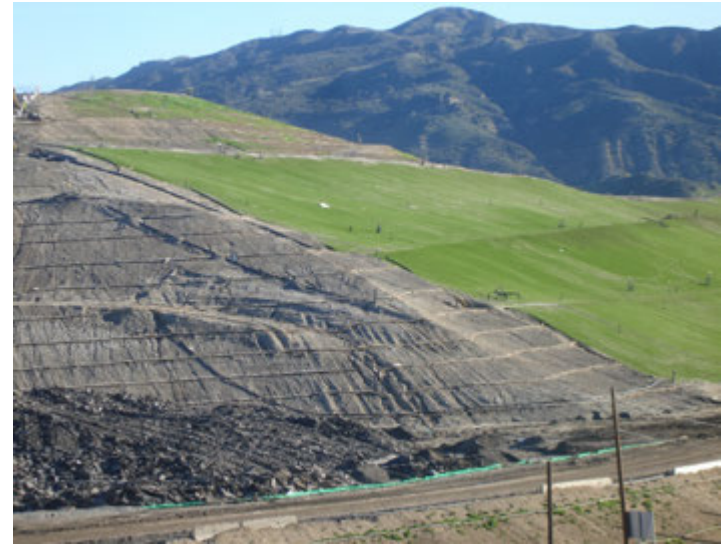
**Photo 118: Posi-Shell and Closure Turf: January 22, 2019**

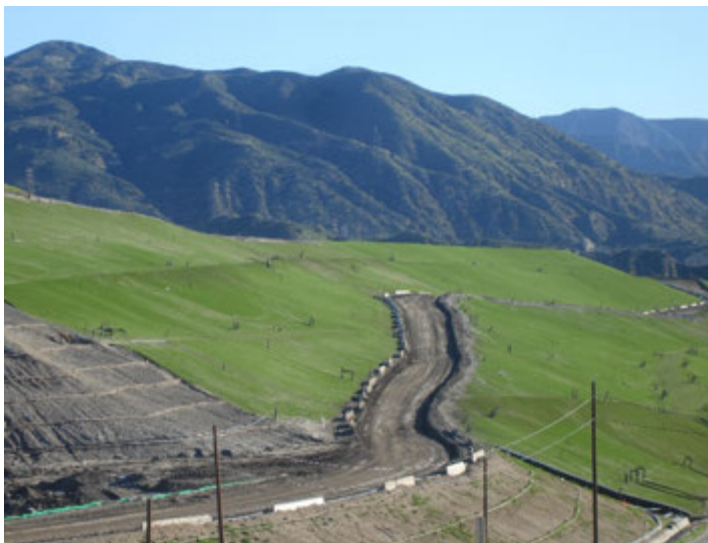
**Photo 119: Posi-Shell and Closure Turf: January 22, 2019**

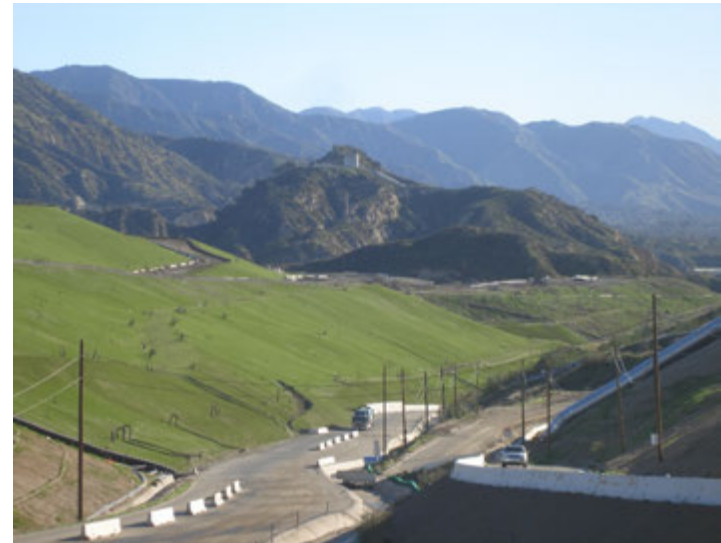
**Photo 120: Posi-Shell and Closure Turf: January 22, 2019**

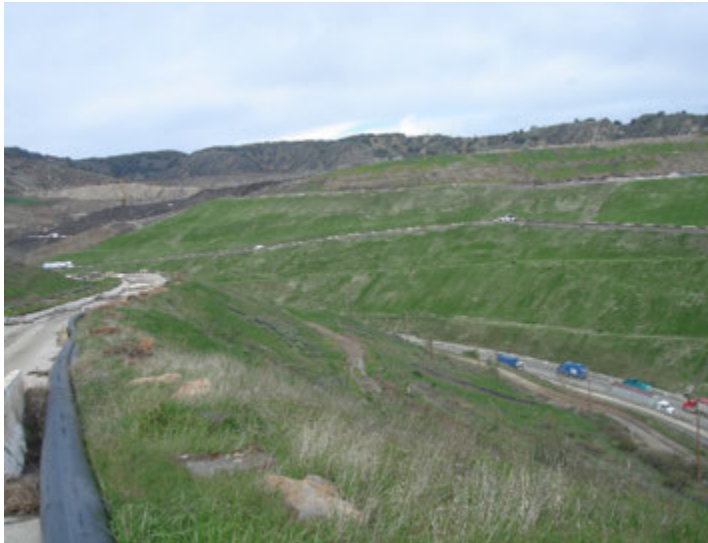
**Photo 121: Closure Turf: February 21, 2019**

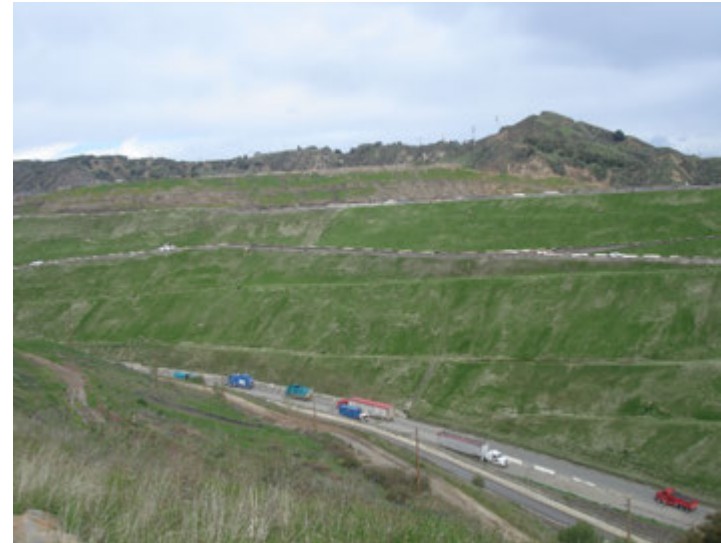
**Photo 122: Closure Turf: February 21, 2019**

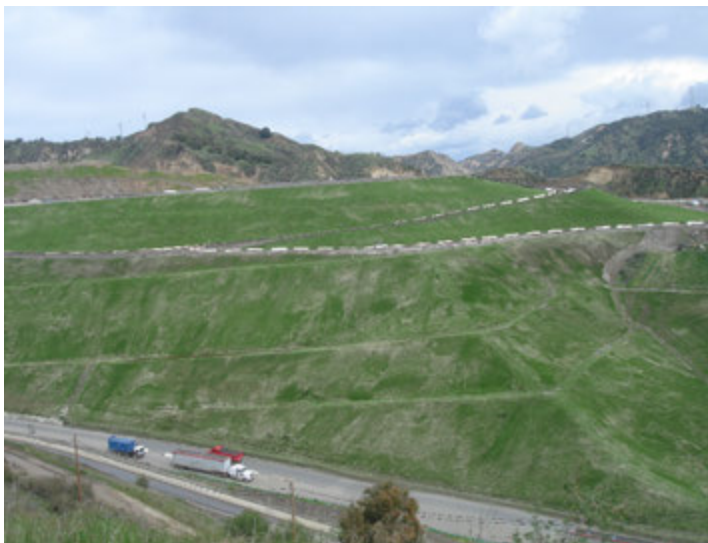
**Photo 123: Closure Turf: February 21, 2019**

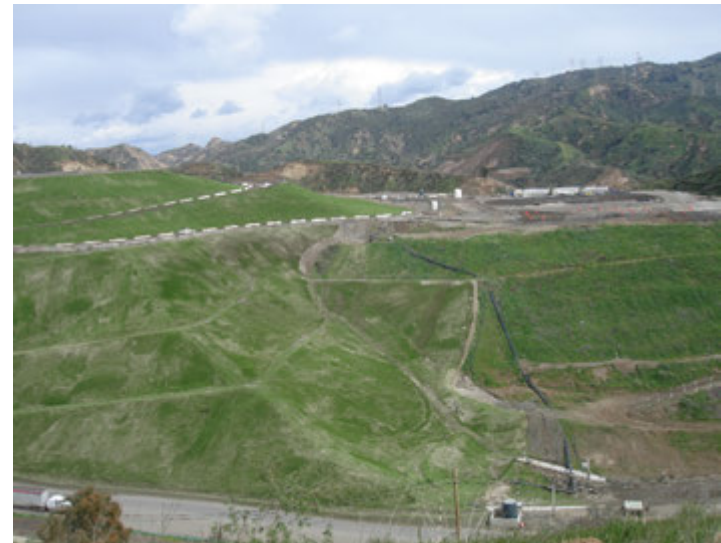
**Photo 124: Closure Turf: February 21, 2019**

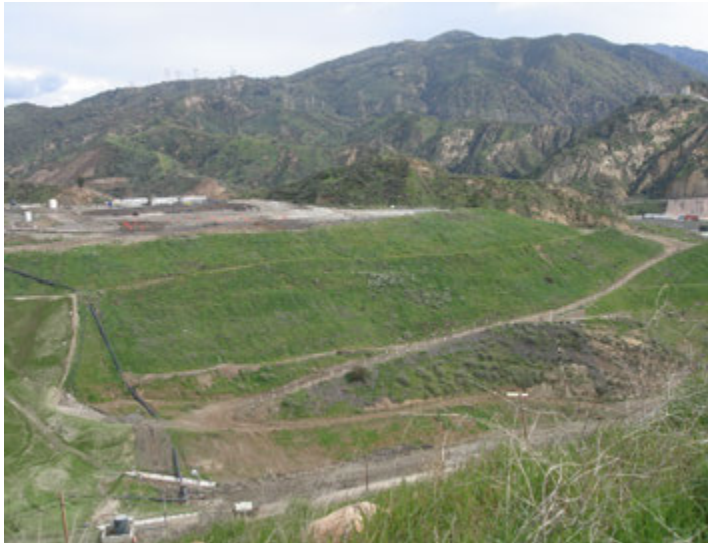
**Photo 125: Closure Turf: February 21, 2019**

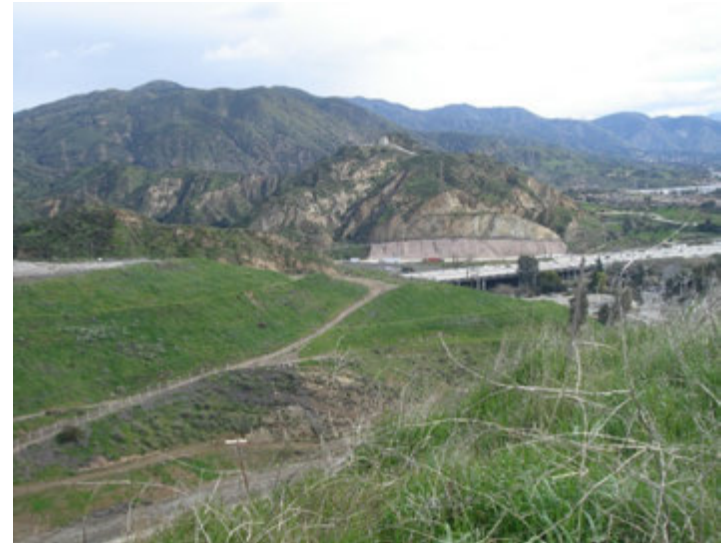
**Photo 126: Closure Turf: February 21, 2019**

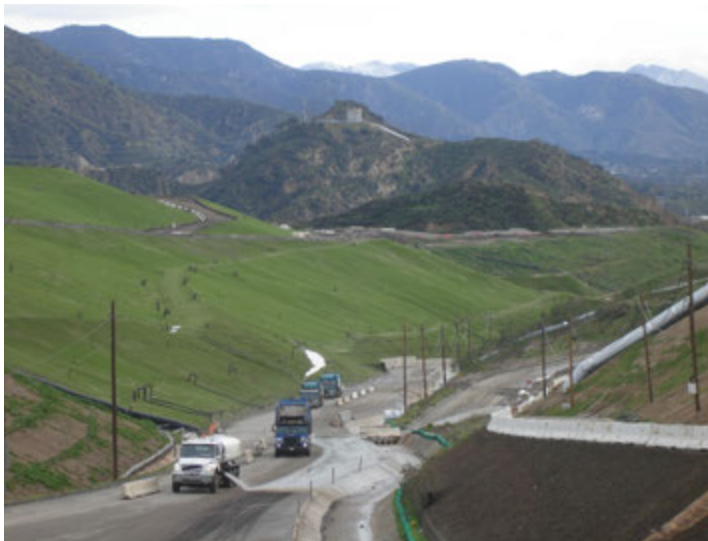
**Photo 127: Closure Turf: February 21, 2019**

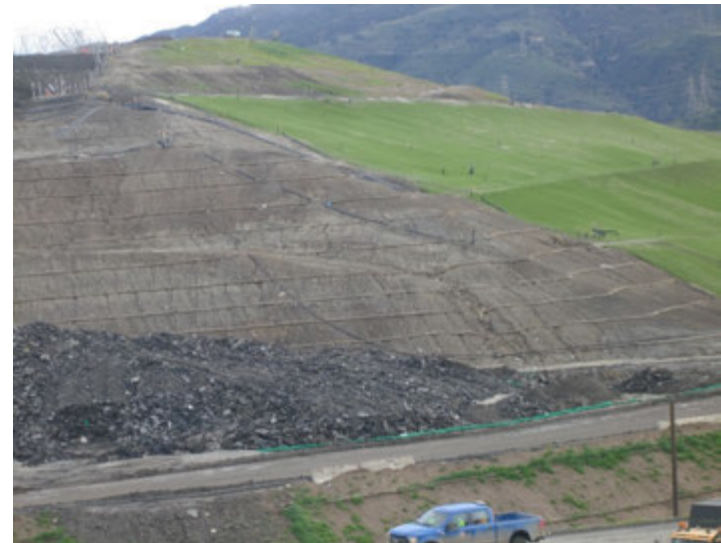
**Photo 128: Closure Turf: February 21, 2019**

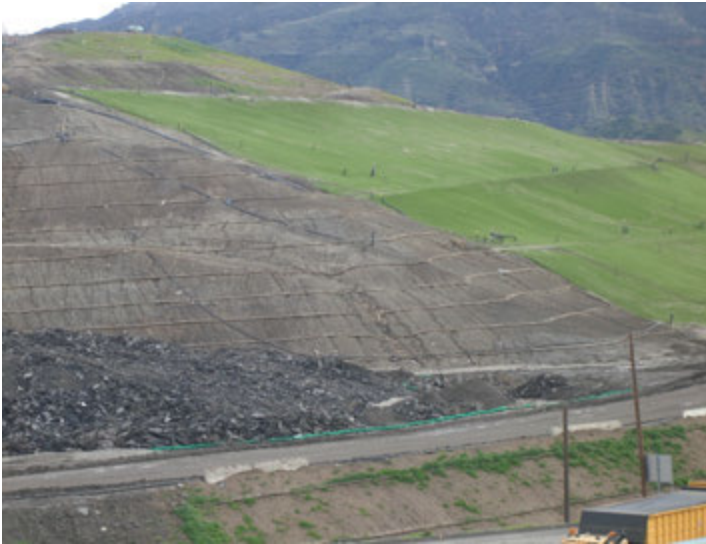
**Photo 129: Closure Turf: February 21, 2019**

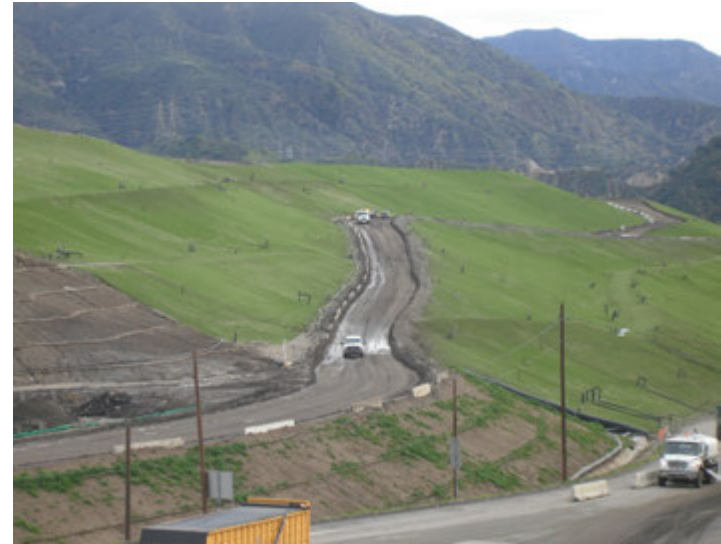
**Photo 130: Closure Turf: February 21, 2019**

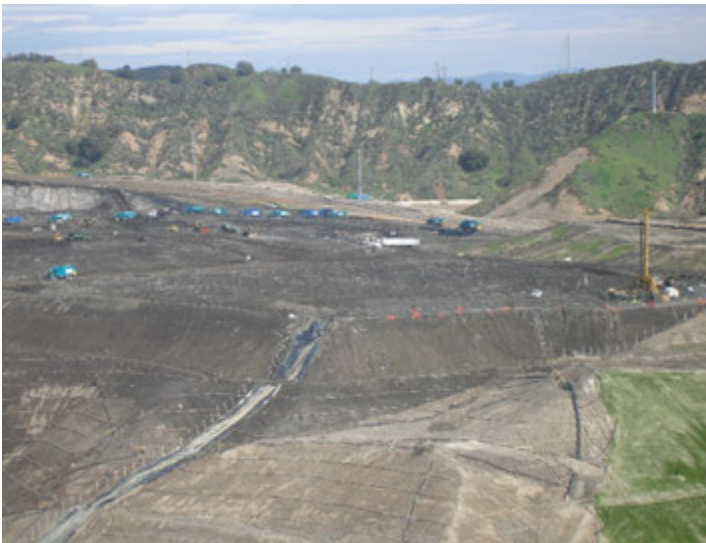
**Photo 131: Closure Turf: March 5, 2019**

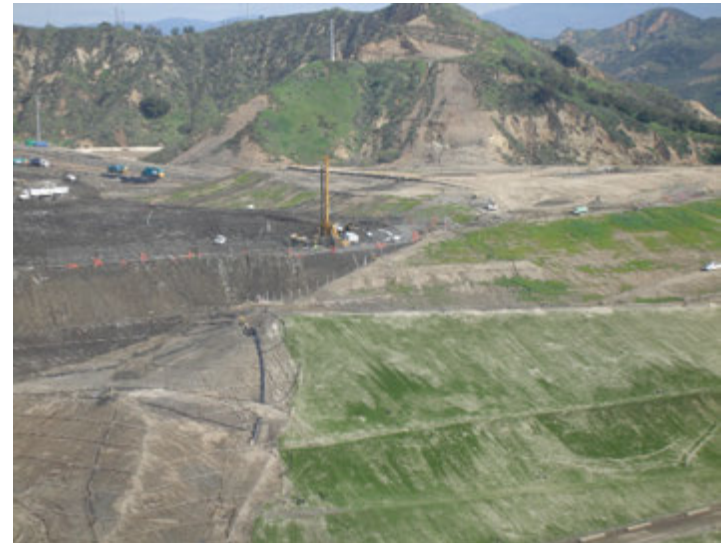
**Photo 132: Closure Turf: March 5, 2019**

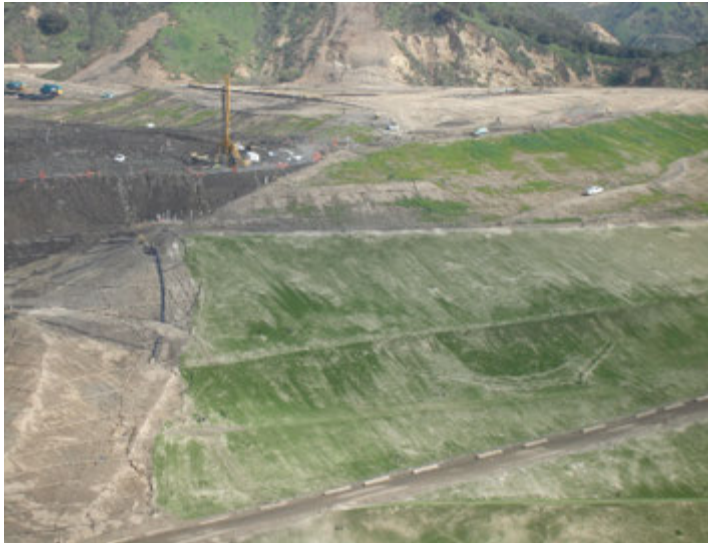
**Photo 133: Closure Turf: March 5, 2019**

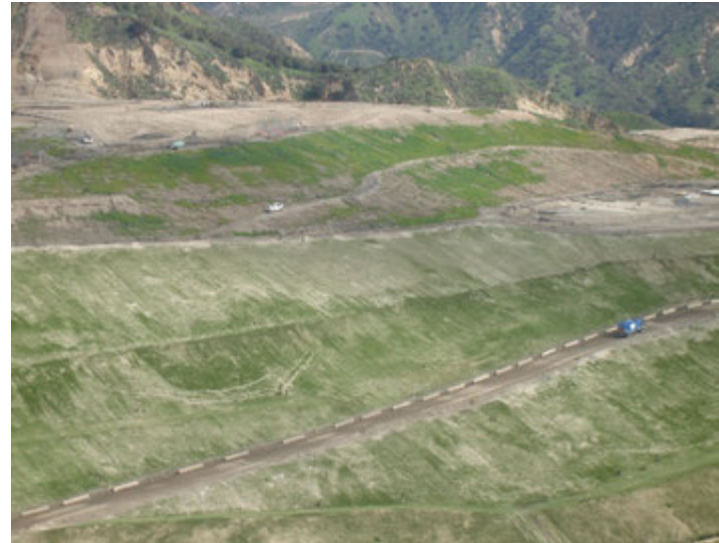
**Photo 134: Closure Turf: March 5, 2019**

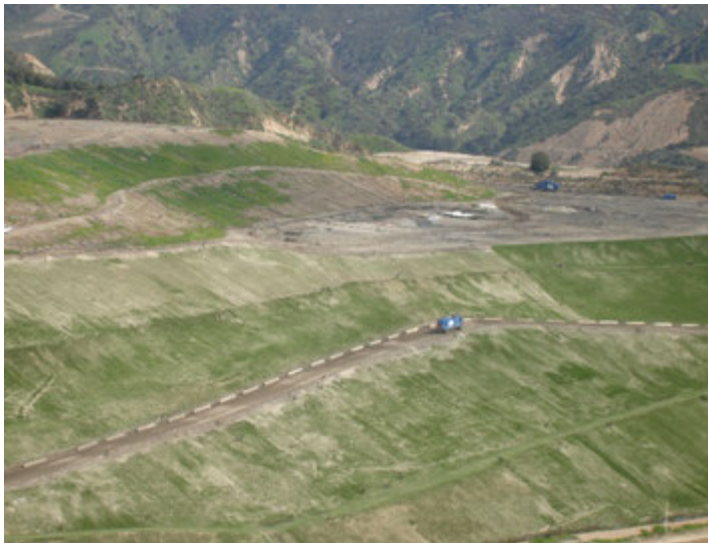
**Photo 135: Closure Turf: March 5, 2019**

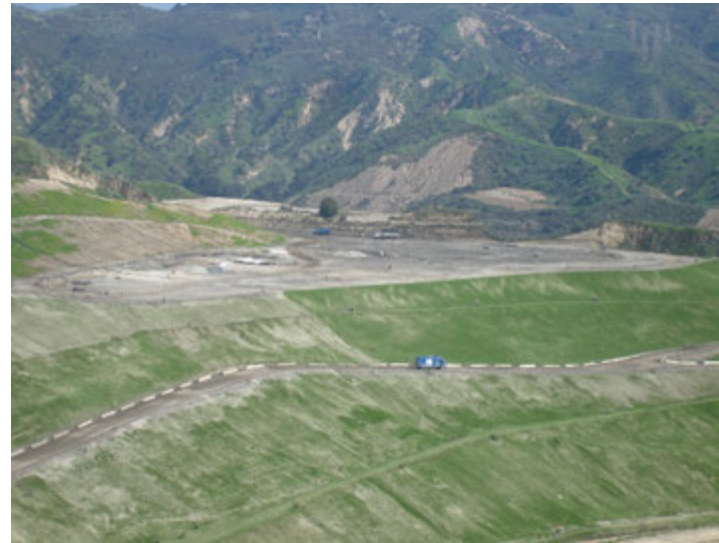
**Photo 136: Closure Turf: March 5, 2019**

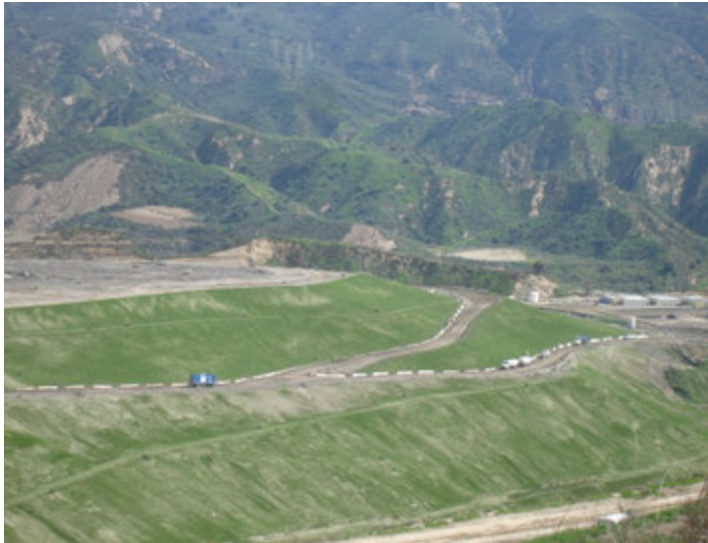
**Photo 137: Closure Turf: March 5, 2019**

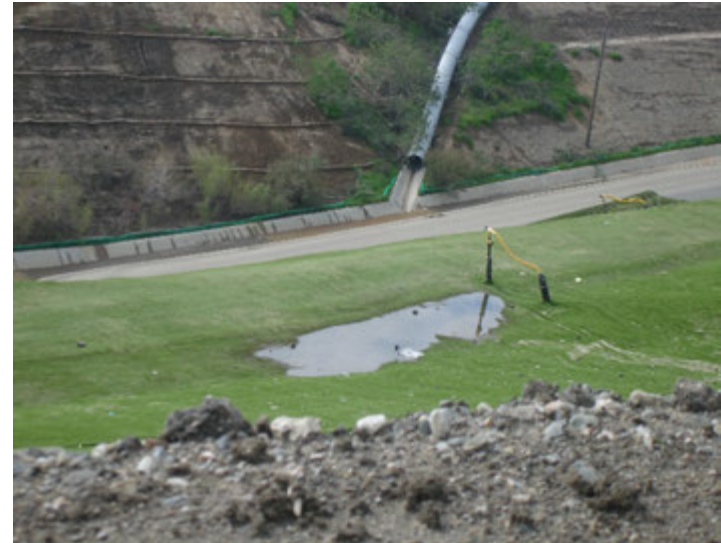
**Photo 138: Closure Turf: March 5, 2019**

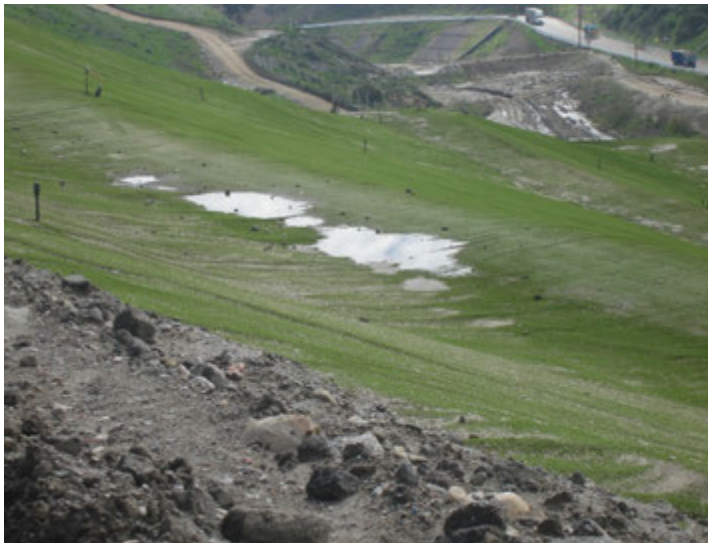
**Photo 139: Closure Turf: March 5, 2019**

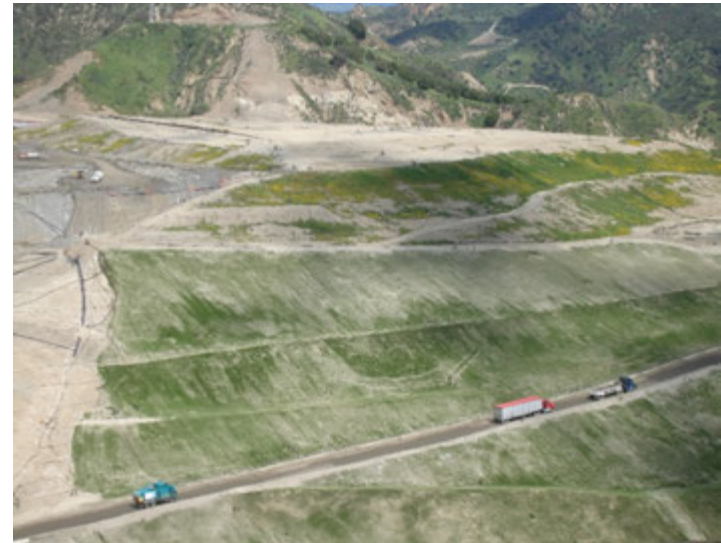
**Photo 140: Closure Turf: March 28, 2019**

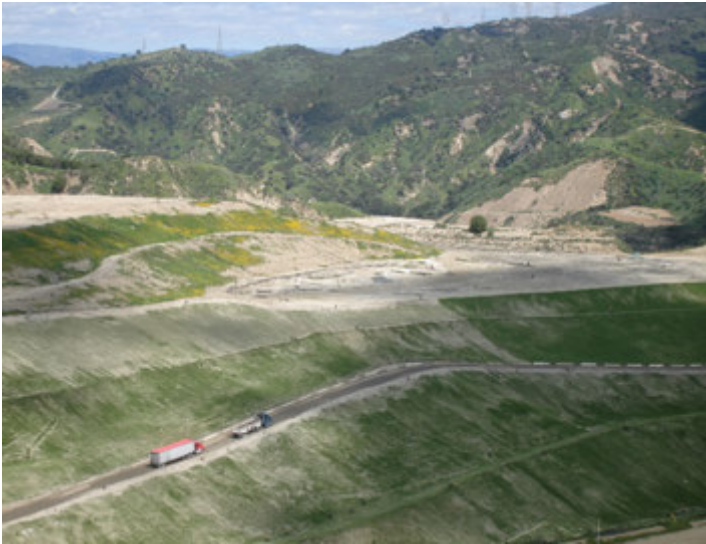
**Photo 141: Closure Turf: March 28, 2019**

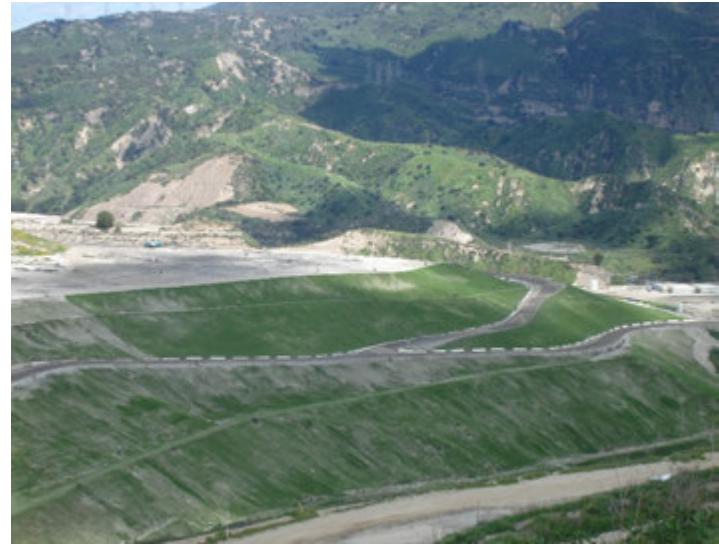
**Photo 142: Closure Turf: March 28, 2019**

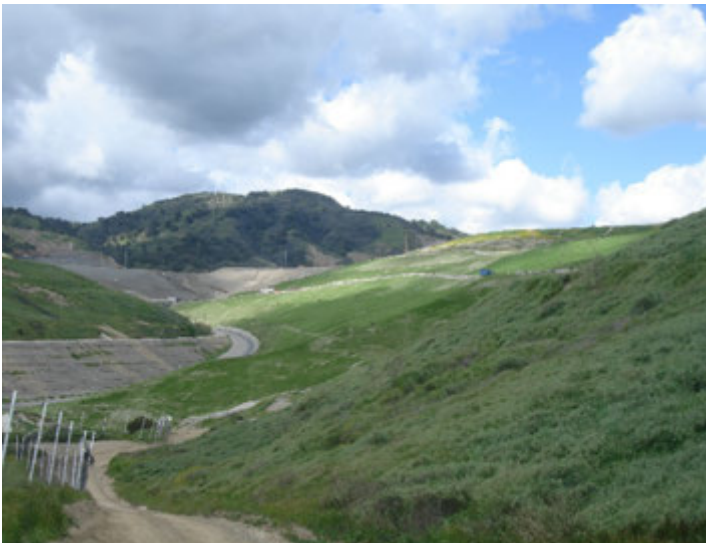
**Photo 143: Closure Turf: March 28, 2019**

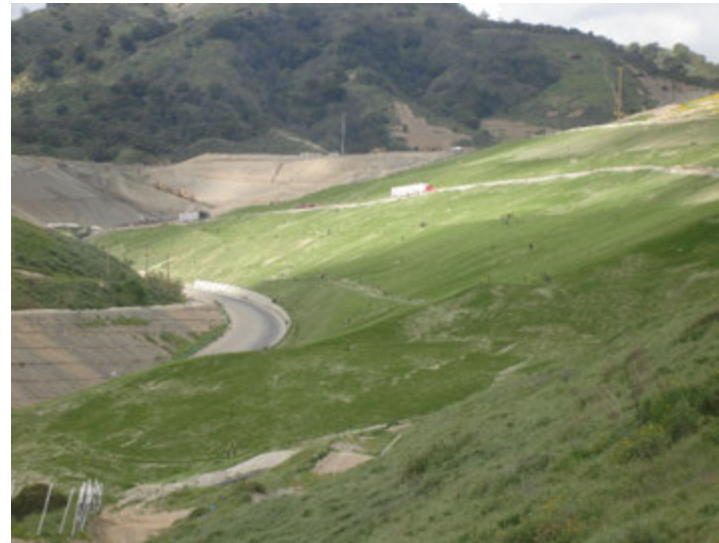
**Photo 144: Closure Turf: March 28, 2019**

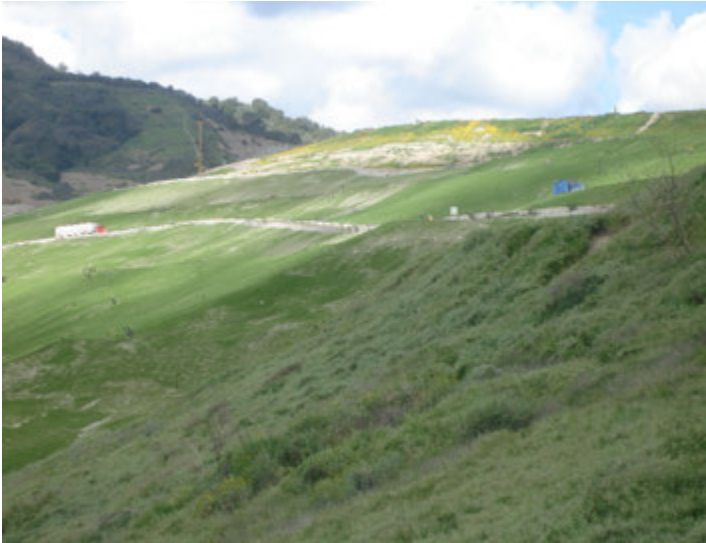
**Photo 145: Closure Turf: March 28, 2019**

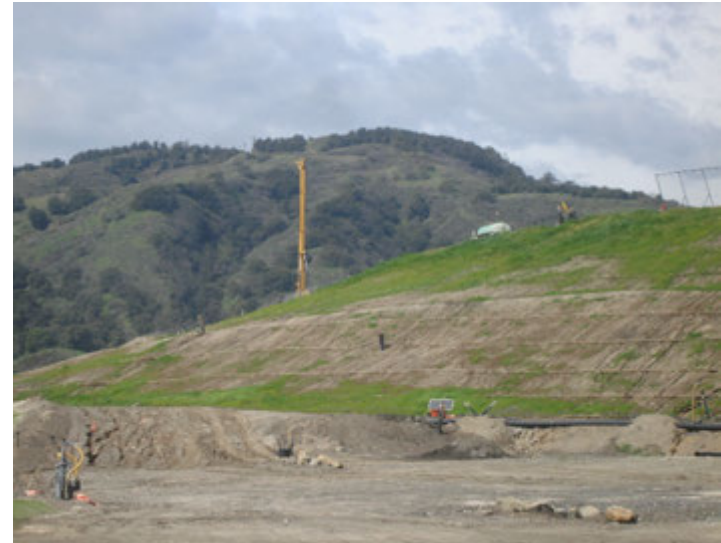
**Photo 146: CC-3A Slopes: March 5, 2019**

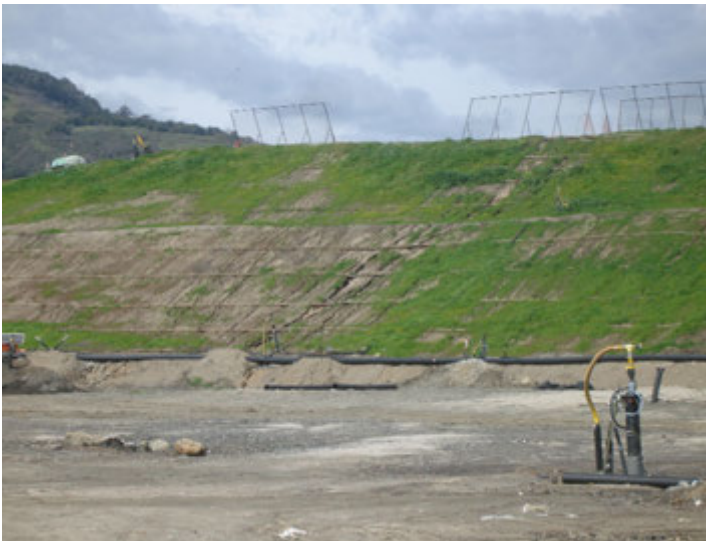
**Photo 147: CC-3A Slopes: March 5, 2019**

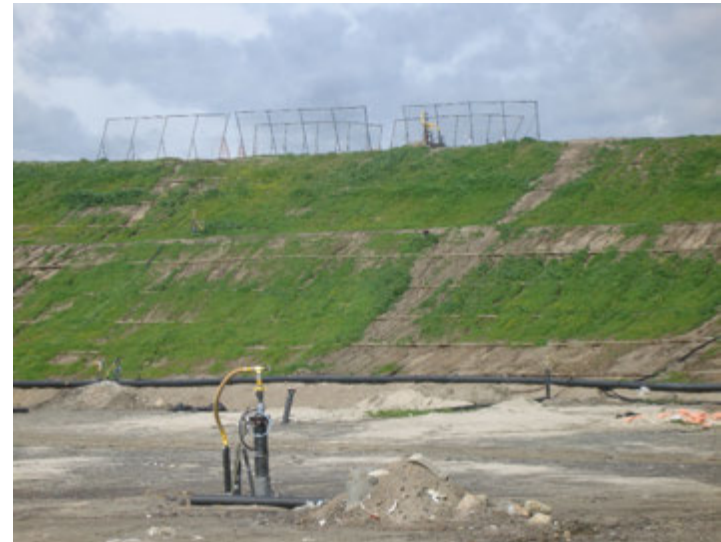
**Photo 148: CC-3A Slopes: March 5, 2019**

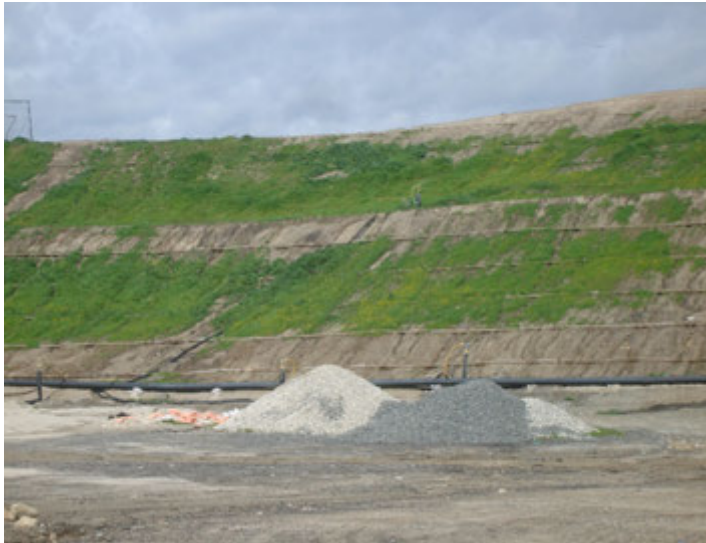
**Photo 149: CC-3A Slopes: March 5, 2019**

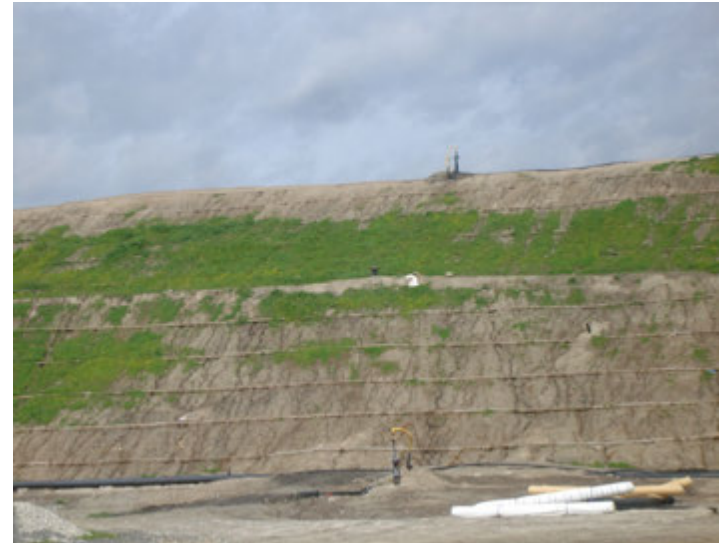
**Photo 150: CC-3A Slopes: March 5, 2019**

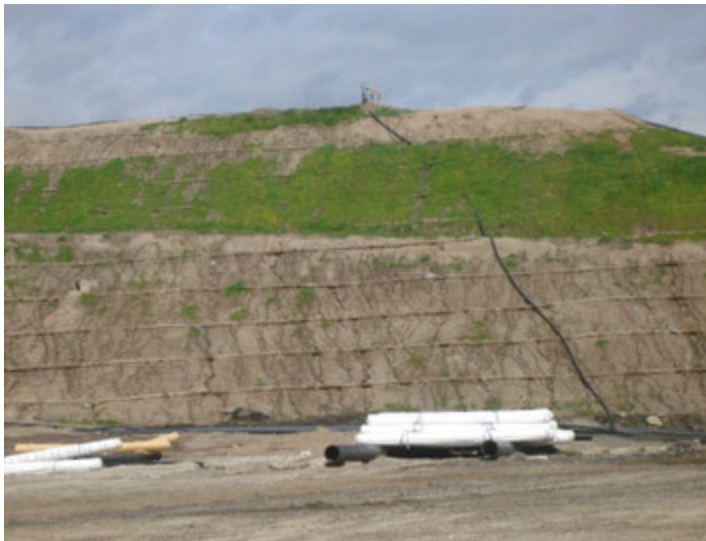
**Photo 151: CC-3A Slopes: March 5, 2019**

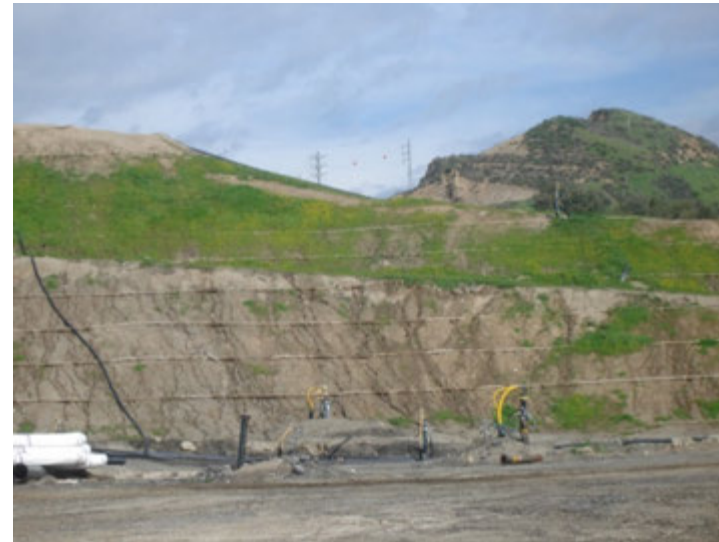
**Photo 152: CC-3A Slopes: March 5, 2019**

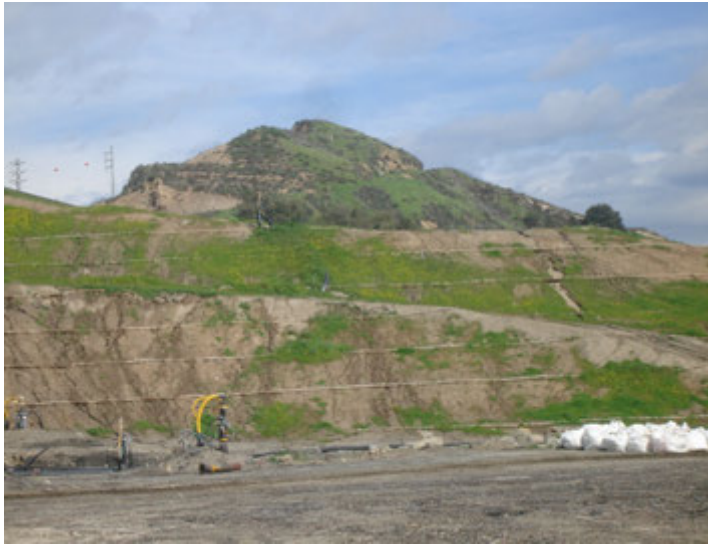
**Photo 153: CC-3A Slopes: March 5, 2019**

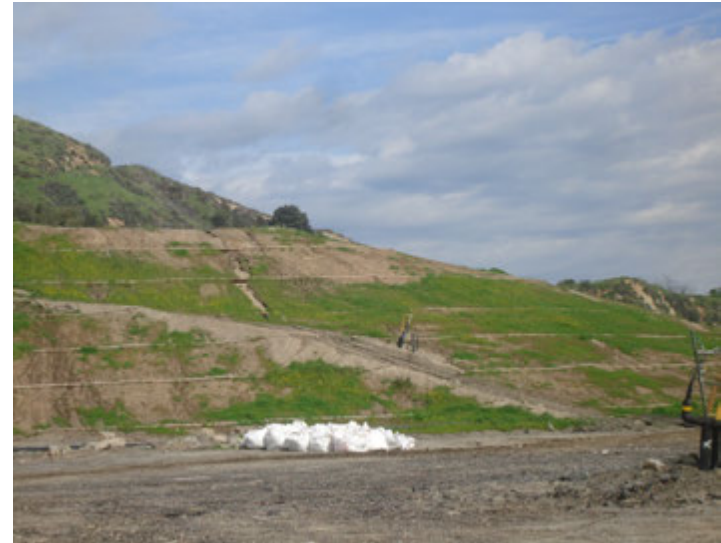
**Photo 154: CC-3A Slopes: March 5, 2019**

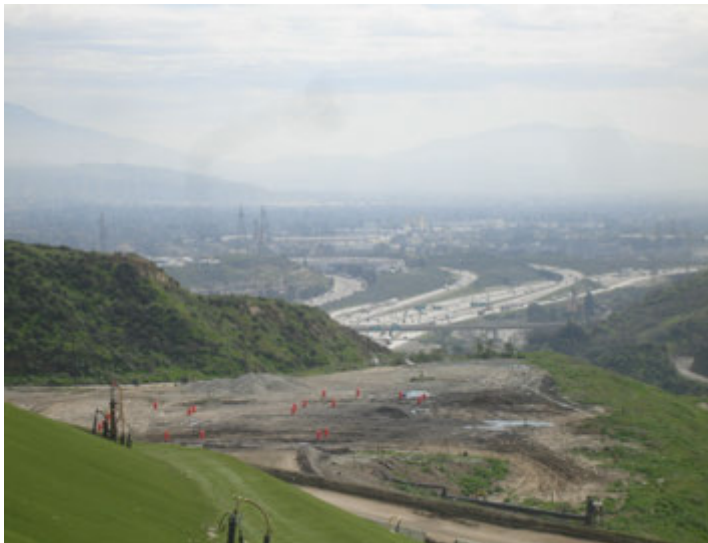
**Photo 155: CC-3B Top Deck: March 5, 2019**

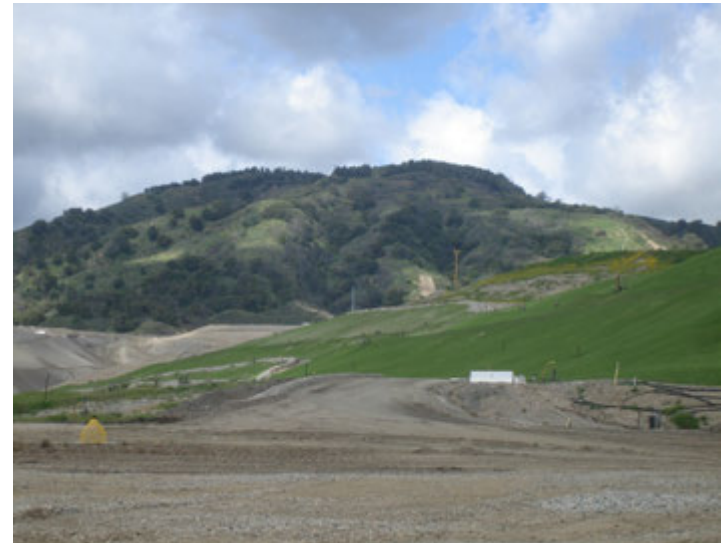
**Photo 156: CC-3B South Slopes: March 28, 2019**

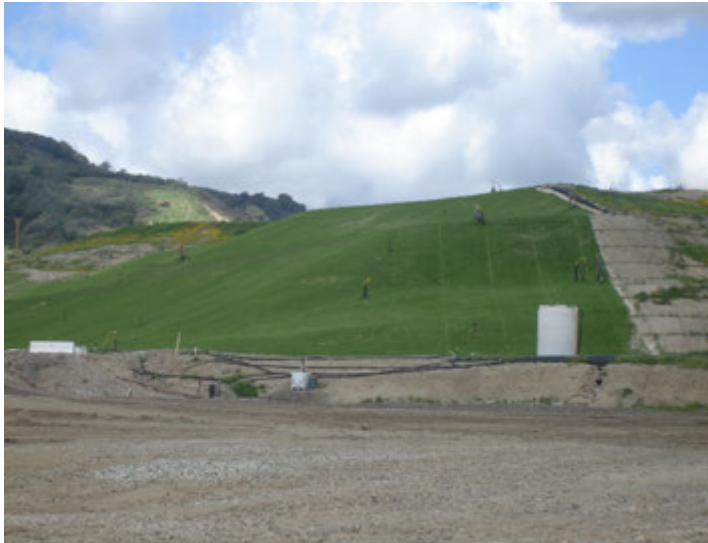
**Photo 157: CC-3B South Slopes: March 28, 2019**

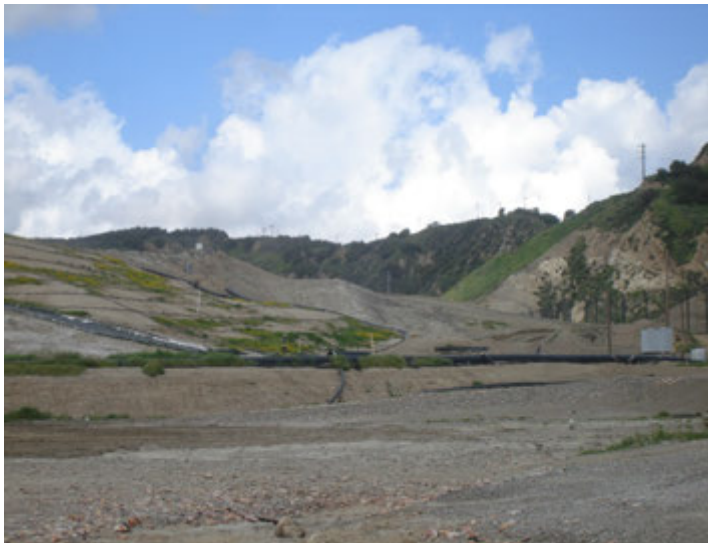
**Photo 158: CC-3B South Slopes: March 28, 2019**

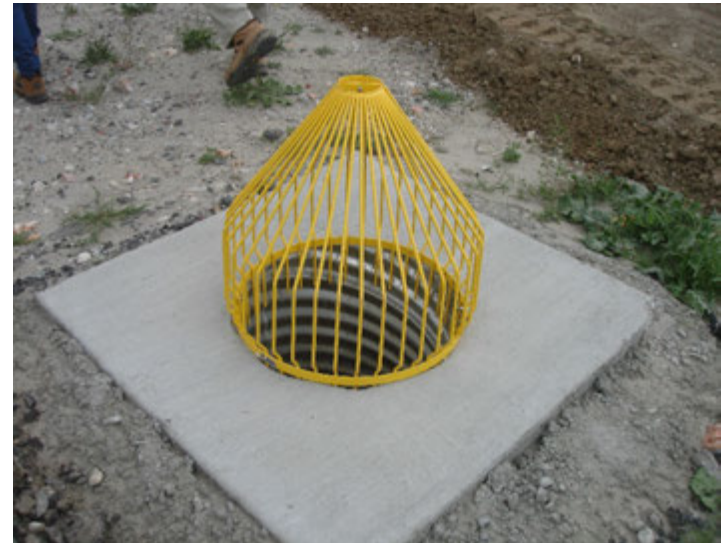
**Photo 159: CC-3B South Slopes: March 28, 2019**

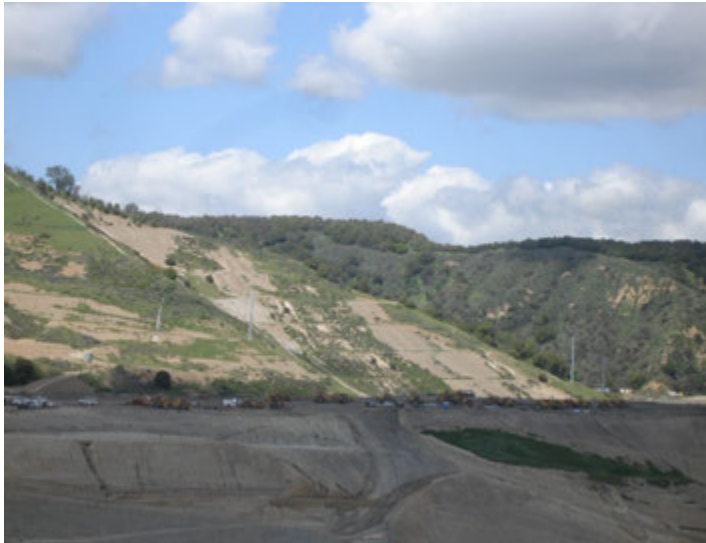
**Photo 160: Old City North Top Deck: March 28, 2019**

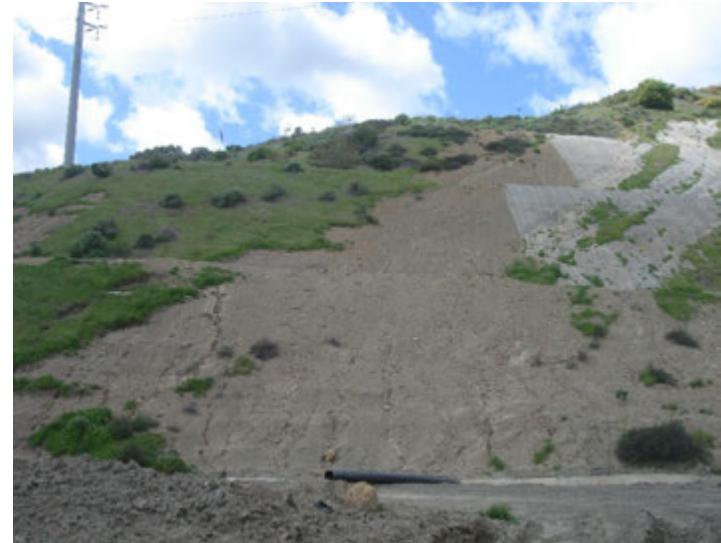
**Photo 161: County Sage Mitigation Area: March 28, 2019**

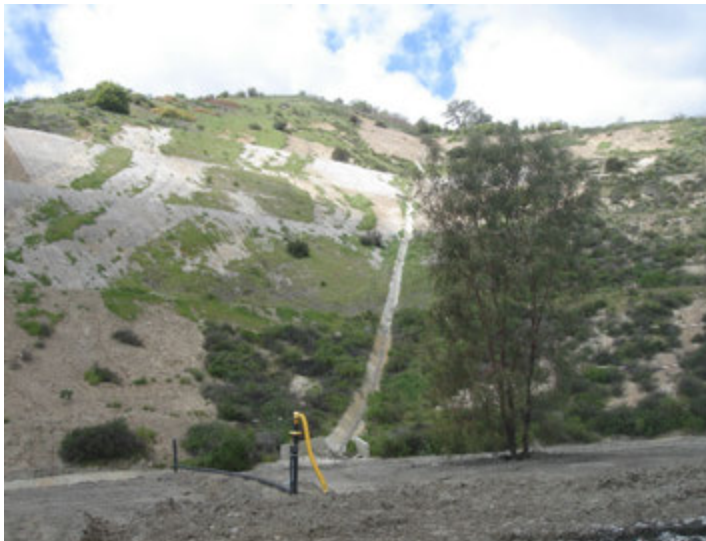
**Photo 162: County Sage Mitigation Area: March 28, 2019**

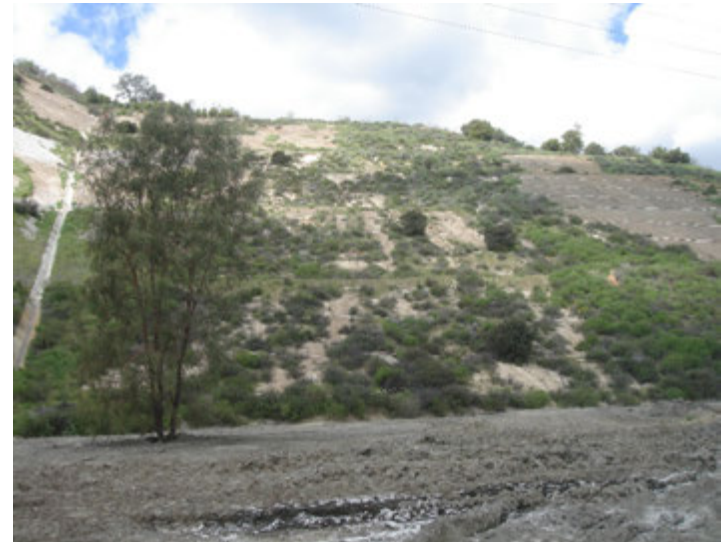
**Photo 163: County Sage Mitigation Area: March 28, 2019**

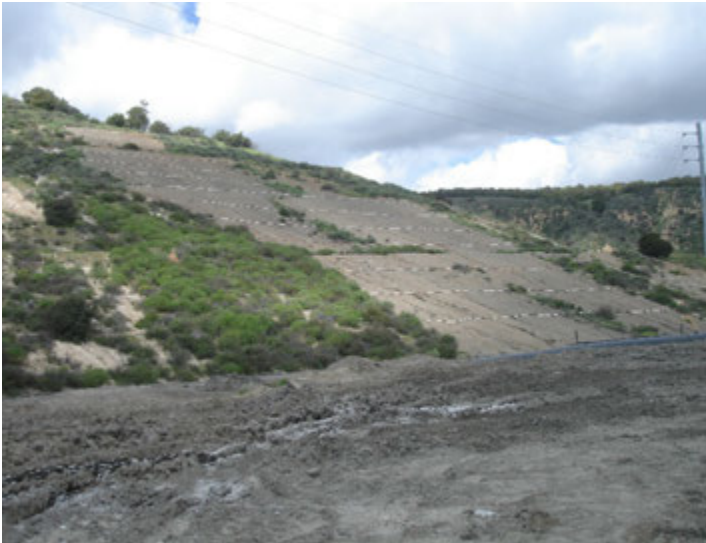
**Photo 164: County Sage Mitigation Area: March 28, 2019**

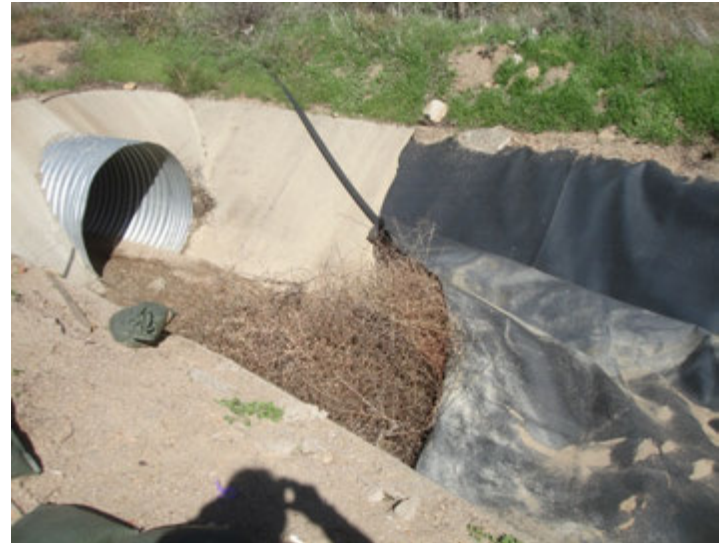
**Photo 165: County Sage Mitigation Area: March 28, 2019**

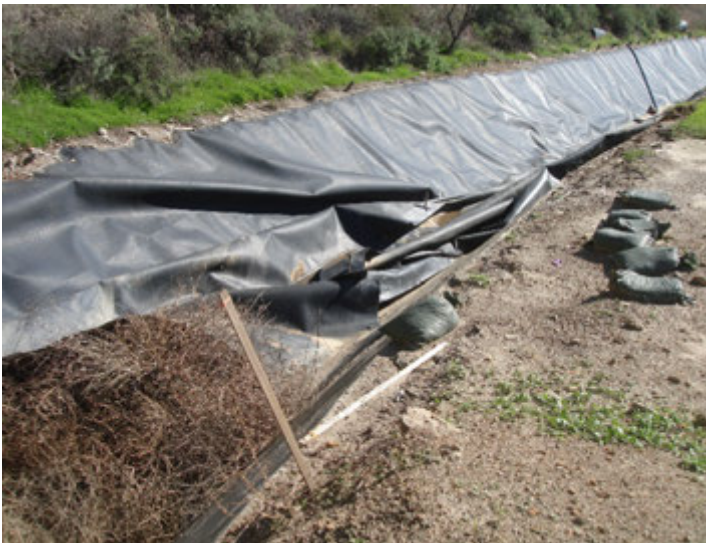
**Photo 166: Basin D Outlet Channel: January 22, 2019**

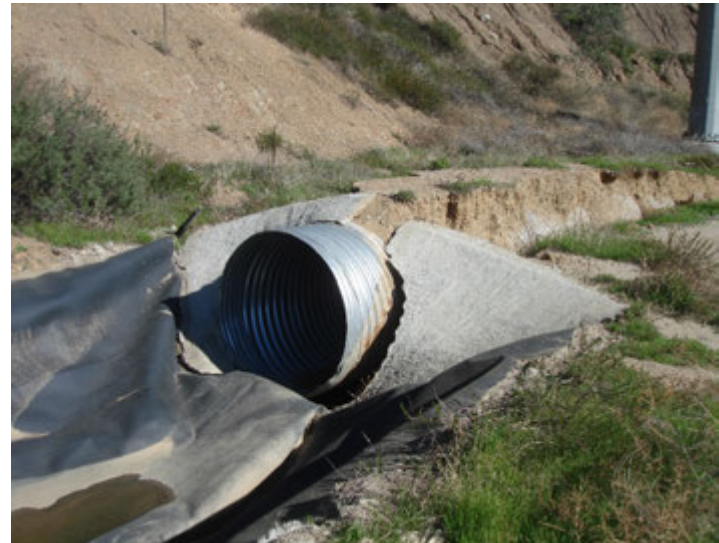
**Photo 167: Basin D Outlet Channel: January 22, 2019**

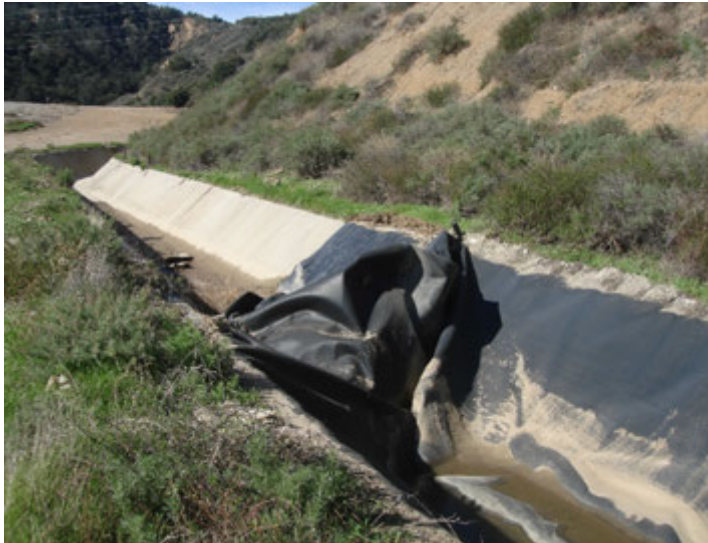
**Photo 168: Basin D Outlet Channel: January 22, 2019**

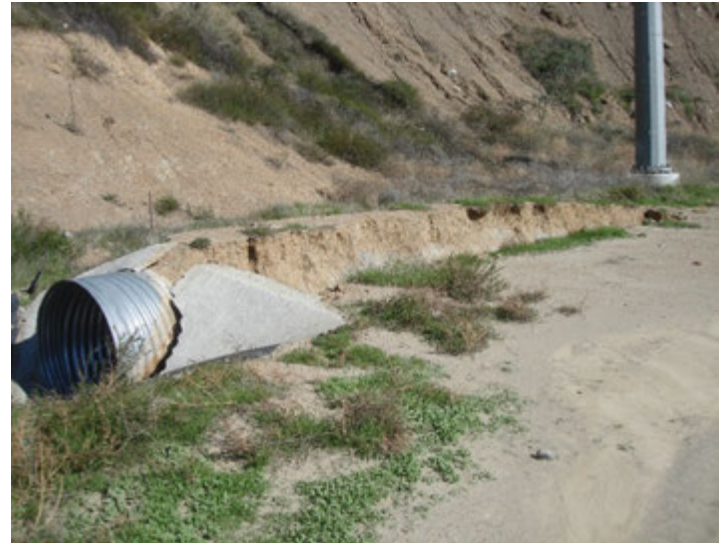
**Photo 169: Basin D Outlet Channel: January 22, 2019**

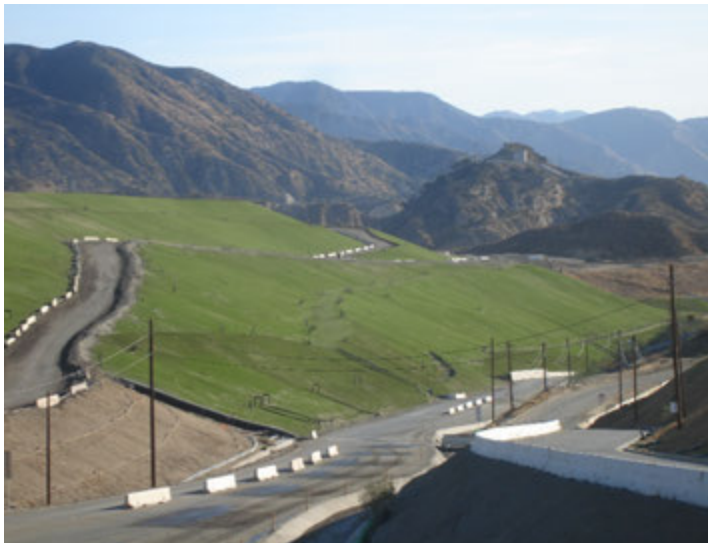
**Photo 170: Basin D Outlet Channel: January 22, 2019**

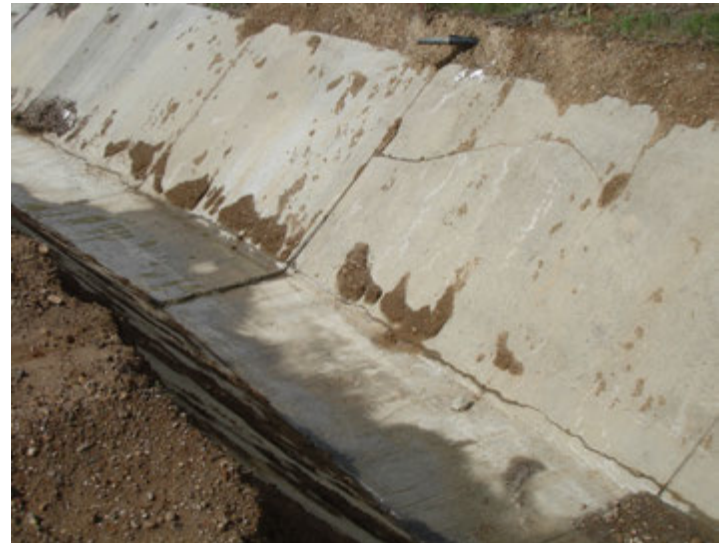
**Photo 171: Posi-Shell and Closure Turf: January 22, 2019**

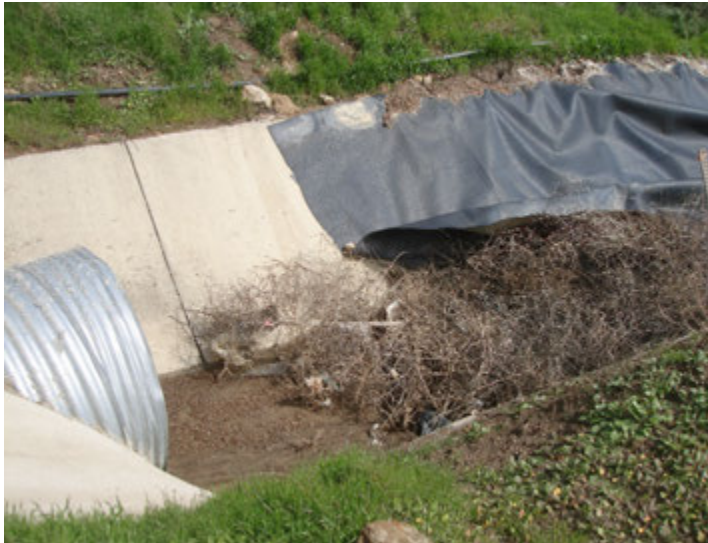
**Photo 172: Basin D Outlet Channel: February 21, 2019**

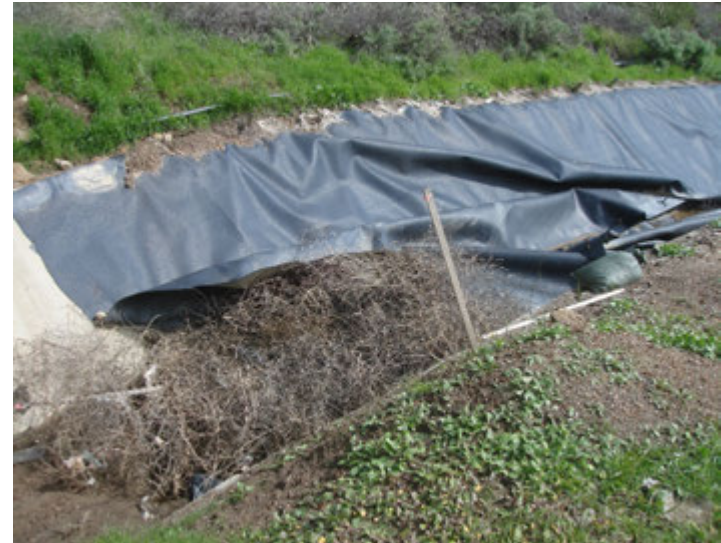
**Photo 173: Basin D Outlet Channel: February 21, 2019**

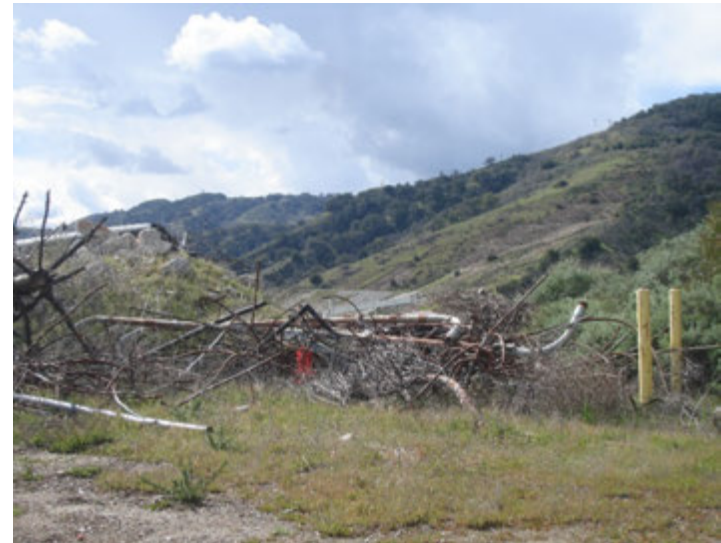
**Photo 175: Waste Material on Old Flares 8 Site: February 21, 2019**

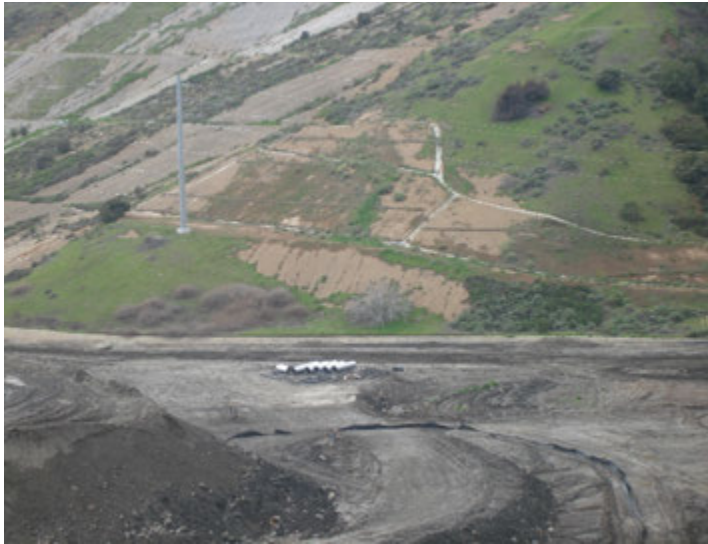
**Photo 176: Waste Material on Old Flares 8 Site: February 21, 2019**
