**Sunshine Canyon Landfill  
Independent Monitor  
Quarterly Site Monitoring Status Report  
January 1, 2019 – March 31, 2019**

April 29, 2019

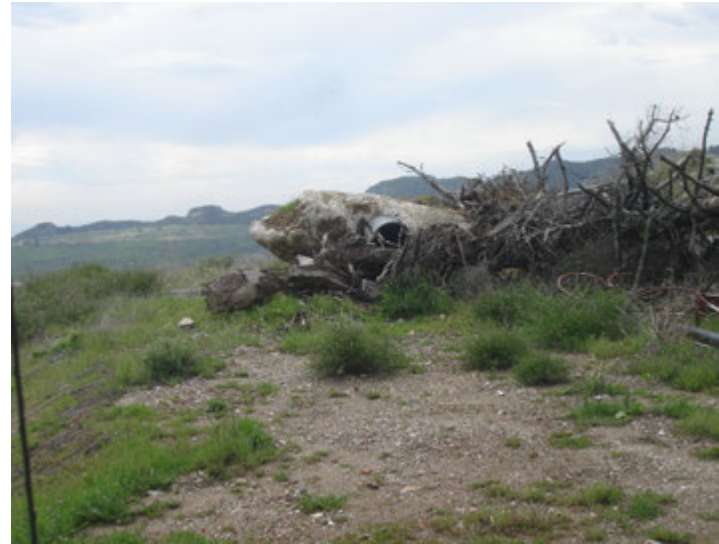
**Photo 177: Waste Material on Old Flare 8 Site: March 5, 2019**

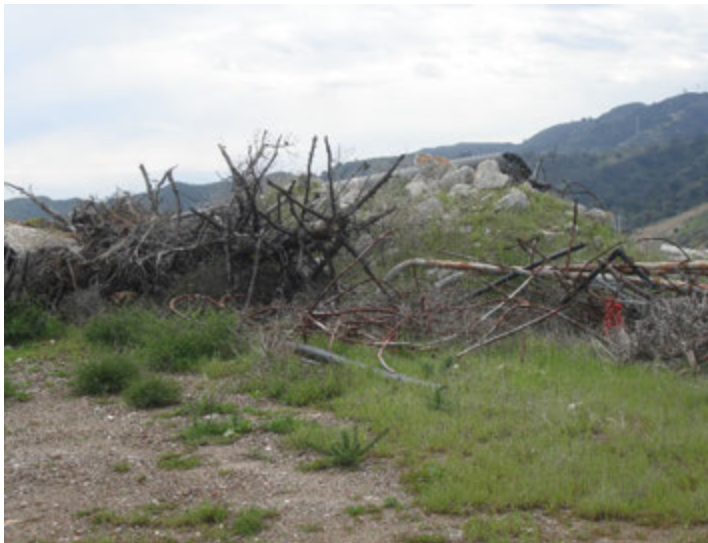
**Photo 178: Waste Material on Old Flare 8 Site: March 5, 2019**

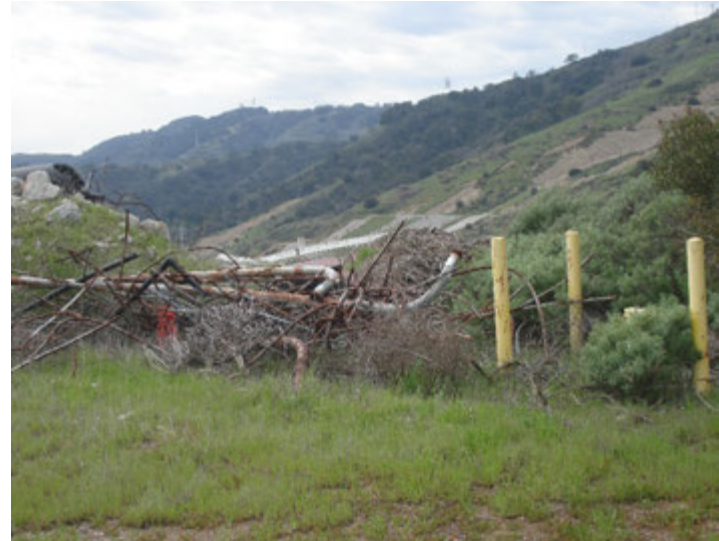
**Photo 179: Waste Material on Old Flare 8 Site: March 5, 2019**

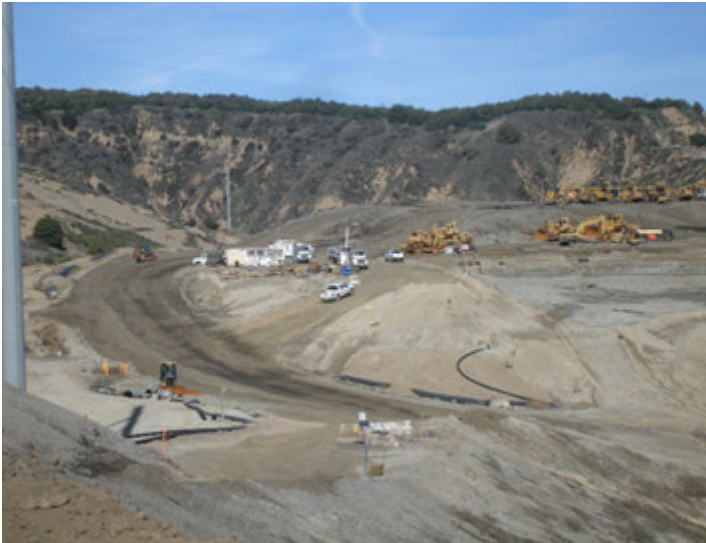
**Photo 184: County Flare Road Plugged Drainage: March 28, 2019**

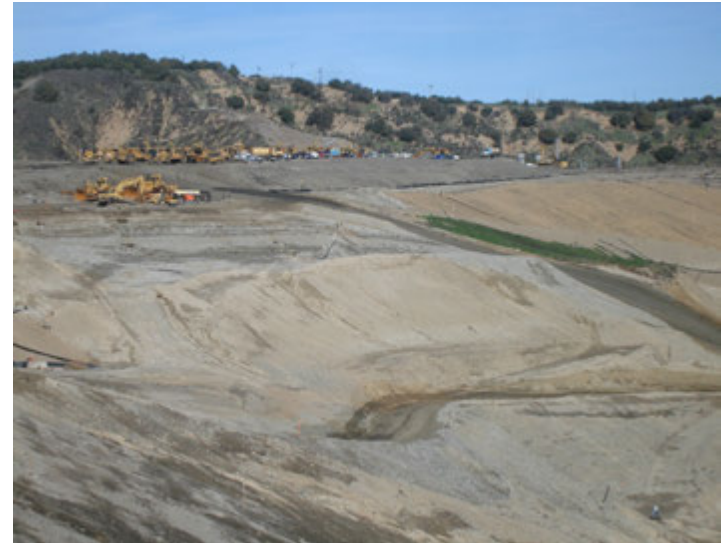
**Photo 185: County Top Deck Stockpile Area: January 22, 2019**

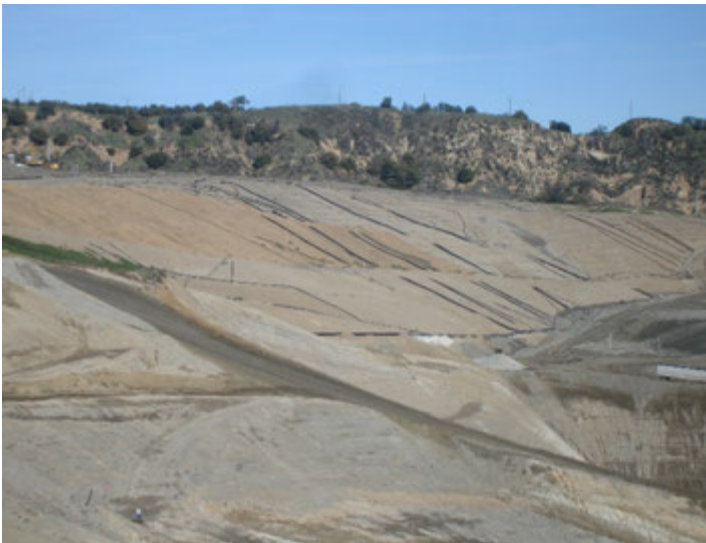
**Photo 186: County Top Deck Stockpile Area: January 22, 2019**

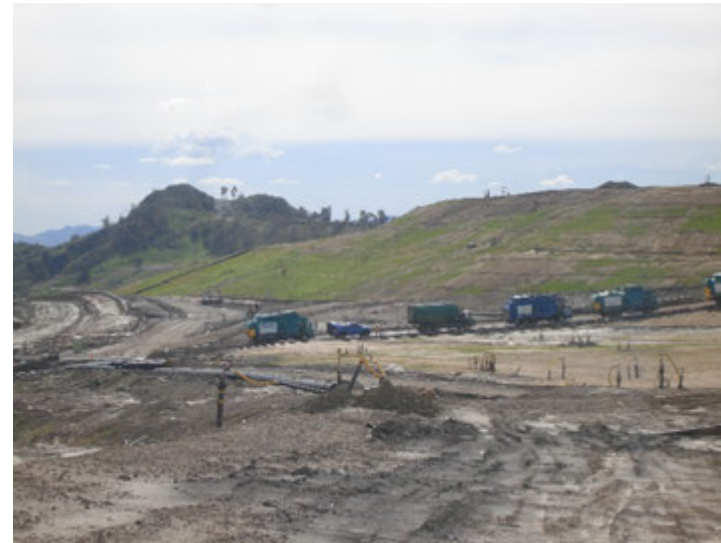
**Photo 187: County Top Deck Stockpile Area: January 22, 2019**

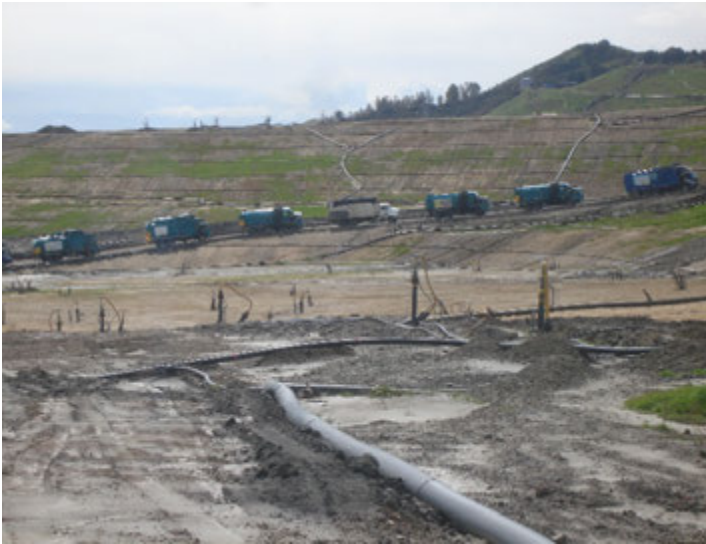
**Photo 188: County Bowl Area: February 21, 2019**

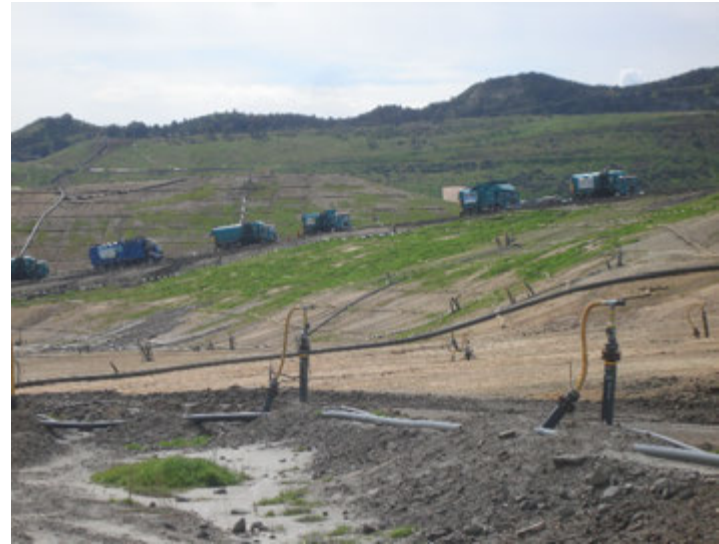
**Photo 189: County Bowl Area: February 21, 2019**

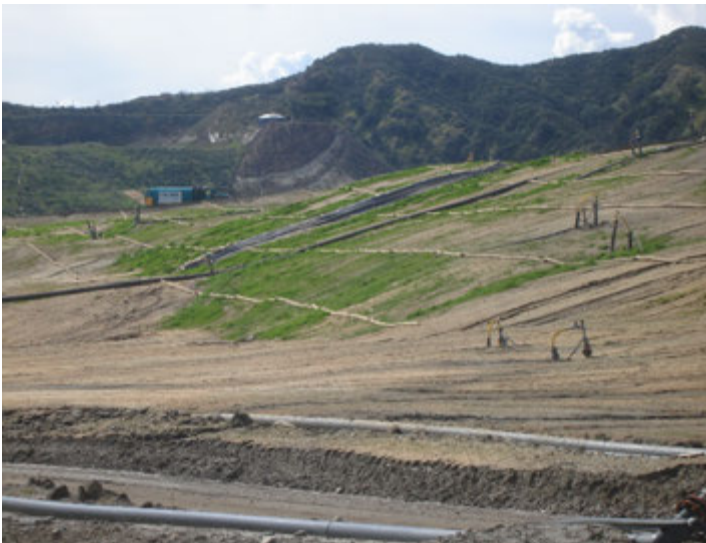
**Photo 190: County Bowl Area: February 21, 2019**

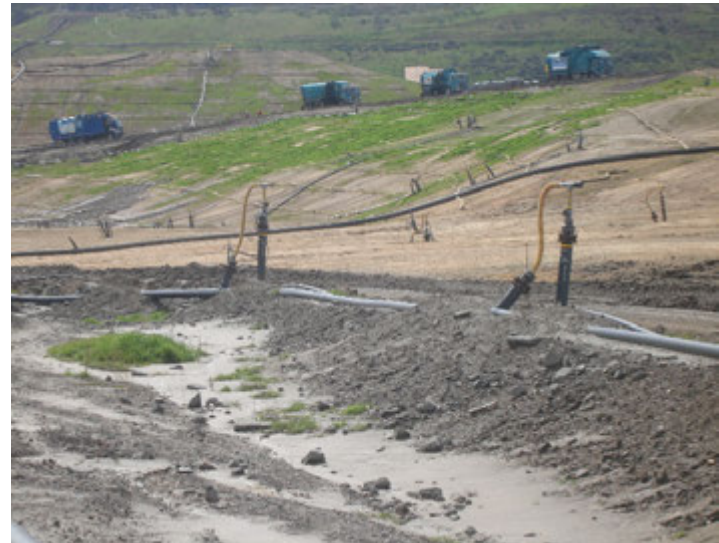
**Photo 191: County Bowl Area: February 21, 2019**

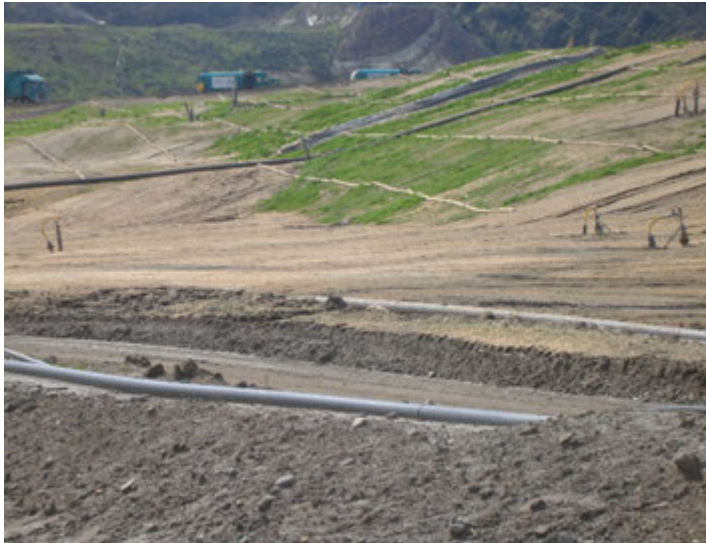
**Photo 192: County Bowl Area: February 21, 2019**

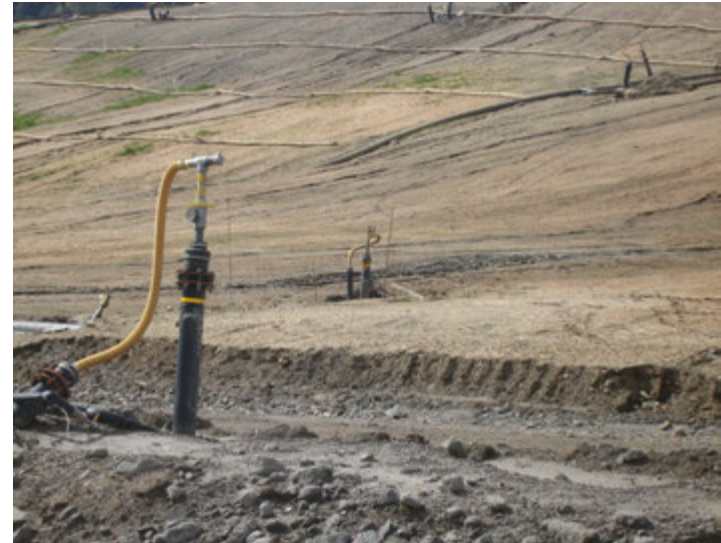
**Photo 193: County Bowl Area: February 21, 2019**

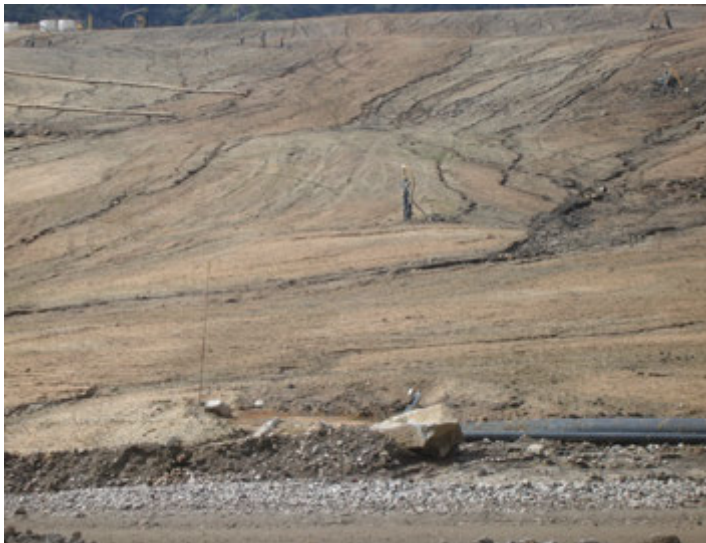
**Photo 194: County Bowl Area: February 21, 2019**

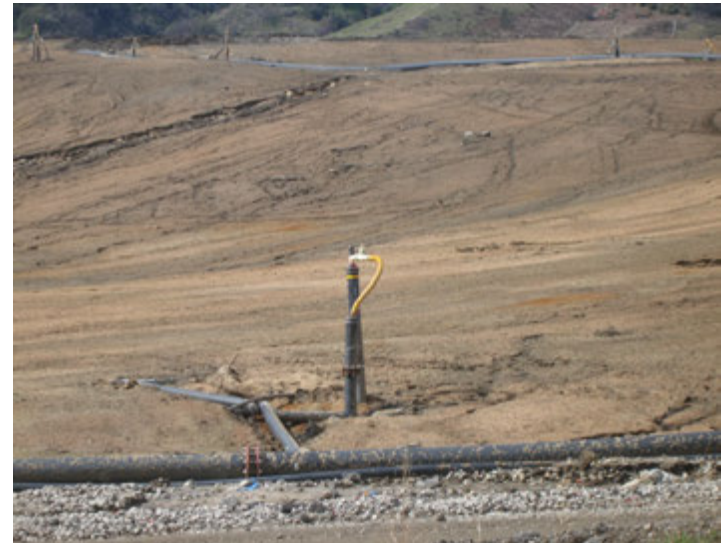
**Photo 195: County Bowl Area: February 21, 2019**

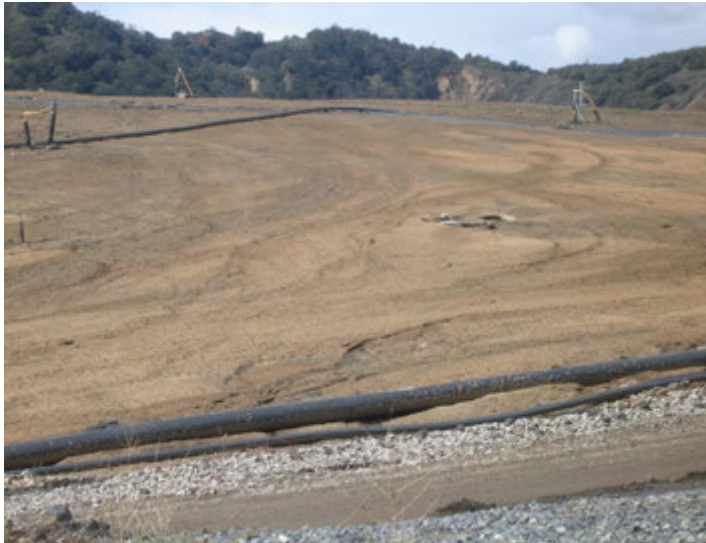
**Photo 196: County Bowl Area: February 21, 2019**

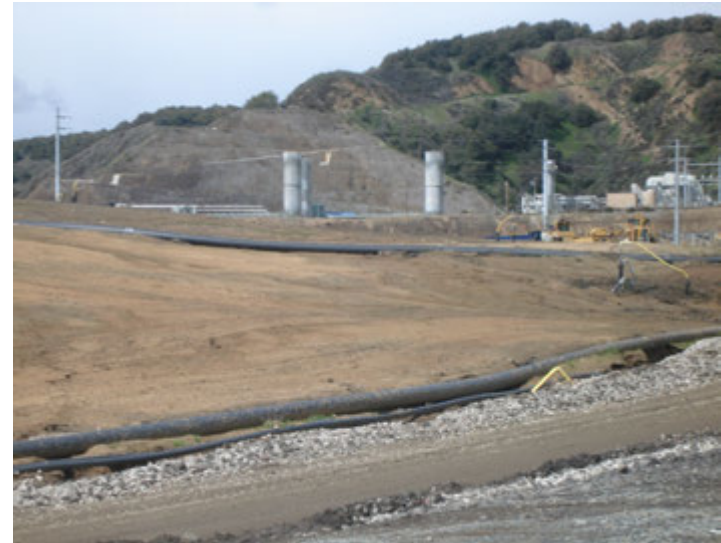
**Photo 197: County Bowl Area: February 21, 2019**

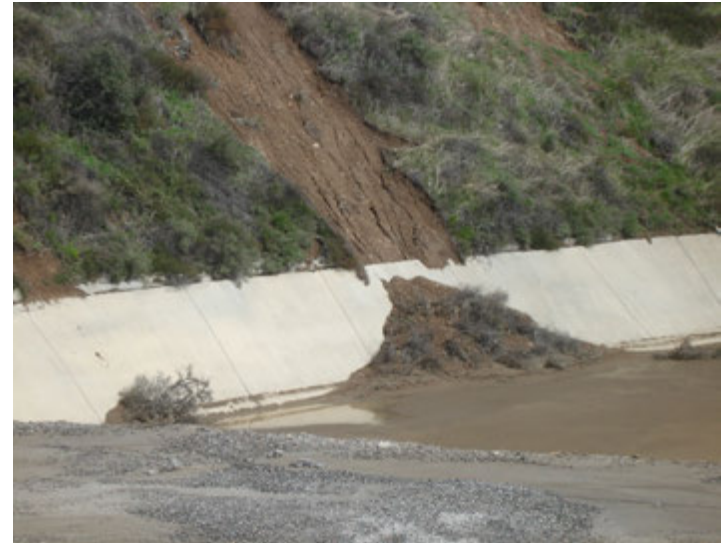
**Photo 253: Basin B: February 21, 2019**

- Seeded slopes were greening up.
- Basin B had a minimal amount of wet sediment on the floor of the basin. There were two areas where the adjacent native slopes sloughed into the basin.
- Basin A had a significant amount of sediment and water was covering approximately One-third of the basin. Water out was minimal.
- Water was being pumped out of the CC-4 Part 3 buttress temporary basin.
- Cell CC-4 Part 1/Part 2 was operating with no areas of concern observed.

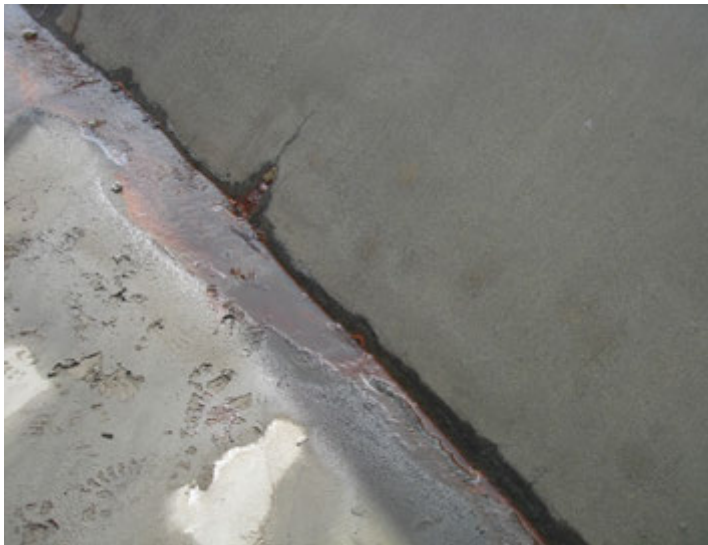
**Photo 316: Terminal Basin Area Alluvial Pumps Not Running:  
March 28, 2019**

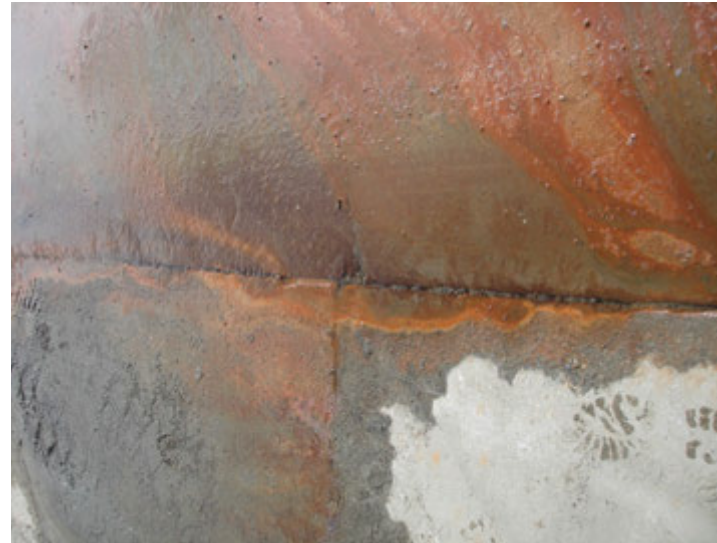
**Photo 317: Terminal Basin Area Alluvial Pumps Not Running:  
March 28, 2019**

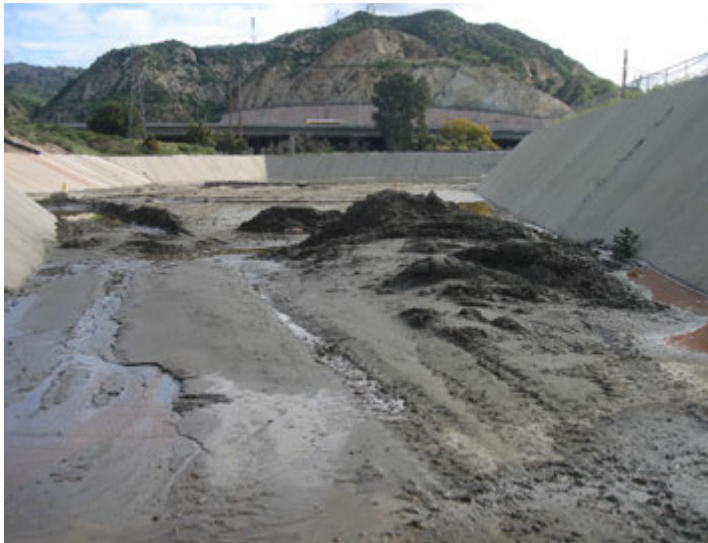
**Photo 318: Terminal Basin Area Alluvial Pumps Not Running:  
March 28, 2019**

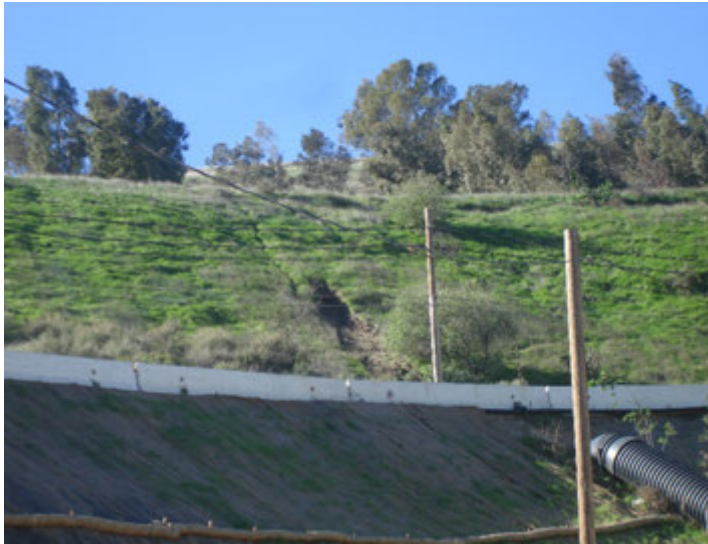
**Photo 380: Main Access Road Slopes Near Terminal Basin: January 22, 2019**

- Main access road: some sloughing occurred on the embankment on the Terminal Basin side, just at the edge of the previously repaired area at the limit of the jute netting (Photo 1)

1. Remove soil from retaining wall drainage ditch.
2. Repair slope erosion below haul road at terminal basin.
3. Eliminate leachate odors at sediment basin 3B sump area.
4. Eliminate landfill gas odors near well 709.

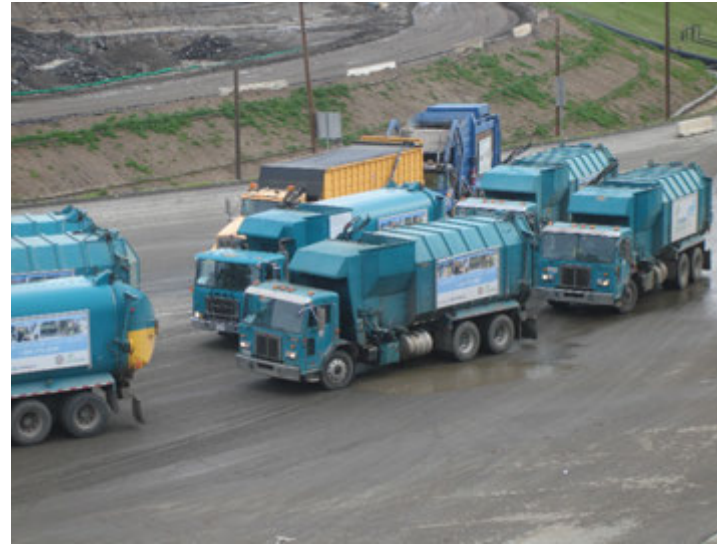
**Photo 381: Main Access Road Old City South Slopes Near Terminal Basin: January 22, 2019**

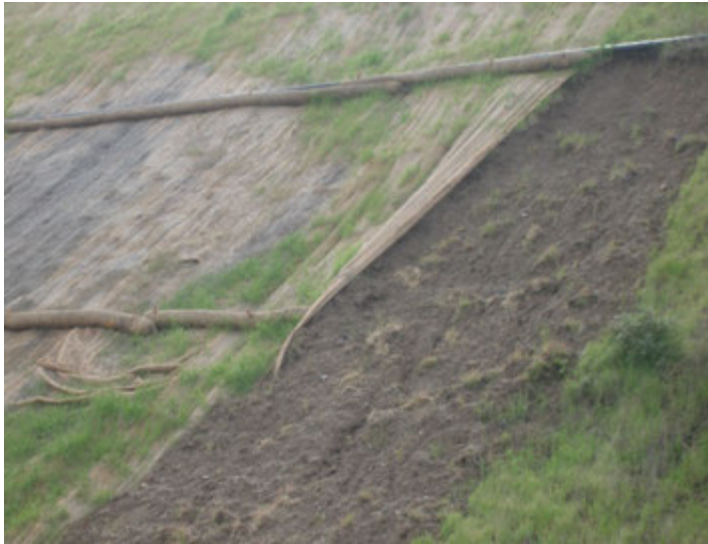
**Photo 384: Main Access Road Slopes Near Terminal Basin: February 21, 2019**

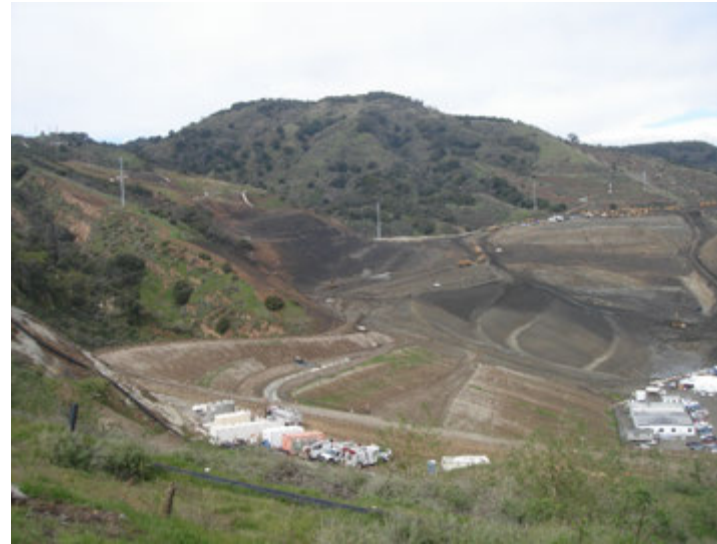
**Photo 385: Main Access Road Slopes Near Terminal Basin:  
February 21, 2019**

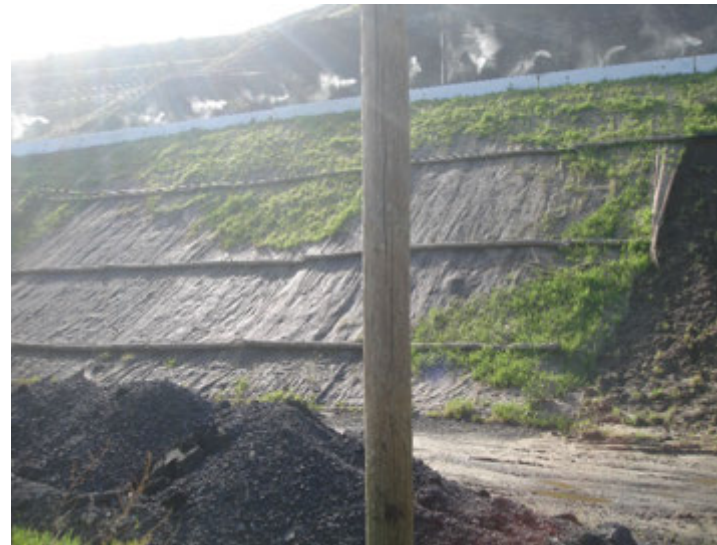
**Photo 393: Main Access Road Slopes Near Terminal Basin: March 5, 2019**

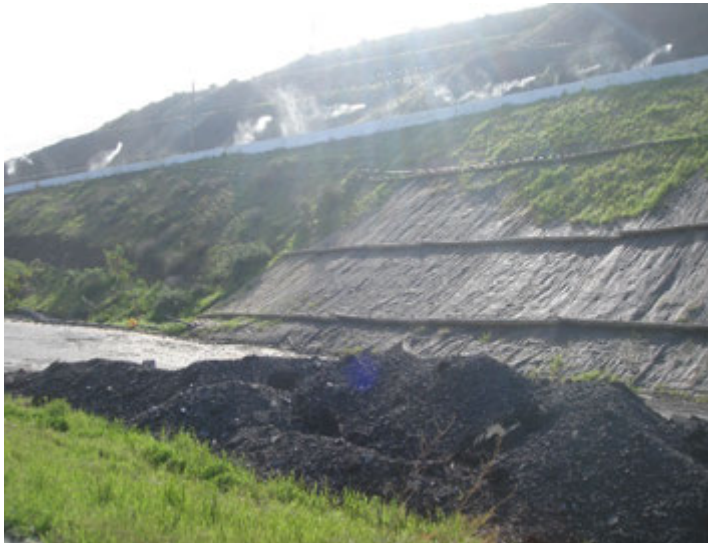
**Photo 394: Main Access Road Slopes Near Terminal Basin: March 5, 2019**

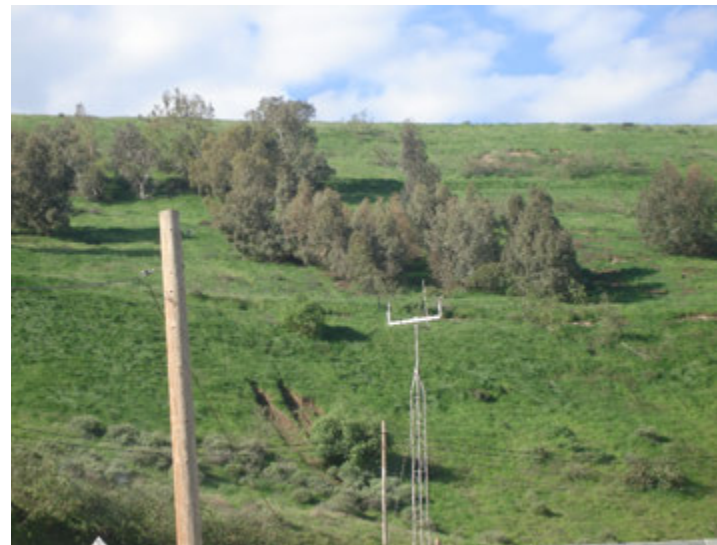
**Photo 395: Main Access Road Slopes Near Terminal Basin: March 5, 2019**

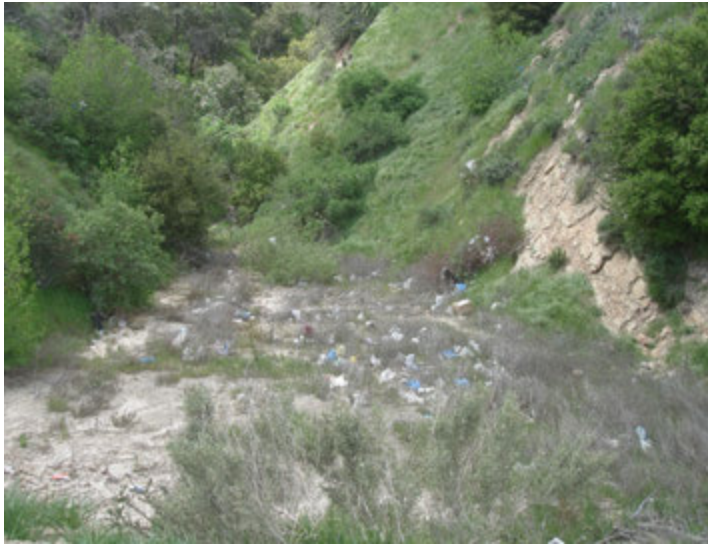
**Photo 412: Windblown Litter in Canyon South of Basin A: March 28, 2019**

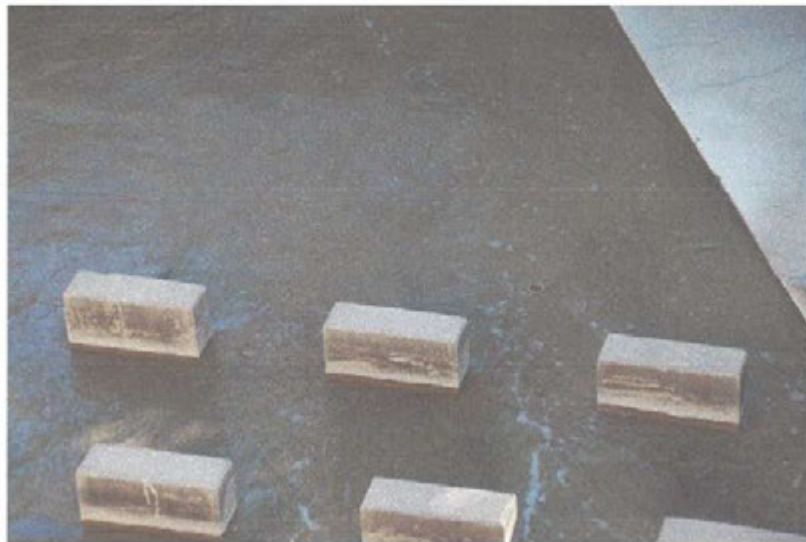
- Refuse has accumulated behind the decant towers (Photo 5)
  - Water was flowing out of the basin (Photo 6)
- Cell CC3 Earthen basin
  - The basin is clean and available for storage

Photo 5: Waste collected behind decant towers at Terminal basin

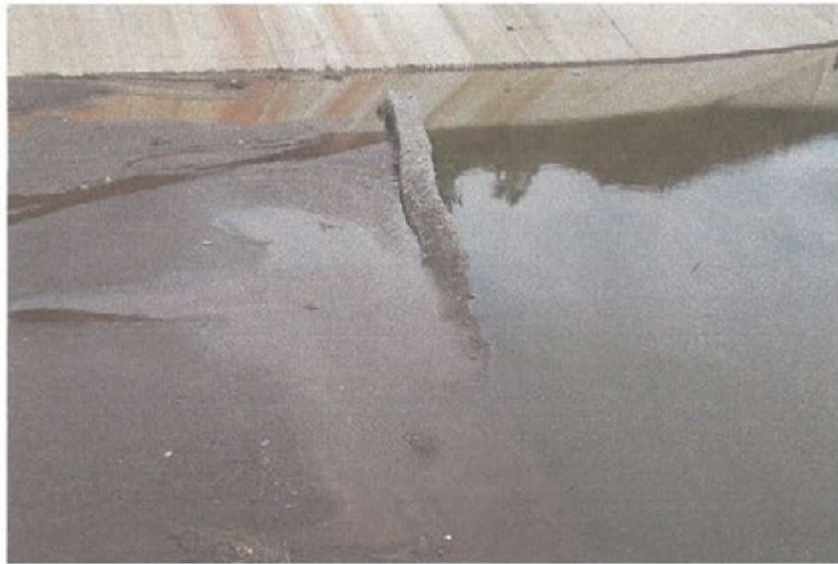
<b>Drainage System</b> <ul style="list-style-type: none"> <li>• Terminal Basin <ul style="list-style-type: none"> <li>– Additional sediments have accumulated upstream of the separator gabion wall and now reach the top tier of the wall on the south side (Photo 3) – But the volume occupied by that sediment should not impact the functionality of the basin.</li> <li>– The three skimmers were raised (Photo 4)</li> <li>– Water was ponding between the gabion wall and has reached the top of the decant towers, water was observed to drain (Photo 5)</li> <li>– Water has seeped through the weep holes at the of the basin wall as indicated by red staining (Photo 6)</li> <li>– Water flowing out of the basin was clean, no waste was observed (Photo 7)</li> </ul> </li> <li>• Cell CC3 Earthen basin <ul style="list-style-type: none"> <li>– The basin is clean and available for storage</li> <li>– Some erosion gullies on downstream side of the earth embankment observed on 22 January 2019 have not worsened and do not pose a stability risk (Photo 8)</li> </ul> </li> </ul>

Photo 3: Sediment level in Terminal Basin

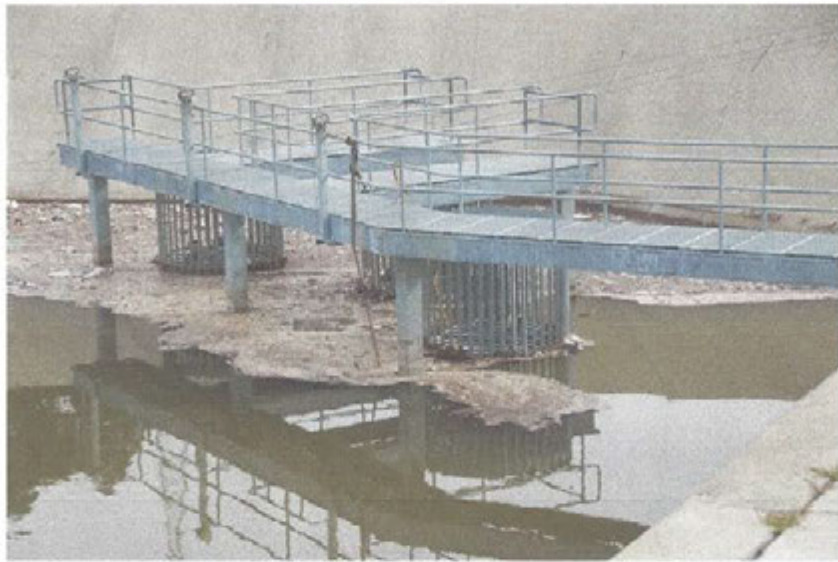
Photo 5: Water level and waste accumulation near decant towers at Terminal basin

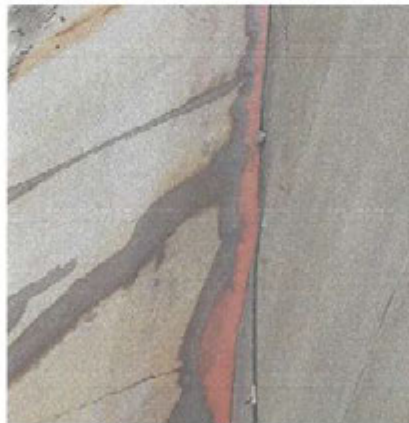
Photo 6: Reddish deposit form water seeping through weep holes at the bottom of the wall

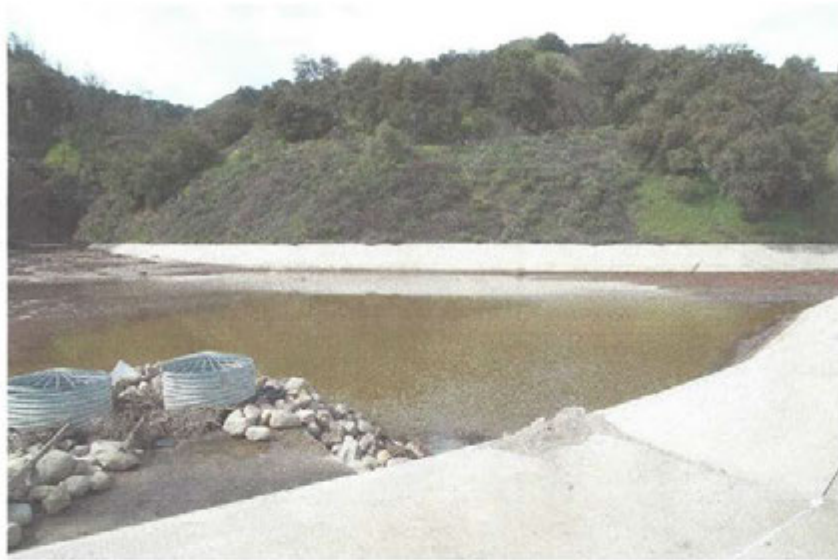
- Basin A
  - Basin held some water (Photo 13) but provide enough capacity for a large storm.
  - Sediments have accumulated at the back, but volume is small enough and should not impact the overall storage capacity of the basin (Photo 13)

Photo 13: Low water volume and limited sediment accumulation in Basin A

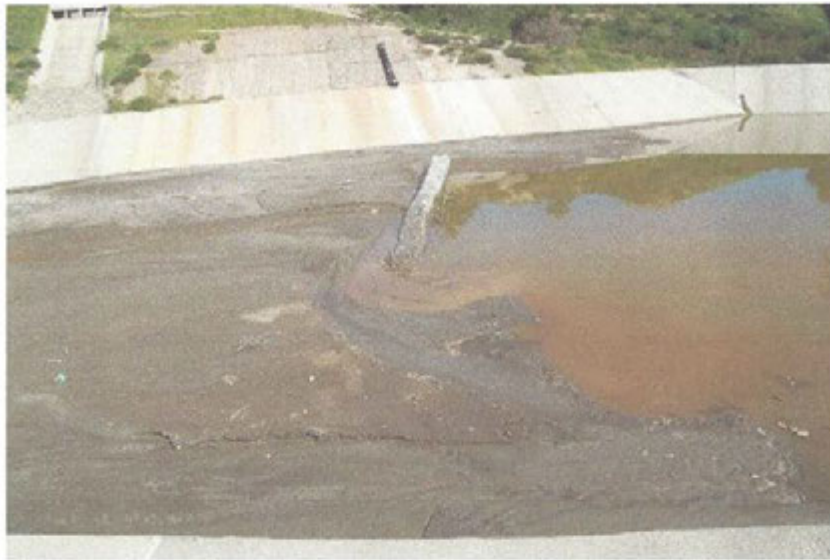
Photo 3: Sediment level in Terminal Basin

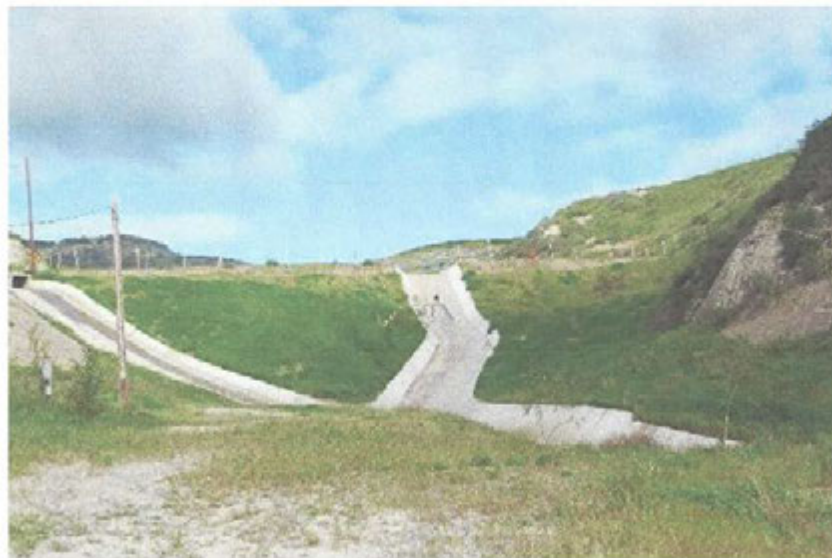
- the erosion gullies on downstream side of the earth embankment observed in previous visits have not worsened and are protected by heavy vegetation and do not pose a stability risk (Photo 8)

Photo 8: Vegetation covering erosion gullies on slope of embankment for earthen basin CC3

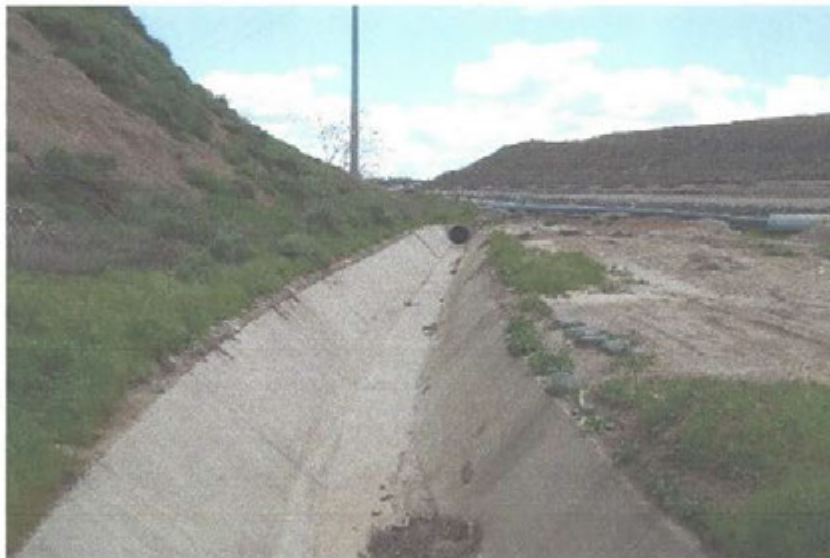
- Segment between power pole access road to Flare Outlet: rumpled geomembrane observed during previous visit has been removed providing full flow capacity in channel (Photo 14)

Photo 14: Cleaned up channel between power pole and access road to Flares 9-11

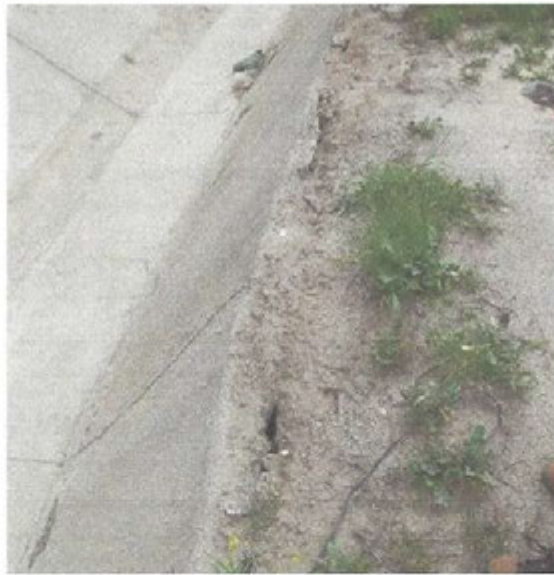
Phot 15: erosion along the edge of concrete channel between power pole and access road to Flares 9-11

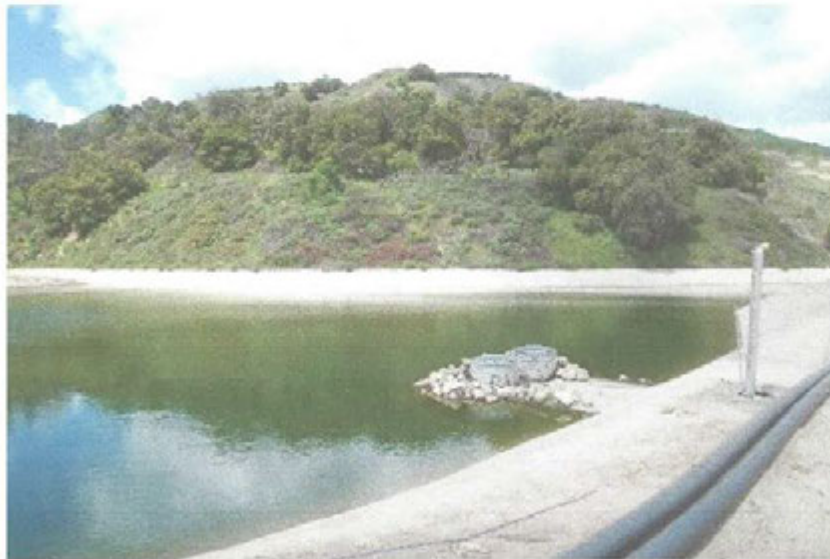
- Basin A
  - Basin held water (Photo 16) but active management approach agreed upon should permit to act in case of a large storm forecast. Due to the excavation for cell CC4 Phase 4, the channel out of Basin A was removed but a new channel will be rebuilt when earthwork is completed. It is our understanding from Republic staff, that when a storm occurs the contractor (Sukut) is responsible for managing the stormwater and whatever resulting erosion. As for previous storms the water would be directed toward a retention basin at the toe of the buttress and pumped out into the main concrete channel connected to the terminal basin.

Photo 16: High water level in Basin A

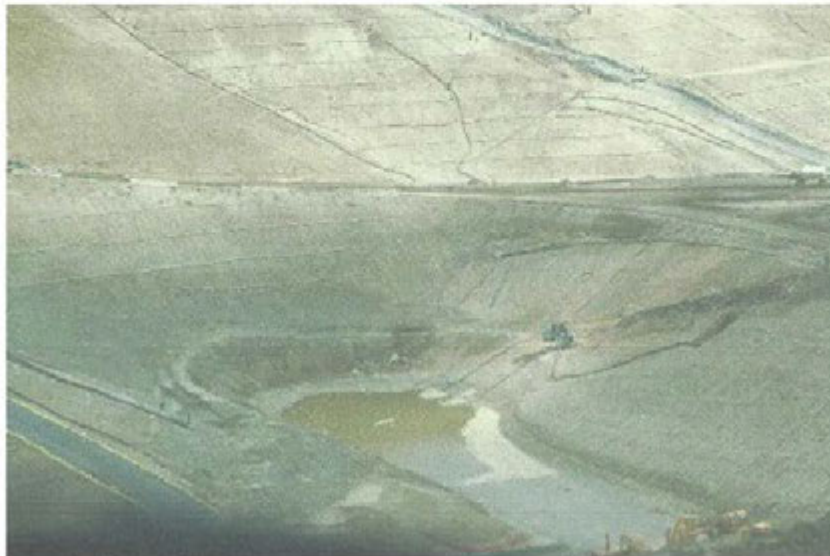
- Moat around Cell CC3 Part 2
  - No water in the moat but a fair amount of sediment. However, the maximum elevation of the water would still be under the elevation of the bottom of the waste in Cell CC4 Phase 3 therefore there is no issue (Photo 18)

Photo 18: Nearly empty moat around Cell CC4 Phase 3

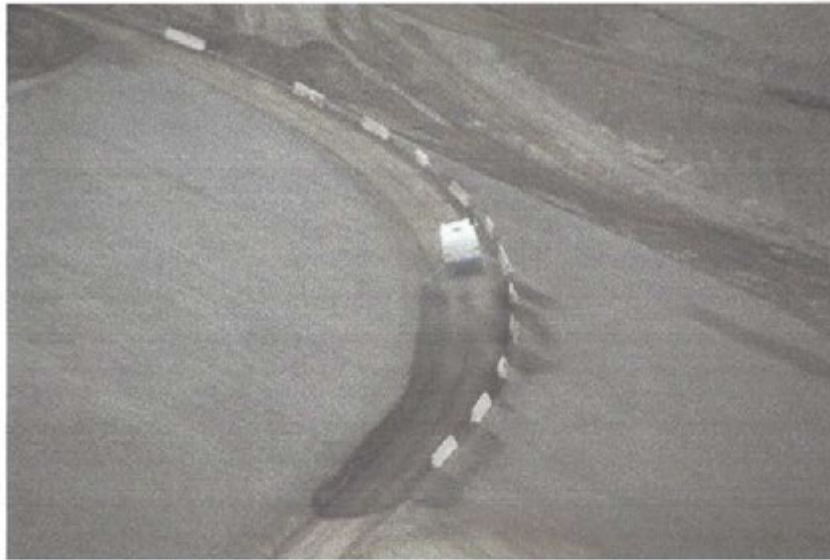
- Fill placement work was ongoing at time of our inspection
- Compaction was monitored by a technician
- Moisture condition and watering of the access roads was on-going throughout the duration of our visit (Photo 19)

Figure 19: Moisture conditioning on roads
