**Sunshine Canyon Landfill
Independent Monitor
Quarterly Site Monitoring Status Report
October 1, 2018 – December 31, 2018**

January 9, 2019

The attached Quarterly Site Monitoring Status Report for the Sunshine Canyon Landfill dated January 9, 2019 is the Fourth Quarterly Report for 2018, issued by UltraSystems. This report covers the monitoring period from October 1, 2018 through December 31, 2018 and is prepared for the City of Los Angeles Department of City Planning and the County of Los Angeles Department of Regional Planning.

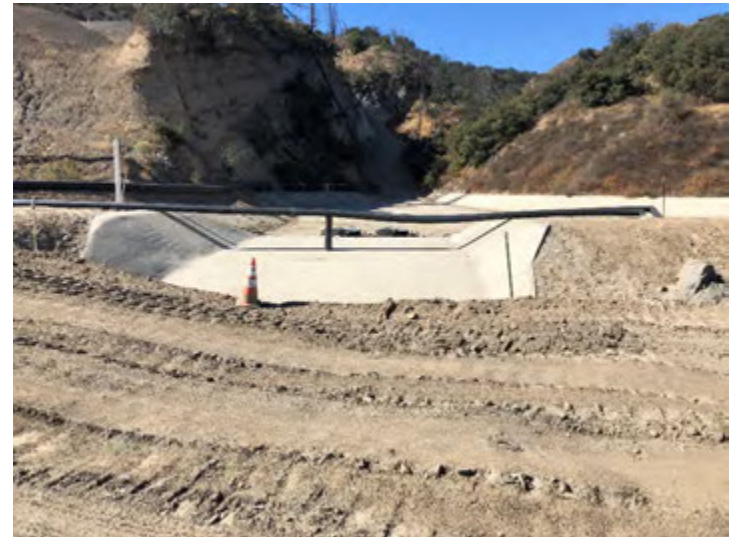
Photo 4: Basin A High Flow Outlet: October 23, 2018

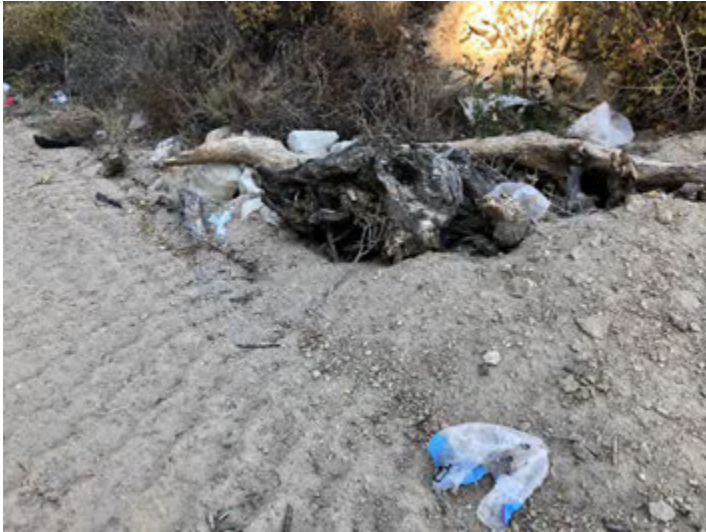
Photo 5: Basin A Hillside Litter: October 23, 2018

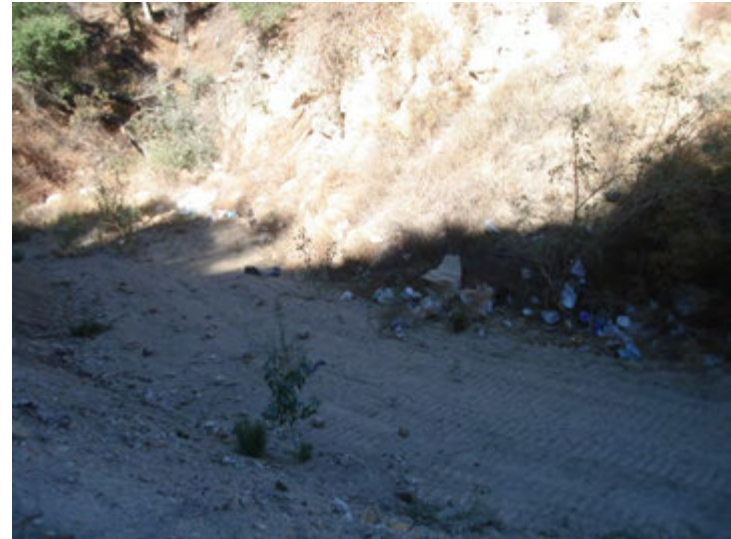
Photo 6: Basin A Hillside Litter: October 23, 2018

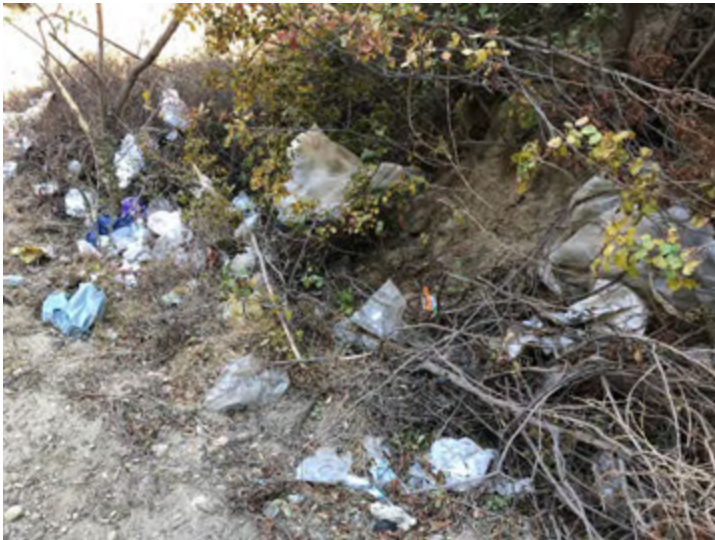
Photo 7: Basin A Hillside Litter: October 23, 2018

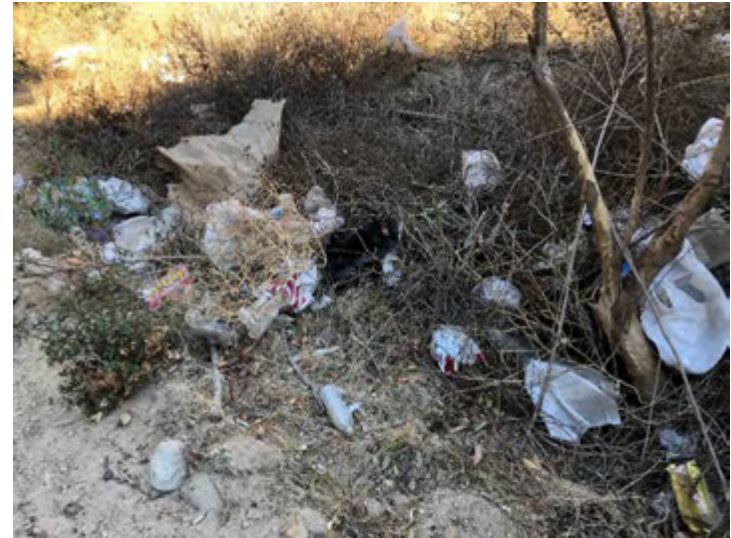
Photo 8: Basin A Hillside Litter: October 23, 2018

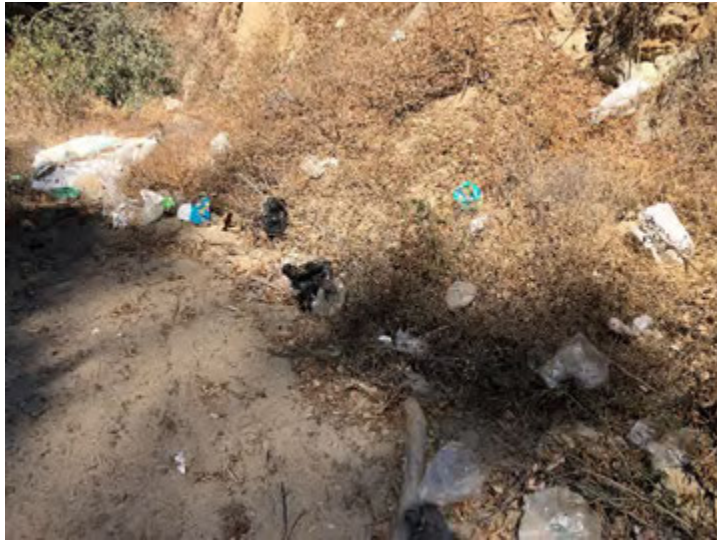
Photo 9: Basin A Hillside Litter: October 23, 2018

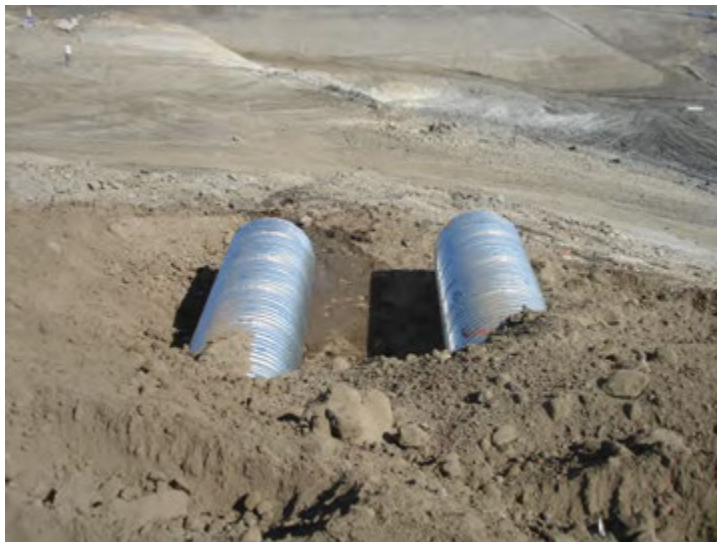
Photo 15: Basin A Temporary Outlet Pipes: November 6, 2018

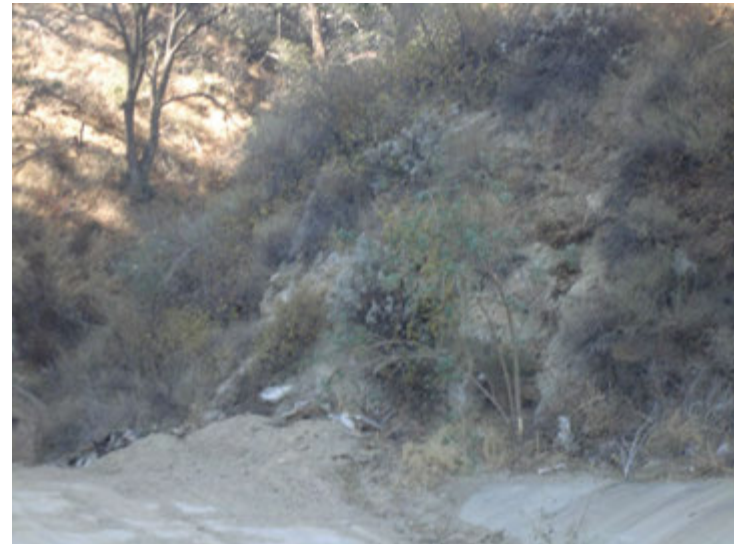
Photo 20: Basin A Native Hillside Windblown Litter: November 20, 2018

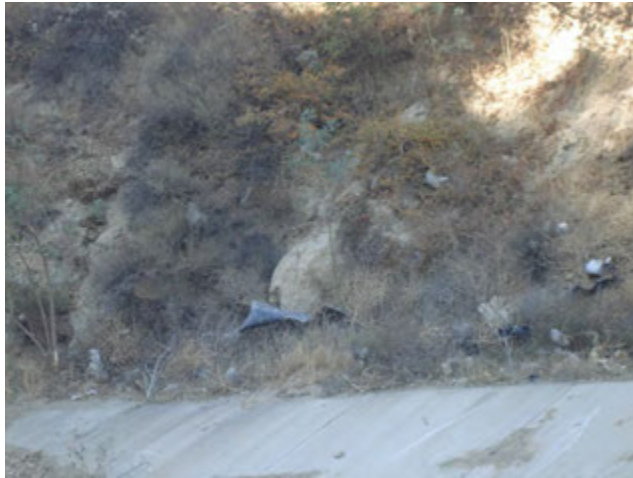
Photo 21: Basin A Native Hillside Windblown Litter: November 20, 2018

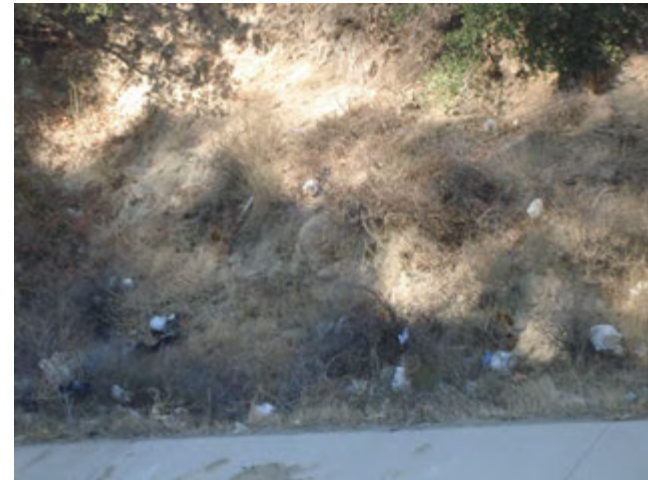
Photo 22: Basin A Native Hillside Windblown Litter: November 20, 2018

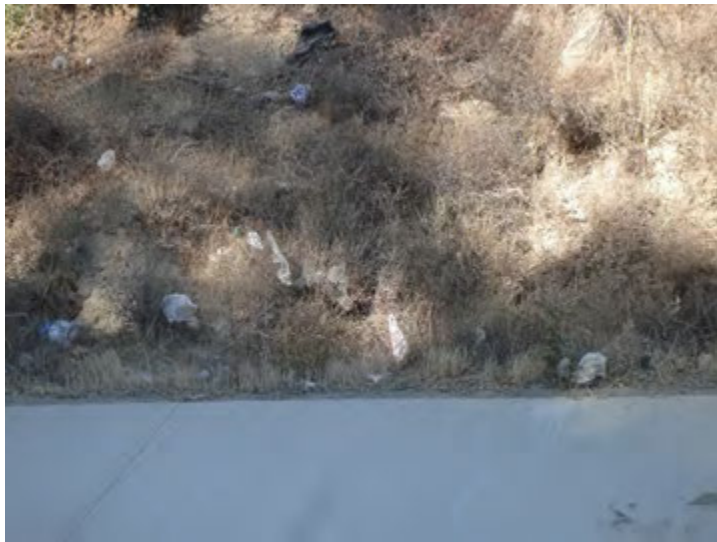
Photo 23: Basin A Native Hillside Windblown Litter: November 20, 2018

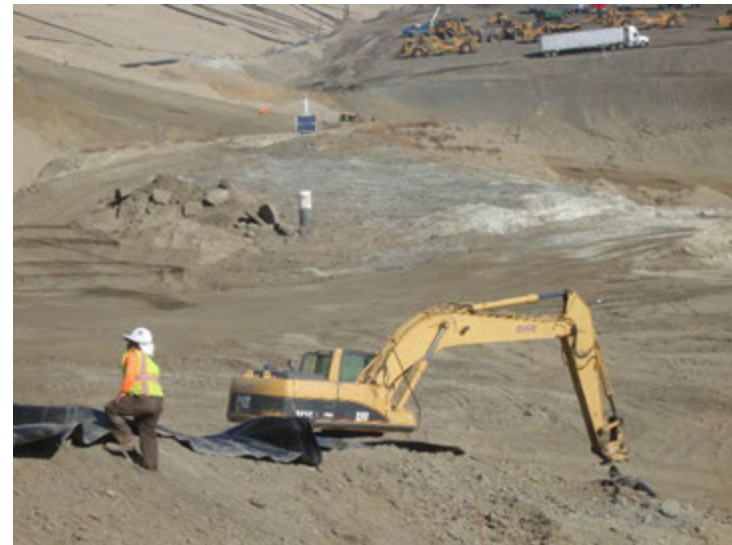
Photo 24: Basin A Temporary Outlet HDPE Channel: November 20, 2018

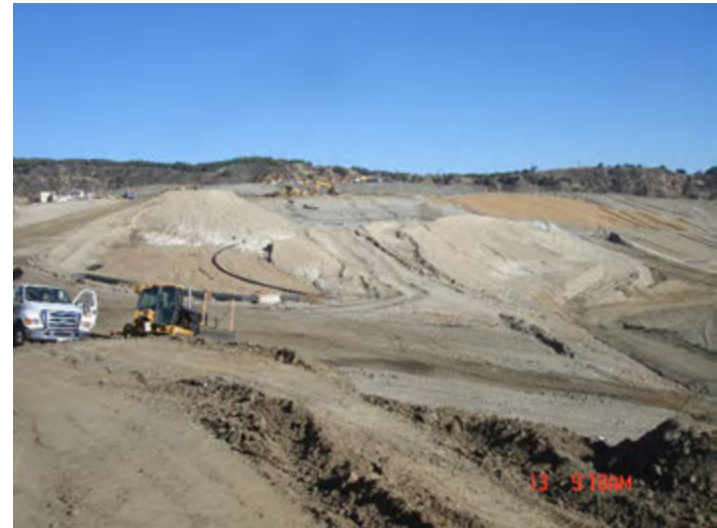
**Photo 71: County Soil Stockpile Erosion Near CC-4 Parts 1&2:
December 13, 2018**

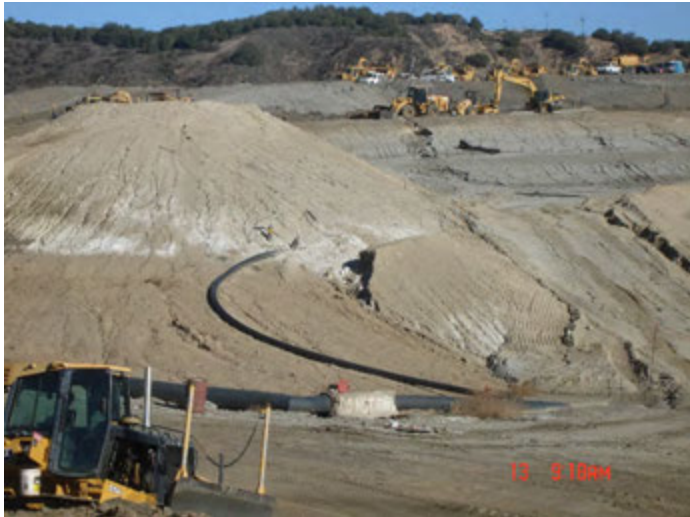
**Photo 72: County Soil Stockpile Erosion Near CC-4 Parts 1&2:
December 13, 2018**

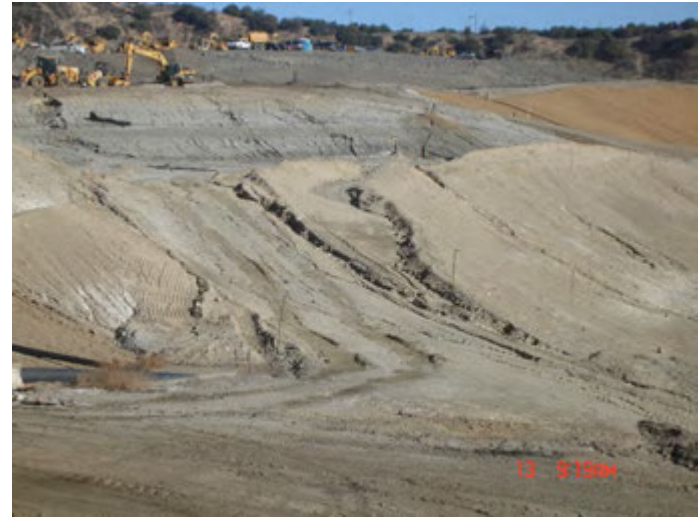
**Photo 73: County Soil Stockpile Erosion Near CC-4 Parts 1&2:
December 13, 2018**

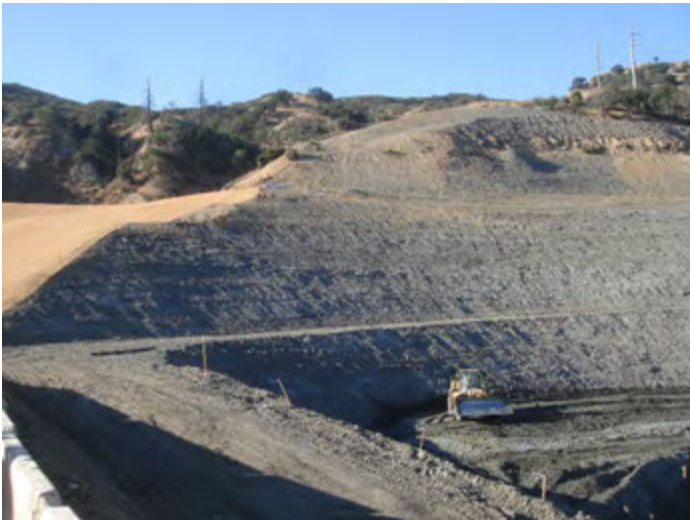
**Photo 74: County Soil Stockpile Erosion Near CC-4 Parts 1&2:
December 13, 2018**

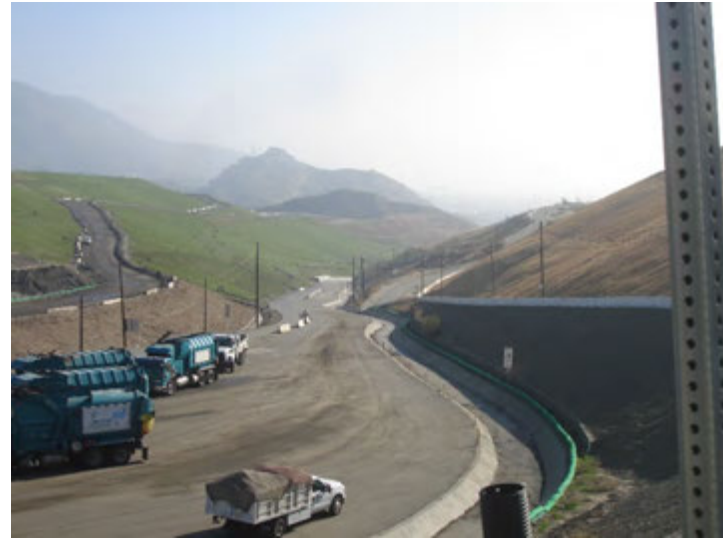
Photo 157: Posi-Shell and Closure Turf: November 6, 2018

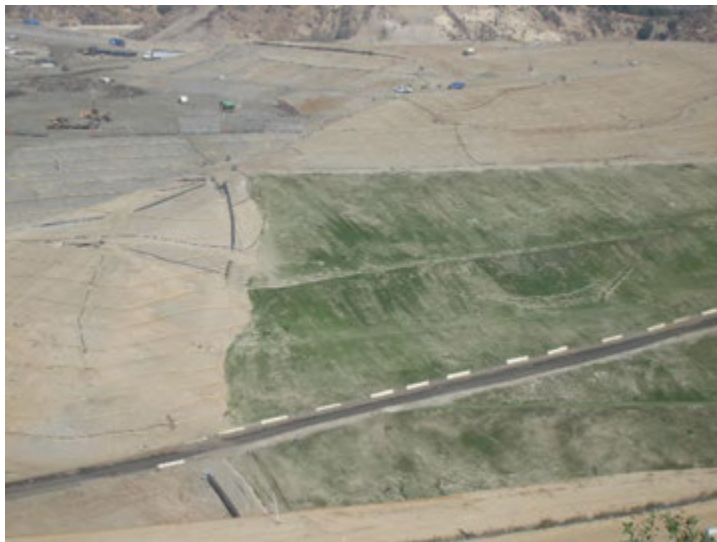
Photo 158: Posi-Shell and Closure Turf: November 6, 2018

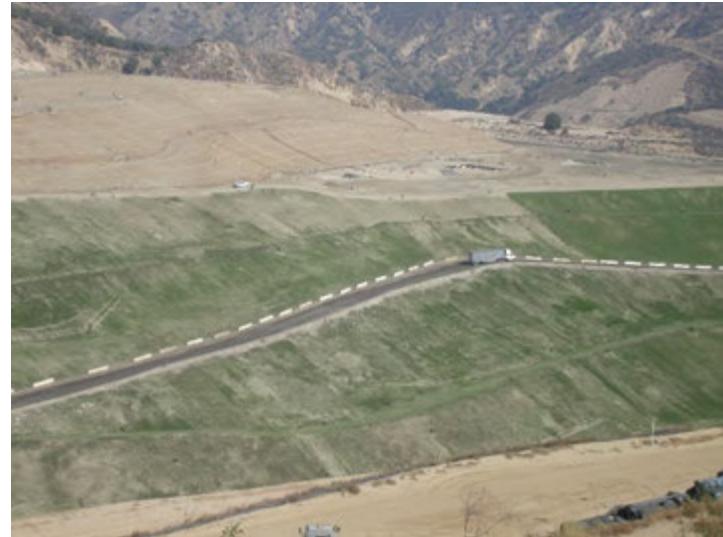
Photo 159: Posi-Shell and Closure Turf: November 6, 2018

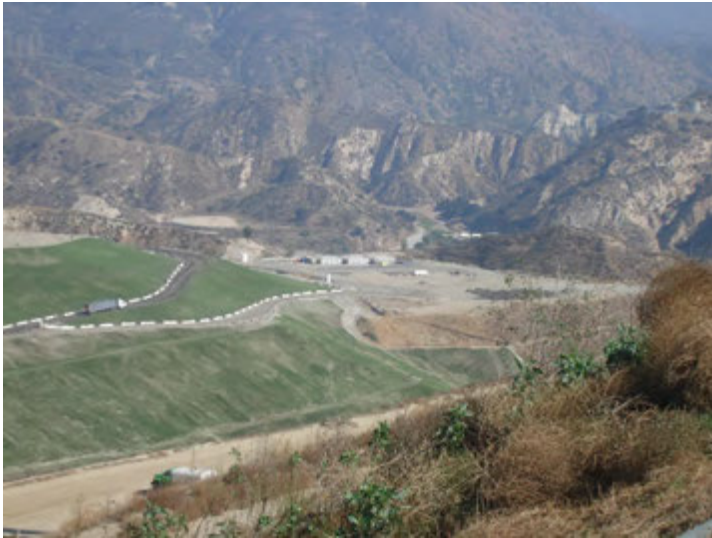
Photo 160: Posi-Shell and Closure Turf: November 6, 2018

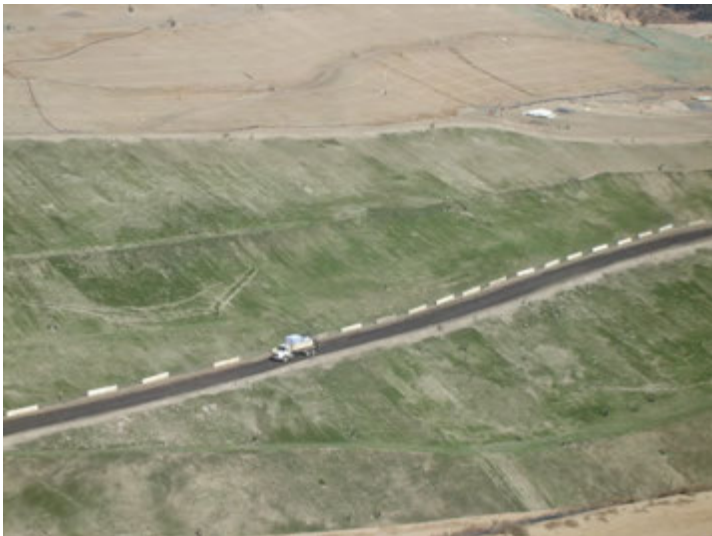
Photo 162: Posi-Shell and Closure Turf: November 20, 2018

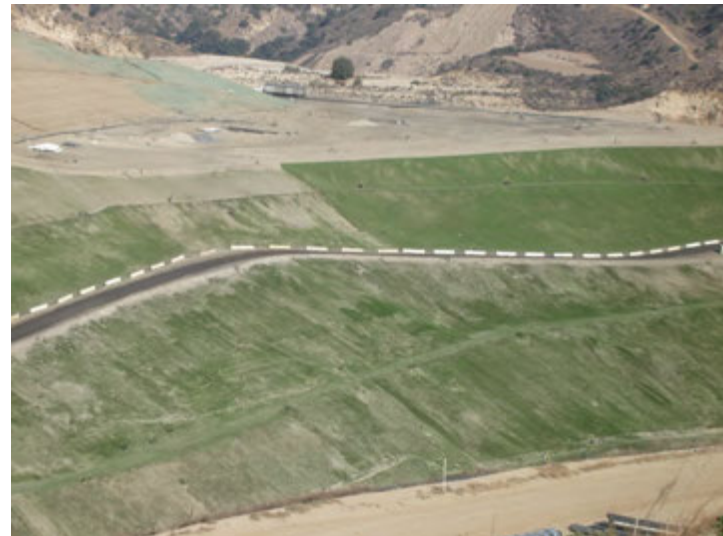
Photo 163: Posi-Shell and Closure Turf: November 20, 2018

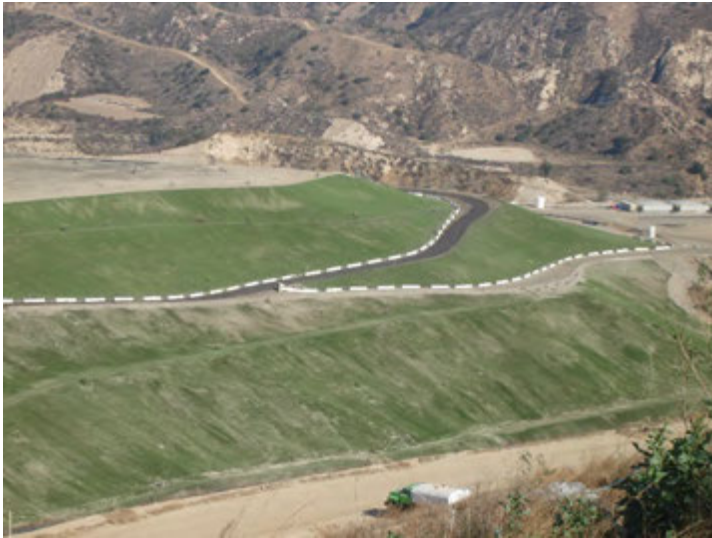
Photo 164: Posi-Shell and Closure Turf: November 20, 2018

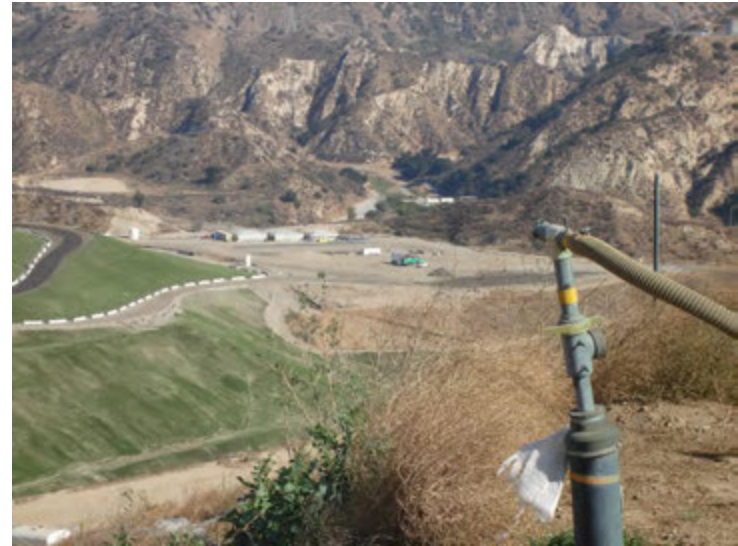
Photo 165: Posi-Shell and Closure Turf: November 20, 2018

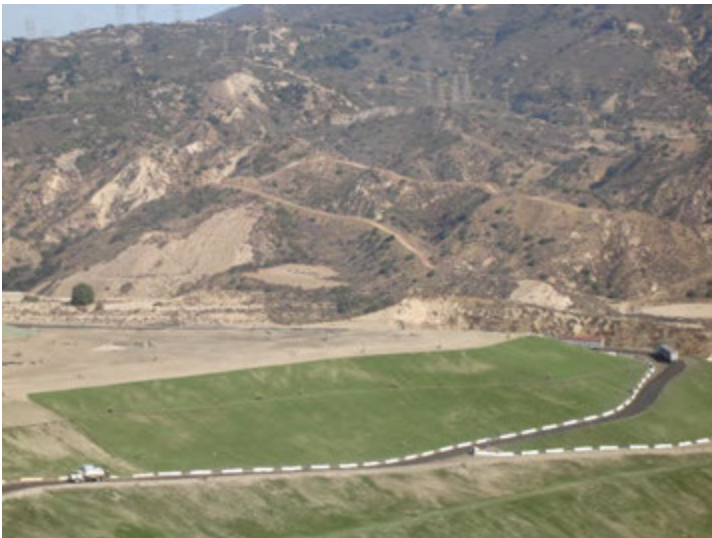
Photo 166: Posi-Shell and Closure Turf: November 20, 2018

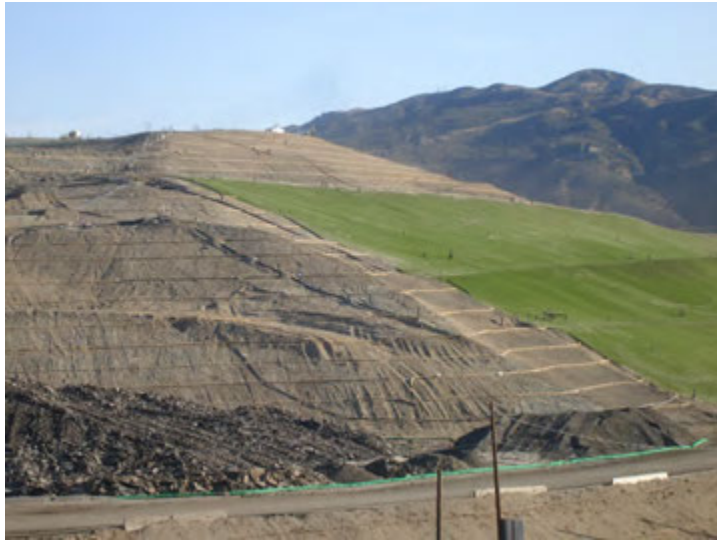
Photo 168: Posi-Shell and Closure Turf: November 20, 2018

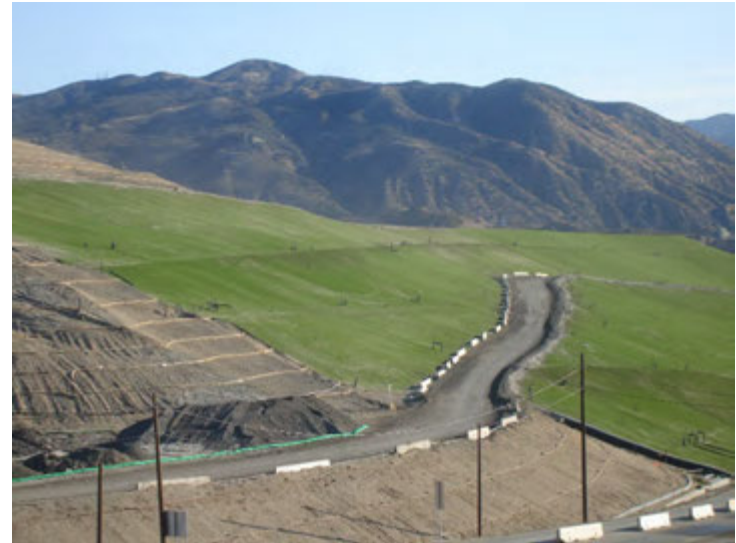
Photo 169: Posi-Shell and Closure Turf: November 20, 2018

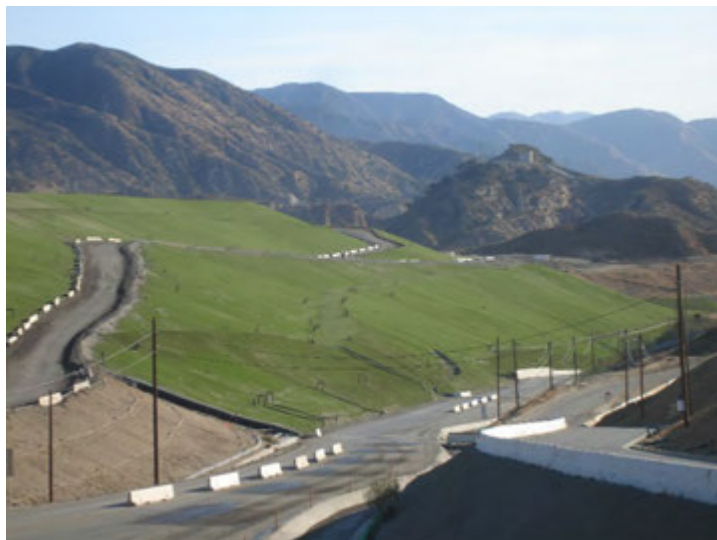
Photo 170: Posi-Shell and Closure Turf: November 20, 2018

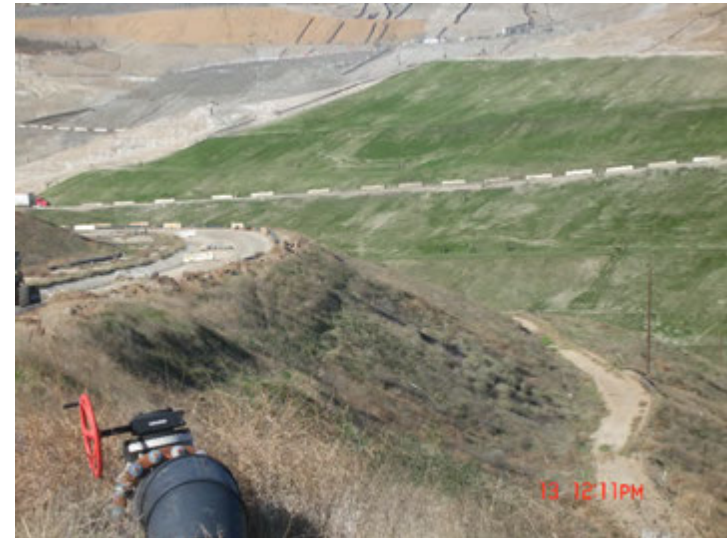
Photo 171: Posi-Shell and Closure Turf: November 20, 2018

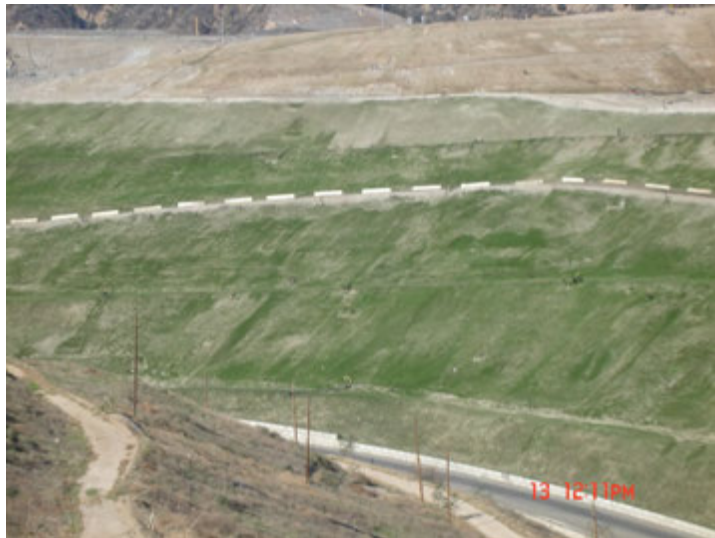
Photo 172: Posi-Shell and Closure Turf: December 13, 2018

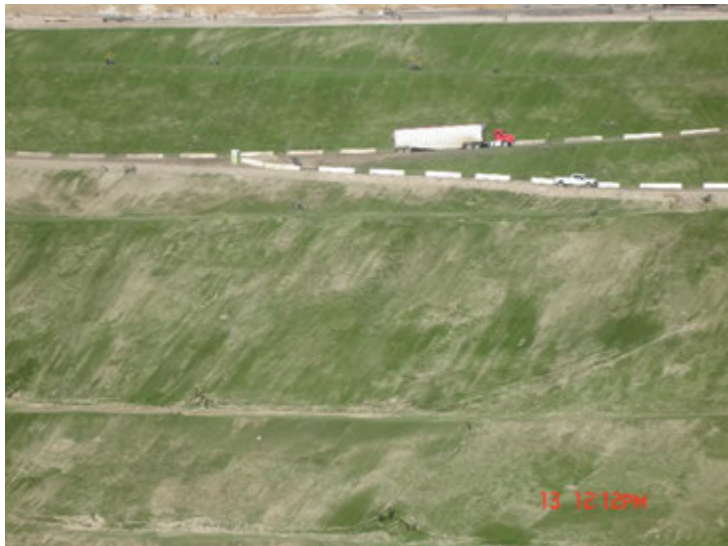
Photo 173: Posi-Shell and Closure Turf: December 13, 2018

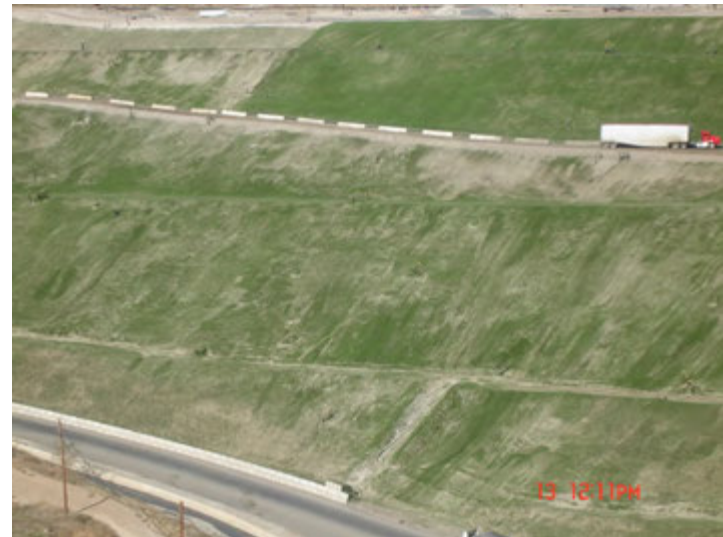
Photo 175: Posi-Shell and Closure Turf: December 13, 2018

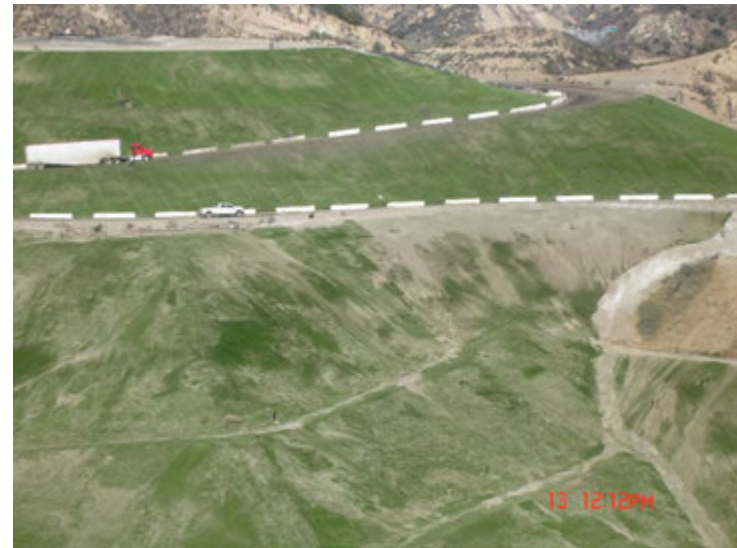
Photo 174: Posi-Shell and Closure Turf: December 13, 2018

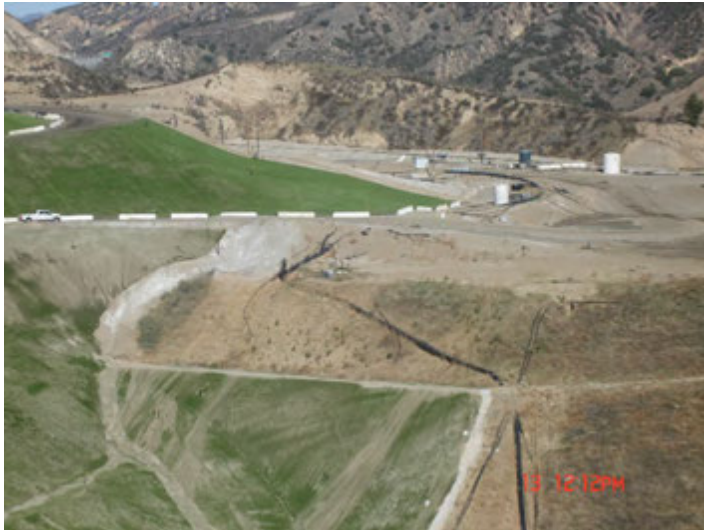
Photo 176: Posi-Shell and Closure Turf: December 13, 2018

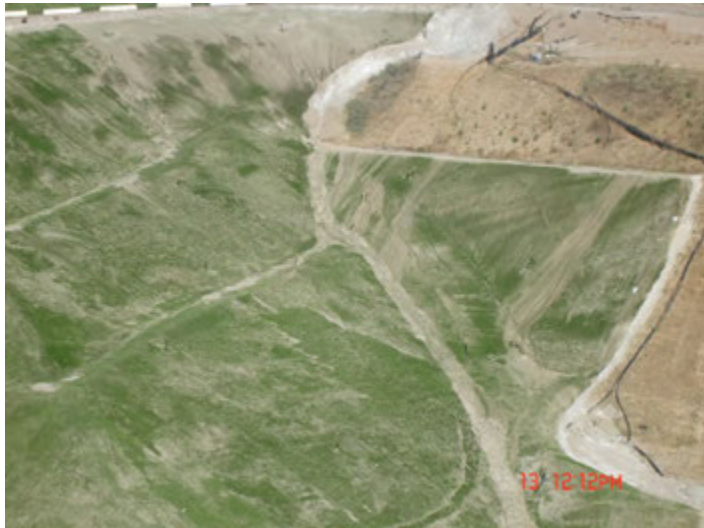
Photo 177: Posi-Shell and Closure Turf: December 13, 2018

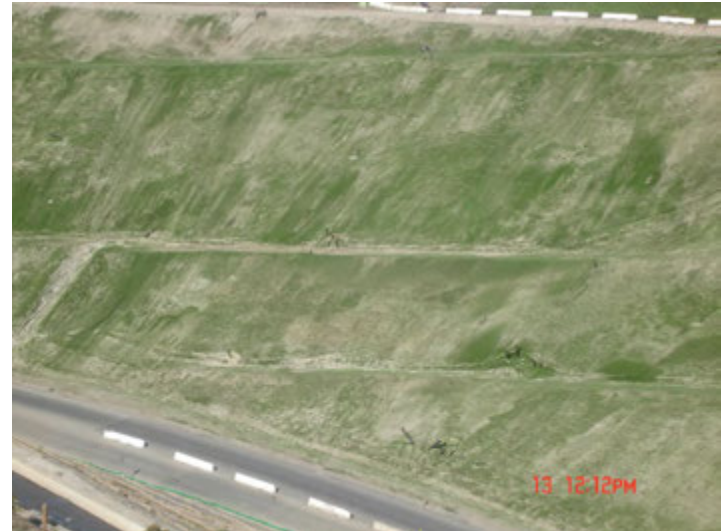
Photo 179: Posi-Shell and Closure Turf: December 13, 2018

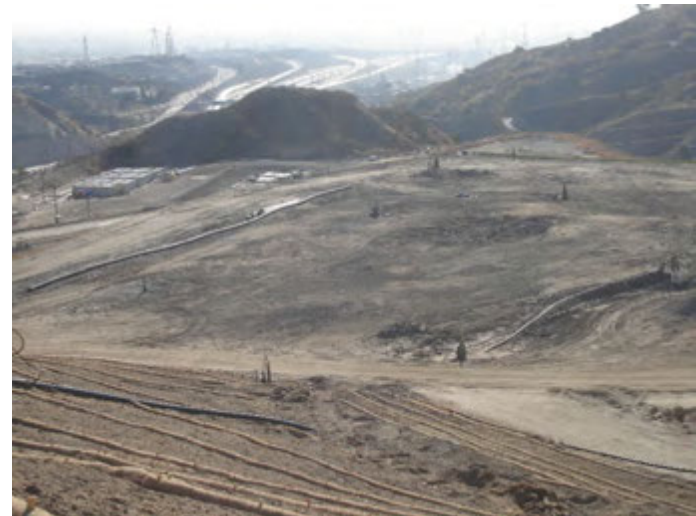
Photo 178: Posi-Shell and Closure Turf: December 13, 2018

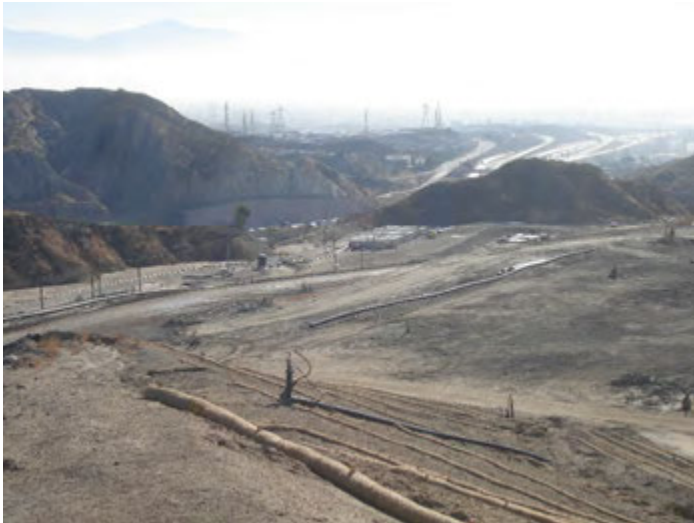
**Photo 180: Old City North Top Deck Liquids Handling Facility:
October 23, 2018**

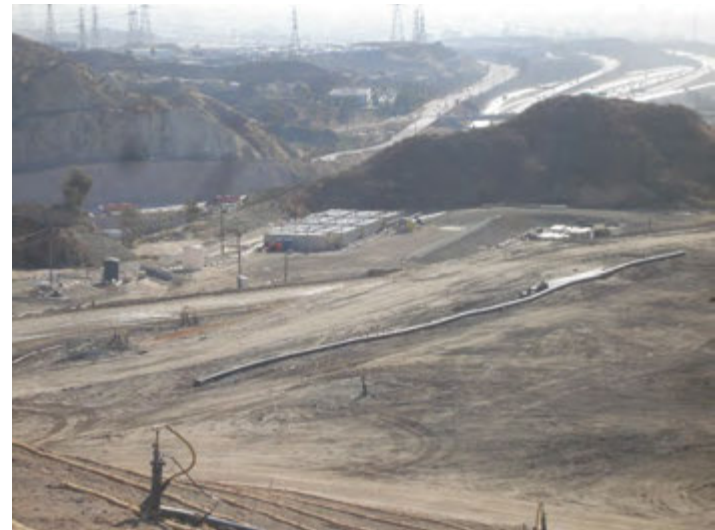
**Photo 181: Old City North Top Deck Liquids Handling Facility:
October 23, 2018**

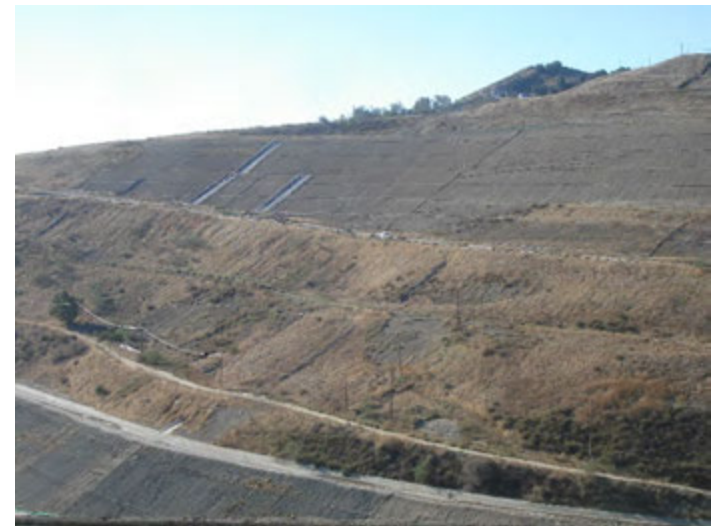
Photo 183: Old City South Slopes: October 23, 2018

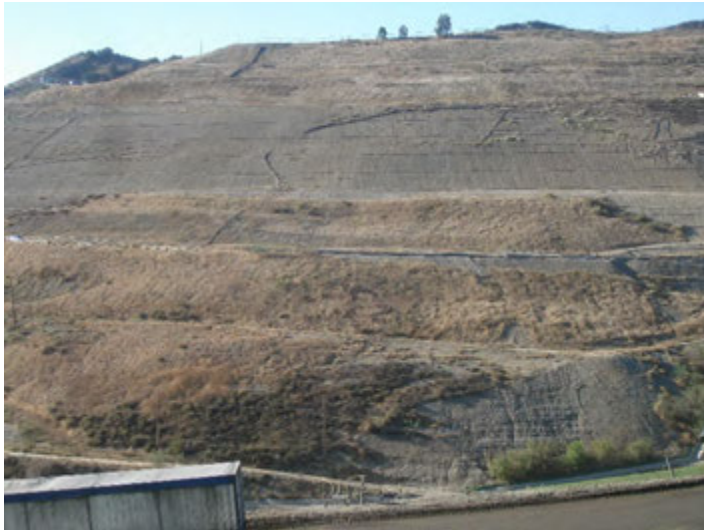
Photo 184: Old City South Slopes: October 23, 2018

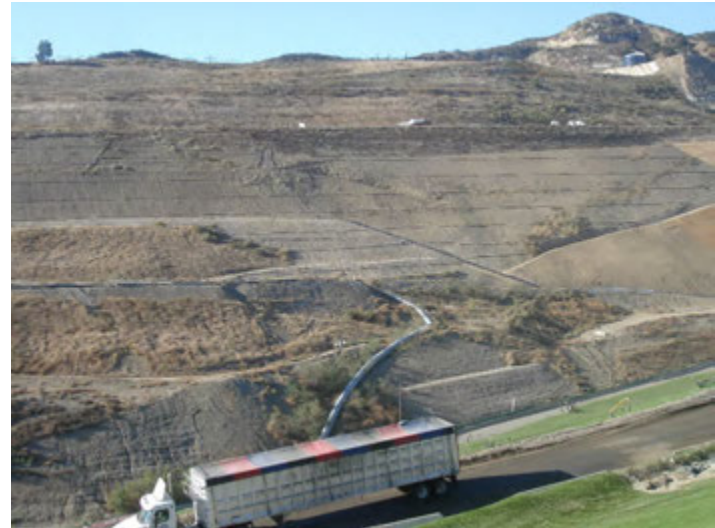
Photo 185: Old City South Slopes: October 23, 2018

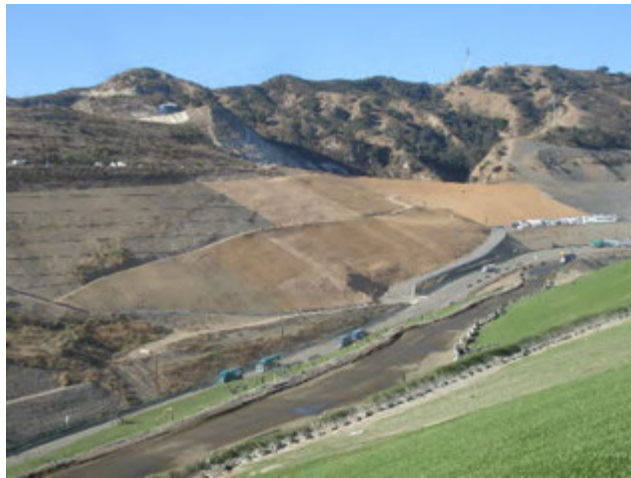
Photo 186: Old City South Slopes: October 23, 2018

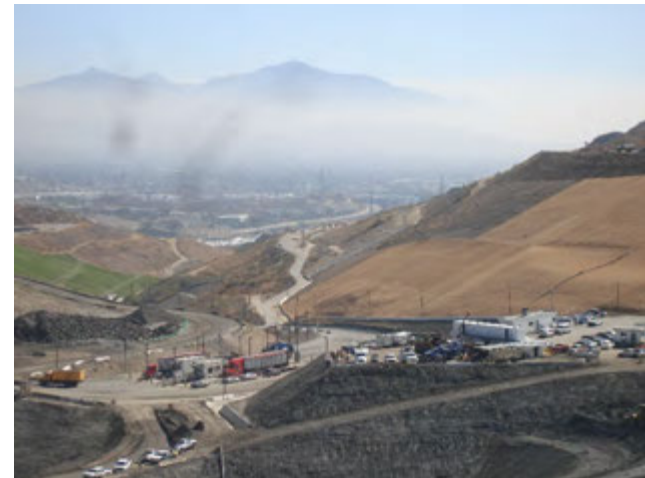
Photo 187: Old City South Slopes: October 23, 2018

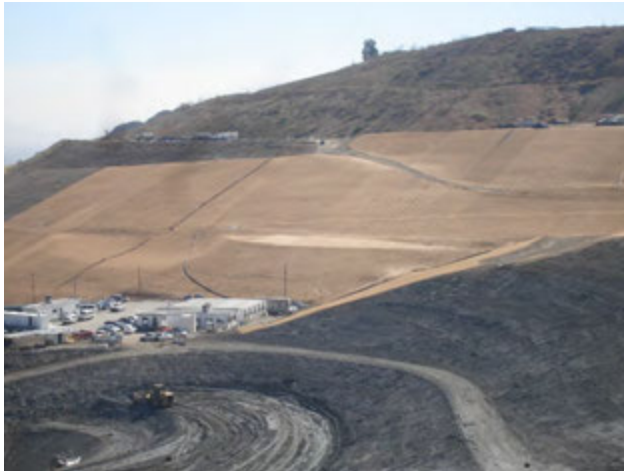
Photo 188: Old City South Slopes: October 23, 2018

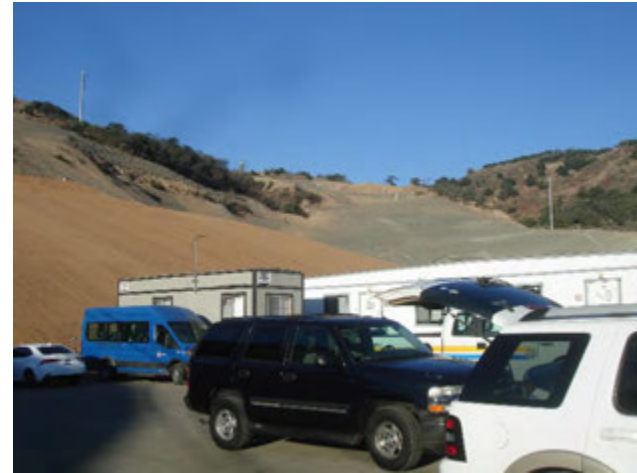
Photo 189: Old City South Slopes: October 23, 2018

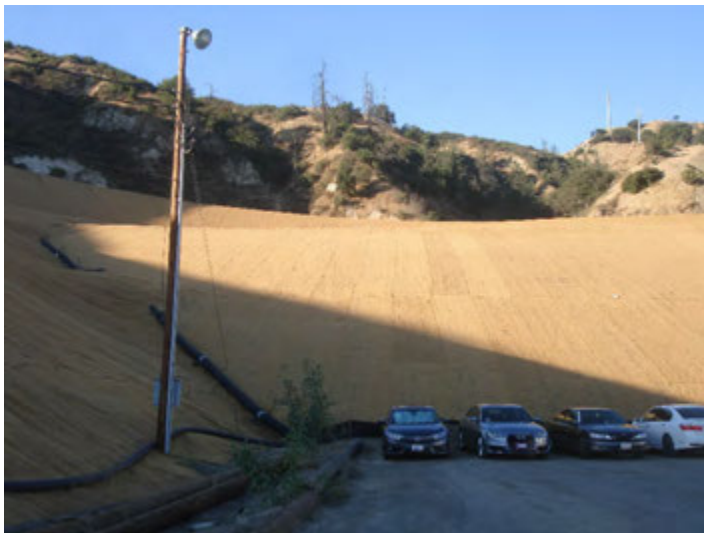
Photo 190: Old City South Slopes: October 23, 2018

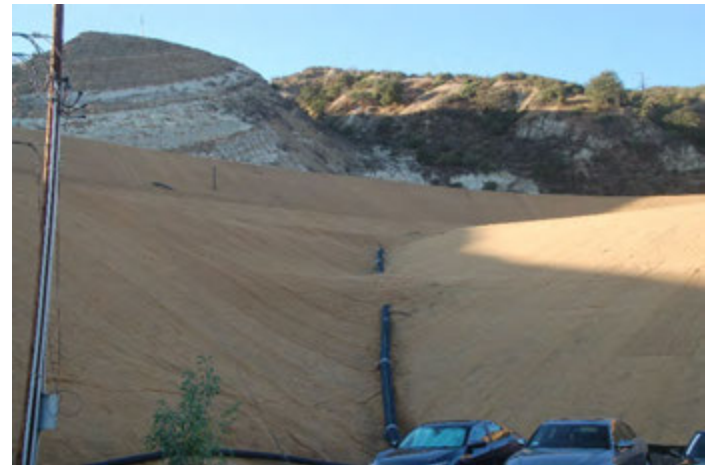
Photo 191: Old City South Slopes: October 23, 2018

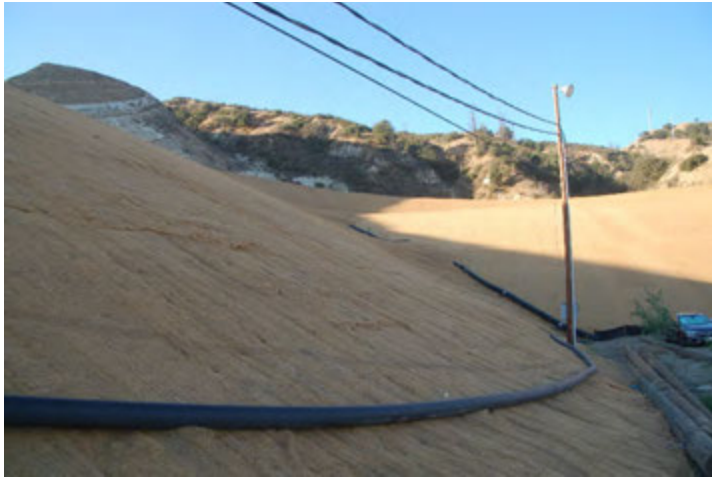
Photo 192: Old City South Slopes: October 23, 2018

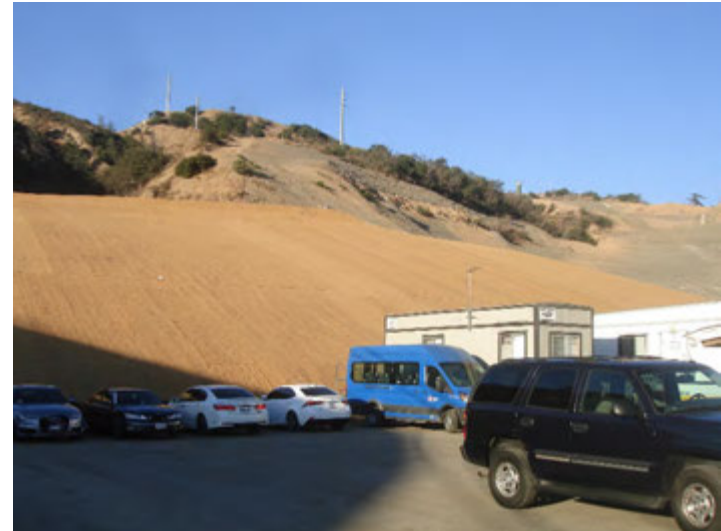
Photo 193: Old City South Slopes: October 23, 2018

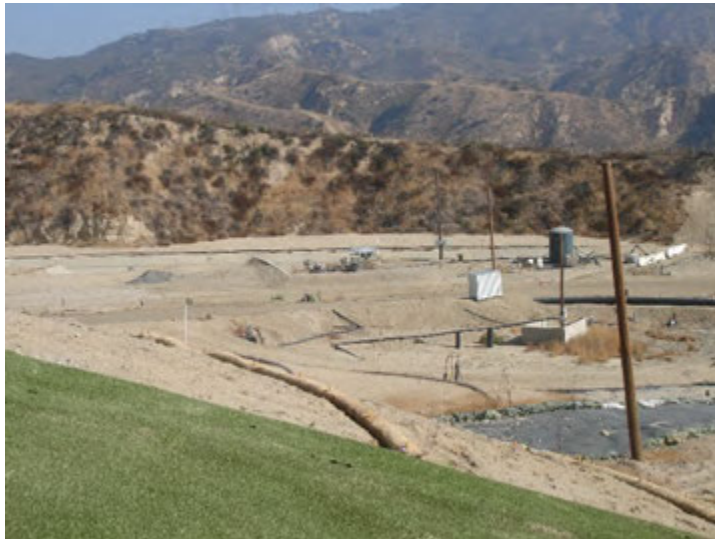
Photo 194: Old City South Slopes: October 23, 2018

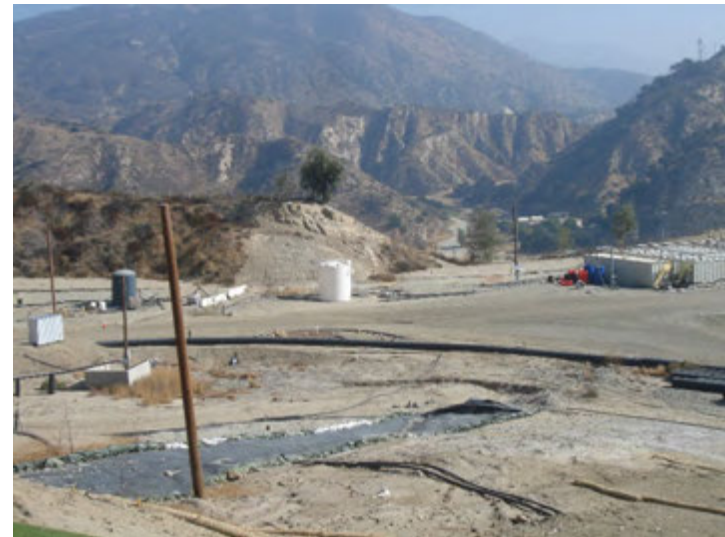
**Photo 195: Old City North Top Deck Liquids Handling Facility:
November 6, 2018**

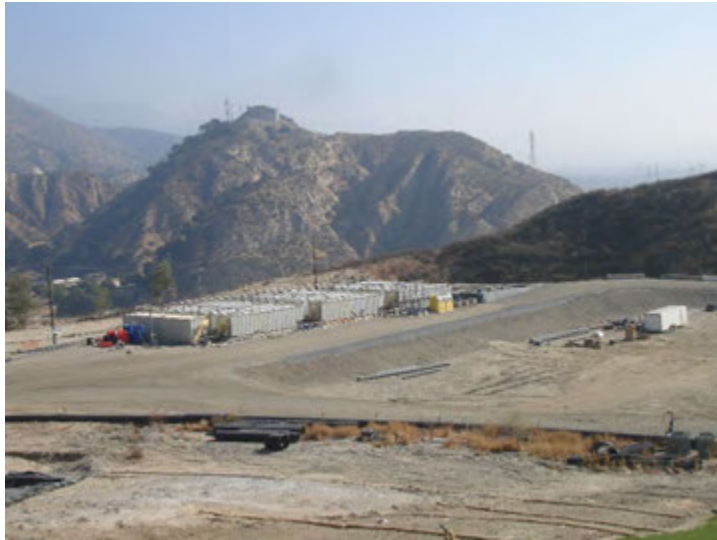
**Photo 196: Old City North Top Deck Liquids Handling Facility:
November 6, 2018**

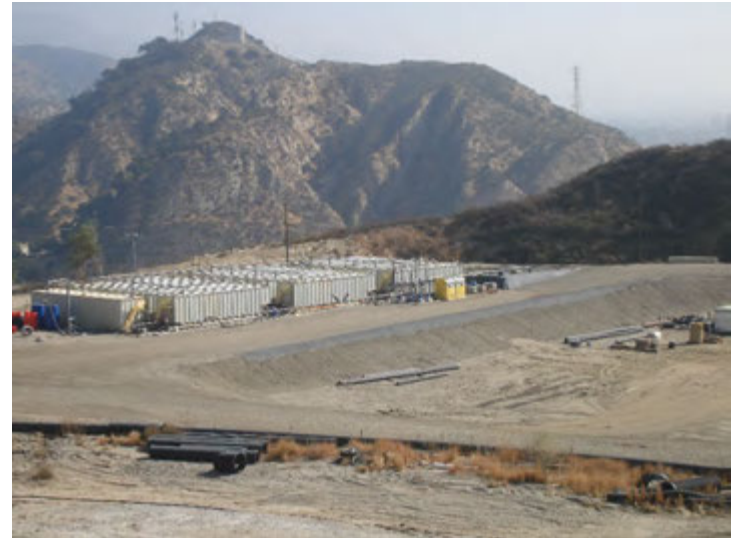
**Photo 197: Old City North Top Deck Liquids Handling Facility:
November 6, 2018**

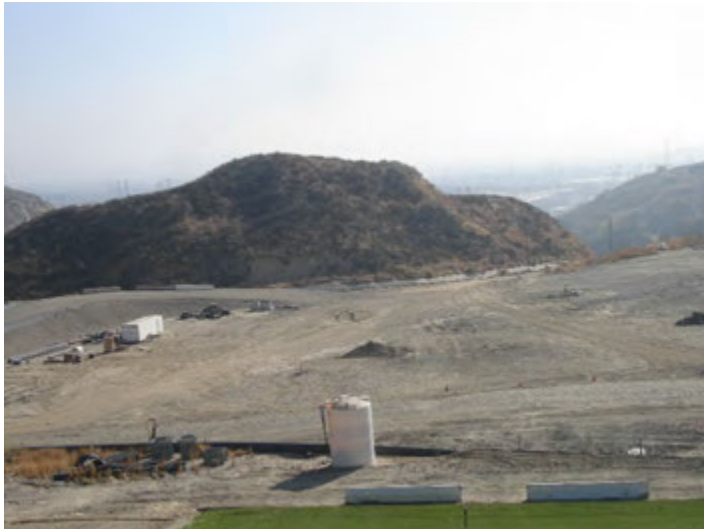
**Photo 198: Old City North Top Deck Liquids Handling Facility:
November 6, 2018**

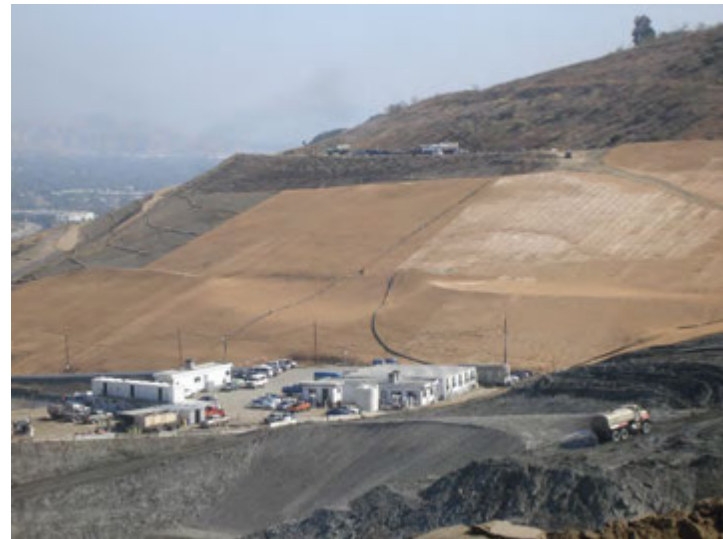
Photo 211: Old City South Soil Stockpile Slump: November 6, 2018

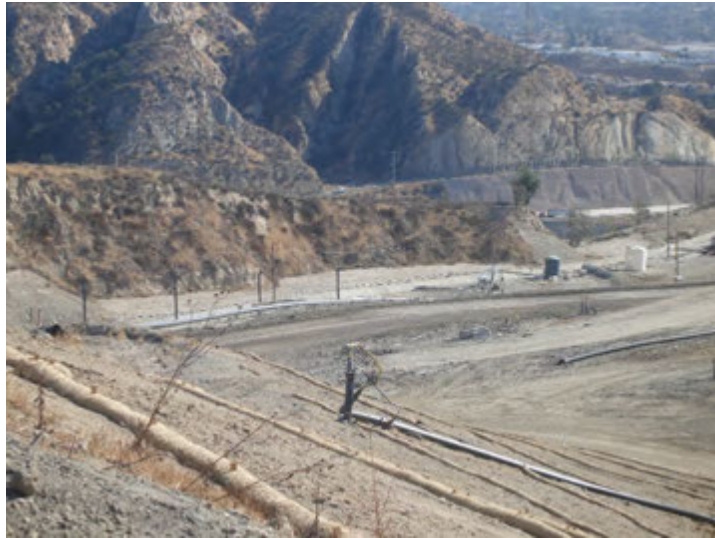
Photo 212: Old City South Soil Stockpile Slump: November 6, 2018

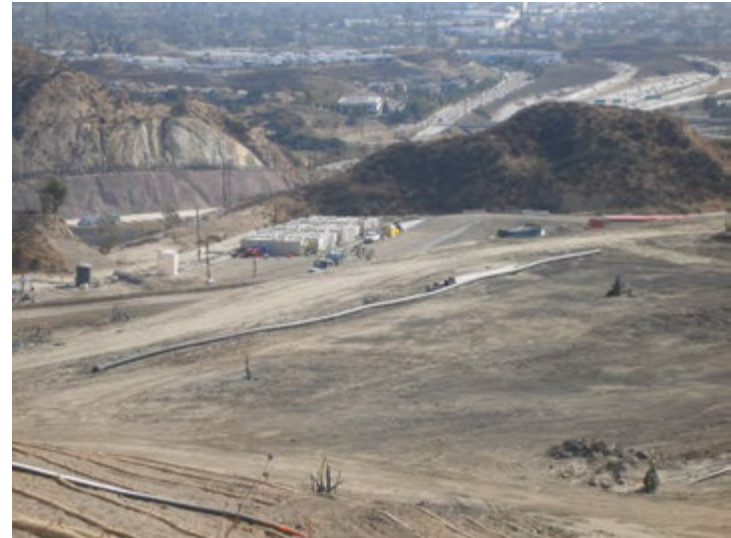
**Photo 213: Old City North Top Deck Liquids Handling Facility:
November 20, 2018**

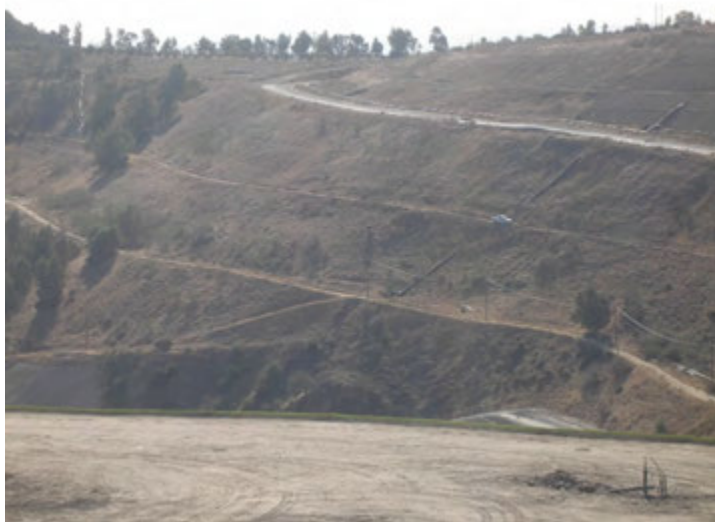
**Photo 214: Old City North Top Deck Liquids Handling Facility:
November 20, 2018**
