**Sunshine Canyon Landfill
Independent Monitor
Quarterly Site Monitoring Status Report
October 1, 2018 – December 31, 2018**

January 9, 2019

The attached Quarterly Site Monitoring Status Report for the Sunshine Canyon Landfill dated January 9, 2019 is the Fourth Quarterly Report for 2018, issued by UltraSystems. This report covers the monitoring period from October 1, 2018 through December 31, 2018 and is prepared for the City of Los Angeles Department of City Planning and the County of Los Angeles Department of Regional Planning.

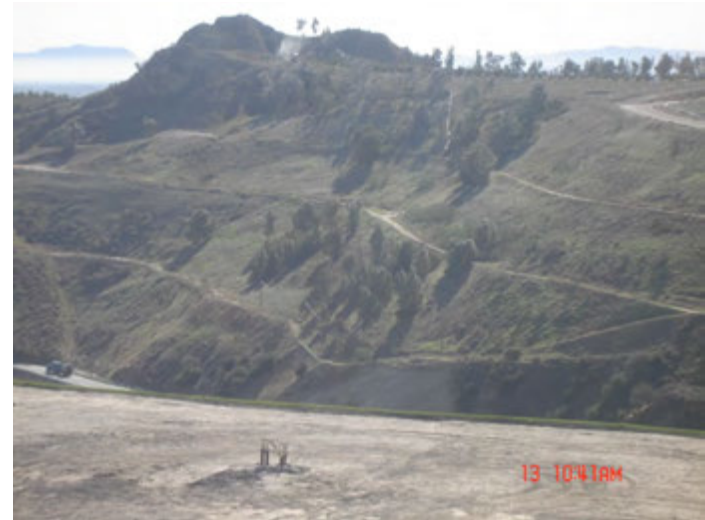
**Photo 225: Old City North Top Deck Liquids Handling Facility:
December 13, 2018**

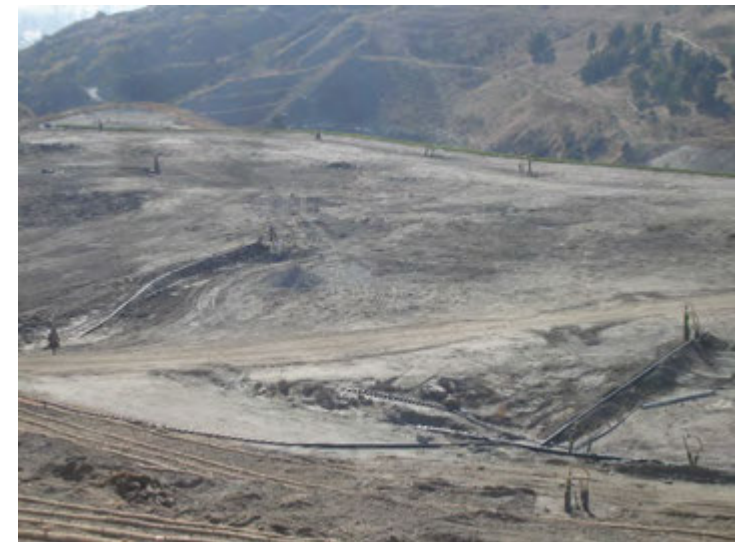
Photo 231: Old City South Soil Stockpile Slump: December 13, 2018

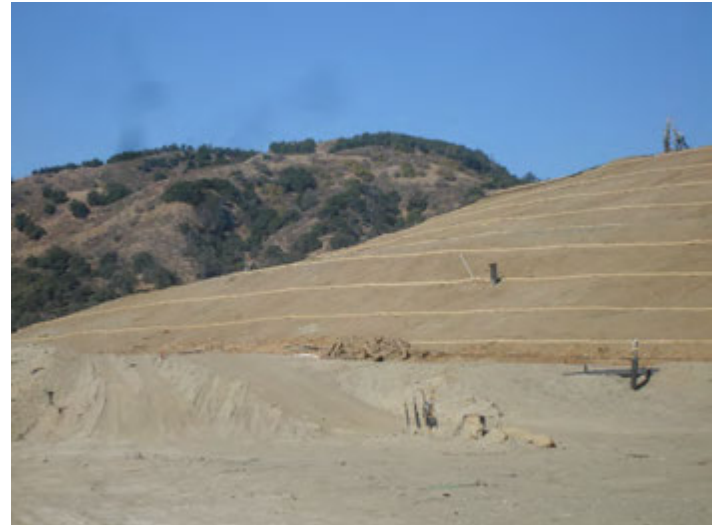
Photo 237: CC3B Top Deck: October 23, 2018

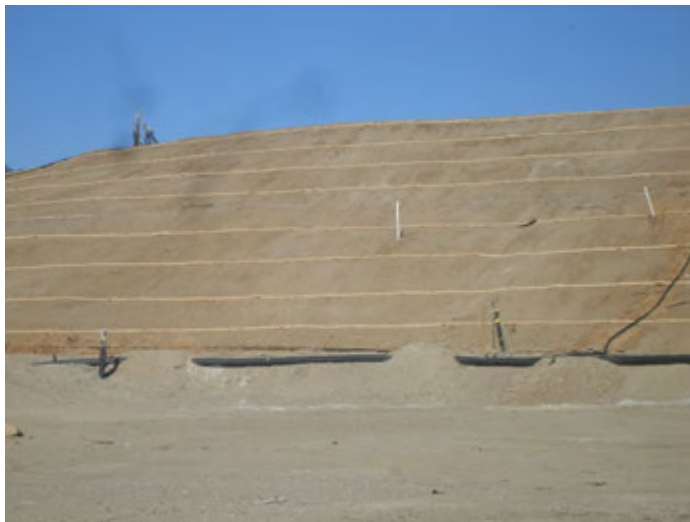
Photo 238: CC3B Top Deck: October 23, 2018

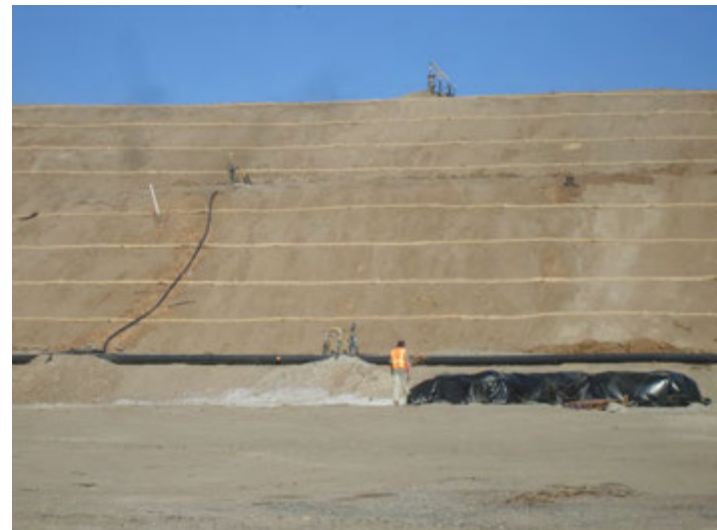
Photo 239: CC3B Top Deck: October 23, 2018

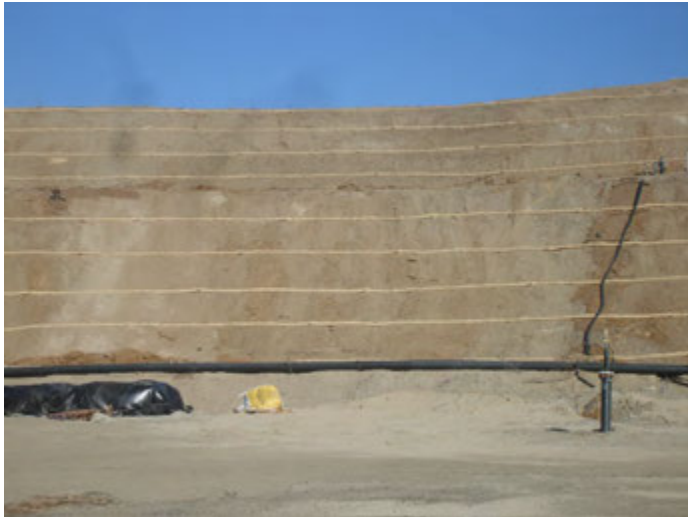
Photo 240: CC3B Top Deck: October 23, 2018

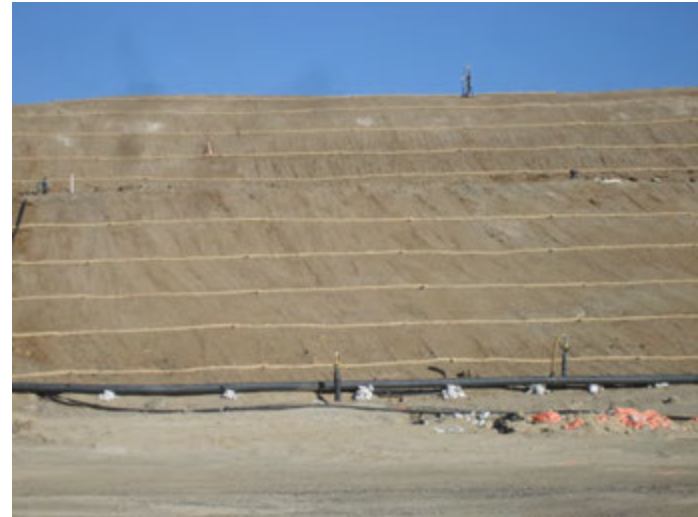
Photo 241: CC3B Top Deck: October 23, 2018

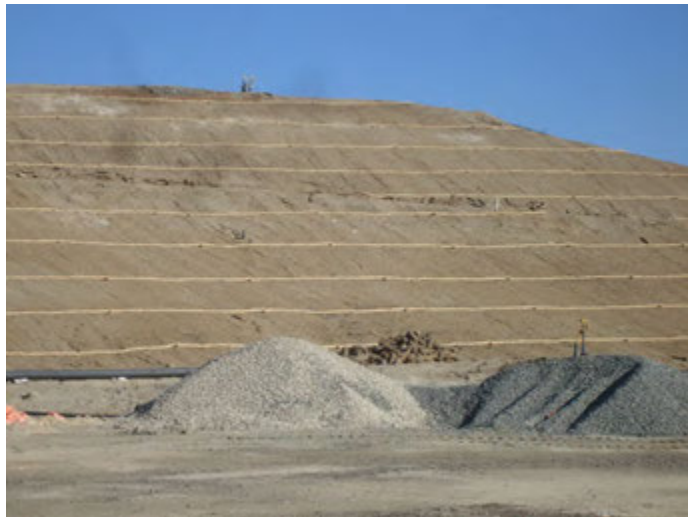
Photo 242: CC3B Top Deck: October 23, 2018

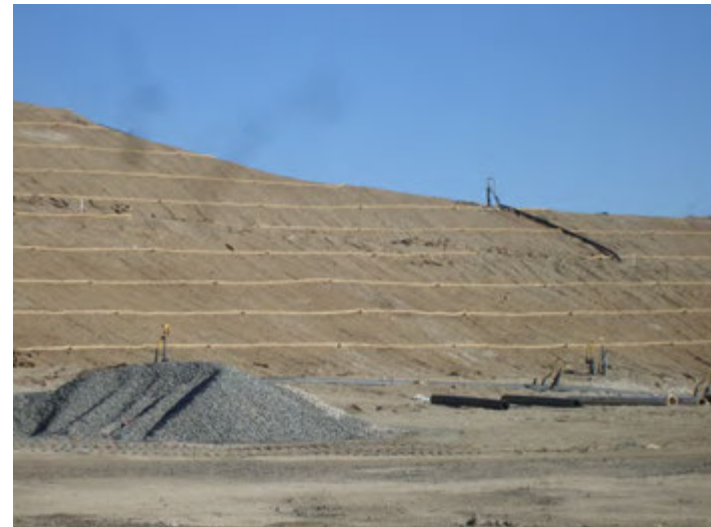
Photo 243: CC3B Top Deck: October 23, 2018

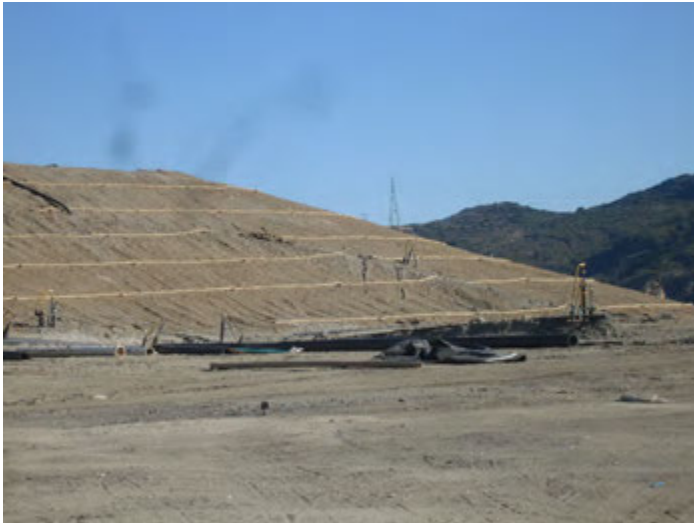
Photo 244: CC3B Top Deck: October 23, 2018

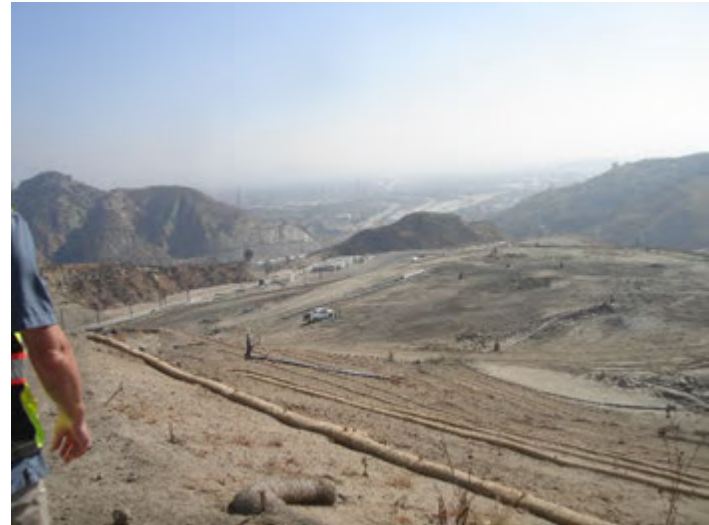
Photo 245: CC3B Top Deck: October 23, 2018

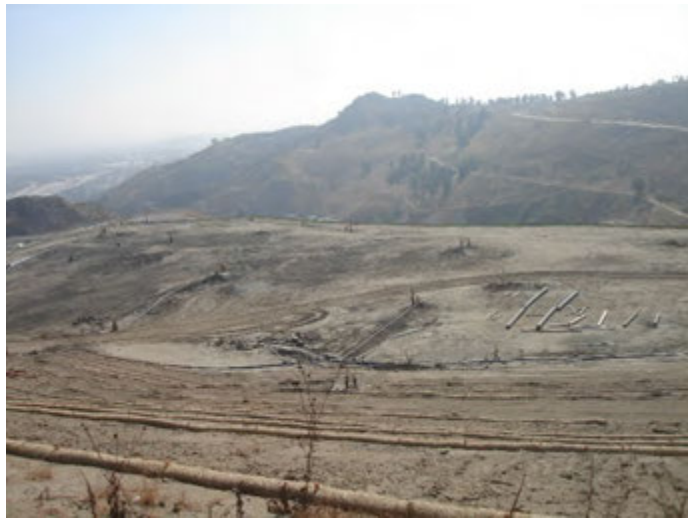
Photo 246: CC3B Top Deck: November 6, 2018

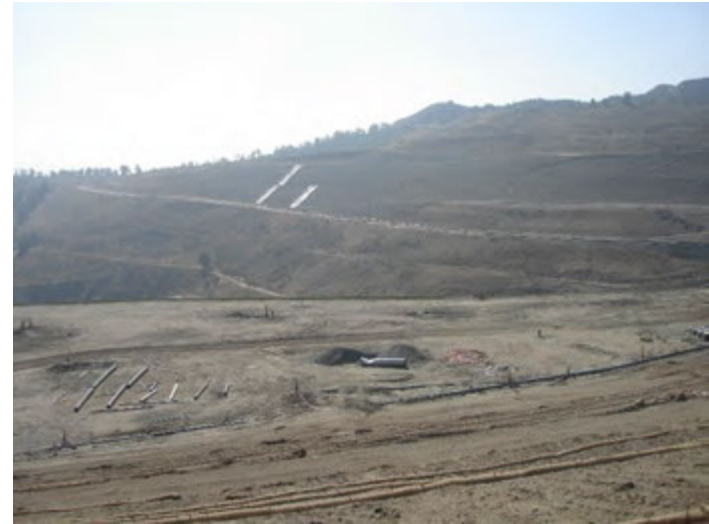
Photo 247: CC3B Top Deck: November 6, 2018

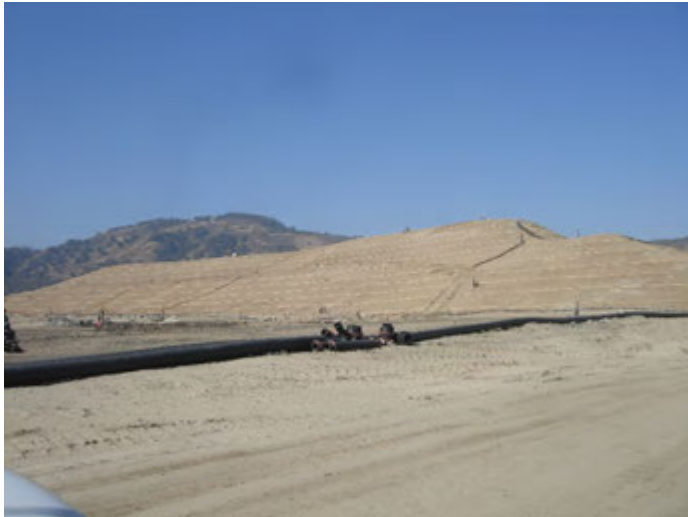
Photo 248: CC3B Top Deck: November 6, 2018

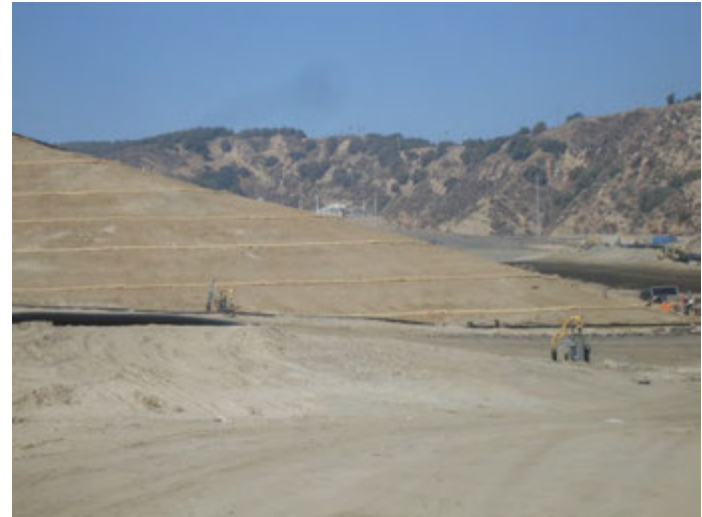
Photo 249: CC3B Top Deck: November 6, 2018

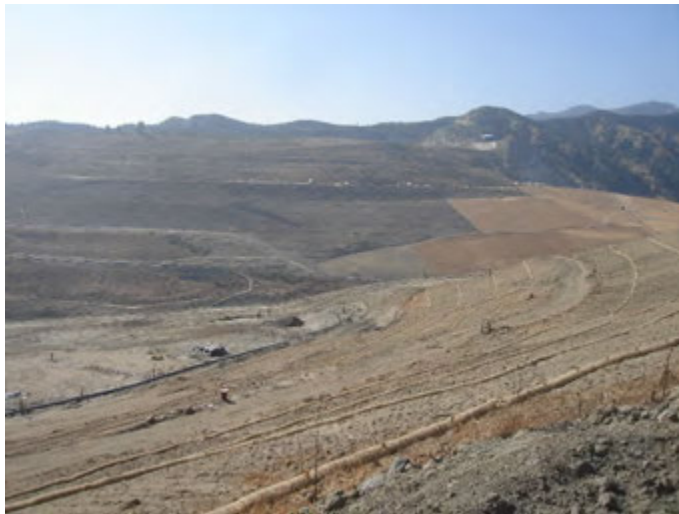
Photo 250: CC3B Top Deck: November 6, 2018

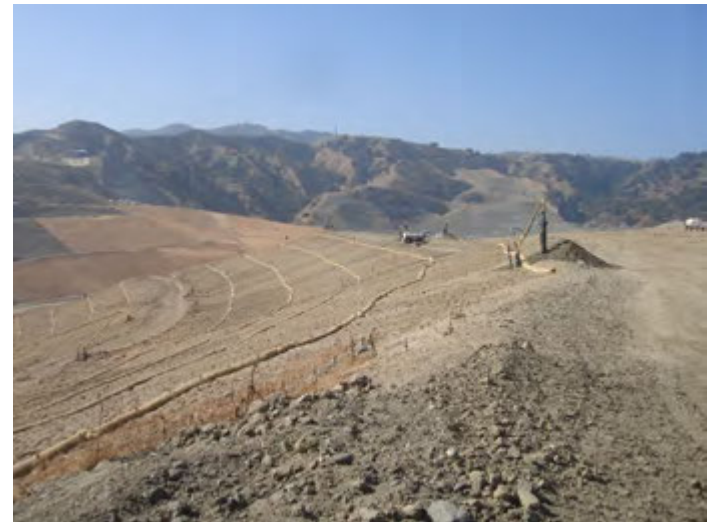
Photo 251: CC3B Top Deck: November 6, 2018

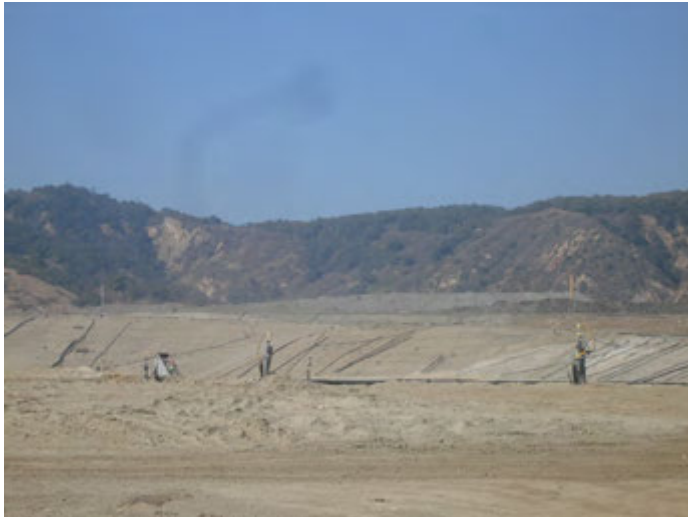
Photo 252: CC3B Top Deck: November 6, 2018

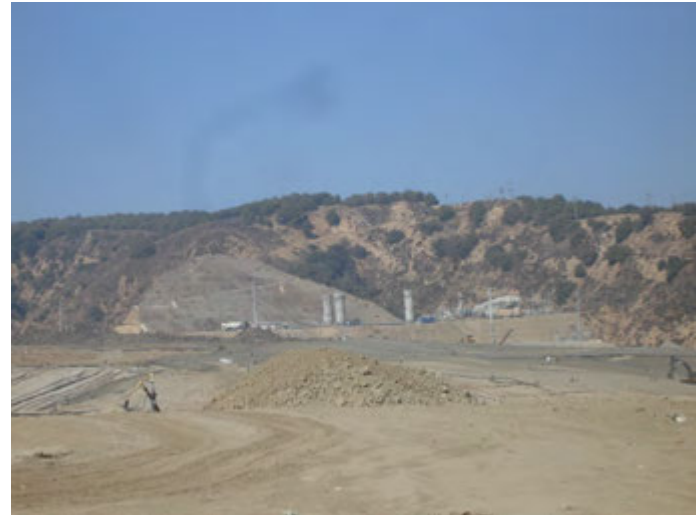
Photo 253: CC3A Top Deck: November 6, 2018

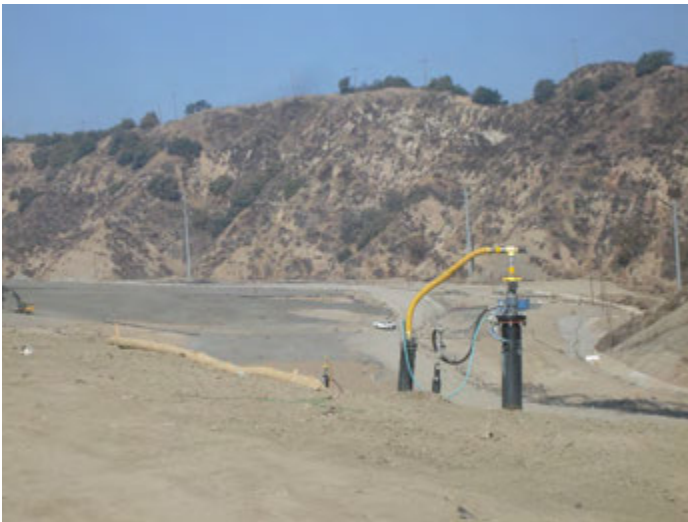
Photo 254: CC3A Top Deck: November 6, 2018

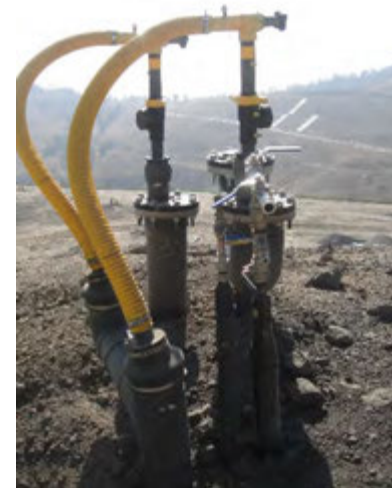
Photo 255: CC3A Top Deck: November 6, 2018

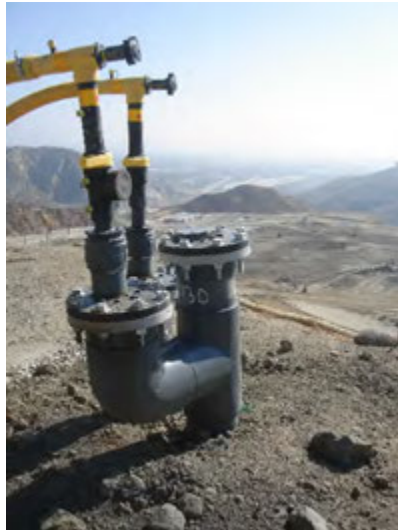
Photo 256: CC3A Top Deck: November 6, 2018

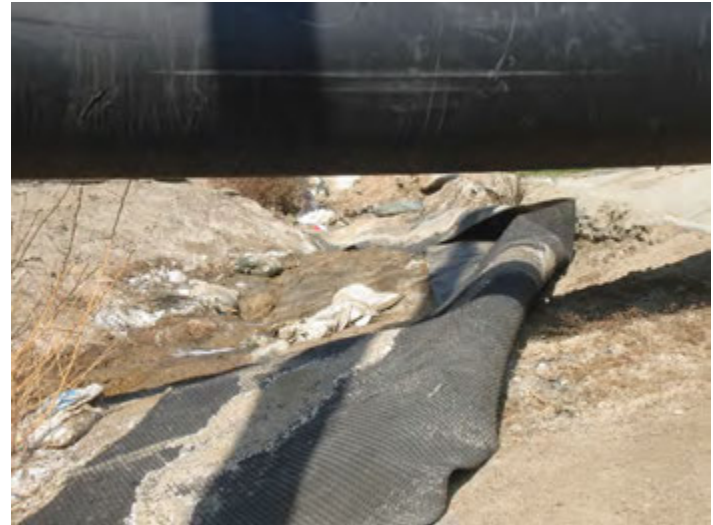
Photo 257: CC3A Top Deck: November 6, 2018

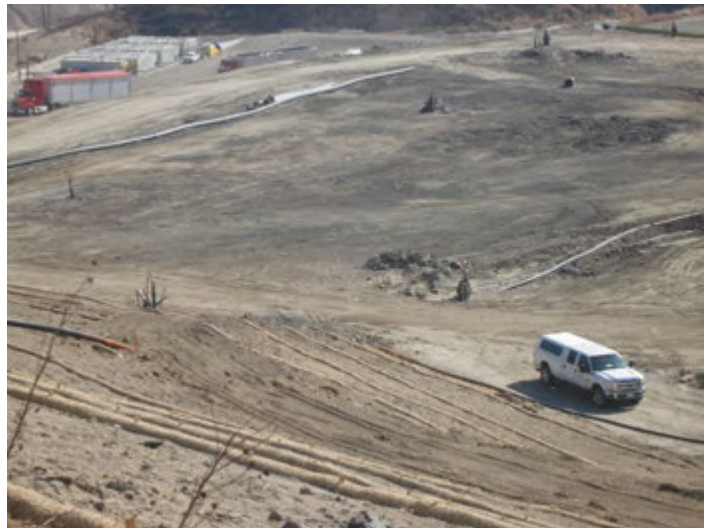
Photo 262: CC3B Alluvial Slope Leak: November 6, 2018

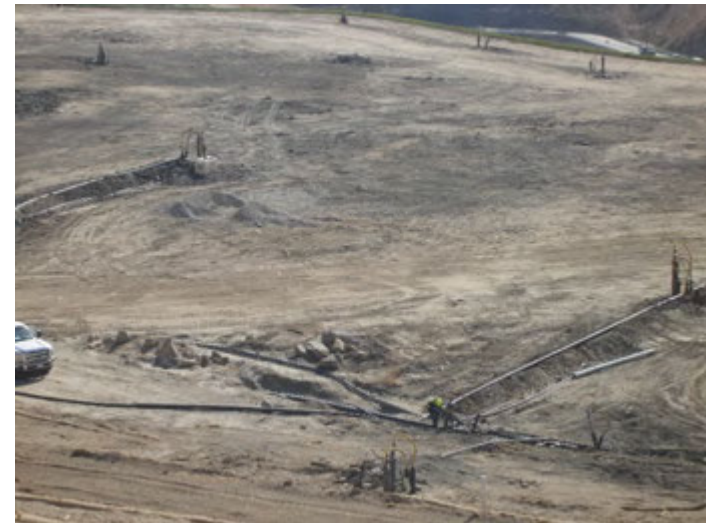
Photo 263: CC3B Top Deck: November 20, 2018

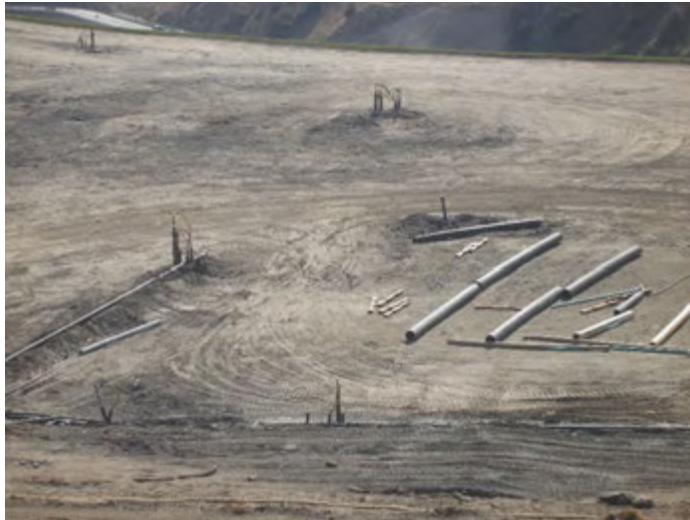
Photo 264: CC3B Top Deck: November 20, 2018

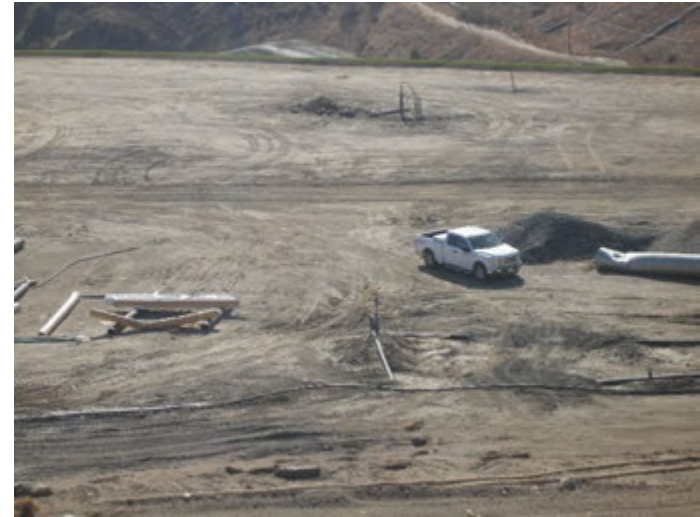
Photo 265: CC3B Top Deck: November 20, 2018

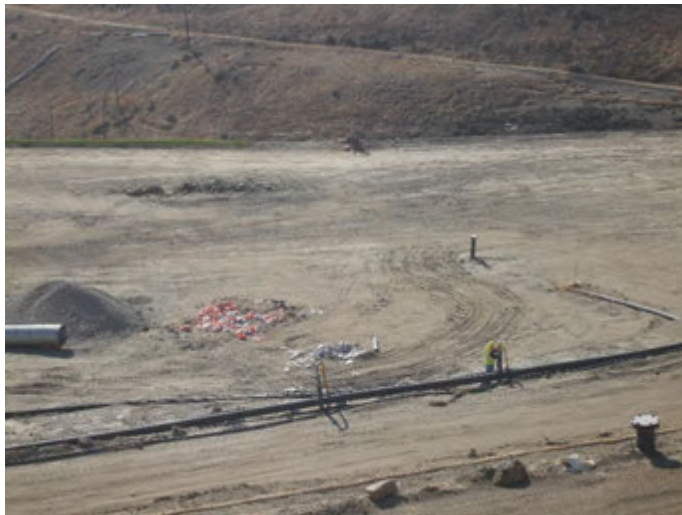
Photo 266: CC3B Top Deck: November 20, 2018

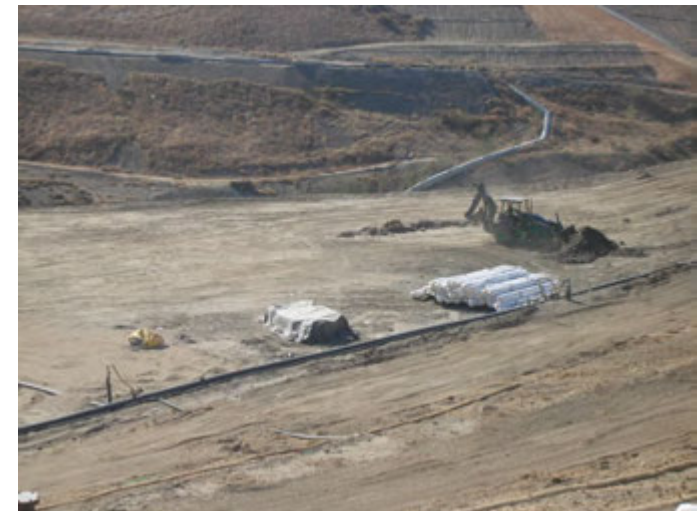
Photo 267: CC3B Top Deck: November 20, 2018

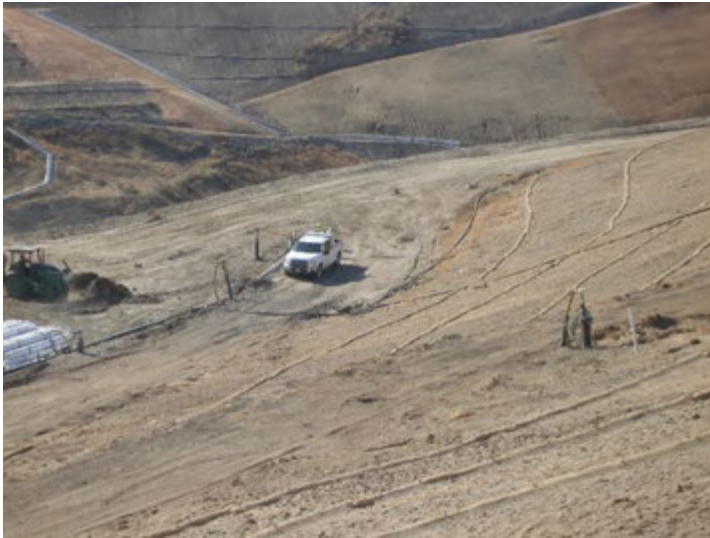
Photo 268: CC3B Top Deck: November 20, 2018

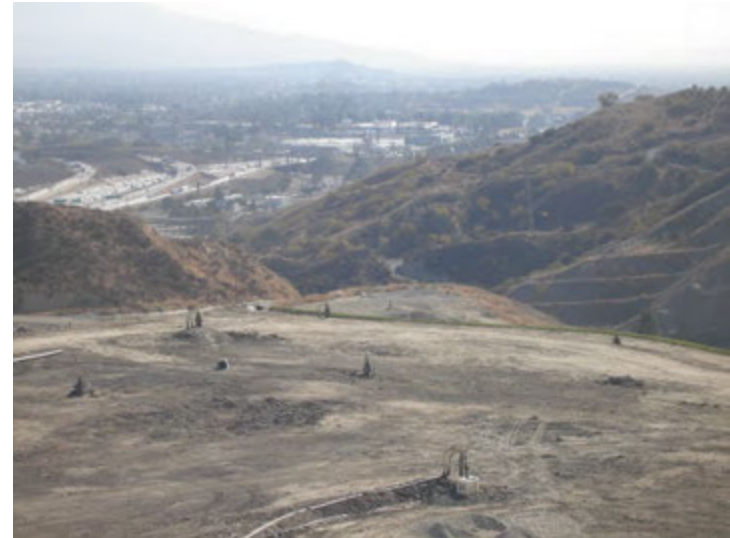
Photo 269: CC3B Top Deck: November 20, 2018

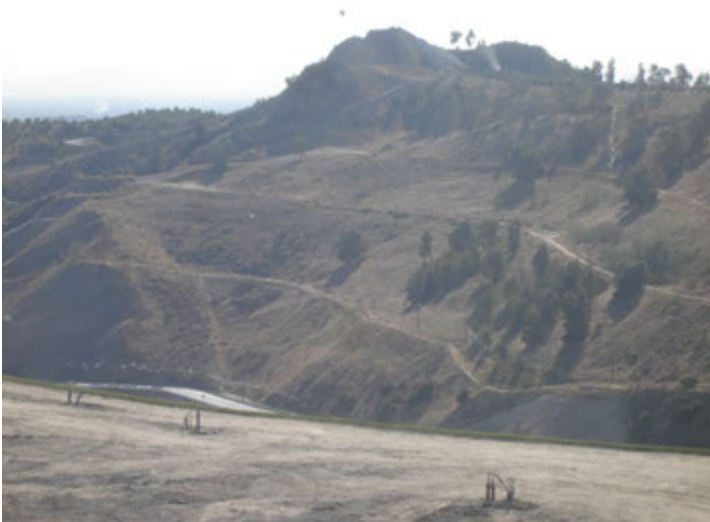
Photo 270: CC3B Top Deck: November 20, 2018

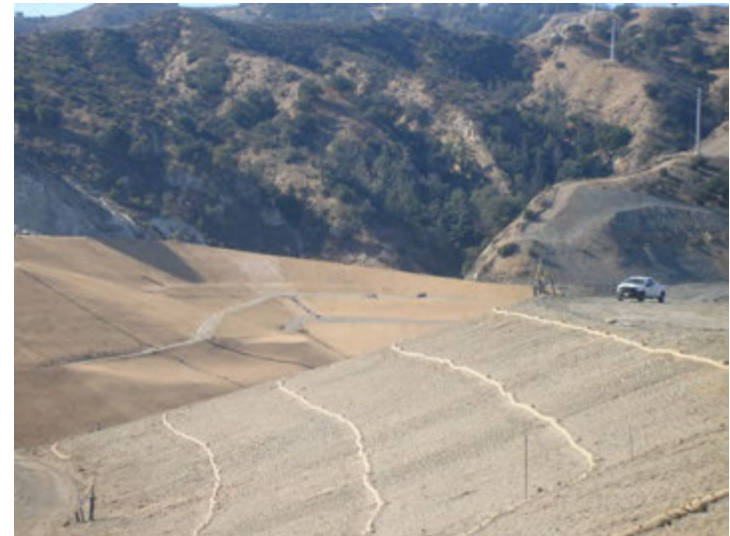
Photo 271: CC3B Top Deck: November 20, 2018

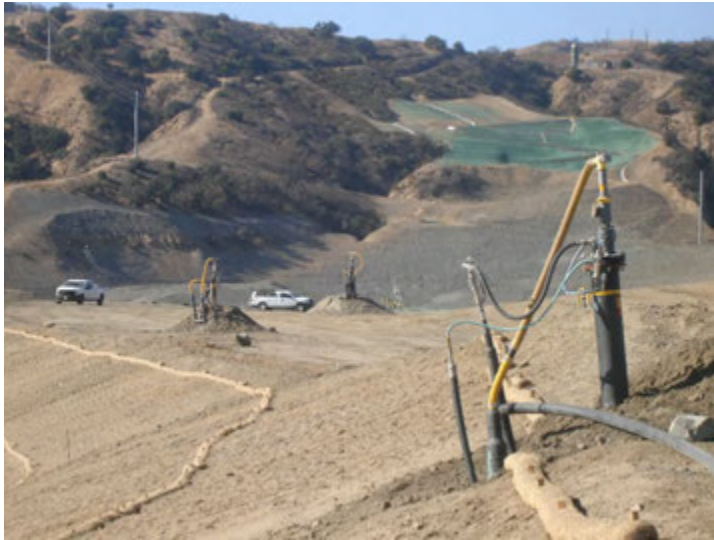
Photo 272: CC3B Top Deck: November 20, 2018

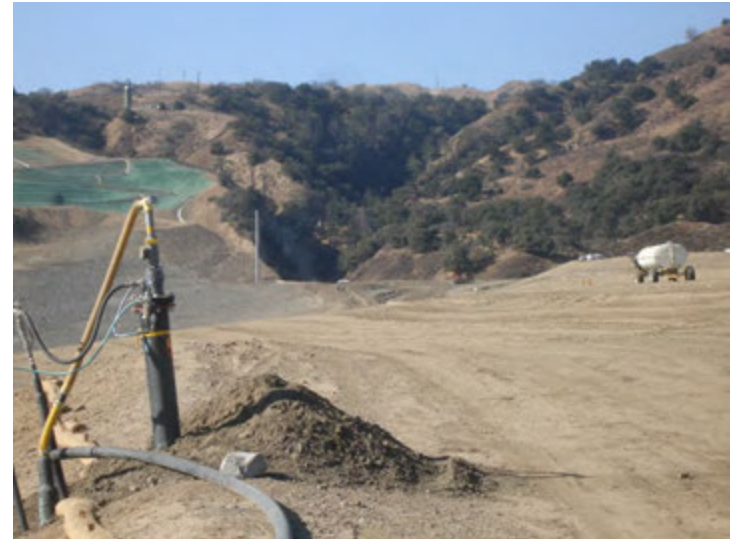
Photo 273: CC3A Top Deck: November 20, 2018

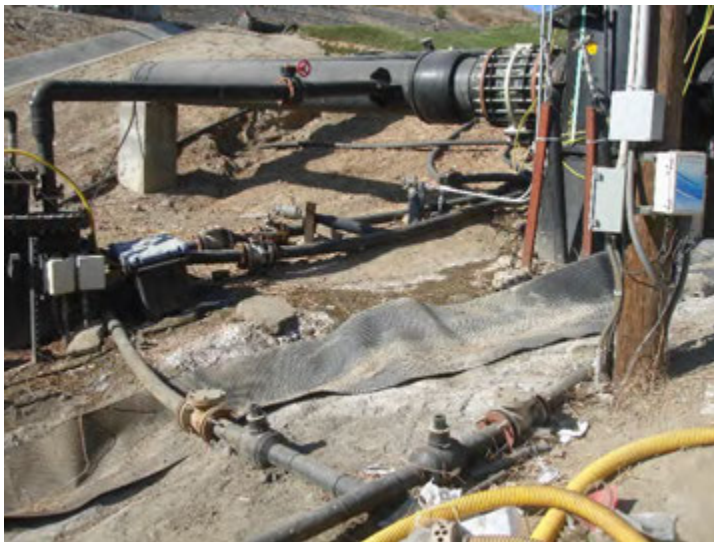
Photo 274: CC3A Top Deck: November 20, 2018

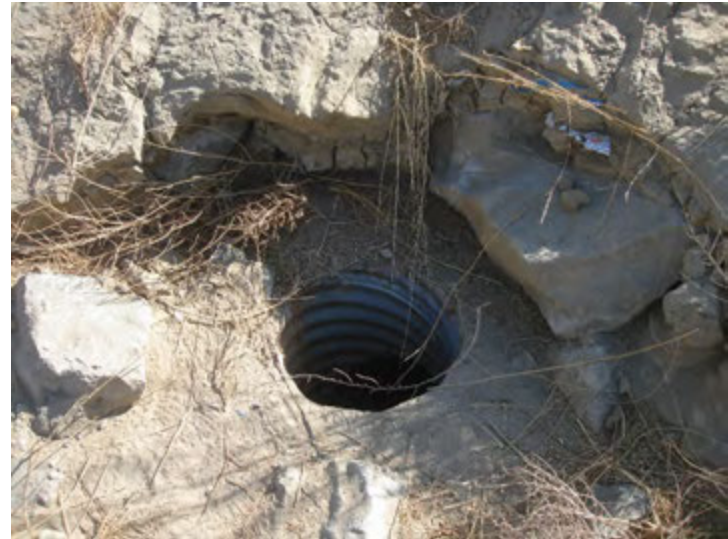
Photo 277: CC3B Alluvial Slope Leak: November 20, 2018

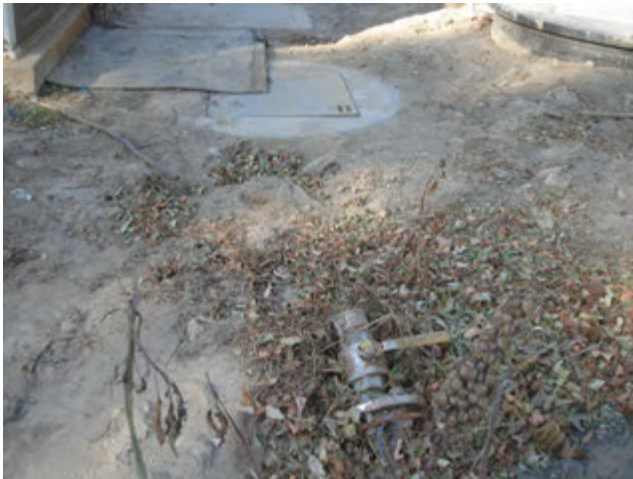
Photo 278: CC3B Low Flow Drain: November 20, 2018

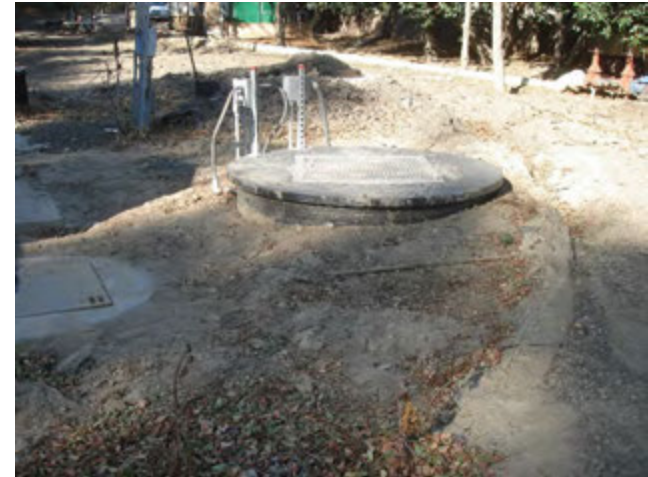
Photo 279: Sewer Connection: November 20, 2018

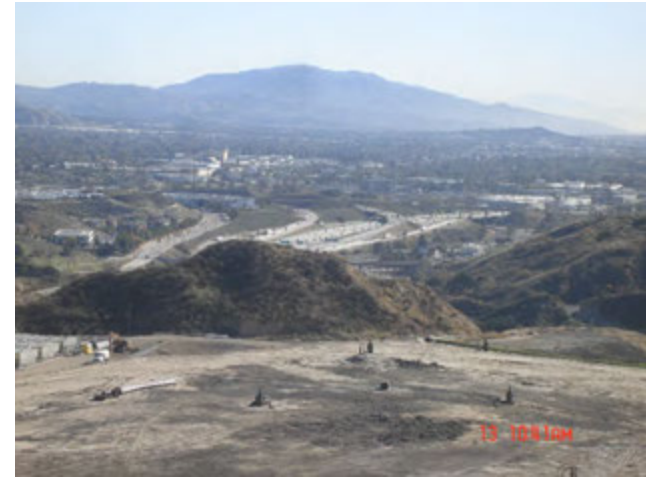
Photo 281: CC3B Top Deck: December 13, 2018

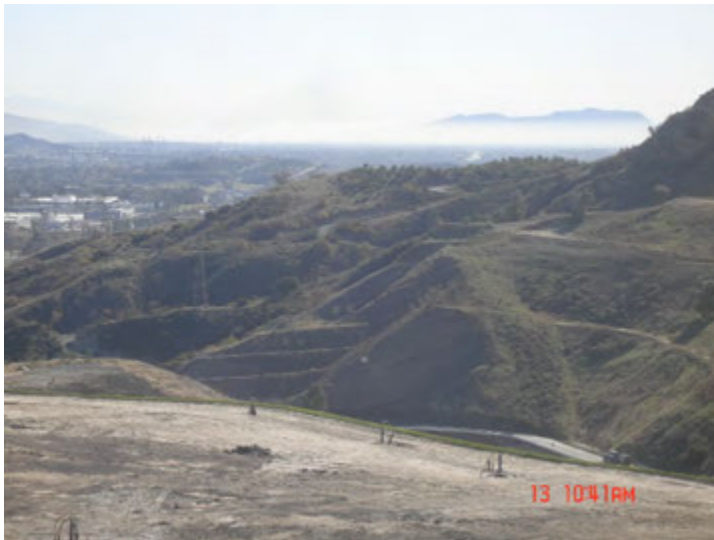
Photo 282: CC3B Top Deck: December 13, 2018

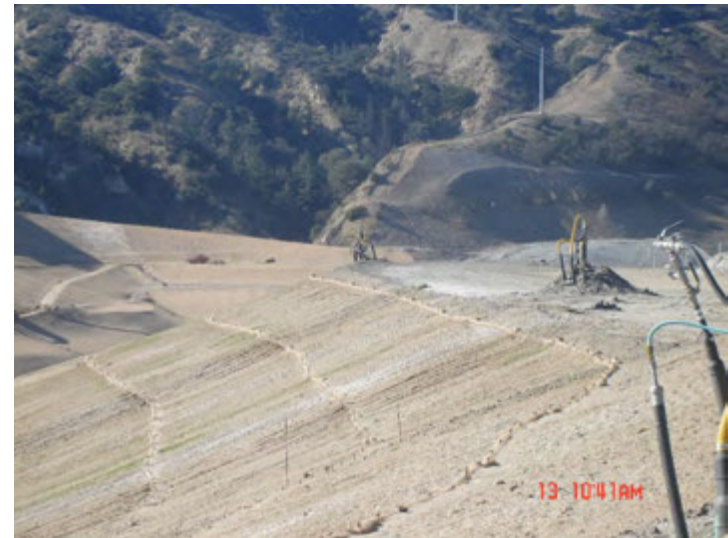
Photo 284: CC3B Top Slope: December 13, 2018

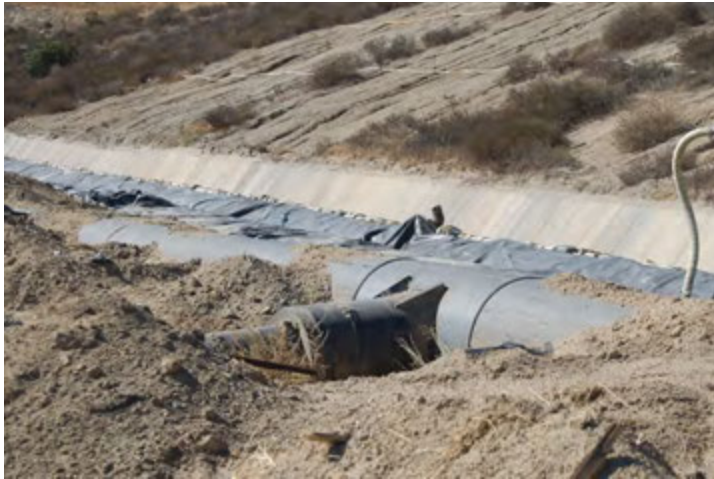
**Photo 285: Sacrificial Liner Replacement Near County Sage:
October 13, 2018**

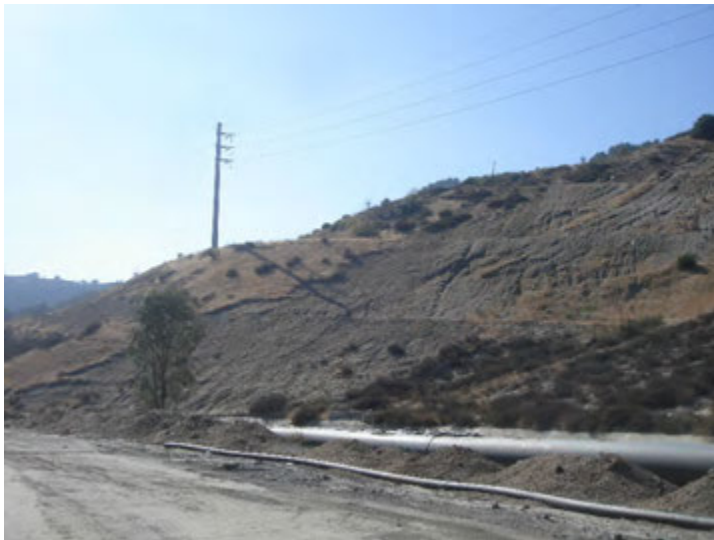
Photo 287: County Sage Mitigation Area Slope: November 6, 2018

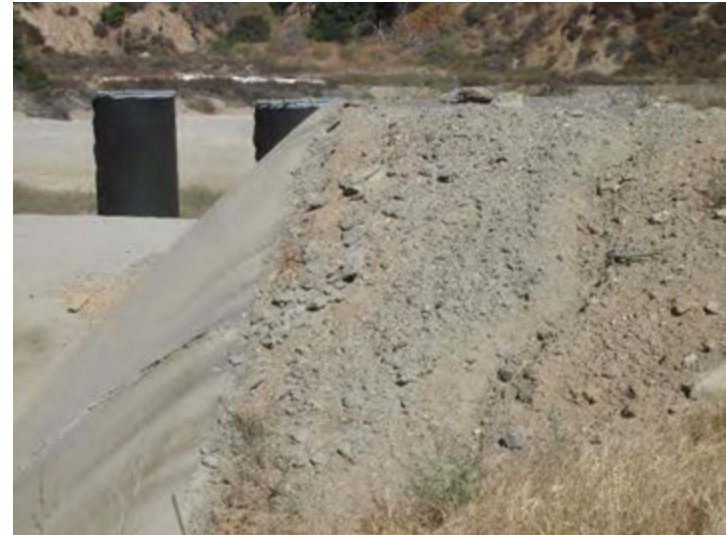
Photo 298: Basin D Westside Channel High Flow Outlet: October 23, 2018

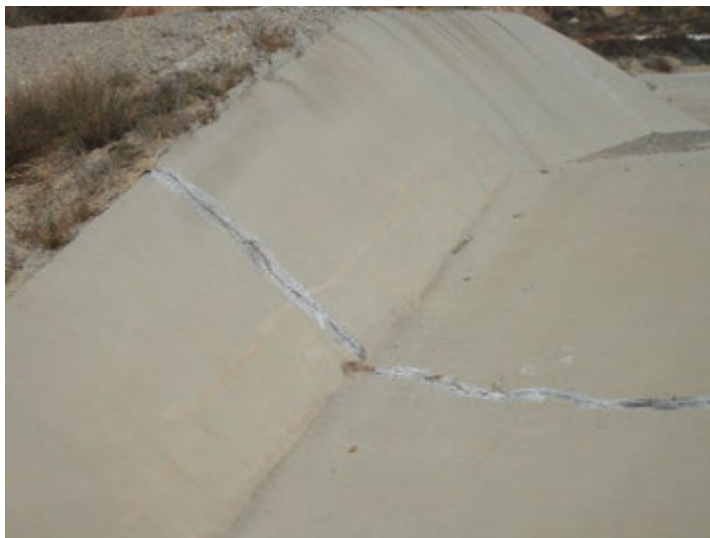
Photo 299: Basin D Westside Channel High Flow Outlet: October 23, 2018

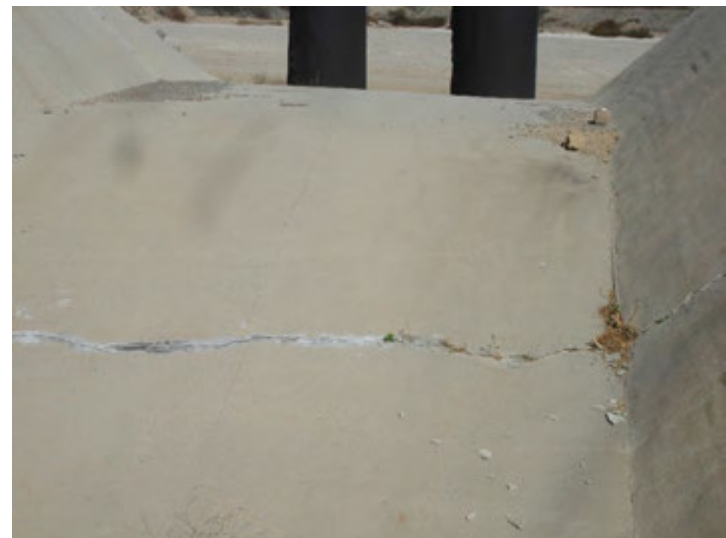
Photo 300: Basin D Westside Channel High Flow Outlet: October 23, 2018

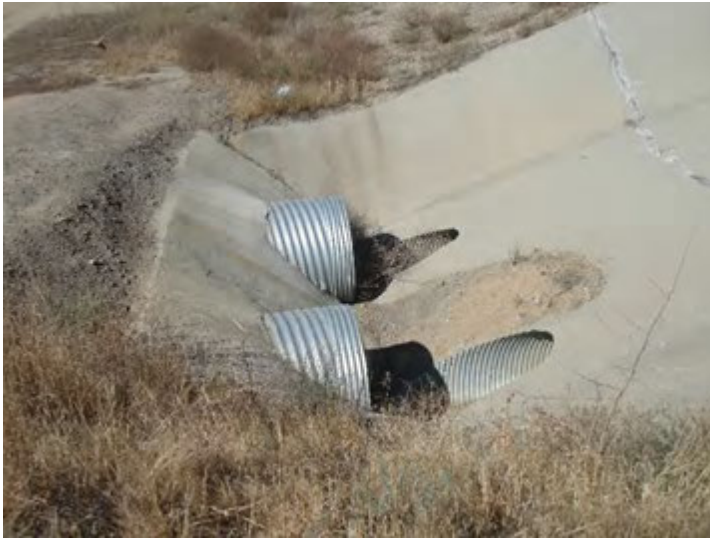
Photo 301: Basin D Westside Channel High Flow Outlet: October 23, 2018

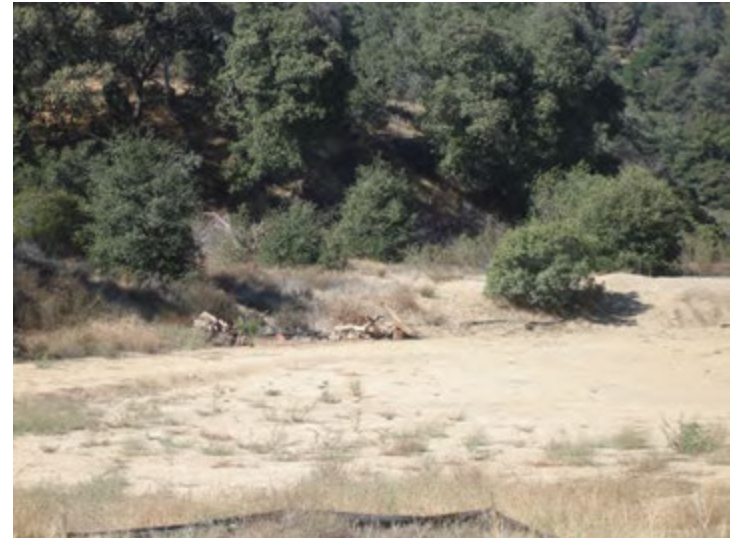
Photo 302: Basin D Adjacent Wood Stockpile: October 23, 2018

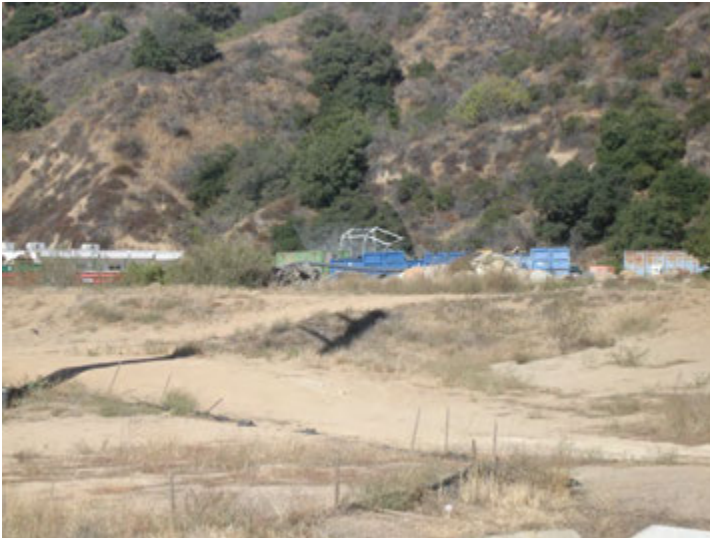
Photo 303: Basin D Adjacent Wood Stockpile: October 23, 2018

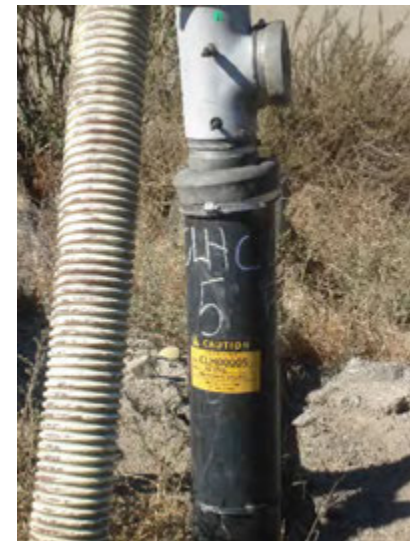
Photo 304: Basin D Adjacent Well with Localized Odors: October 23, 2018

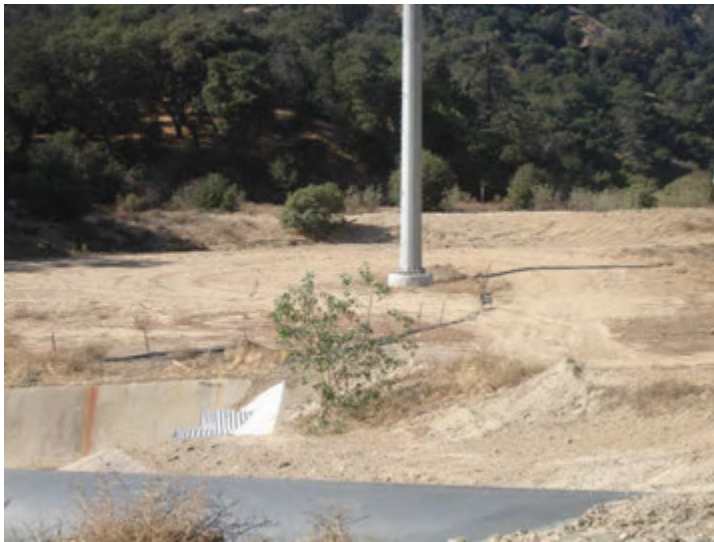
Photo 305: Basin D Wood Stockpile Removed: November 20, 2018

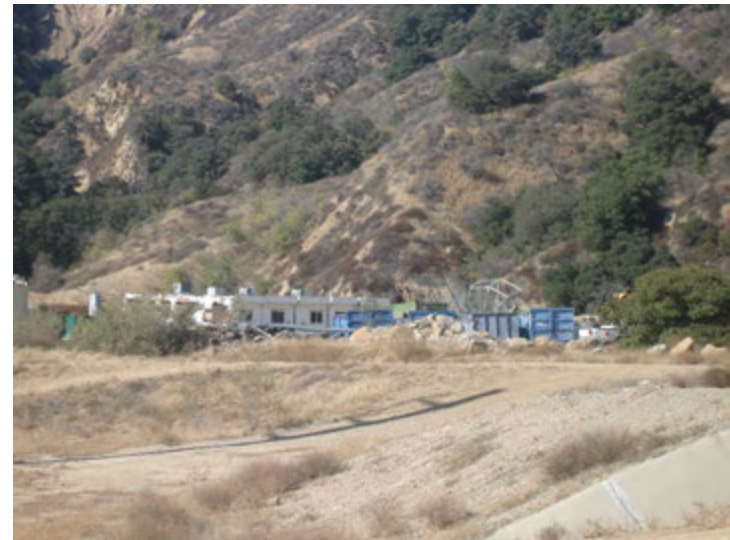
Photo 306: Basin D Wood Stockpile Removed: November 20, 2018

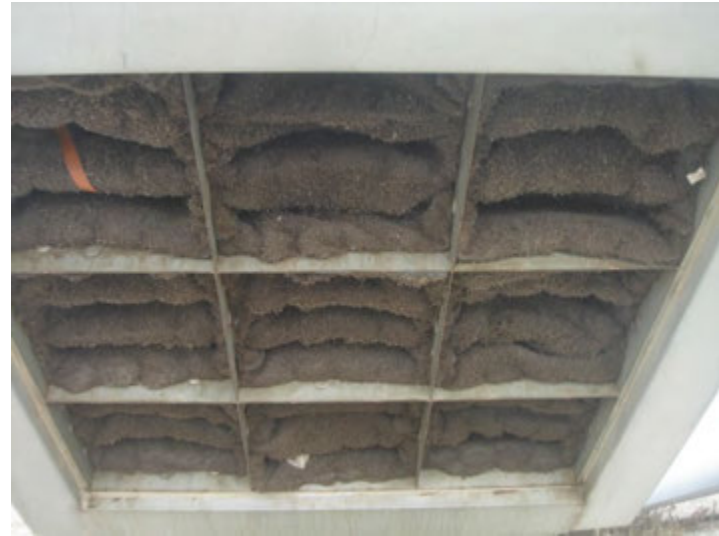
Photo 365: Gat to Energy Turbine Replaced: October 23, 2018

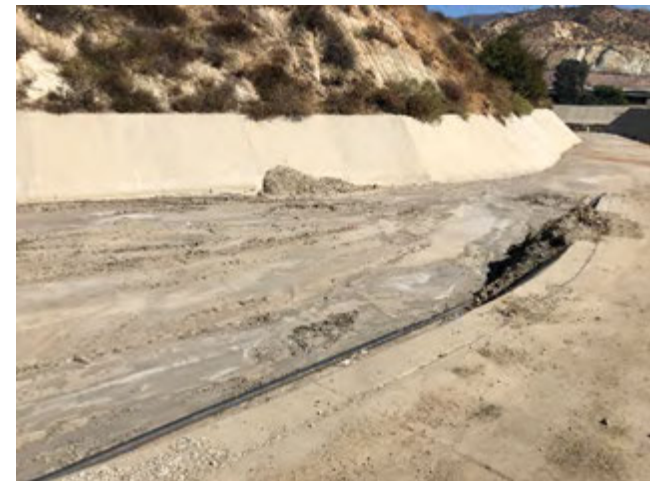
Photo 383: Terminal Basin Westside Drainage Channel: October 23, 2018

- Well 3013D was hot to the touch and had a burnt odor.
- The dirt slopes adjacent to the westside inlet channel into the terminal basin were graded and repaired.
- The terminal basin had ponding water around the outlet risers. The slopes below the main access road were graded and covered with jute netting.
- Sage mitigation Deck B was being irrigated to condition the soil to raise the pH.
- The prior Deck A subsurface oxidation near PCW 224 was extinguished.

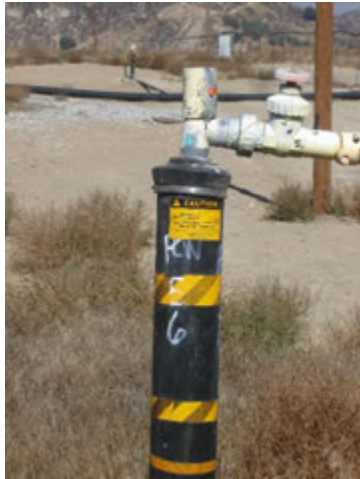
**Photo 460: Deck A Sage Mitigation Area High Level CO Wells:
October 23, 2018**

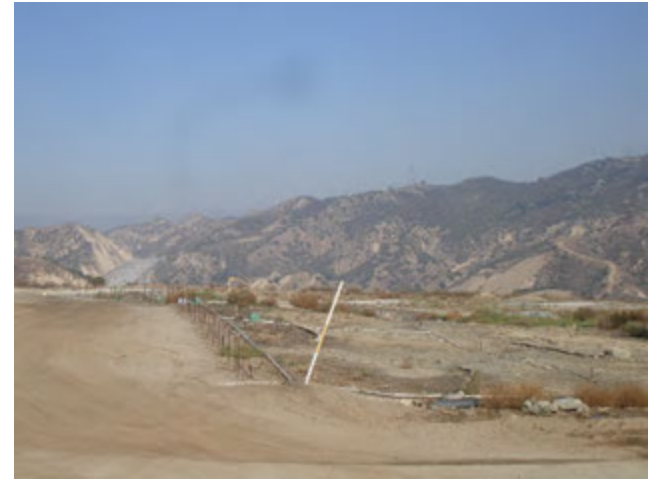
**Photo 461: Deck A Sage Mitigation Area High Level CO Wells:
October 23, 2018**

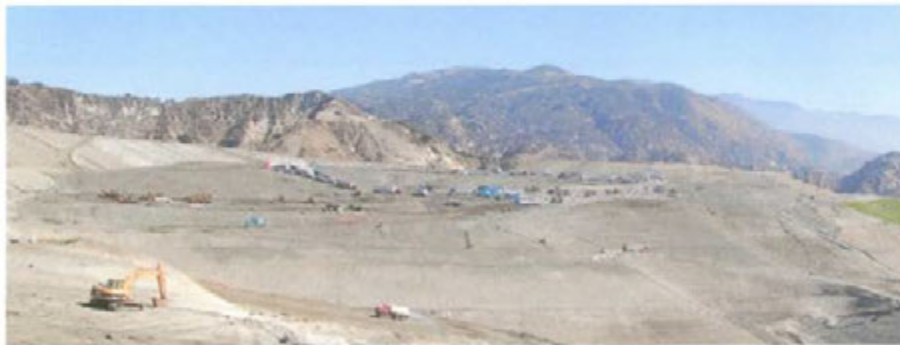
Photo 2: Waste placement at Cell CC4 – Part 1

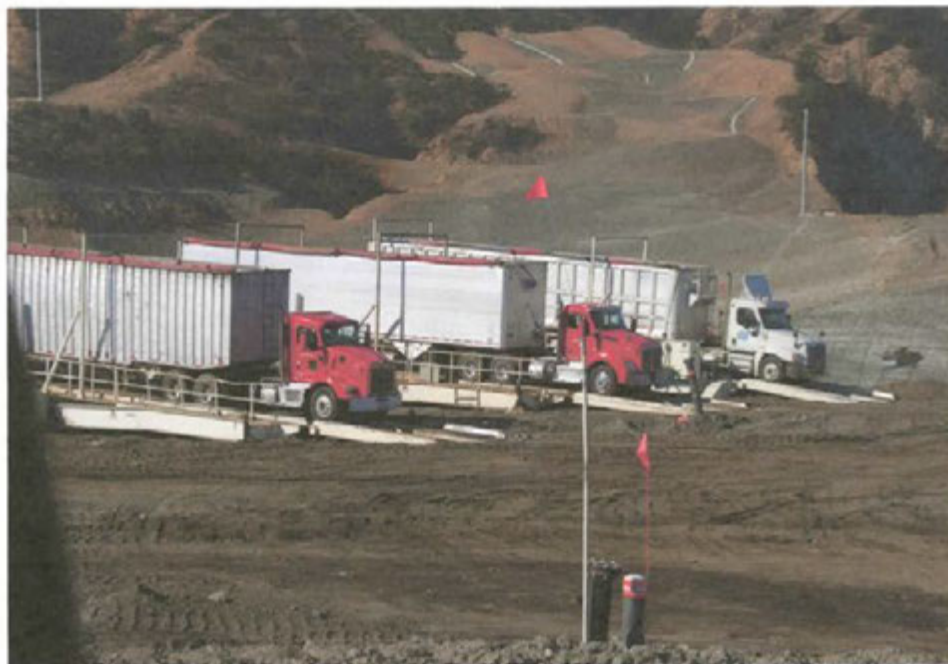
Photo 3: Tilters in use at waste face on Cell CC4 Part 1

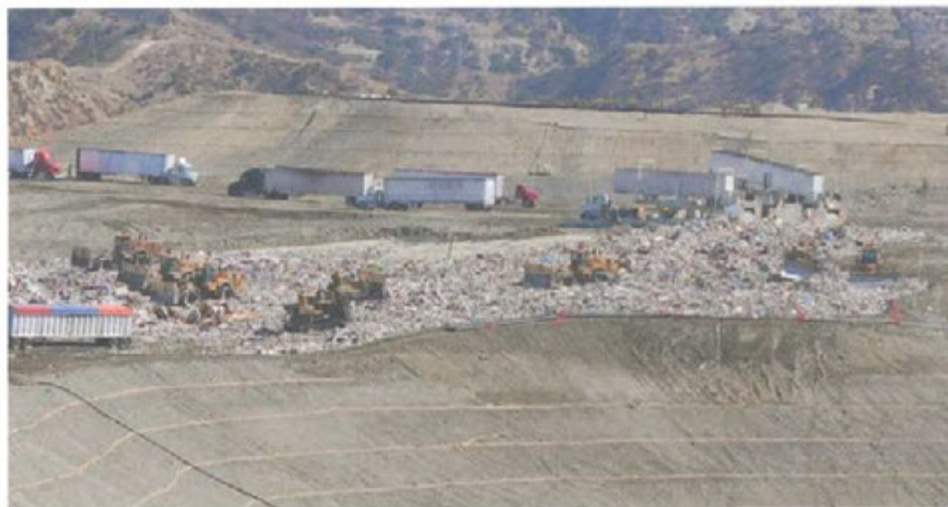
Photo 4: Interim over in use at Cell CC4 Part 1
