**Sunshine Canyon Landfill
Independent Monitor
Quarterly Site Monitoring Status Report
October 1, 2018 – December 31, 2018**

January 9, 2019

The attached Quarterly Site Monitoring Status Report for the Sunshine Canyon Landfill dated January 9, 2019 is the Fourth Quarterly Report for 2018, issued by UltraSystems. This report covers the monitoring period from October 1, 2018 through December 31, 2018 and is prepared for the City of Los Angeles Department of City Planning and the County of Los Angeles Department of Regional Planning.

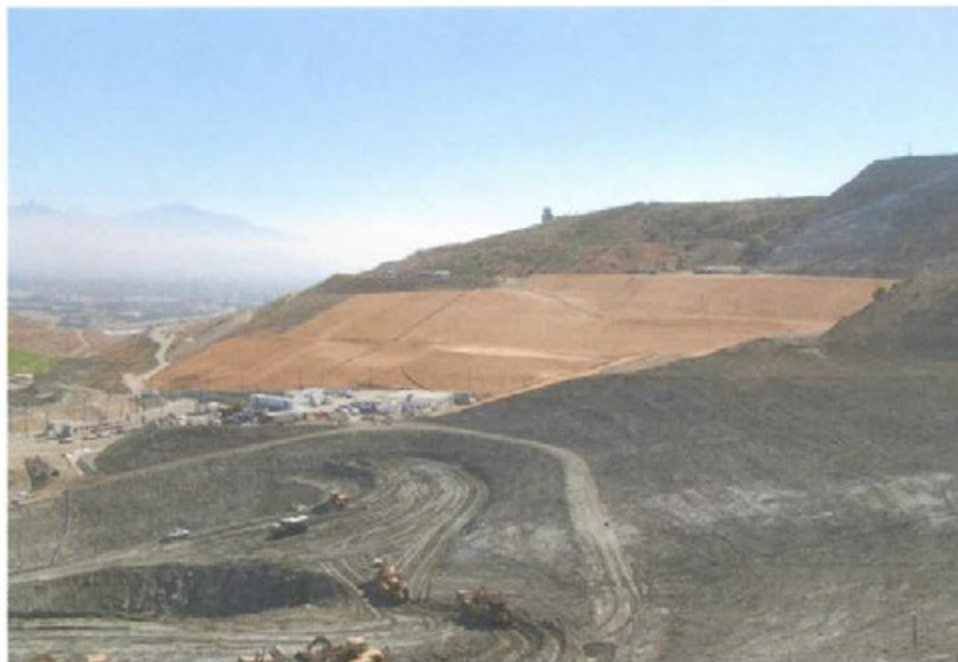
<p>results. Their plan is to direct the water toward the toe of the buttress where a retention basin currently exists (Photo 10) and pump the water out.</p> <ul style="list-style-type: none"> • Basin B <ul style="list-style-type: none"> – Basin is clean • Basin D <ul style="list-style-type: none"> – Basin is clean – Vegetation including a small bush growing through the crack observed in previous visits has been removed • Channels <ul style="list-style-type: none"> – all clean • Moat around Cell CC3 Part 2 <ul style="list-style-type: none"> – a fair amount of sediment has accumulated and could cause problem to the pump slated to empty the moat during/after a storm (Photo 11)
<p>Excavation for Cell 4 Phase 3</p> <ul style="list-style-type: none"> • Excavation was ongoing with scrapper and dozers • Compaction provided scrapers and dozers traffic, no rollers are used to compact the material • In place density and moisture control are monitored by nuclear gauge testing (Photo 12) • no sign of potential geotechnical issues – the different geologic formations in the area can be clearly seen <ul style="list-style-type: none"> – Horizontal drains are in place – Prism system in use to monitor movement

Figure 10: Potential retention basin at toe of buttress for Cell CC4 part 3

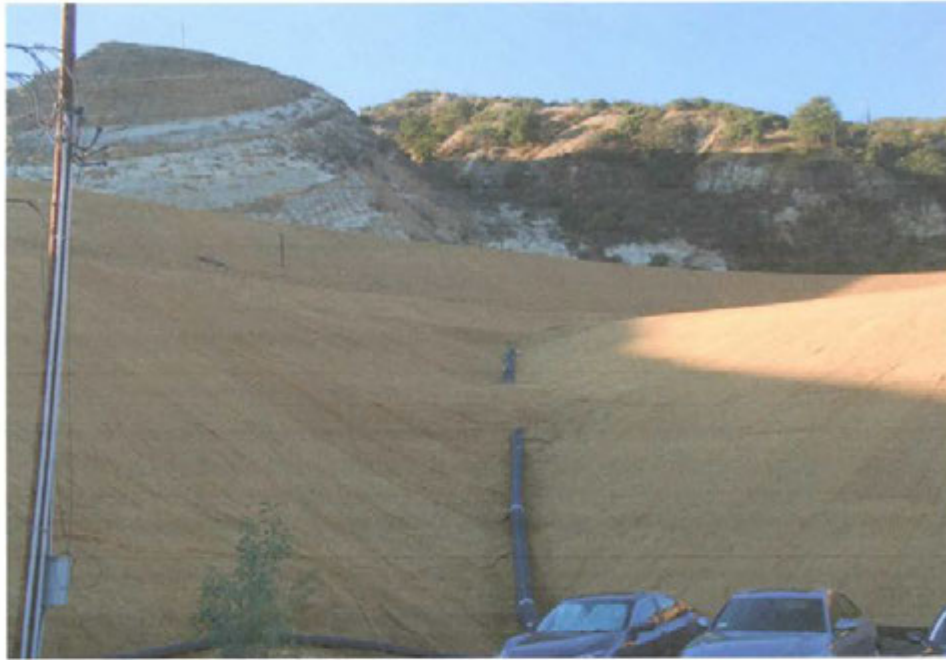
Photo 13: Erosion protection BMPs behind the administration buildings

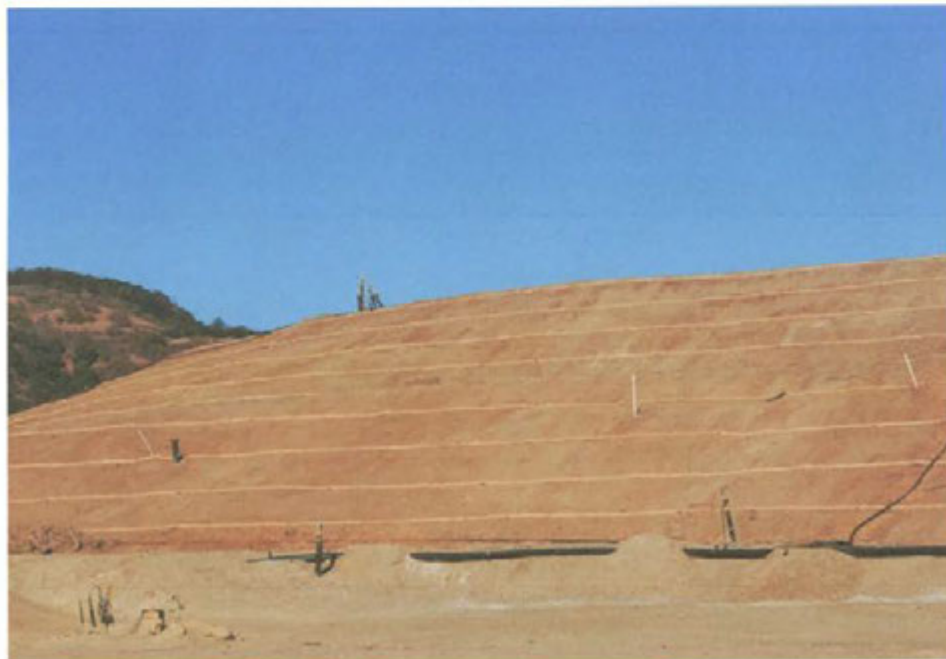
Photo 14: Erosion protection BMPs on the slopes of Cell CC3

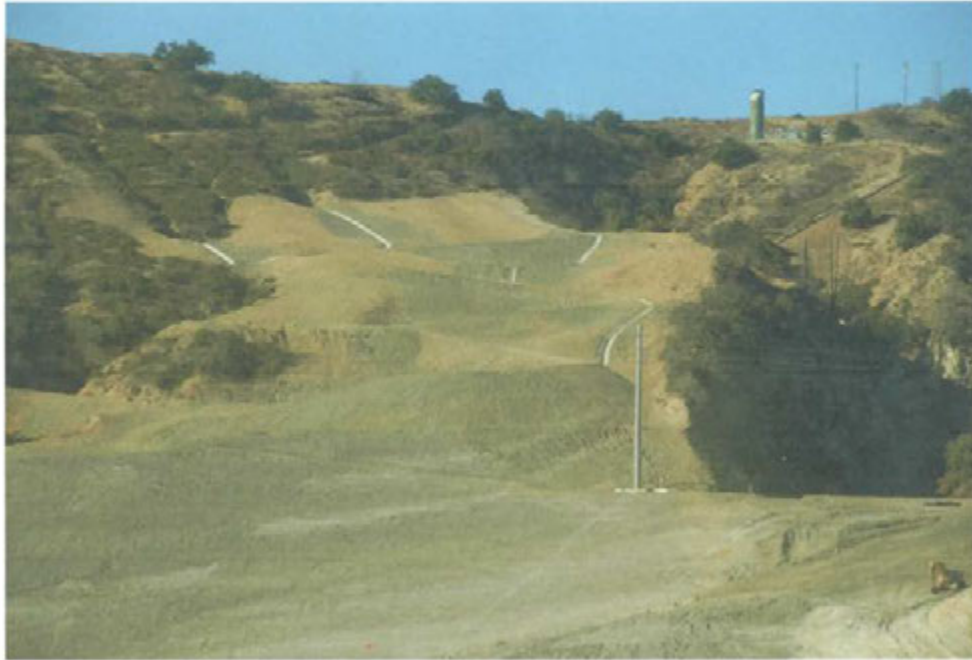
Photo 15: Shotcrete ditches on slope beneath Flare 3

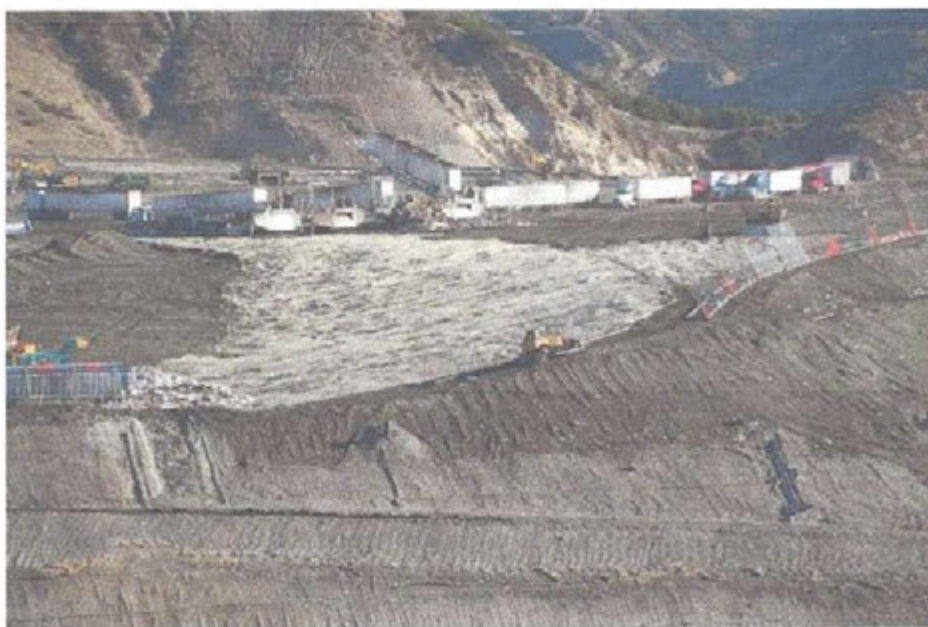
Photo 2: Waste placement at Cell CC4 with Interim over

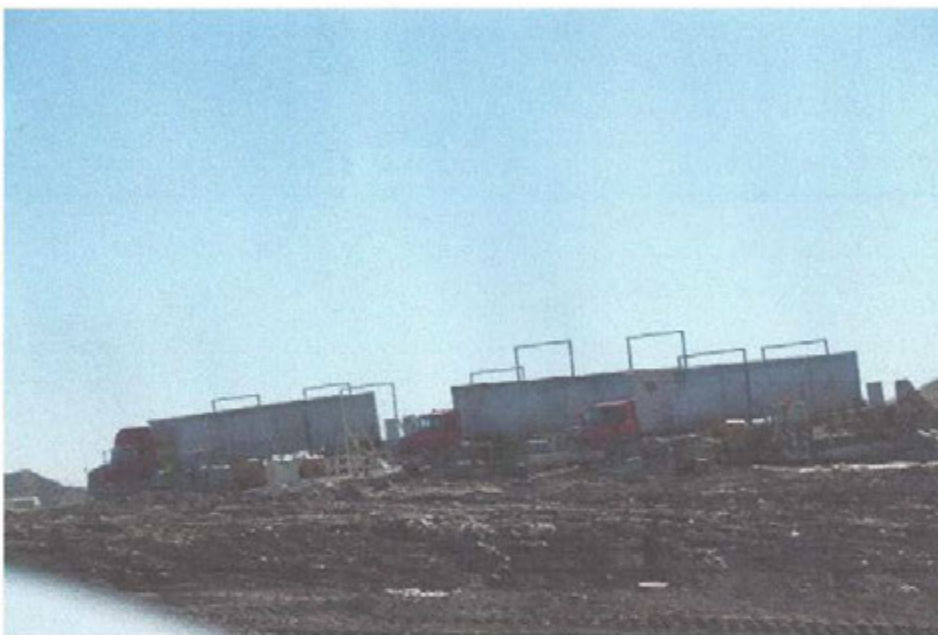
Photo 3: Tilters in use at waste face on Cell CC4

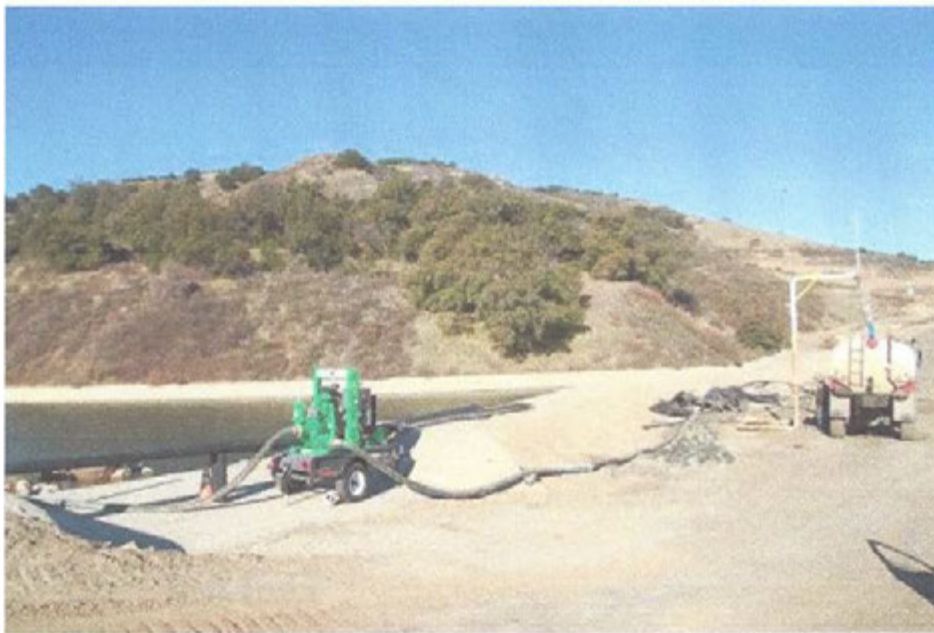
Photo 8: Water from basin A is used for construction by Sukut

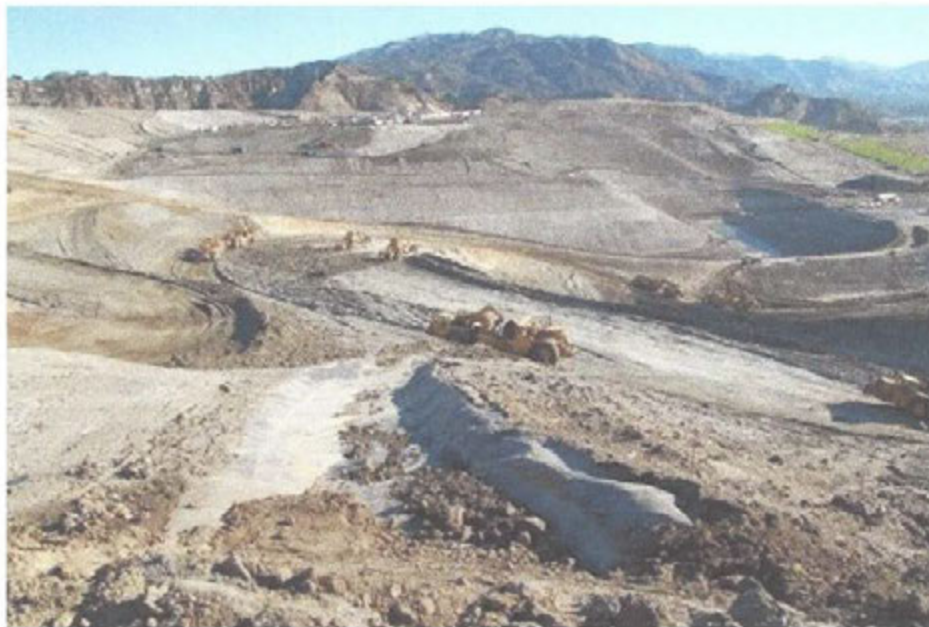
<p>responsible for managing the stormwater and whatever erosion results. Their plan is to direct the water toward through a lined swale (Photo 9) the toe of the buttress where a retention basin currently exists and pump the water out into the main concrete channel connected to the terminal basin. The plan worked well during the earlier storm.</p> <ul style="list-style-type: none"> • Basin D <p>Basin is clean</p> <ul style="list-style-type: none"> • Basin B <p>Basin is essentially clean with a small amount of sediment near the intake towers (Photo 10)</p> <ul style="list-style-type: none"> • Channels <p>Main channels are clean</p> <ul style="list-style-type: none"> • Outlet of concrete ditch along the access road to Flare 9-11 and the energy recovery plant is blocked by sediment (Photo 11) • Moat around Cell CC3 Part 2 <p>Moat around Cell CC4 Part 2</p> <ul style="list-style-type: none"> • water accumulated and was pumped out (Photo 12) <p>Access road to Flare 3</p> <ul style="list-style-type: none"> • A large erosion gully has formed on the fill at the end of the unfinished roadway and ditch (Photo 13) leading to a large erosion feature on the fill slope (Photo 14) leading

Photo 9: Lined swale to drain Basin A towards temporary basin at toe of buttress

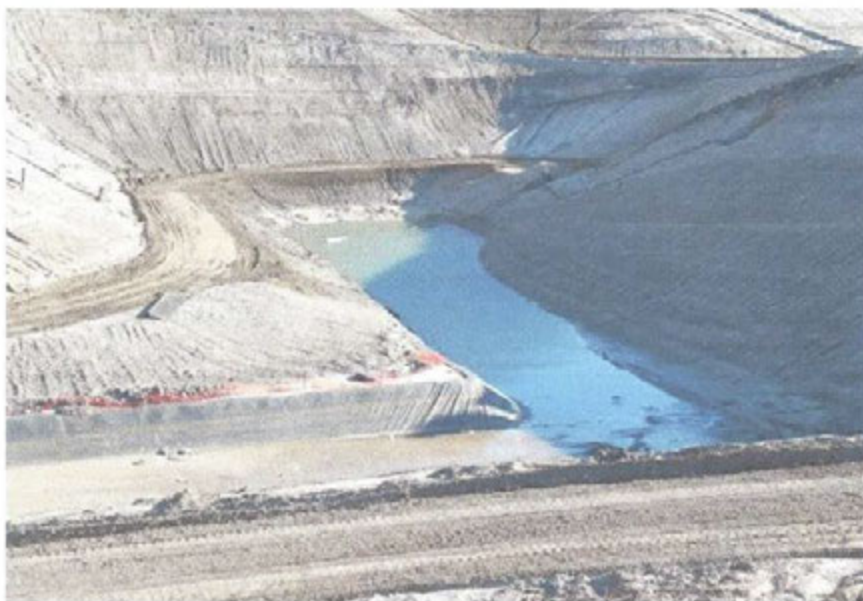
Photo 12: Pumping of water out of moat around Cell CC4 Part 2
